RE: City of Magnolia - Big Creek W Inspection (Columbia Co)

### OFFICE OF WATER QUALITY INSPECTION REPORT

AFIN: 14-00059 | PERMIT #: AR0043613 | DATE: 11/9/2021

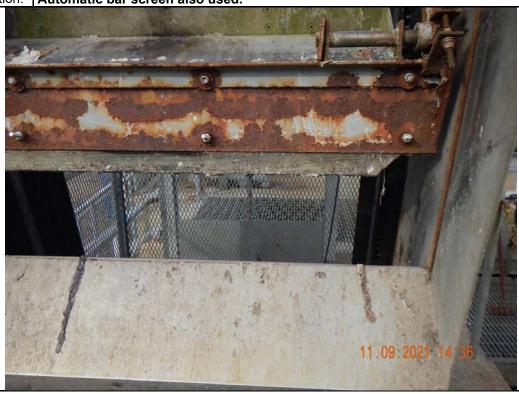
Photographer: Michael Young	Date:	11/9/2021	Time:	14:37
Witness:			Photo #:	4

Description: Grit screener below the grate. Parts for cyclonic driver replaced recently.

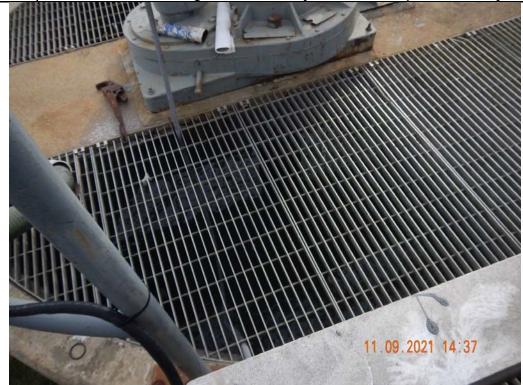
## Office of Water Quality Photographic Evidence Sheet Location: City of Magnolia - Big Creek WWTP Photographer: Michael Young Date: 11/9/2021 Time: 14:37 Witness: Photo #: 5

Description: Influent flow monitoring location for internal monitoring.

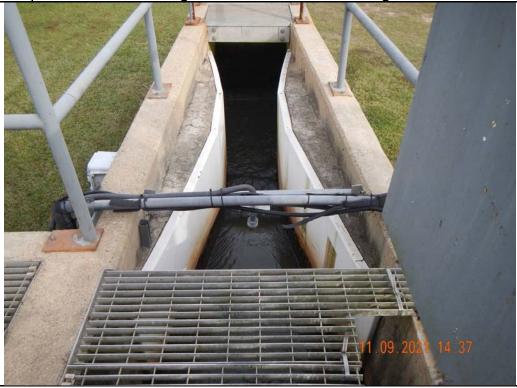
Photographer: Michael Young Date: 11/9/2021 Time: 14:38
Witness: Photo #: 6

Description: Chemical addition for pH adjustment is automatic based upon pH readings.

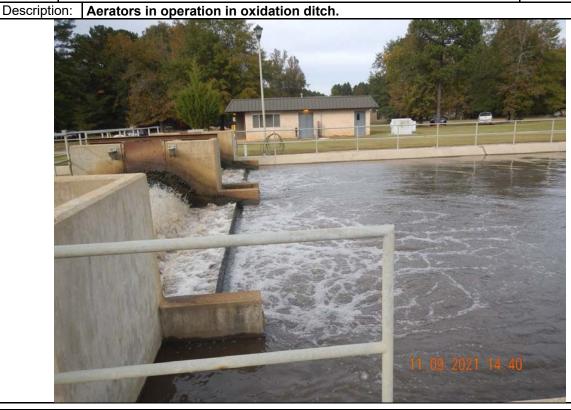
Photographer: Michael Young	Date: 11/9/2021	Time:	14:40
Witness:		Photo #	10

- 1.) At the time of the inspection, several aerators were not in operation (see Photos 10-11). This is a violation of permit condition Part III. (B.) (1.) (A.).
- 2.) Composite samples for WET testing and effluent monitoring are not being collected as a flow-weighted composite. This is a violation of permit conditions Part II. (10.) (B.) (iv.) (b.). and Part IV. (9.).

The first item states there were aerators not in operation. The fins on the rotors have been replaced as of December 9, 2021. Photos are below.

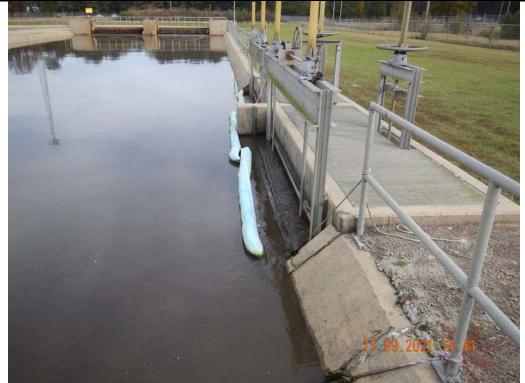
### City of Magnolia - Big Creek WWTP Photographer: Michael Young Date: 11/9/2021 Time: 14:42 Witness: Photo #: 13

Description: Splitter box for clarifiers. Water is being routed to one clarifier.

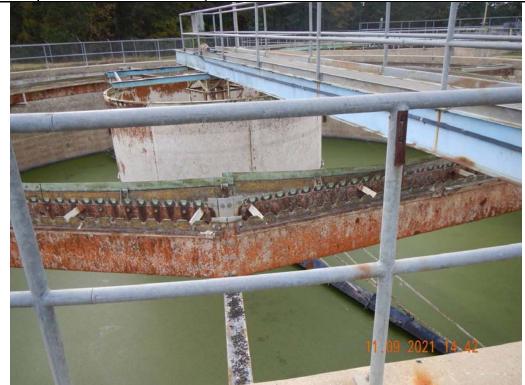
Office of Water Quality Photographic Evidence Sheet								
Location:	City	of Magno	olia - Bi	g Creek WWTP				
Photograpl	her:	Michael `	Young		Date:	11/9/2021	Time:	14:44
Witness:							Photo #	t: 15

Description: Clarifier in operation at time of inspection.

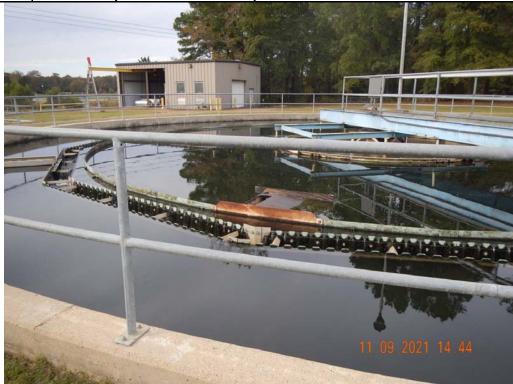
Photographer: Michael Young	Date:	11/9/2021	Time:	14:44
Witness:			Photo #:	16

Description: Clarifier in operation at time of inspection.

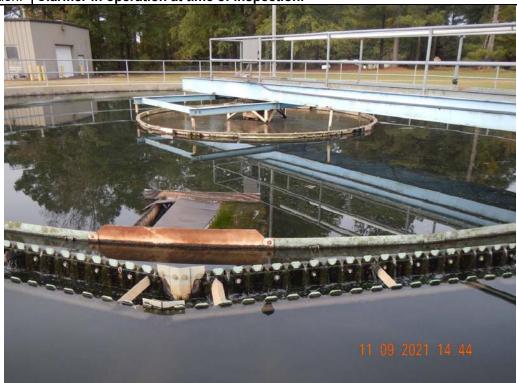
# Office of Water Quality Photographic Evidence Sheet Location: City of Magnolia - Big Creek WWTP Photographer: Michael Young Date: 11/9/2021 Time: 14:46 Witness: Photo #: 17 Description: Clarifier not in operation and not in plan of replacement. Third clarifier is not needed.

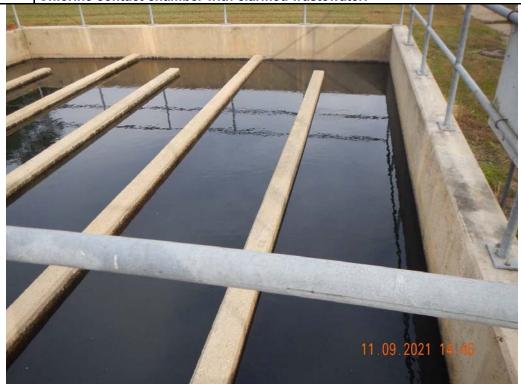
## Office of Water Quality Photographic Evidence Sheet Location: City of Magnolia - Big Creek WWTP Photographer: Michael Young Date: 11/9/2021 Time: 14:46 Witness: Photo #: 19

Description: Chlorine contact chamber.

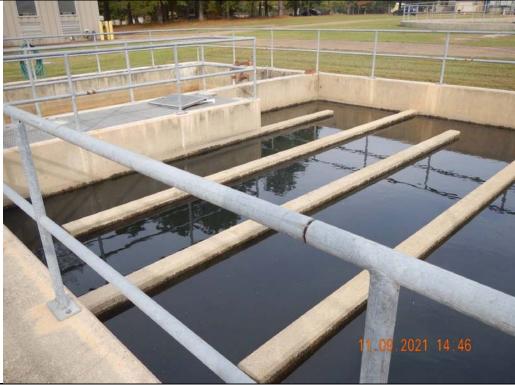
Photographer: Michael Young Date: 11/9/2021 Time: 14:46
Witness: Photo #: 20

Description: Sulfur dioxide used to dechlorinate and post-aeration.

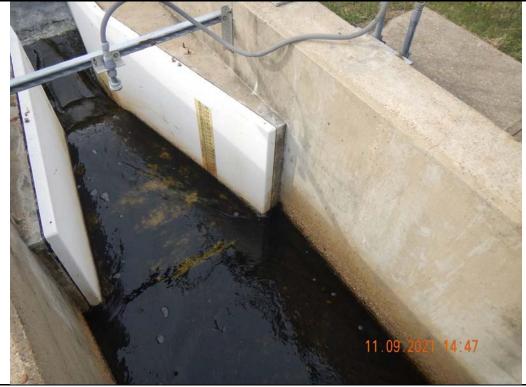
Photographer: Michael Young Date: 11/9/2021 Time: 14:47
Witness: Photo #: 22

Description: Totalizer used on Parshall flume to measure flow. Calibration frequency acceptable.

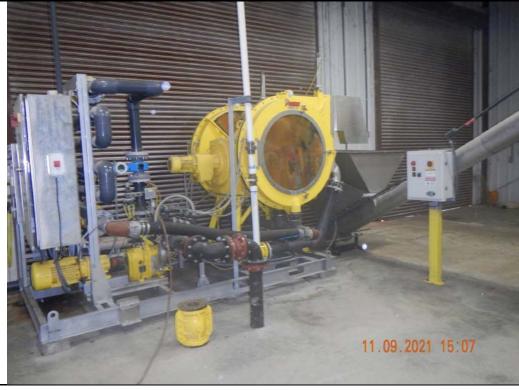
Photographer: Michael Young	Date:	11/9/2021	Time:	15:07
Witness:			Photo #:	28

Description: Therma-Flite drying components.

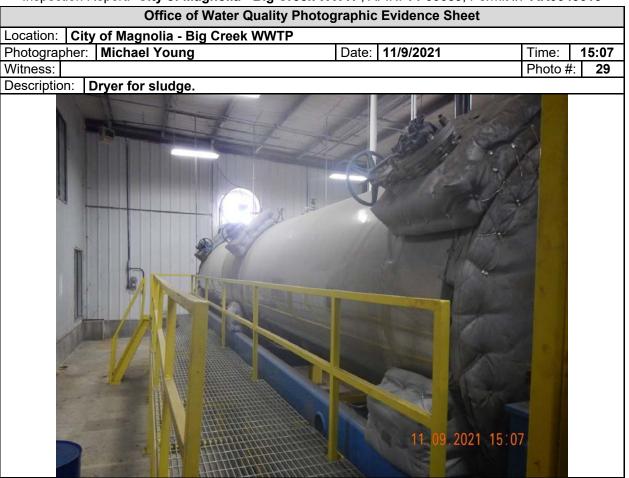
Figure 1. Overview of the treatment components at Big Creek WWTP - City of Magnolia.
