**RE: Inspection conducted on January 12, 2022**  
**AFIN 16-00923**  
**Permit Number 0254-S1-R4**

**Office of Land Resources  
Regulated Waste Operations  
Class 1 Landfill Inspection Form**

| <b>Site Name</b> | Craighead County SWDA Class 1 | <b>County</b> | Craighead | <b>AFIN</b> | 16-00199 |

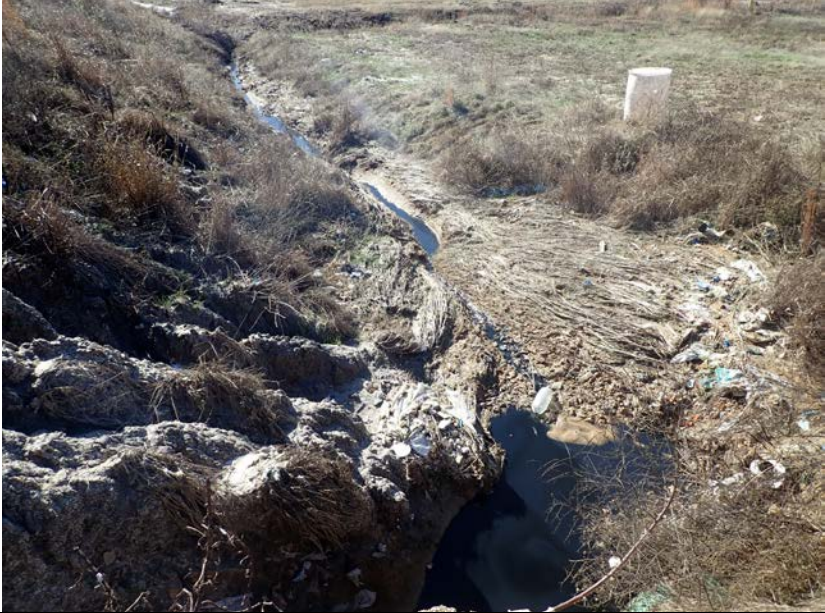
| <b>Photo #</b> | 1 | <b>Of</b> | 4 | | <b>Date</b> | 1/12/2022 | <b>Time</b> | 1122 |

| | <b>Regulation</b> | <b>Item Description</b> | <b>Comments</b> |
|---|---|---|---|
| X | 419(a)(5) | Cause Discharge/Leachate Leaving Landfill | Leachate discharge observed on the west slope of Cell 1. (Refer to Photos #1 - #4.) |

| <b>Description</b> | Leachate discharge observed on the west slope of Cell 1. | | | | | | | |

You should immediately initiate actions to correct the alleged violations cited. A written response of the corrective actions taken, or to be taken, must be submitted within thirty (30) calendar days from the date on this letter to the attention of Tobin Baker. The response may include, but is not limited to, photographs, copies of disposal receipts, records, or analytical results, as applicable. If you have any questions regarding the alleged violations, please do not hesitate to contact me at (501) 837-2097 or [bakert@adeq.state.ar.us](mailto:bakert@adeq.state.ar.us).

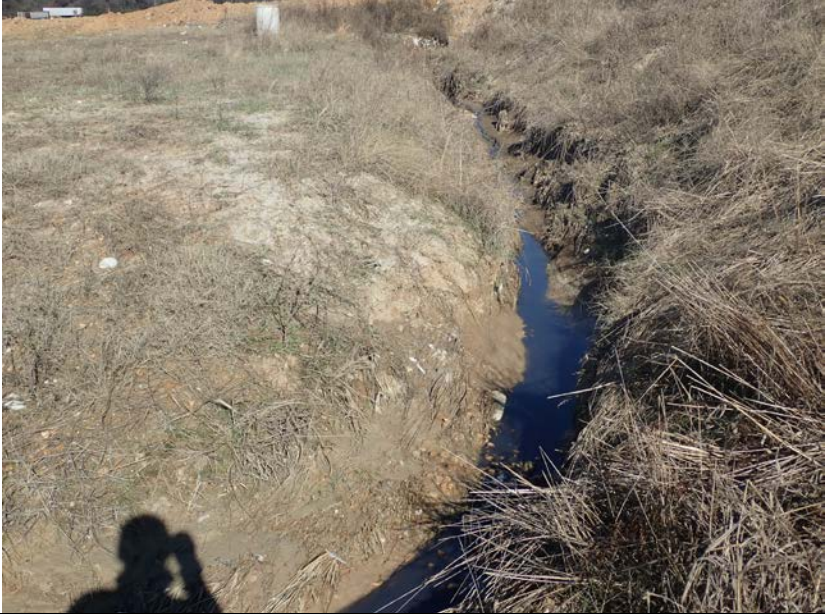
| <b>Photo #</b> | 2 | <b>Of</b> | 4 | | <b>Date</b> | 1/12/2022 | <b>Time</b> | 1123 |

| <b>Description</b> | Leachate discharge observed on the west slope of Cell 1. | | | | | | | |

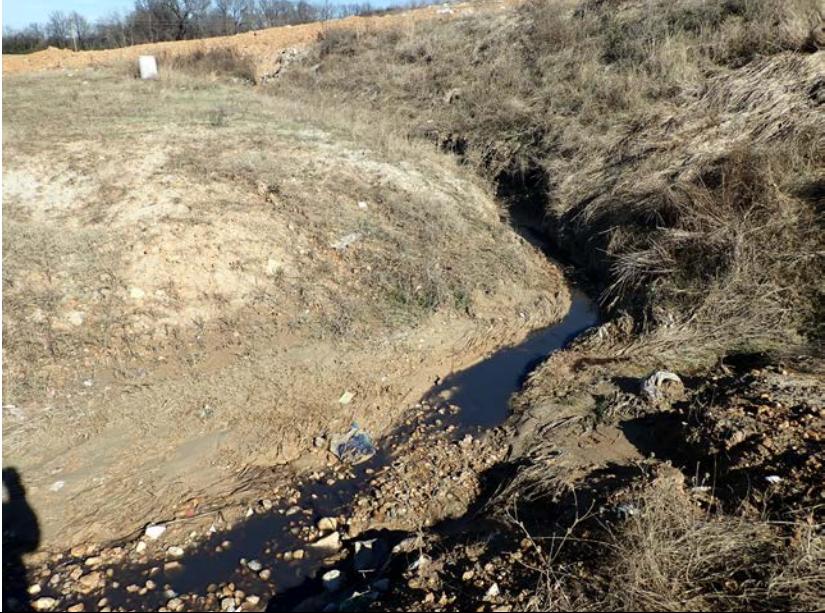
| <b>Photo #</b> | 3 | <b>Of</b> | 4 | | <b>Date</b> | 1/12/2022 | | <b>Time</b> | 1123 | |

| <b>Description</b> | Leachate discharge observed on the west slope of Cell 1. | | | | | | | | | |

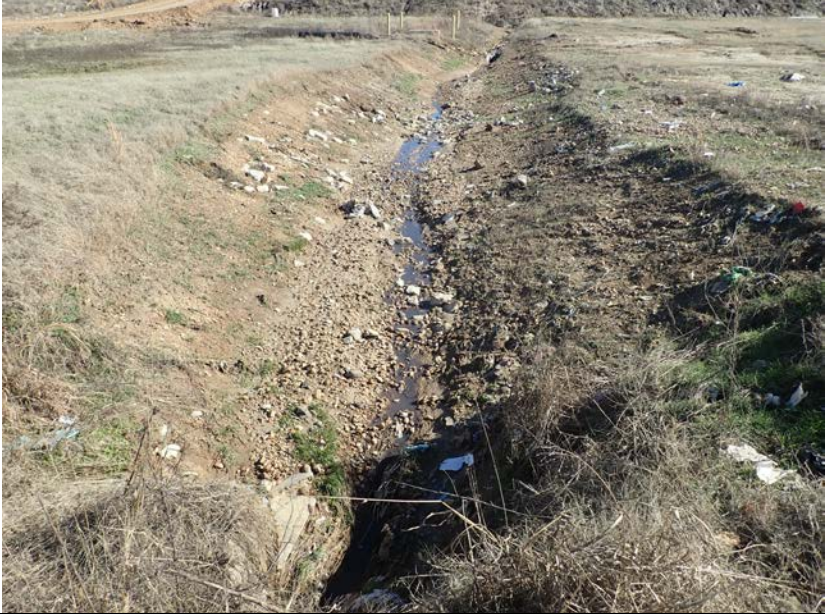
| <b>Photo #</b> | 4 | <b>Of</b> | 4 | | <b>Date</b> | 1/12/2022 | | <b>Time</b> | 1125 | |

| <b>Description</b> | Leachate discharge observed on the west slope of Cell 1. | | | | | | | | | |
