RE: City of Trumann WWTP Inspection
AFIN: 56-00047 Permit No.: AR0035602

ENVIRONMENTAL QUALITY	OFFICE OF WATER QUALITY				
	INSPECTION REPORT				
	AFIN: 56-00047	PERMIT #: AR0035602	DATE: 2/10/2022		
	COUNTY: 56 Poinsett	PDS #: 119548	MEDIA: WN		
GPS LAT: 35.682519 LONG: -90.464141 LOCATION: Entrance					
FACILITY INFORMATION		INSPECTION INFORMATION			
NAME: City of Trumann WWTP LOCATION: ~0.36 miles East of N. Speedway St. CITY: Trumann		FACILITY TYPE: 1 - Municipal INSPECTOR ID#: 112347 S - State FACILITY EVALUATION RATING: N INSPECTION TYPE: Compliance Assistance DATE(S): 2/10/2022 ENTRY TIME: 10:22 EXIT TIME: 10:53 PERMIT EFFECTIVE DATE: 2/1/2021 PERMIT EXPIRATION DATE: 1/31/2026			
RESPONSIBLE OFFICIAL		INSPECTION PARTICIPANTS			
NAME: / TITLE Barbara Lewallen / Mayor COMPANY: City of Trumann MAILING ADDRESS: 704 Hwy. 463 North CITY, STATE, ZIP: Trumann AR 72472 PHONE & EXT: / FAX: / EMAIL: mayor@cityoftrumann.org CONTACTED DURING INSPECTION: No		FAYETTEVILLE SHALE RELATED: N FAYETTEVILLE SHALE VIOLATIONS: N NAME/TITLE/PHONE/FAX/EMAIL/ETC.: Scotty Jones/ Public Works Director/ scottypw@gmail.com Lorre Holt/ Laboratory Technician Hannah Jones/ Laboratory Assistant

Office of W

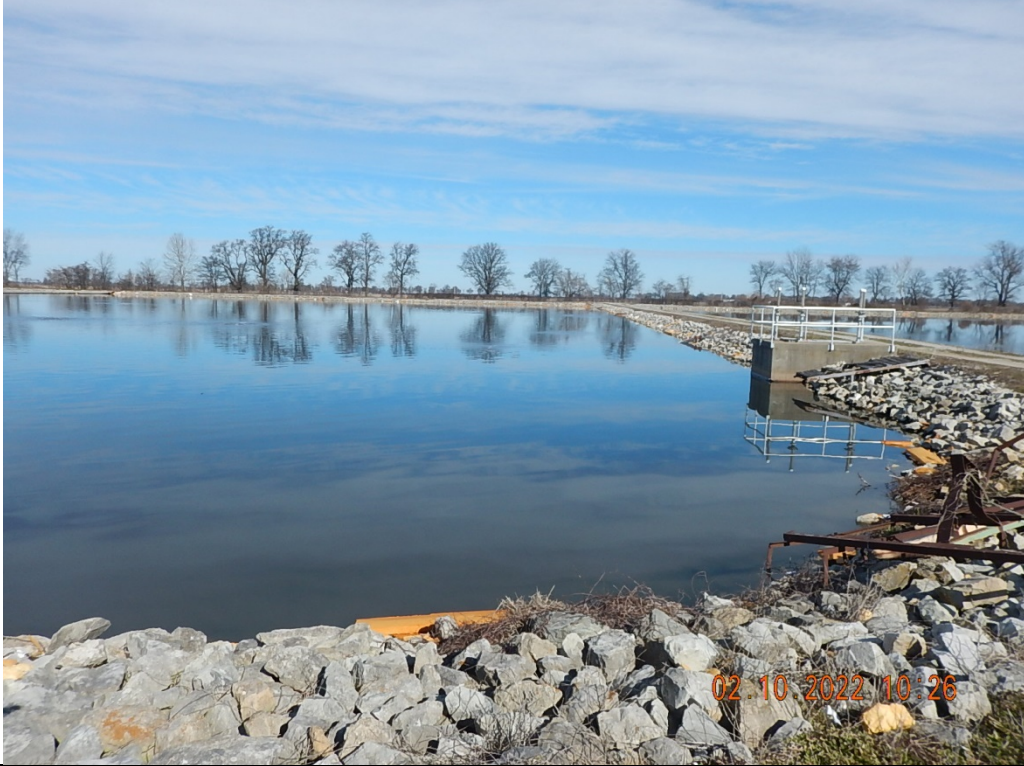
Location:	City of Trumann WWTP		
Photographer:	Sarah Frasher	Date:	2/10/2022
Time:	10:26	Witness:	None
Photo #:	1	Description:	View of the southwest corner of Cell 3.

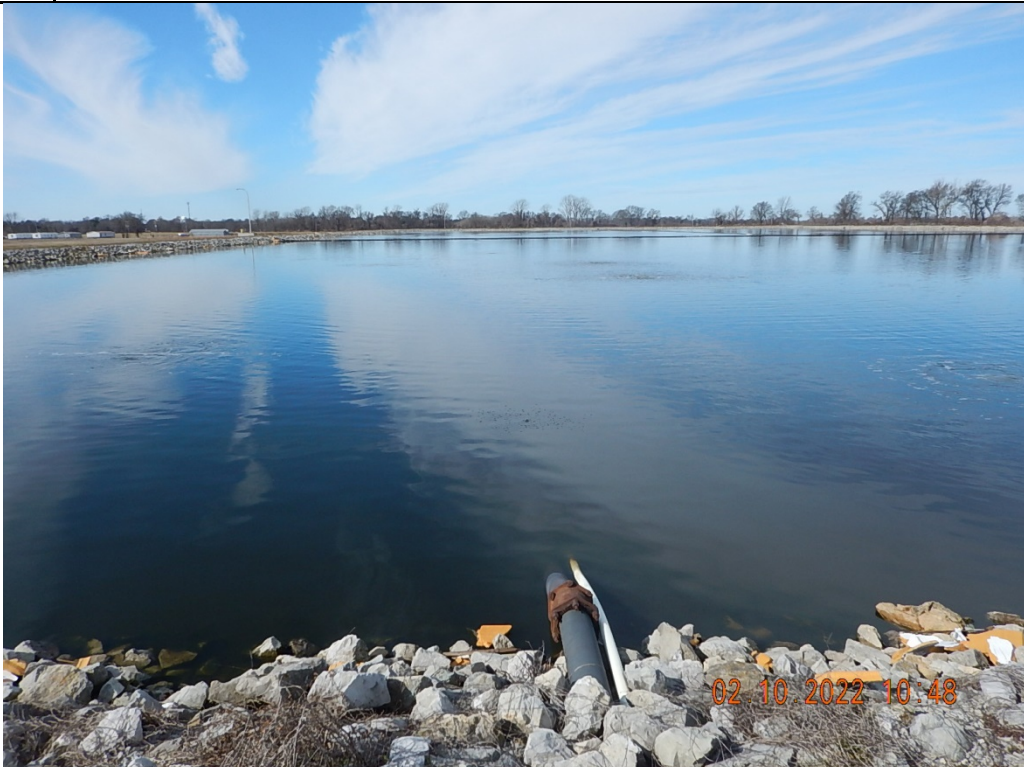
Photographer:	Sarah Frasher	Date:	2/10/2022
Time:	10:48	Witness:	None
Photo #:	2	Description:	View of the aeration for Cell 3, the location of where aeration was raised out of the water due to an air pocket in the liner.

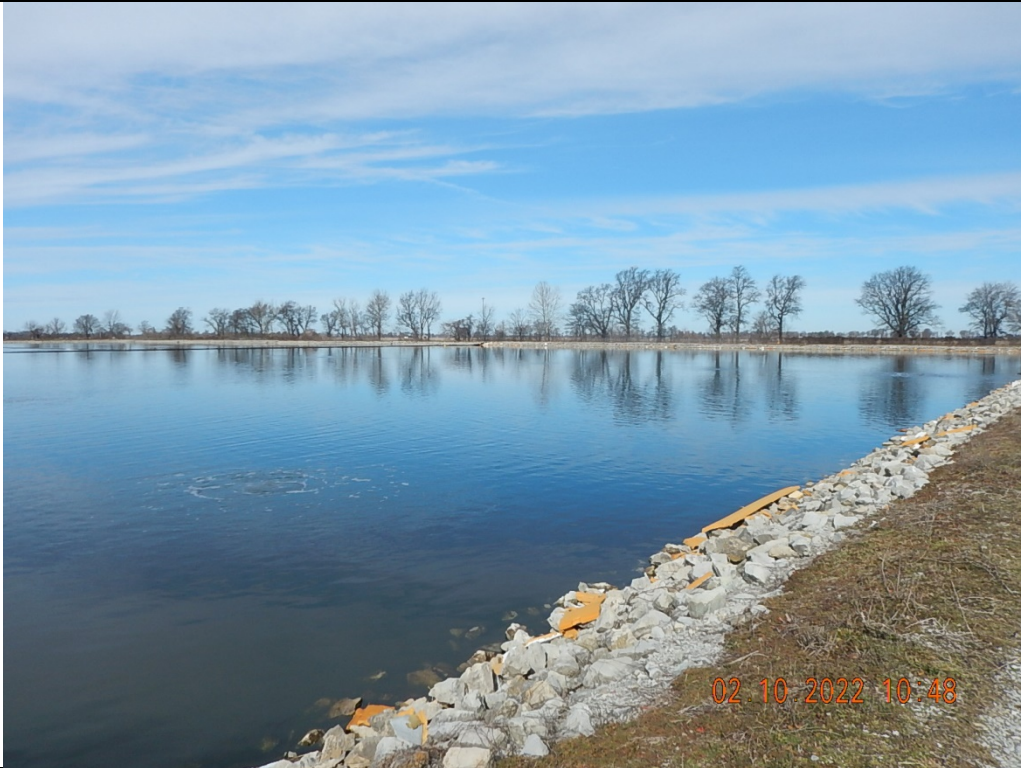
Location:	City of Trumann WWTP		
Photographer:	Sarah Frasher	Date:	2/10/2022
Time:	10:48	Witness:	None
Photo #:	3	Description:	View of northwest area of Cell 3, the location of the area approximately where the air pocket in the liner occurred.

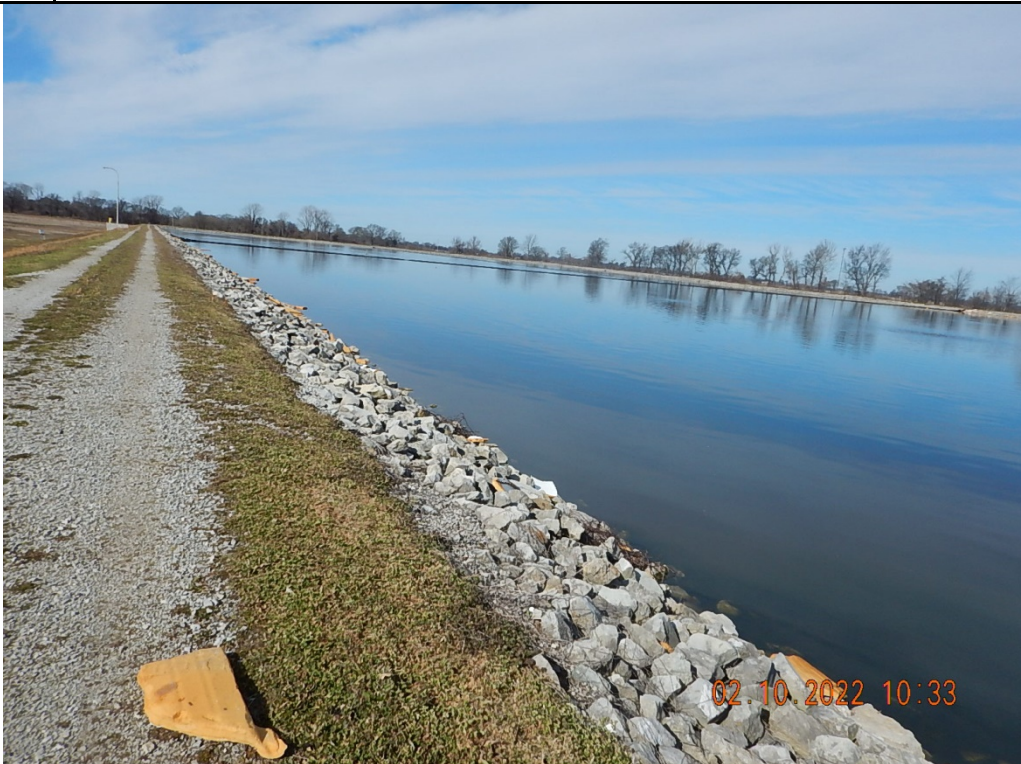
Photographer:	Sarah Frasher	Date:	2/10/2022
Time:	10:33	Witness:	None
Photo #:	4	Description:	View of the lagoon levee of Cell 3. Note the debris and other trash left from the December 2021 tornado.

AREA EVALUATIONS (S=Satisfactory, M=Marginal, U=Unsatisfactory, N=Not Applicable/Evaluated)					
N	PERMIT	N	FLOW MEASUREMENT	N	STORMWATER
N	RECORDS/REPORTS	N	LABORATORY	N	FACILITY SITE REVIEW
N	OPERATION & MAINTENANCE	N	EFFLUENT/RECEIVING WATER	N	SELF-MONITORING PROGRAM
N	SAMPLING	N	SLUDGE HANDLING/DISPOSAL	N	PRETREATMENT
N	OTHER:				
SUMMARY OF FINDINGS					
This compliance assistance inspection was conducted in response to possible tornado damage that occurred on December 10, 2021.					
GENERAL COMMENTS					
Met with Scotty Jones, Public Works Director, on February 10, 2022, to discuss the recent damage that occurred at the wastewater plant. A tornado caused significant damage to the area on December 10, 2021. An air pocket approximately 20-25 feet in length and 3 feet in height was observed in Cell 3 on December 28, 2021. This air pocket also caused the aeration line as well as the curtain to rise up about 3 feet in the air. Mr. Jones decided to cut the liner to release the air and prevent any further damage. The plant has been meeting effluent limits so far, but the staff at the wastewater plant are concerned it may become a problem during the warmer months. The city has hired a contractor and plans to evaluate the tear and repair any damage as soon as funds are available. The wastewater treatment plant staff plans to remove any storm debris still inside the lagoon levee as weather conditions allow.

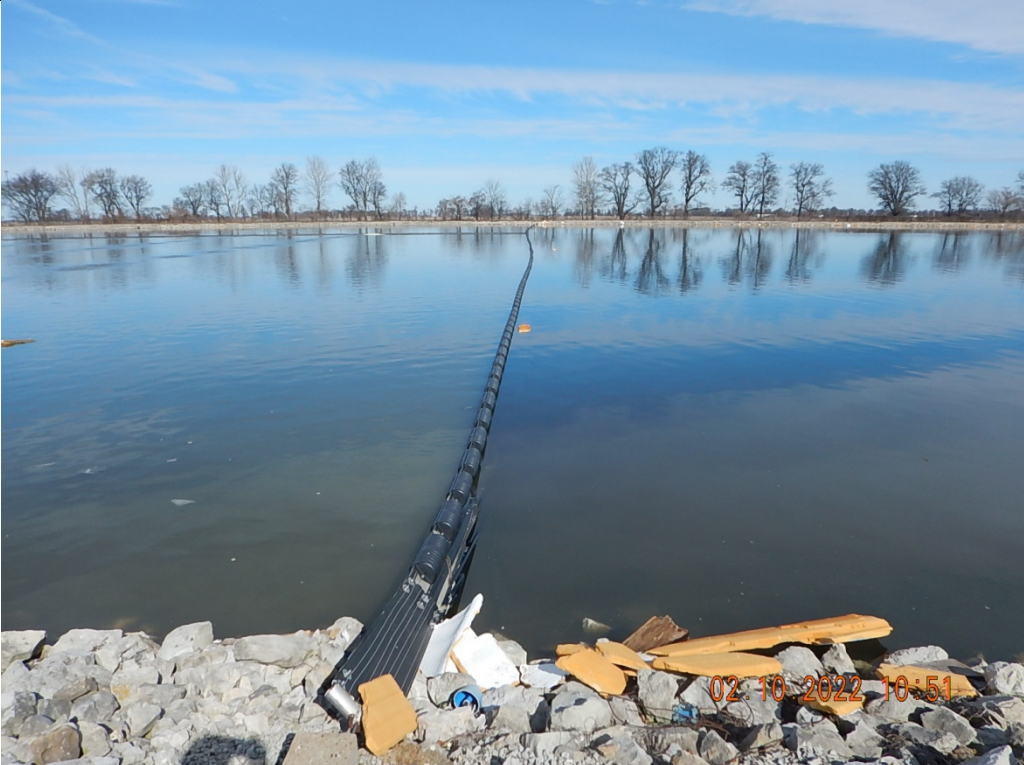
Office of Water Quality Photographic Evidence Sheet			
Location:	City of Trumann WWTP		
Photographer:	Sarah Frasher	Date:	2/10/2022
Witness:	None	Time:	10:51
		Photo #:	5
Description:	View of the curtain. Note this curtain came 3 feet out of the water during the air pocket in the liner.
