RE: Batesville WWTP Inspections (Independence Co)

AFIN: 32-00044 NPDES Permit No.: AR0020702

OFFICE OF WATER QUALITY INSPECTION REPORT

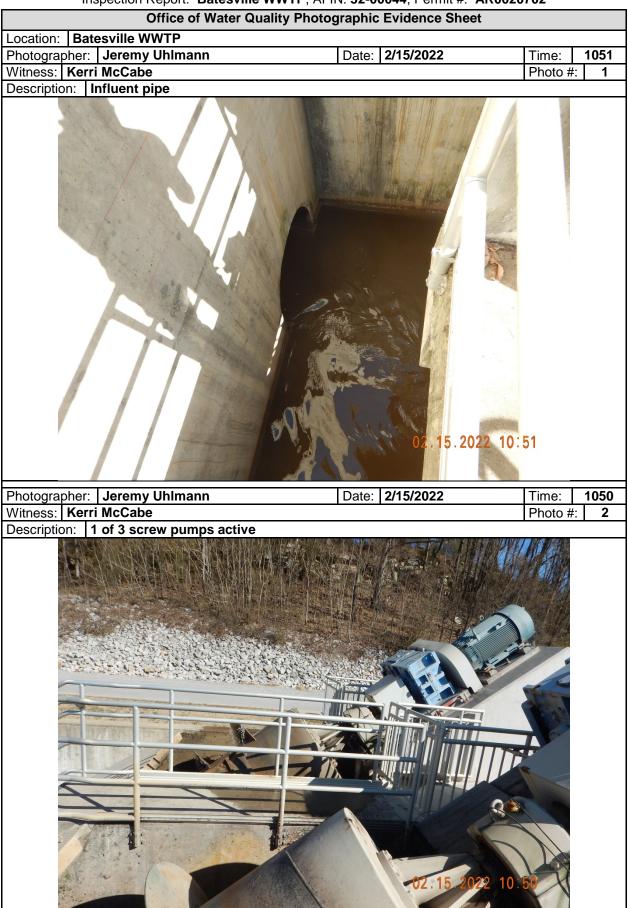
Office of Water Quality Photographic Evidence Sheet Location: Batesville WWTP Photographer: Jeremy Uhlmann Date: 2/15/2022 Time: 1056 Witness: Kerri McCabe Photo #: 3 Description: Comminutors with overflow and flow measurement in background

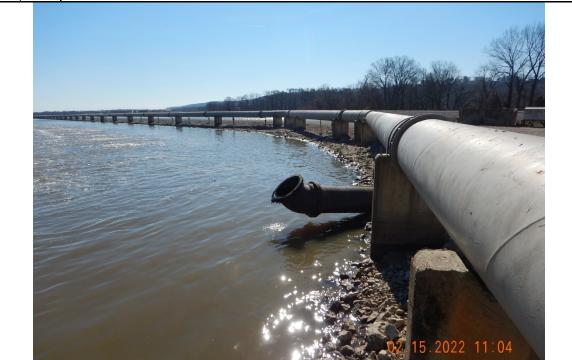
Photographer:Jeremy UhlmannDate:2/15/2022Time:1104Witness:Kerri McCabePhoto #:6Description:Return line from DAF

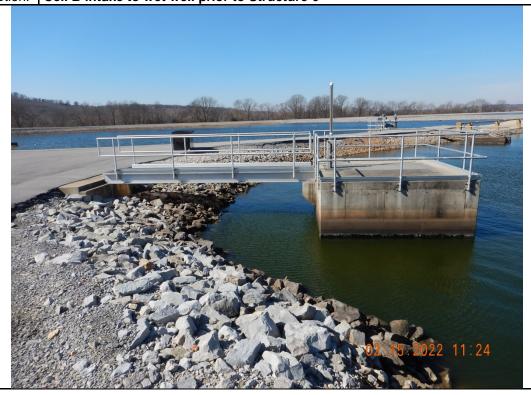
Office of Water Quality Photographic Evidence Sheet								
Location: Batesville WWTP								
Photographer: Jeremy Uhlmann Date: 2/15/2022 Time: 1124							1124	
Witness: Kerri McCabe Photo #: 9								
Description: Cell B intake to wet well prior to Structure 6

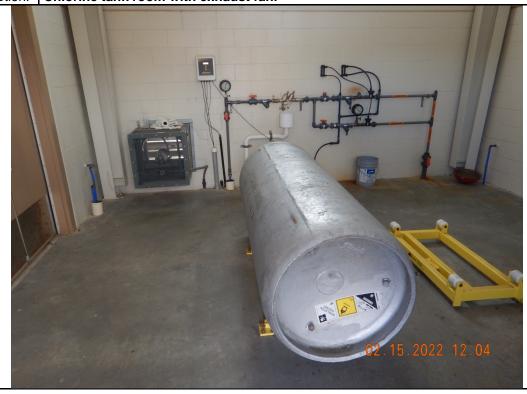
Cocation: Batesville WWTP Photographer: Jeremy Uhlmann Witness: Kerri McCabe Description: Chlorine tank room with exhaust fan.

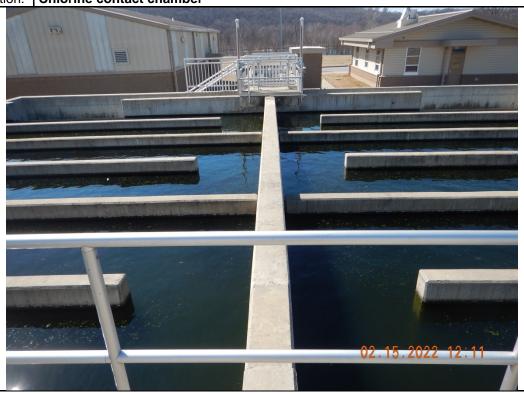
Cocation: Batesville WWTP Photographer: Jeremy Uhlmann Witness: Kerri McCabe Description: Chlorine contact chamber Office of Water Quality Photographic Evidence Sheet Date: 2/15/2022 Time: 1211 19
