RE: Georgia-Pacific Crossett LLC Inspection (Ashley Co)

AFIN: 02-00013 NPDES Permit No.: AR0001210

OFFICE OF WATER QUALITY INSPECTION REPORT

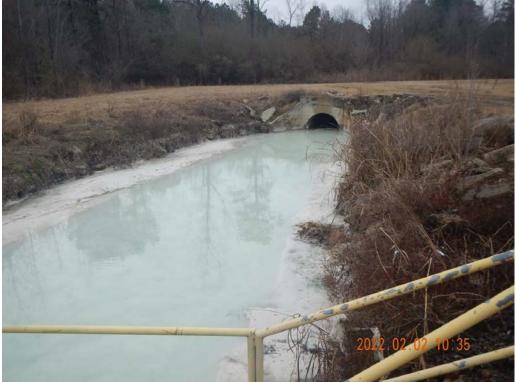
Office of Water Quality Photographic Evidence Sheet Location: Georgia-Pacific Crossett LLC Photographer: Michael Young Date: **02/02/2022** Time: 10:35 Witness: Photo #:

Description: Wastewater discharged from covered pipe for treatment.

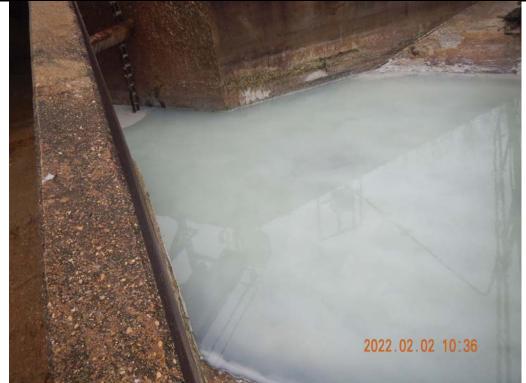
Photographer: Michael Young Date: 02/02/2022 10:36 Time: Witness: Photo #:

Description: Wastewater from the GP-Crossett facility flowing toward the clarifier.

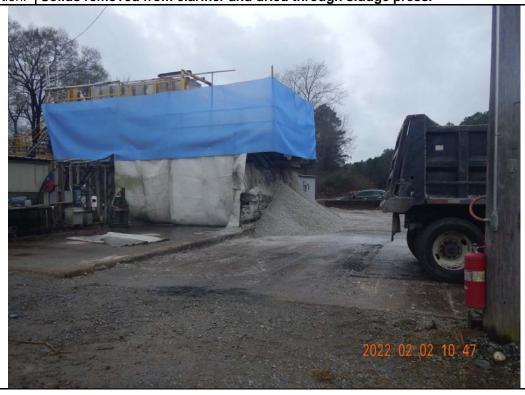
Office of Water Quality Photographic Evidence Sheet							
Location: C	Location: Georgia-Pacific Crossett LLC						
Photographer: Michael Young Date: 02/02/2022 Time: 10:47					10:47		
Witness:	Witness: Photo #: 7						
Description:	Description: Solids removed from clarifier and dried through sludge press.

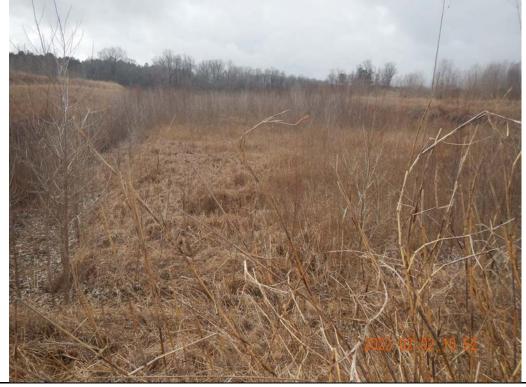
Office of Water Quality Photographic Evidence Sheet Location: Georgia-Pacific Crossett LLC Photographer: Michael Young Date: 02/02/2022 Time: 10:52 Witness: Photo #: 9

Description: Abandoned ash basin that is no longer in use.

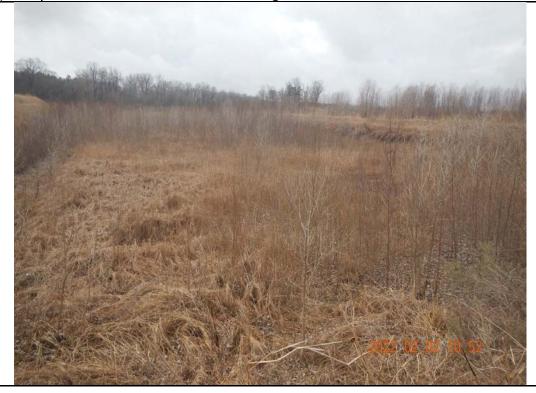
Photographer: Mic	hael Young	Date:	02/02/2022	Time:	10:52
Witness:				Photo #:	10

Description: Abandoned ash basin that is no longer in use.

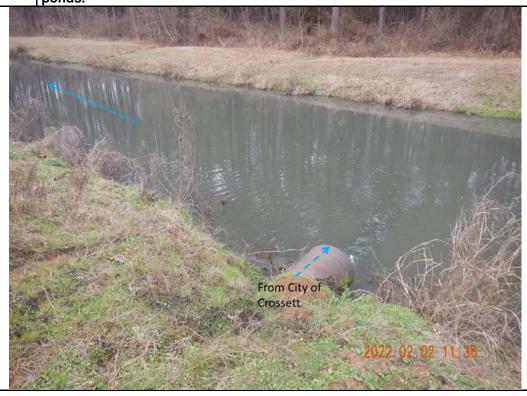
Office of Water Quality Photographic Evidence Sheet Location: Georgia-Pacific Crossett LLC Photographer: Michael Young Date: 02/02/2022 Time: 11:33 Witness: Photo #: 13 Description: Discharge pipe of municipal wastewater from the City of Crossett wastewater ponds.

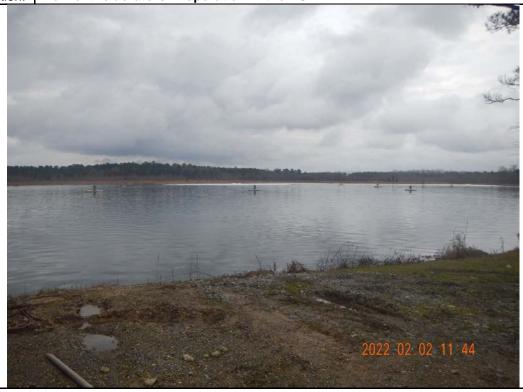
Photographer: Michael Young	Date	:	02/02/2022	Time:	11:44
Witness:				Photo #:	14

Description: View of the aerators in operation in the ASB.

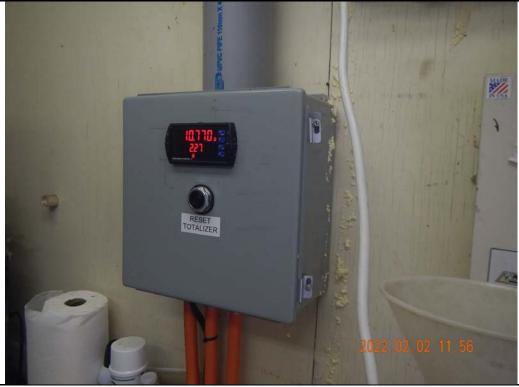
Office of Water Quality Photographic Evidence Sheet Location: Georgia-Pacific Crossett LLC Photographer: Michael Young Date: 02/02/2022 Time: 11:56 Witness: Photo #: 19

Description: Totalizer for flow measurements at Outfall 001.
