RE: Inspection conducted on May 4, 2022
AFIN 60-01071
Permit Number 0266-S1

**Office of Land Resources
Regulated Waste Operations
Class 1 Landfill Inspection Form**

Site Name	City of Little Rock Class 1 Landfill	County	Pulaski	AFIN	60-01071
Facility Address	10803 Ironton Cutoff, Little Rock, AR 72206	Phone #	501-888-74493	Permit #	0266-S1
Permittee Address	10803 Ironton Cutoff, Little Rock, AR 72206	Email Address	ncharles@littlerock.gov	PDS #	120192
Date	5/4/2022	Entry Time	1052	Exit Time	1307

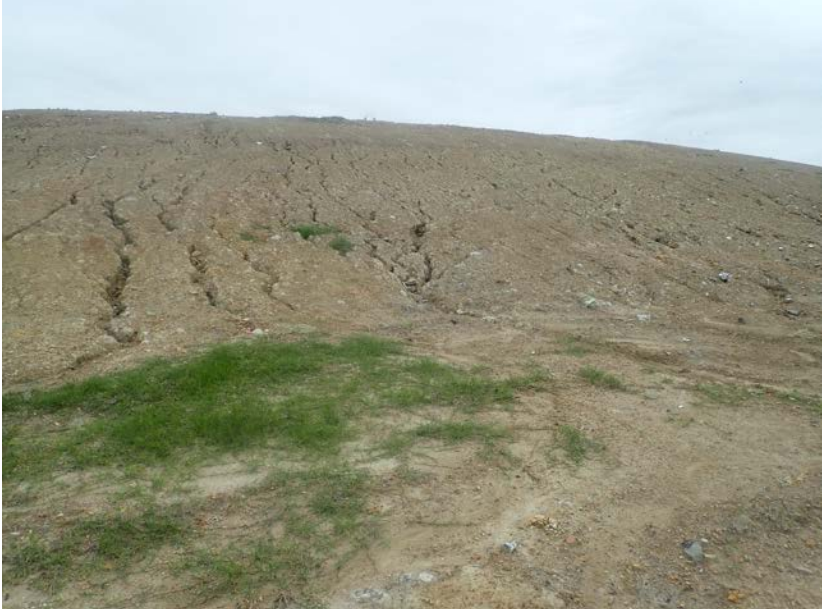
Location	City of Little Rock Class 1 Landfill			Permit	60-01071	AFIN	60-01071
Photographer	Kim Davenport		<i>KD</i>	Witness	N/A		
Photo #	1	Of	4	Date	5/4/2022	Time	1206
Description	A view of the southern slope of Cell 4 observed with lack of vegetation, erosion rills, and exposed waste.

You should immediately initiate actions to correct the alleged violations cited. A written response of the corrective actions taken, or to be taken, must be submitted within thirty (30) calendar days from the date on this letter to the attention of Kim Davenport. The response may include, but is not limited to, photographs, copies of disposal receipts, records, or analytical results, as applicable. If you have any questions regarding the alleged violations, please do not hesitate to contact me at (501) 682-0586 or davenportk@adeq.state.ar.us.

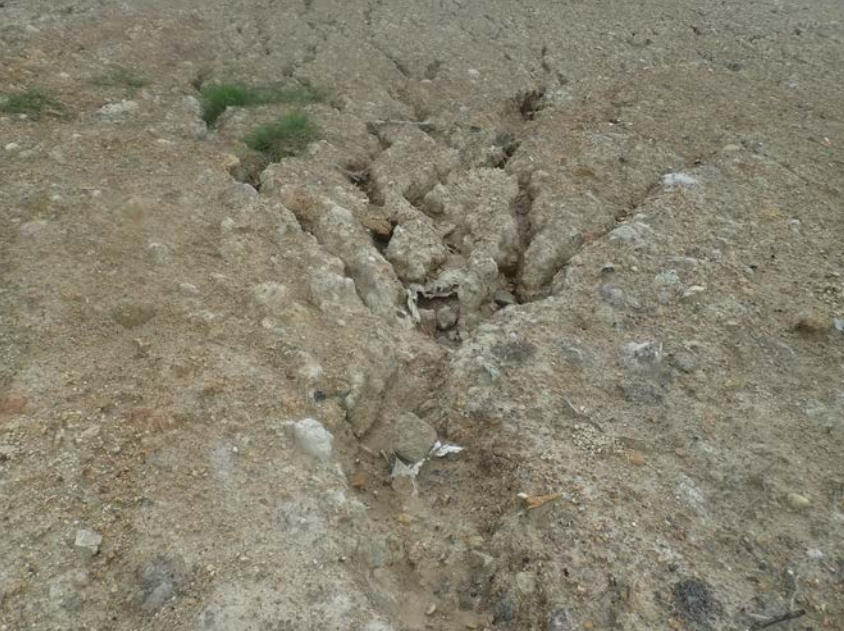
Location	City of Little Rock Class 1 Landfill			Permit	0266-S1	AFIN	60-01071
Photographer	Kim Davenport		<i>KD</i>	Witness	N/A		
Photo #	2	Of	4	Date	5/4/2022	Time	1206
Description	A closer view of Photo #1. Lack of vegetation, erosion rills, and exposed waste observed.

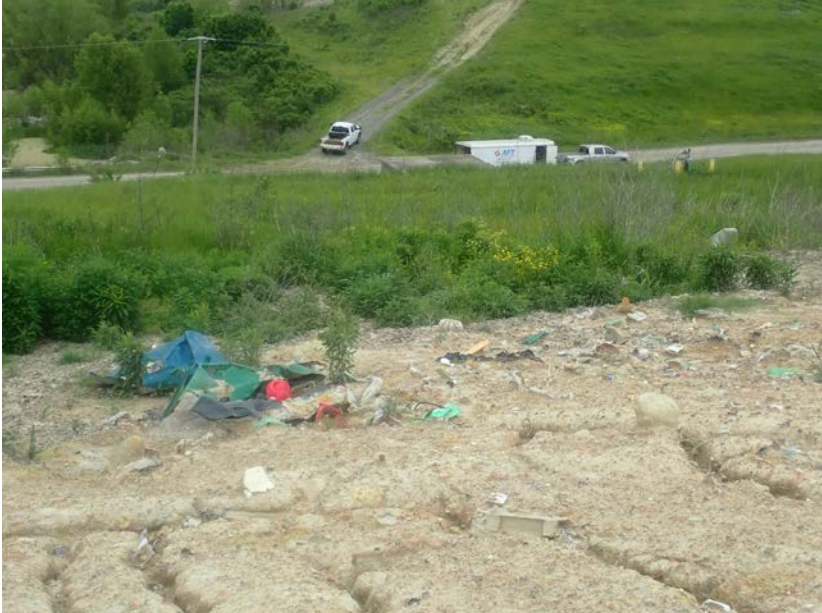
Location	City of Little Rock Class 1 Landfill			Permit	60-01071	AFIN	60-01071
Photographer	Kim Davenport		<i>KD</i>	Witness	N/A		
Photo #	3	Of	4	Date	5/4/2022	Time	1227
Description	An example is shown of cover defects resulting in exposed waste at Cell #9 (over Cell 3).
