RE: Helena WWTP Inspections (Phillips Co)

AFIN: 54-00083 NPDES Permit No.: AR0043389

OFFICE OF WATER QUALITY INSPECTION REPORT

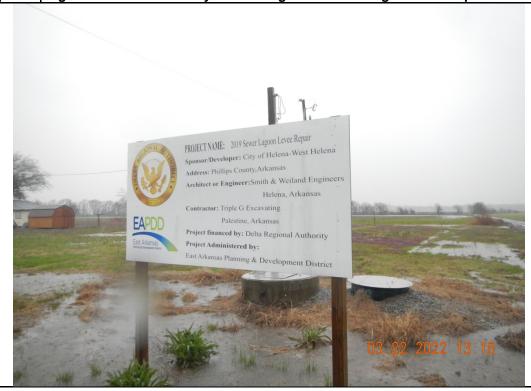
Photographer: Aaron Baggett Date: 3/22/2022 Time: 1250
Witness: Kerri McCabe Photo #: 2

- The access road to the lagoons was rutted and in need of repair at the time of inspection. The lagoons
 must be accessible by vehicle for inspection and maintenance at all times.
- Some sections of the levees were not accessible by vehicle. During the inspection, the operators
 indicated they were unsure if the access road and levees would be accessible or safely travelled by
 vehicle and were unable to comment on their stability.
- There is inadequate freeboard in the lagoons, particularly in Cell 3 and Cell 4. Levels in the lagoons have risen high enough for wave action to occur above the rip-rap stabilization along the levees (Photos 2; 8)

- The access road to the treatment facility is in need of repair.
- Sections of the lagoon levees were not safely accessible by vehicle at the time of inspection.
- There was inadequate freeboard in the lagoons at the time of the inspection.
- 2) The following items violate Part 1, Section A of the permit:
 - Only seven samples were taken in January 2021.
 - No samples were taken for the first three weeks of October 2021.

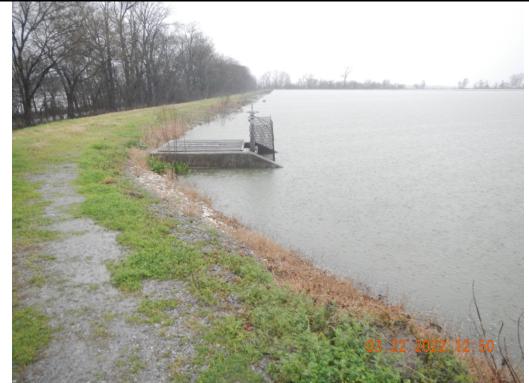
Witness: Kerri McCabe Photo #: 3

It should be noted that the previously-damaged levee separating Cells 2 and 4 has been repaired and is now functional (Photo 3).

Description: Levee between Cells 2 and 4 that was repaired in 2019; facing approximately northwest.

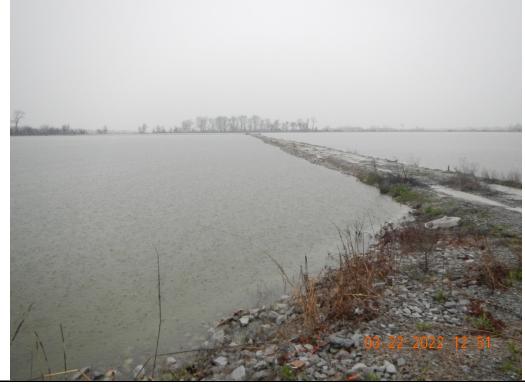
Photographer:Aaron BaggettDate:3/22/2022Time:1251Witness:Kerri McCabePhoto #:4

Description: Cell 2 overview; large ruts in levee in foreground; facing approximately north.

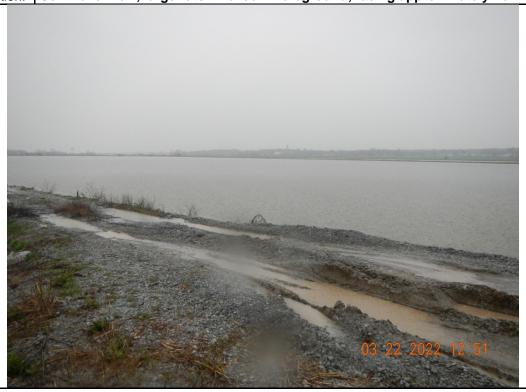
Office of Water Quality Photographic Evidence Sheet								
Location: Helena WWTP								
Photographer: Aaron Baggett Date: 3/22/2022 Time: 1251								
Witness: Kerri McCabe Photo #: 5						: 5		
Description:		evee along eastern boundary ortheast.	of Cell 2; rut in	levee in bottom	eft of photo; f	acing

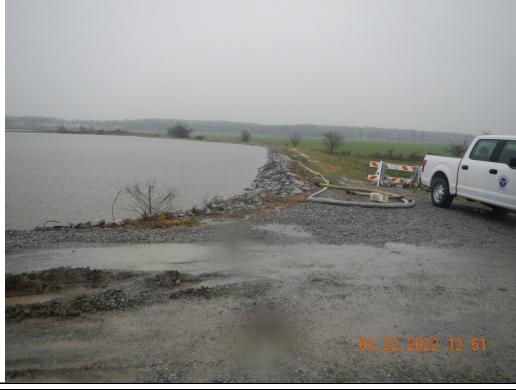
Photograph	ner: Aaron Baggett	Date:	3/22/2022	Time:	1255
Witness: Kerri McCabe				Photo #:	6

Description: Levee between Cells 3 and 4; facing northeast.

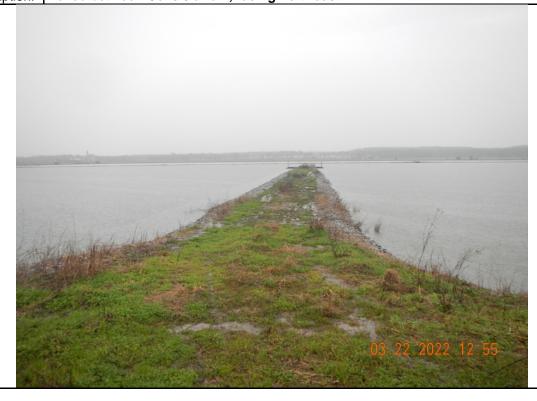
Cocation: Helena WWTP Photographer: Aaron Baggett Date: 3/22/2022 Time: 1255 Witness: Kerri McCabe Photo #: 7 Description: Levee between Cells 3 and 4; facing east.

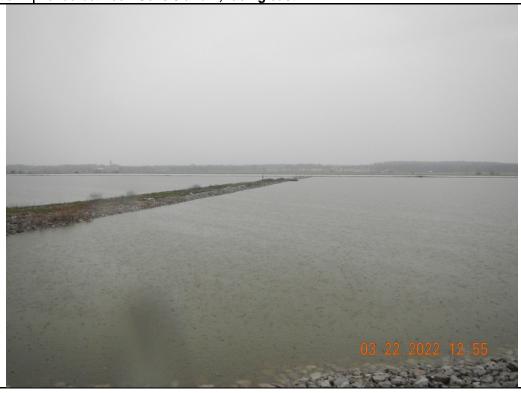
Photographe	: Aaron Ba	aggett			Date:	3/22/2022	2	Time:	1256
Witness: Kerri McCabe					Photo #	: 8			
	107 4	•

Description: Western levee of Cell 3; facing northwest. Level in this cell is above the rip-rap along the levee.

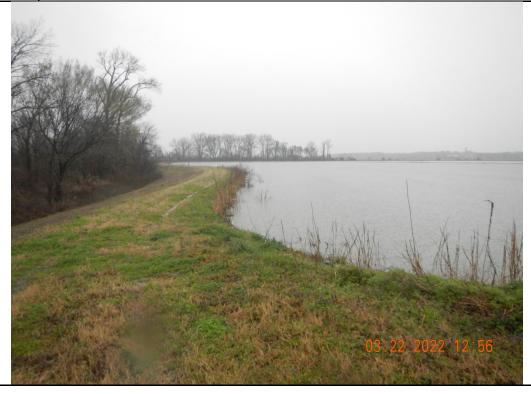
Office of Water Quality Photographic Evidence Sheet							
Location: Helena WWTP							
Photographe	: Aaron Baggett	Date:	3/22/2022	Time:	1304		
Witness: Kerri McCabe Photo #: 9							
Description:	Description: Levee between Cells 1 and 2; facing west.

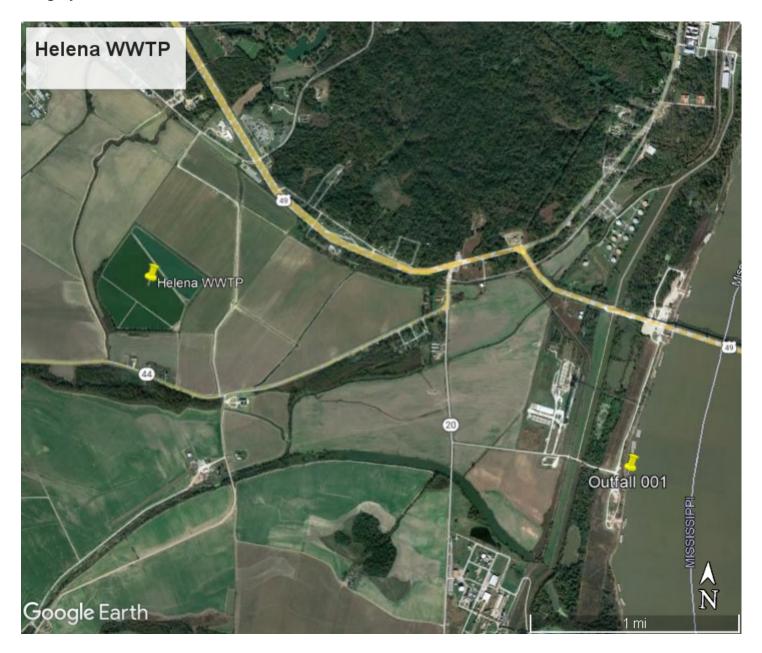
The treatment system for Outfall 001 consists of a four-cell lagoon system.

Figure 2. Google Earth image depicting components and simplified flow path of the Helena WWTP; satellite base imagery dated 11/11/2020.
