RE: City of Decatur WWTP Inspection
AFIN: 04-00052 **Permit No.: AR0022292**

<p>ENVIRONMENTAL QUALITY</p>	OFFICE OF WATER QUALITY INSPECTION REPORT				
	AFIN: 04-00052	PERMIT #: AR0022292	DATE: 11/16/2021		
	COUNTY: 04 Benton	PDS #: 123277	MEDIA: WN		
	GPS LAT: 36.34417 LONG: -94.47271 LOCATION: General Area				
FACILITY INFORMATION		INSPECTION INFORMATION			
NAME: City of Decatur WWTP LOCATION: 985 Austin Avenue CITY: Decatur		FACILITY TYPE: 1 - Municipal INSPECTOR ID#: 104111 S - State FACILITY EVALUATION RATING: 1 - Unsatisfactory INSPECTION TYPE: Compliance Evaluation			
RESPONSIBLE OFFICIAL		DATE(S): 11/16/2021 ENTRY TIME: 10:34 EXIT TIME: 15:00 PERMIT EFFECTIVE DATE: 11/30/2020 PERMIT EXPIRATION DATE: 11/30/2025			
NAME: / TITLE Robert Tharp / Mayor COMPANY: City of Decatur MAILING ADDRESS: PO Box 247 CITY, STATE, ZIP: Decatur AR 72722 PHONE & EXT: / FAX: 479-752-3912 / EMAIL: bobtharp@decaturarkansas.us & james.boston@decaturarkansas.us		FAYETTEVILLE SHALE RELATED: N FAYETTEVILLE SHALE VIOLATIONS: N

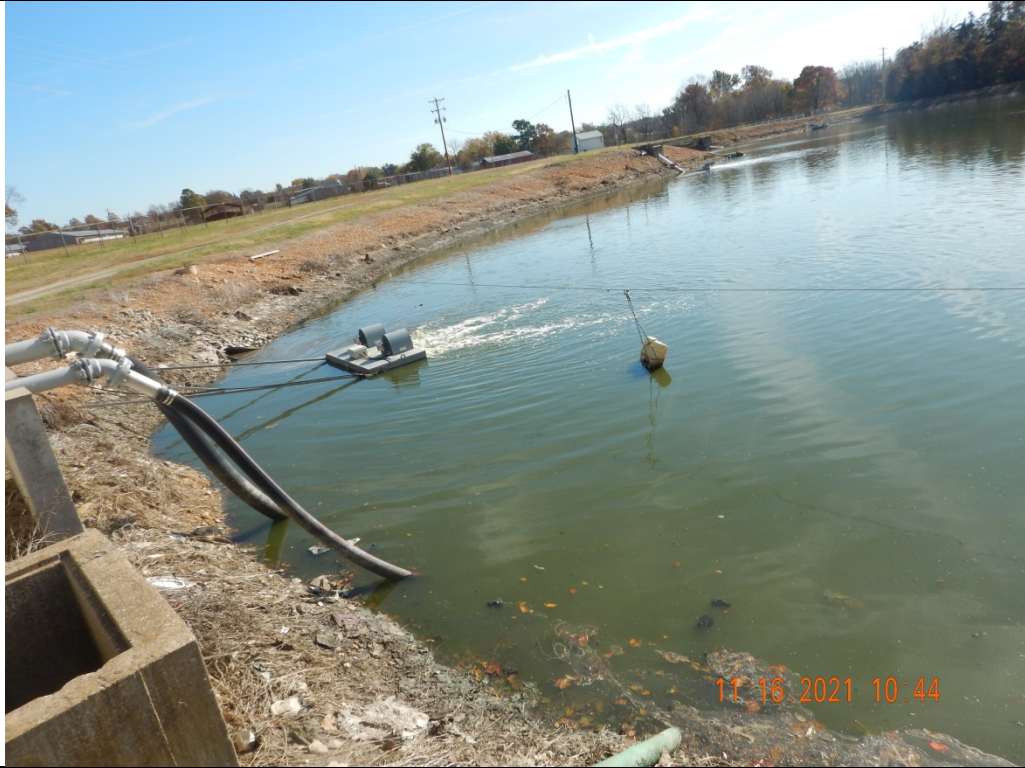
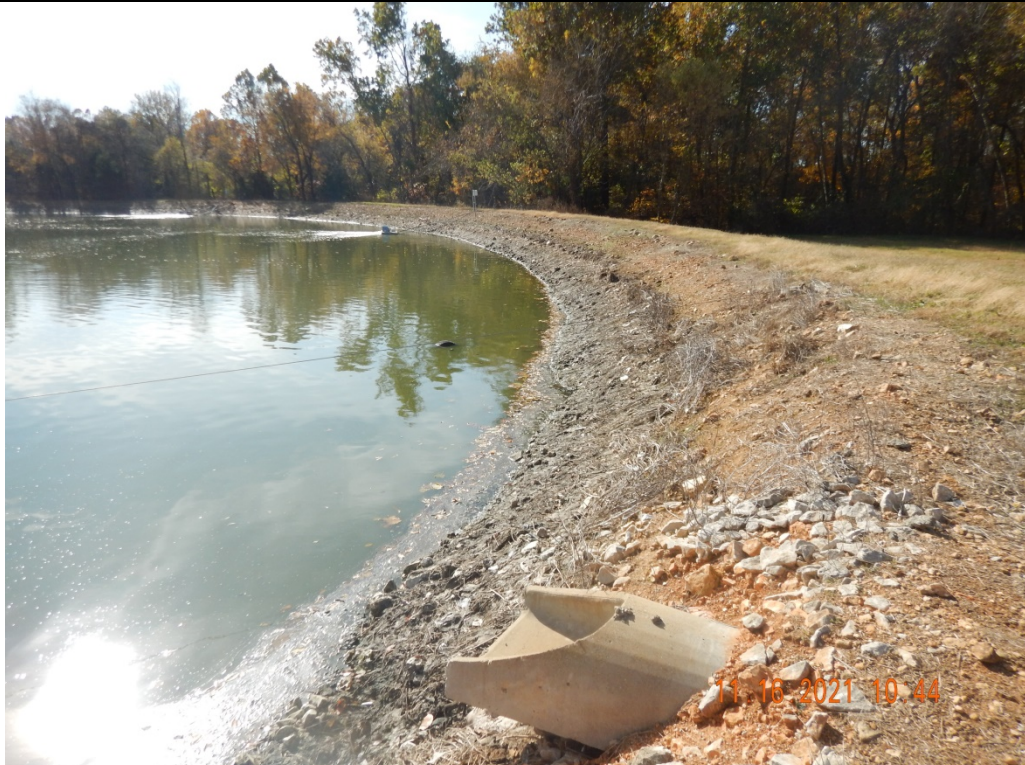
Location:	City of Decatur WWTP		
Photographer:	Garrett Grimes, District 1 Inspector	Date:	11/16/2021
Witness:		Time:	10:44
		Photo #:	1
Description:	Equalization basin with aerators.

The walkthrough began at the head of the plant starting at the equalization basin. The basin appeared to be well maintained with vegetation on the berms kept to a minimum and aerators functional (Photos #1 - #2). Influent from the City's two major sources of wastewater: the City of Centerton and Simmons Foods in Gentry, were examined with no issues noted (Photos #3 - #4). Influent samples were being collected, but the refrigeration unit for the influent composite sampler was not operational at the time of the inspection (Photos #5 - #6). Alum is added to the wastewater prior to entering the plant. Equipment for these additions was operational, but there was evidence of leaking alum solution from one of the storage buildings (Photos #7 - #8). Following the equalization basin, solids and grit removal screens were examined with excessive solids build up noted in the path to the bar screens causing overflows to the secondary screen (Photos #9 - #10). The solids/grit accumulation area is covered and no active wastewater leaks were observed in the area (Photo #11).

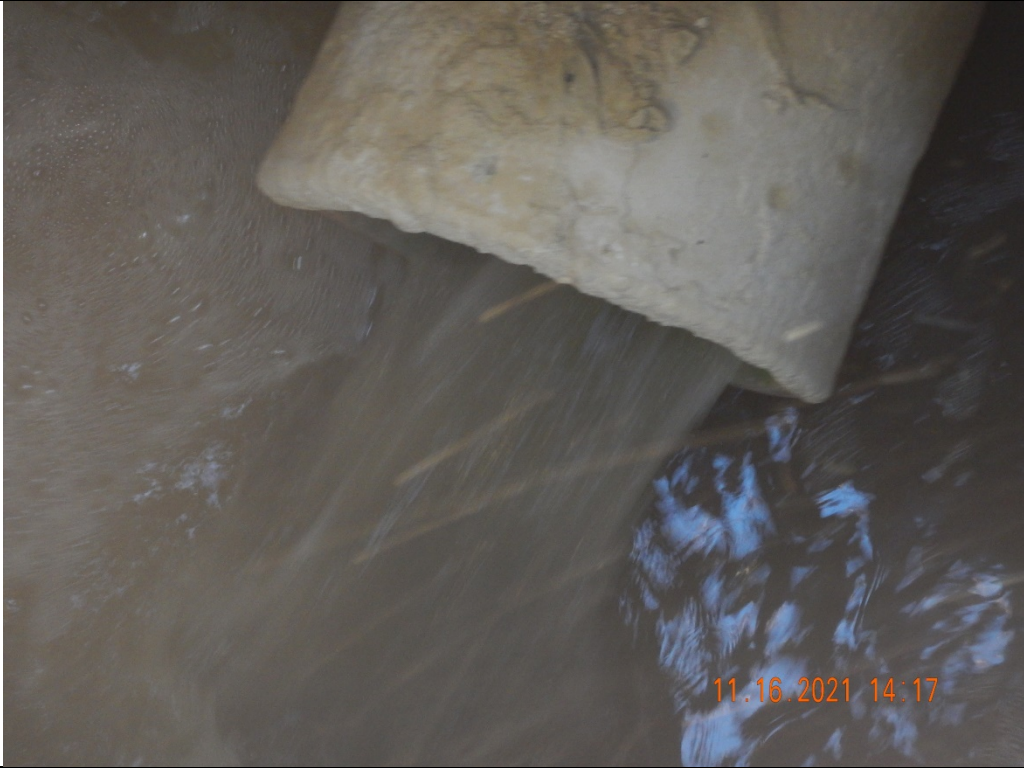
Location:	City of Decatur WWTP		
Photographer:		Date:	11/16/2021
Witness:		Time:	14:17
		Photo #:	3
Description:	Influent from the City of Centerterton.

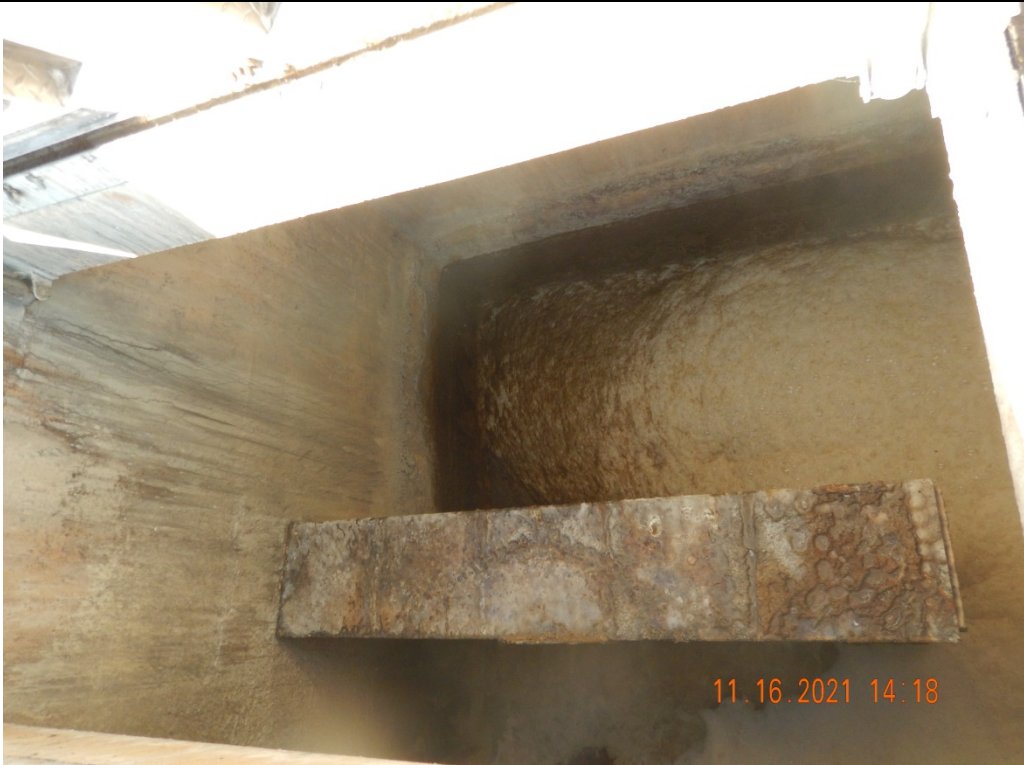
Photographer:	Garrett Grimes, District 1 Inspector	Date:	11/16/2021
Witness:		Time:	14:18
		Photo #:	4
Description:	Influent from the Simmons Foods plant in Gentry, AR.

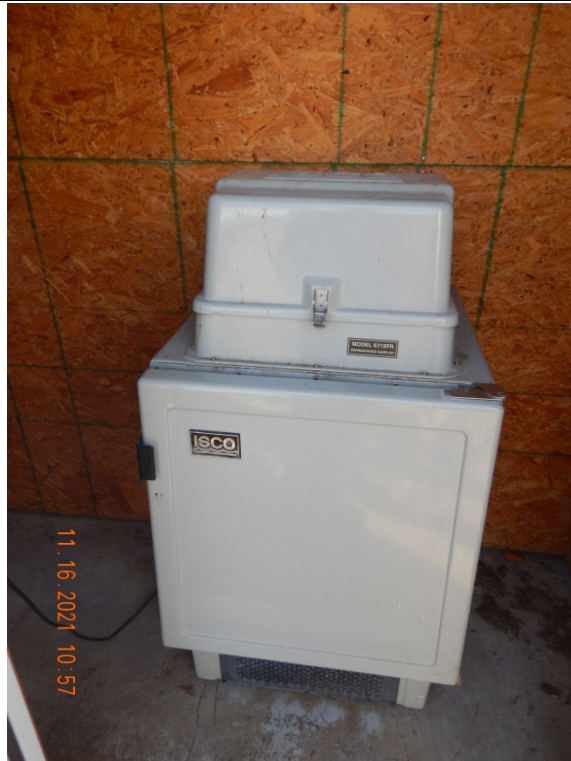
4. **Part III, Section B.1.A of the permit.**
 - a. **Composite sampling of influent was occurring during the inspection. However, the refrigeration unit of the composite sampling equipment was not functional at the time of the inspection. This unit must be repaired or alternative methods used to insure that sampled influent is being held at the proper temperature.**

Location:	City of Decatur WWTP		
Photographer:	Garrett Grimes, District 1 Inspector	Date:	11/16/2021
Witness:		Time:	10:57
		Photo #:	5
Description:	Composite sampler running during the inspection.

4. **Report Item 4.a:** Your response states that the city is in the process of obtaining a replacement sampling unit for influent BOD and TSS samples. This item will be referred to the DEQ - Office of Water Quality - Enforcement Branch for further review.
5. **Report Item 4.b:** No additional information required.
6. **Report Item 4.c:** Your response to "Report Item 5" states that the spiral screen has been replaced with an automated bar screen and that this has resulted in increased

3. Part III section A. We are in the process of getting a new sampler for the once-a-month BOD and TSS test we are required to do for the permit.
4. Section C. Since your visit, we have put up a new alum building. And moved the pumps to the east building where we have containment in case of any leaks. This is a big step toward minimizing leak chances in the future.

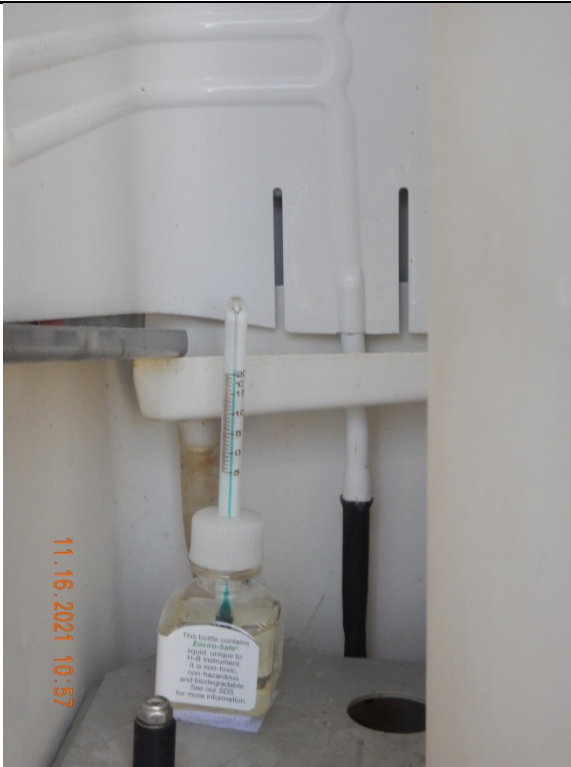
Photographer:	Garrett Grimes, District 1 Inspector	Date:	11/16/2021
Witness:		Time:	10:57
		Photo #:	6
Description:	Thermometer within the composite sampler refrigeration unit showing the unit is not functioning.

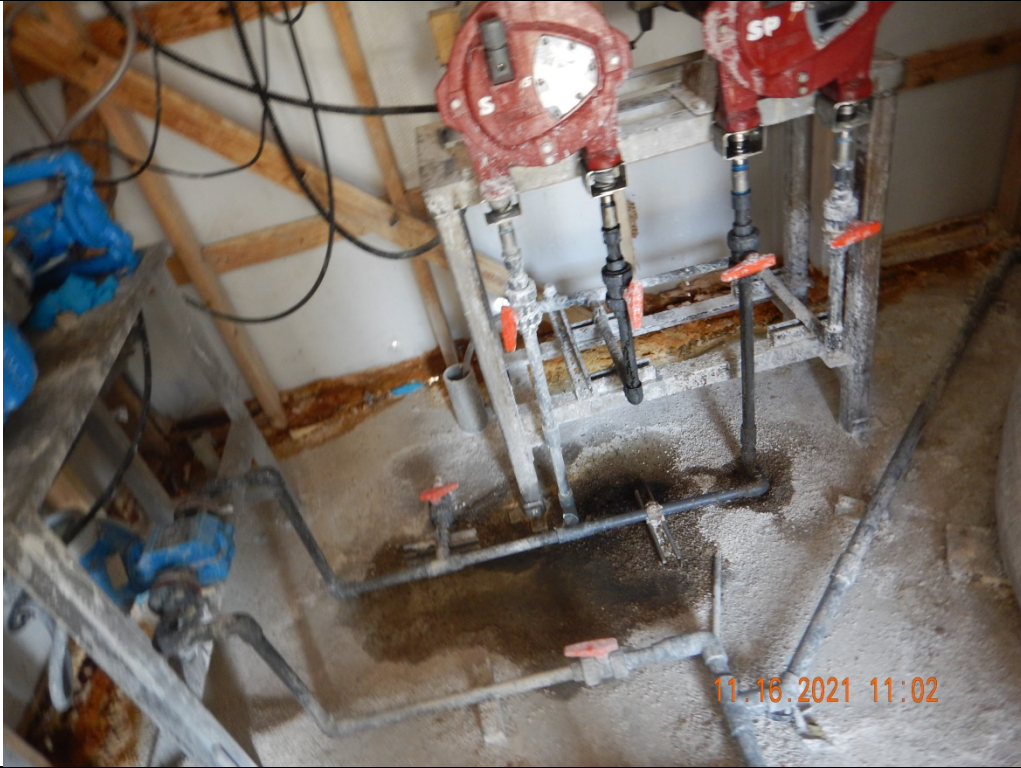
- b. **Evidence of leaking alum was observed from the side of a storage building. Discharges of alum to the ground must be prevented.**
 - c. **Solids were observed accumulating at the high level bar screen at the head of the plant. These solids must be removed.**

Location:	City of Decatur WWTP		
Photographer:	Garrett Grimes, District 1 Inspector	Date:	11/16/2021
Witness:		Time:	11:03
		Photo #:	7
Description:	Alum storage building showing evidence of leaks.

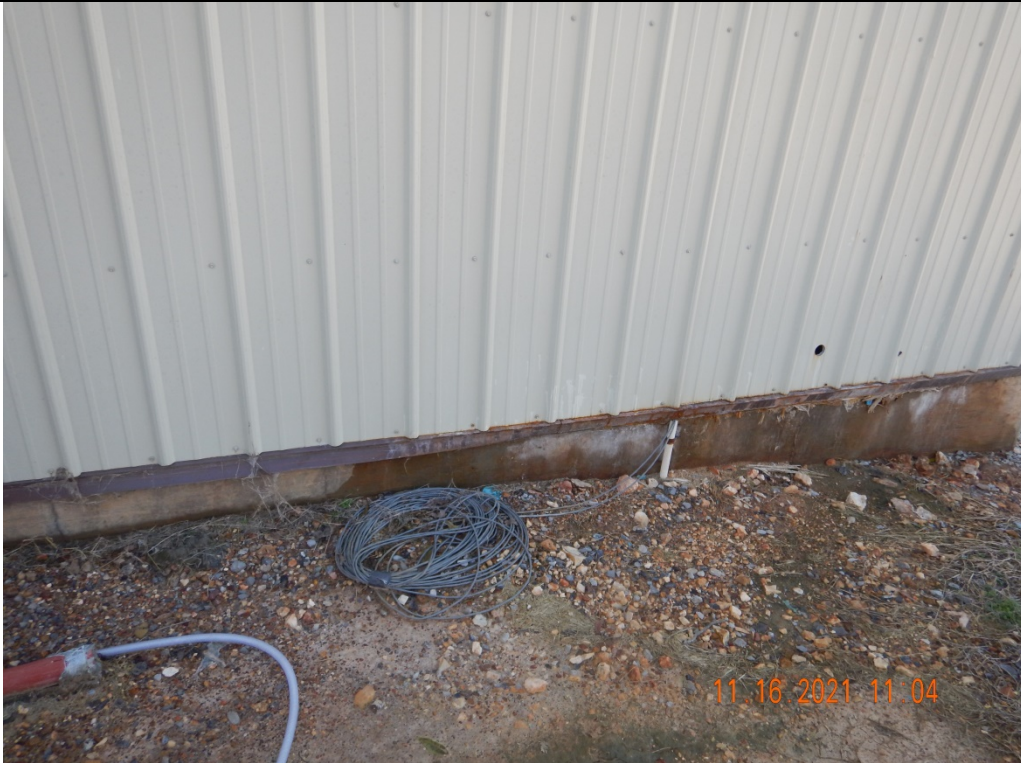
Photographer:	Garrett Grimes, District 1 Inspector	Date:	11/16/2021
Witness:		Time:	11:04
		Photo #:	8
Description:	Evidence of leaks from alum storage building.

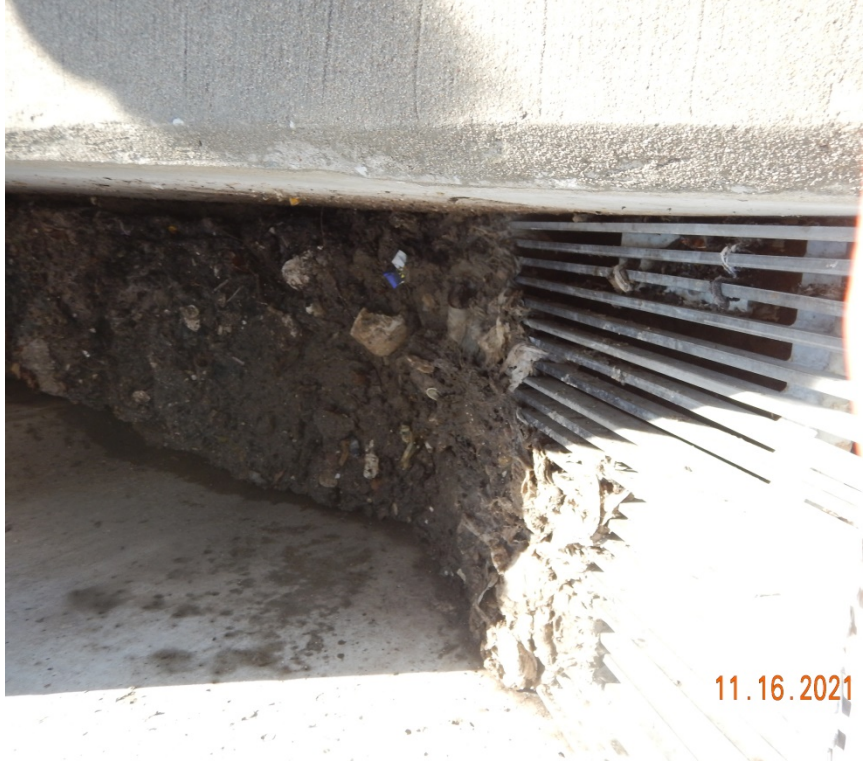
Location:	City of Decatur WWTP		
Photographer:	Garrett Grimes, District 1 Inspector	Date:	11/16/2021
Witness:		Time:	11:08
		Photo #:	9
Description:	High level bar screen showing an abundance of solids.

2. The other big item is we have replaced our Westec screen from your photo on page 7 of your report, with a Aqualitec brand screen, that is better equipped to catch wipes. So far it is working fantastic. I have attached a photo of the replacement screen, that replaced the Westec screen from your photo.

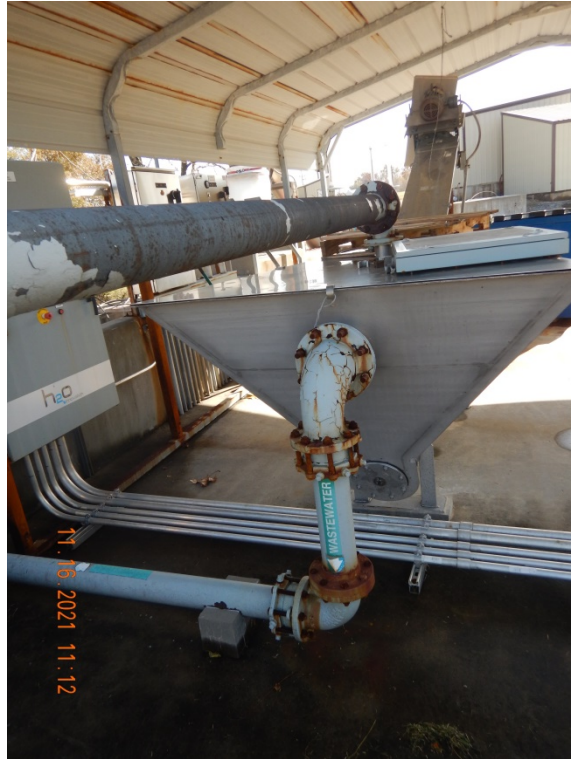
Location:	City of Decatur WWTP		
Photographer:	Garrett Grimes, District 1 Inspector	Date:	11/16/2021
Witness:		Time:	11:12
		Photo #:	11
Description:	Grit and solids collection area.

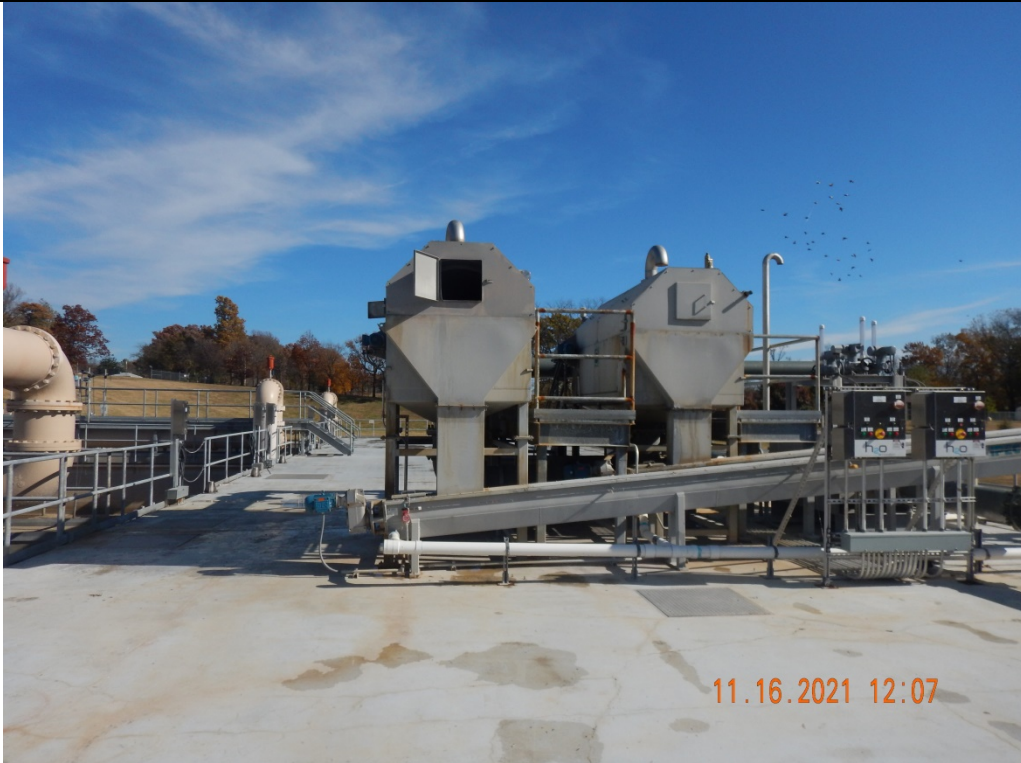
5. **At the time of the inspection, an overflow had occurred recently within the plant at the MBR unit. This was due to a failure at the fine mesh screen where wastewater enters the unit. When a failure occurs at this screen, the screen becomes impassible to wastewater resulting in overflow from the unit onto the surrounding ground. From the MBR unit, wastewater flows downstream to the remains of a former treatment pond. At the time of the inspection, wastewater was observed within the former treatment pond. The City of Decatur did not note discharges from this pond off the boundaries of the site. However, this pond's ability to hold wastewater is not known. Therefore, all overflows from the unit to this pond must be reported as per Part III, Section D.6 of the permit. Furthermore, the City of Decatur must call the DEQ Office of Water Quality-Permits Branch concerning the use of this former pond and any possible required modifications to the permit.**

Photographer:	Garrett Grimes, District 1 Inspector	Date:	11/16/2021
Witness:		Time:	12:07
		Photo #:	12
Description:	Fine mesh screen on the MBR unit.

10. **Report Item 5:** Your response states that the replacement of the spiral screen with the automated bar screen has increased the facility's capacity to remove screenings at the headworks and prevent downstream clogs. However, the response states that the closed, former treatment pond is still intended for use for overflows. This item will be referred to the DEQ - Office of Water Quality – Enforcement Branch for further review.

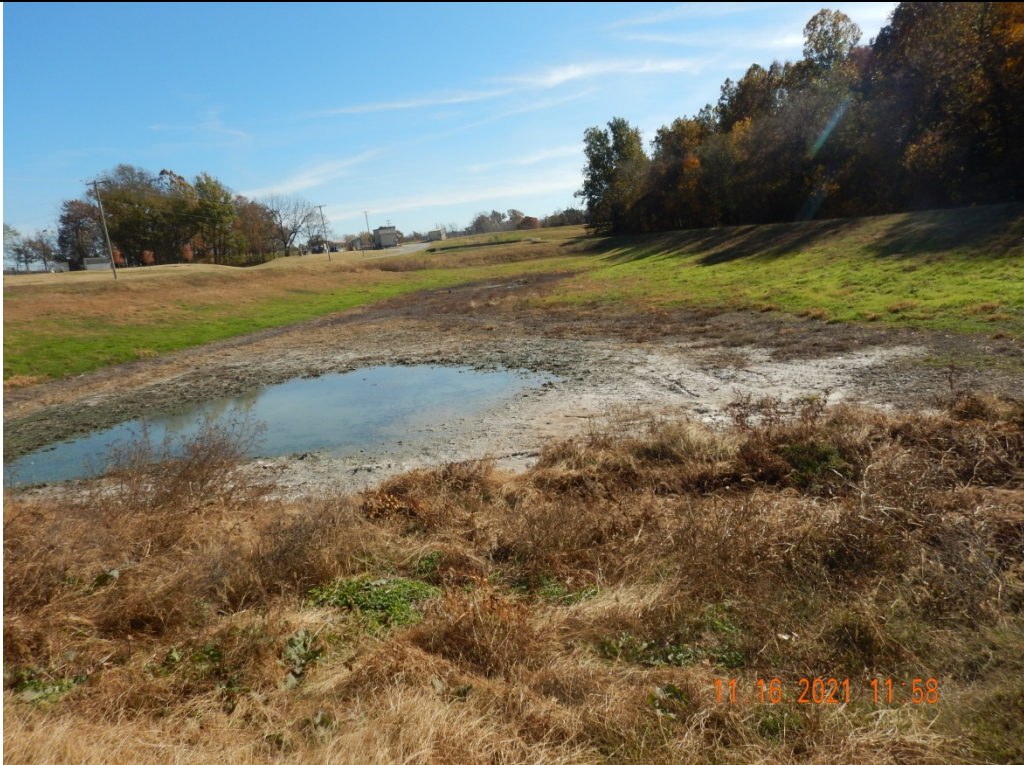
The City of Decatur operates a MBR. The MBR unit was also mentioned in the complaints received by DEQ prior to the inspection alleging overflows from this system, and there was evidence of this on satellite imagery in use by Benton County (Attachment 3). Mr. Boston confirmed wastewater overflows have occurred from this unit twice in the year 2021. Mr. Boston stated that these occurred in February 2021 and recently prior to the inspection. According to Mr. Boston, wastewater must pass through a fine mesh screen prior to entering the MBR unit and freezing in February 2021 and a recent power outage caused the screen to cease functioning and become fouled (Photo #12). When this occurs, wastewater can no longer pass through the mesh and overflows from the inlet of the MBR, according to Mr. Boston. After the wastewater overflows it follows a westward path to remains of an unused wastewater treatment pond (Photos #13 - #14). Mr. Boston stated that he did not believe wastewater was able to leave this pond and that it would evaporate over time.

Photographer:	Garrett Grimes, District 1 Inspector	Date:	11/16/2021
Witness:		Time:	11:58
		Photo #:	14
Description:	Wastewater accumulation in the unused pond.

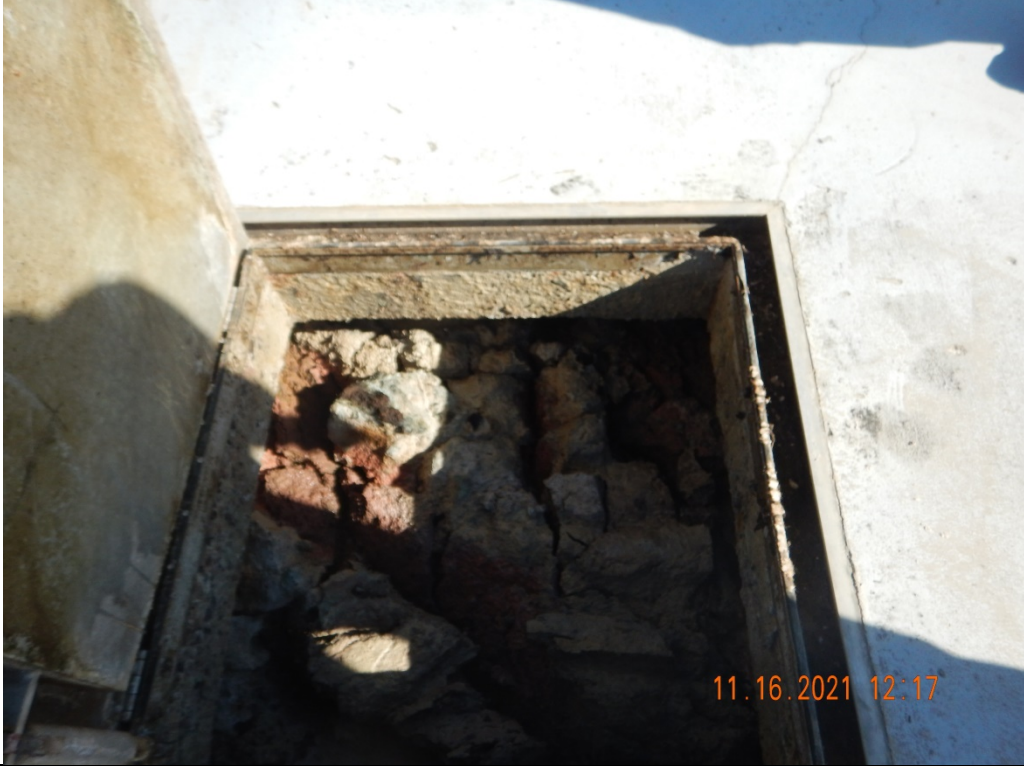
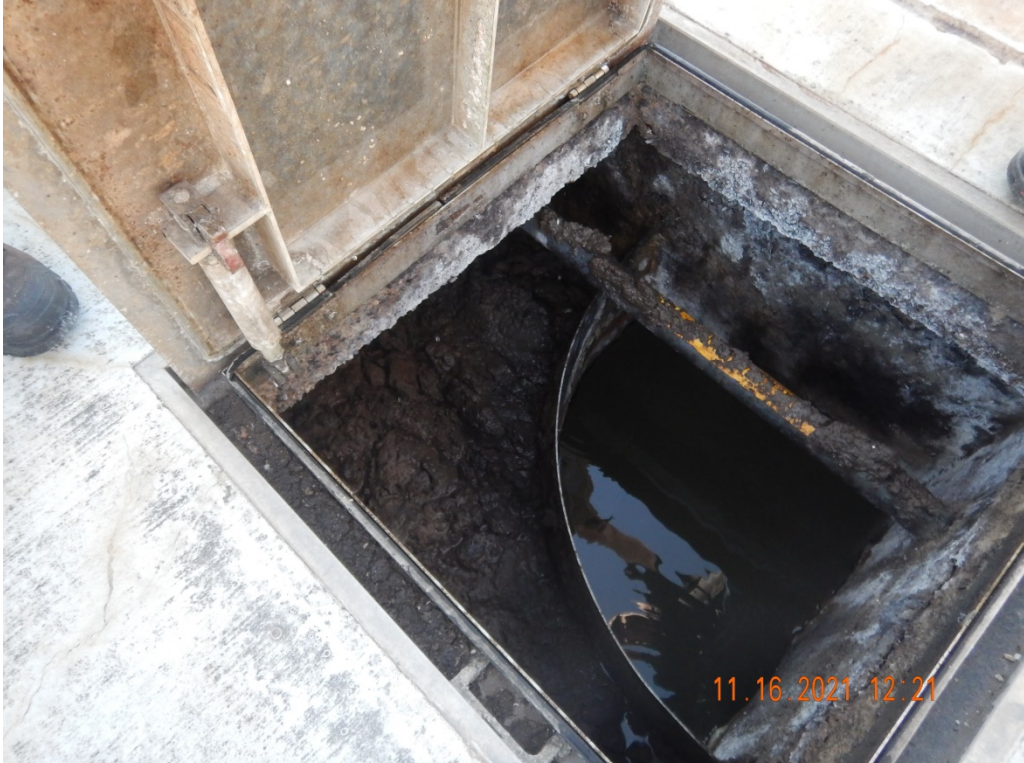
- d. **A large cap of solids was observed accumulating in the anaerobic zone of the Membrane Bioreactor (MBR) unit. Mr. Boston stated that this cap was likely from grease that enters the unit and that it was not currently affecting treatment. However, this cap is increasing in size and concerns were raised about future impact to treatment. The City did not have a plan to deal with this cap at the time of the inspection.**

A large (~4') cap of solids was observed in the anaerobic zone of the MBR unit (Photos #15 - #16). Mr. Boston stated that this cap may be from grease, and that it was not currently affecting treatment. Mr. Boston stated that the City had recently completed maintenance on the MBR membrane filters which included a chemical clean of the filters. Mr. Boston also stated that these filters are serviced once weekly and that a chemical clean with dilute bleach and citric acid are used as part of this process (Photos #17 - #18). According to Mr. Boston, the use of these chemicals is standard for cleaning MBRs and does not negatively affect the plant. The City is currently assessing adding an additional filter unit to the MBR to increase the treatment capacity of the plant.

Location:	City of Decatur WWTP				
Photographer:	Garrett Grimes, District 1 Inspector	Date:	11/16/2021	Time:	12:17
Witness:				Photo #:	15
Description:	Solids build up on the surface of the anaerobic zone in the MBR.

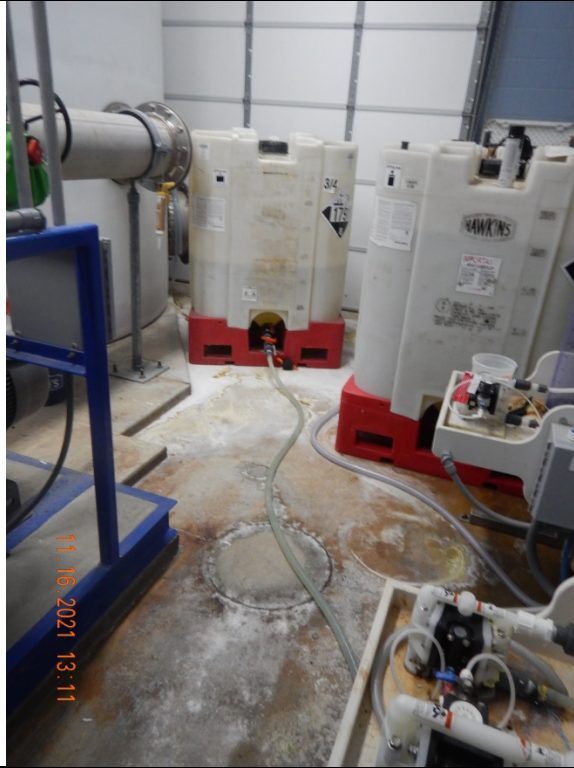
Location:	City of Decatur WWTP		
Photographer:	Garrett Grimes, District 1 Inspector	Date:	11/16/2021
Witness:		Time:	13:11
		Photo #:	17
Description:	Chemicals used to clean the filter membranes.

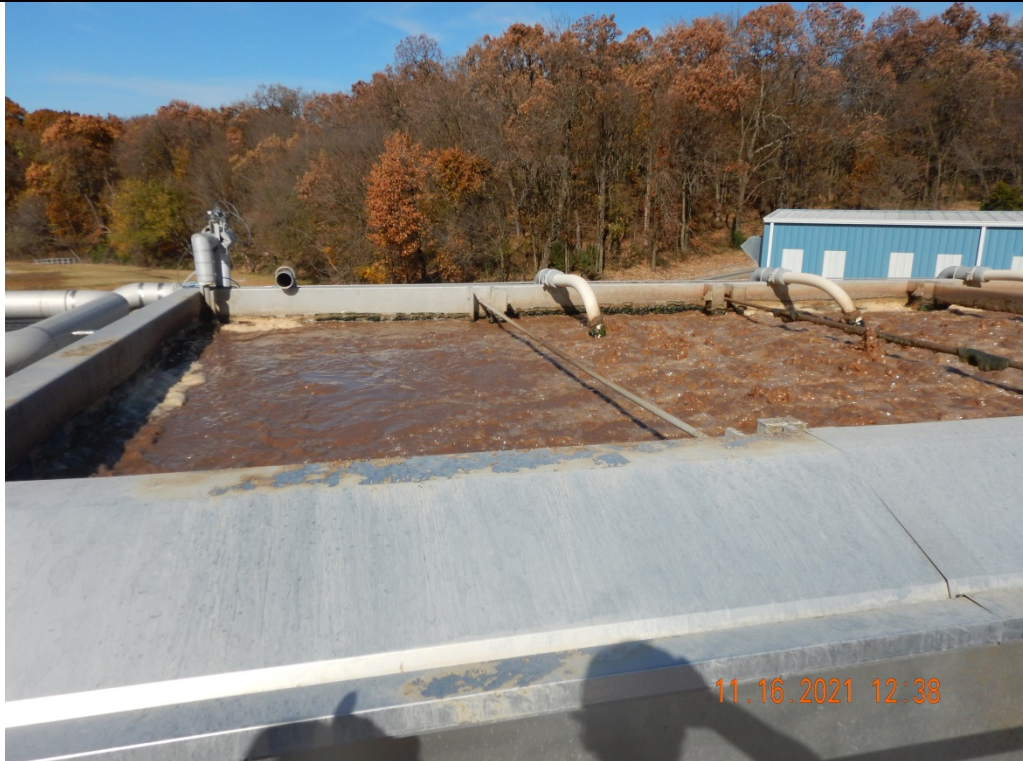
Photographer:	Garrett Grimes, District 1 Inspector	Date:	11/16/2021
Witness:		Time:	12:38
		Photo #:	18
Description:	Filter membrane location within the MBR.

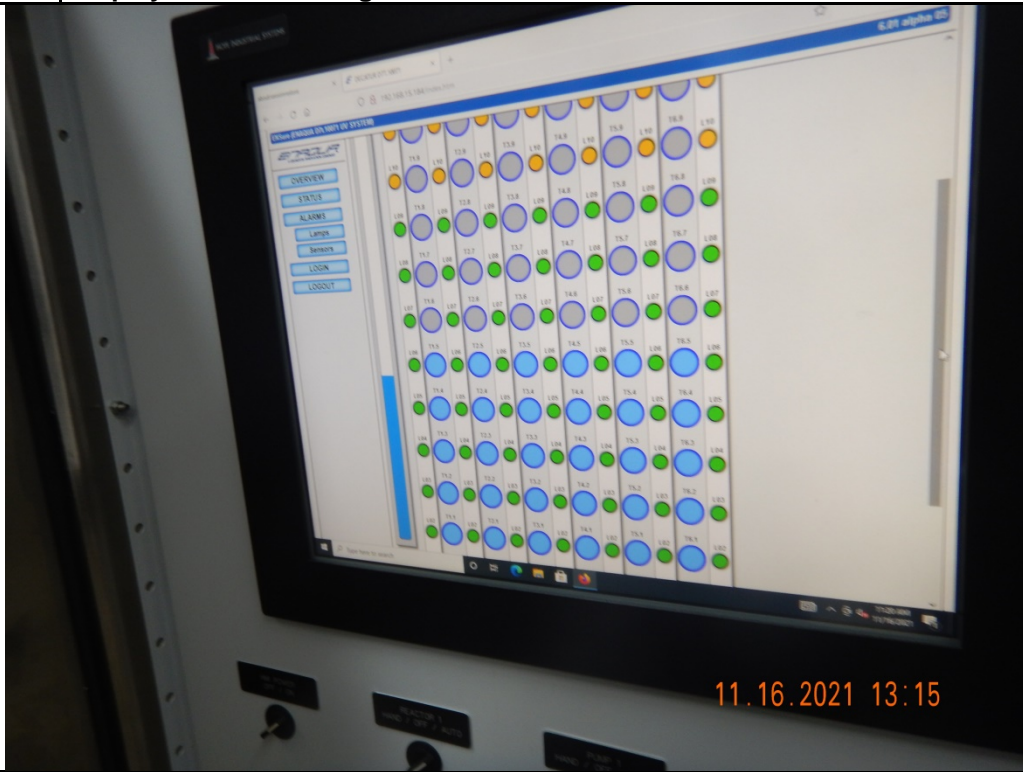
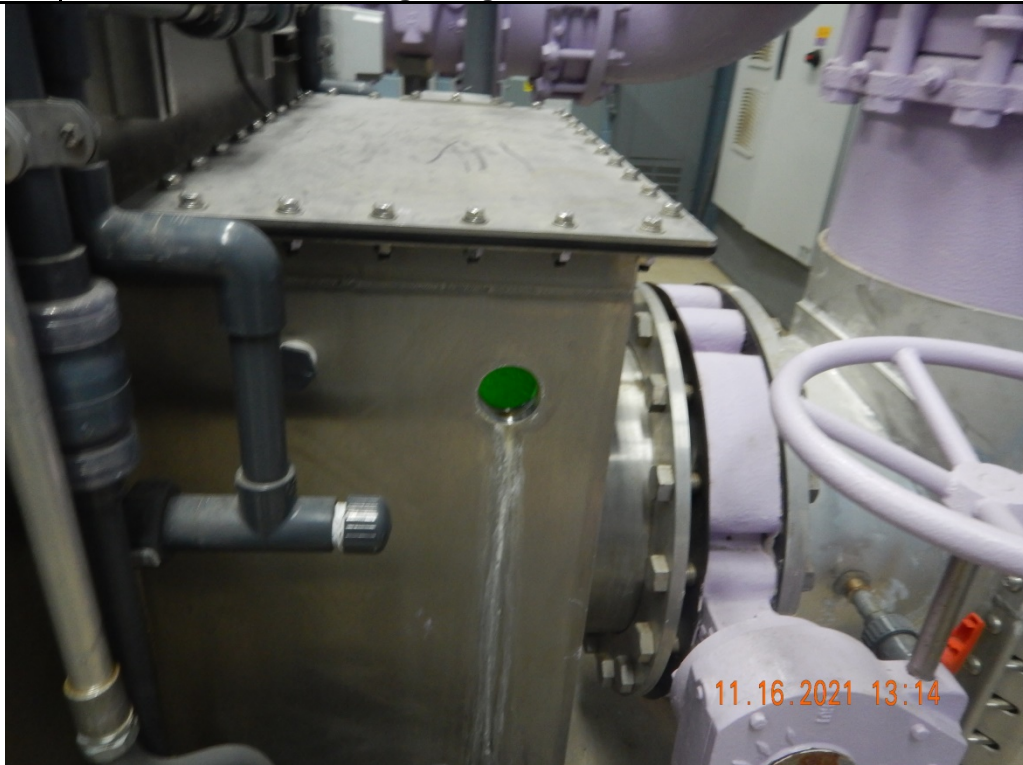
Following the MBR, wastewater is routed through UV treatment for disinfection. UV light banks were operational and appeared in good working condition (Photos #19 - #20). The composite sampler in this area was also in good working condition. The UV disinfection is the last area of active treatment, but effluent is passively oxygenated prior to discharge from Outfall 001 (Photo #21). Algae were observed accumulating on the surface of this area, but did not appear to impair functionality. Effluent discharged appeared clear and in good condition with no solids visibly discharged or accumulating in the receiving stream (Photos #22 - #23).

Location:	City of Decatur WWTP		
Photographer:	Garrett Grimes, District 1 Inspector	Date:	11/16/2021
Witness:		Time:	13:15
		Photo #:	19
Description:	Display screen showing functional UV banks.

Photographer:	Garrett Grimes, District 1 Inspector	Date:	11/16/2021
Witness:		Time:	13:14
		Photo #:	20
Description:	UV treatment tank showing UV lights are active.

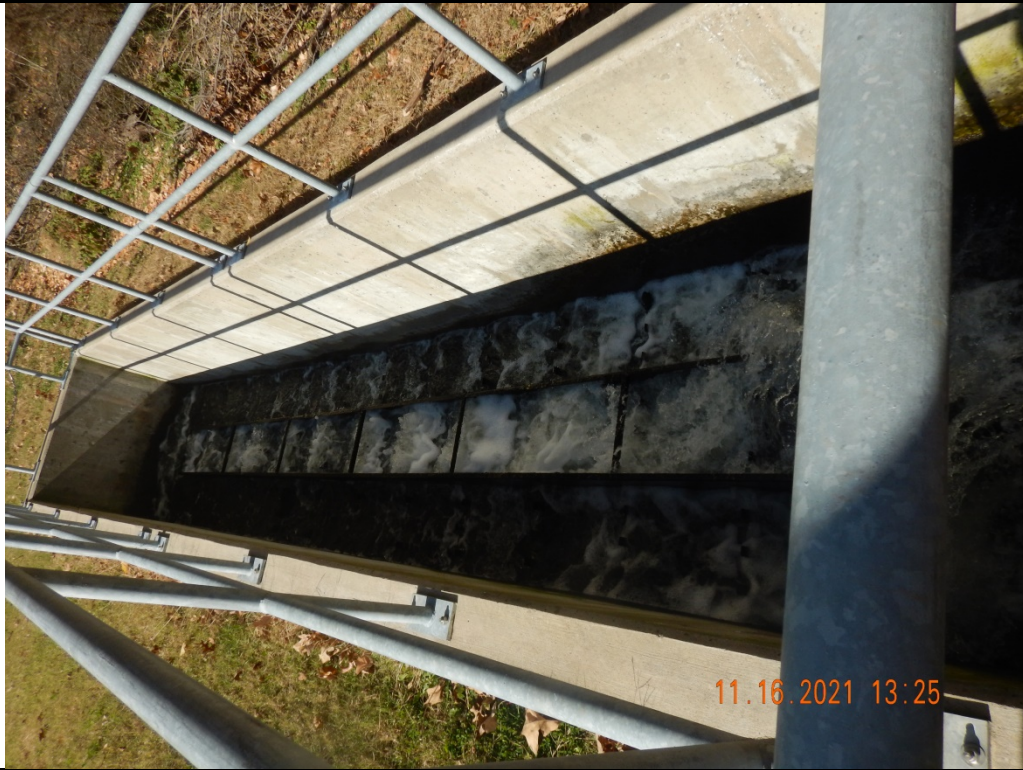
Location:	City of Decatur WWTP		
Photographer:	Garrett Grimes, District 1 Inspector	Date:	11/16/2021
Witness:		Time:	13:25
		Photo #:	21
Description:	Passive aeration prior to discharge.

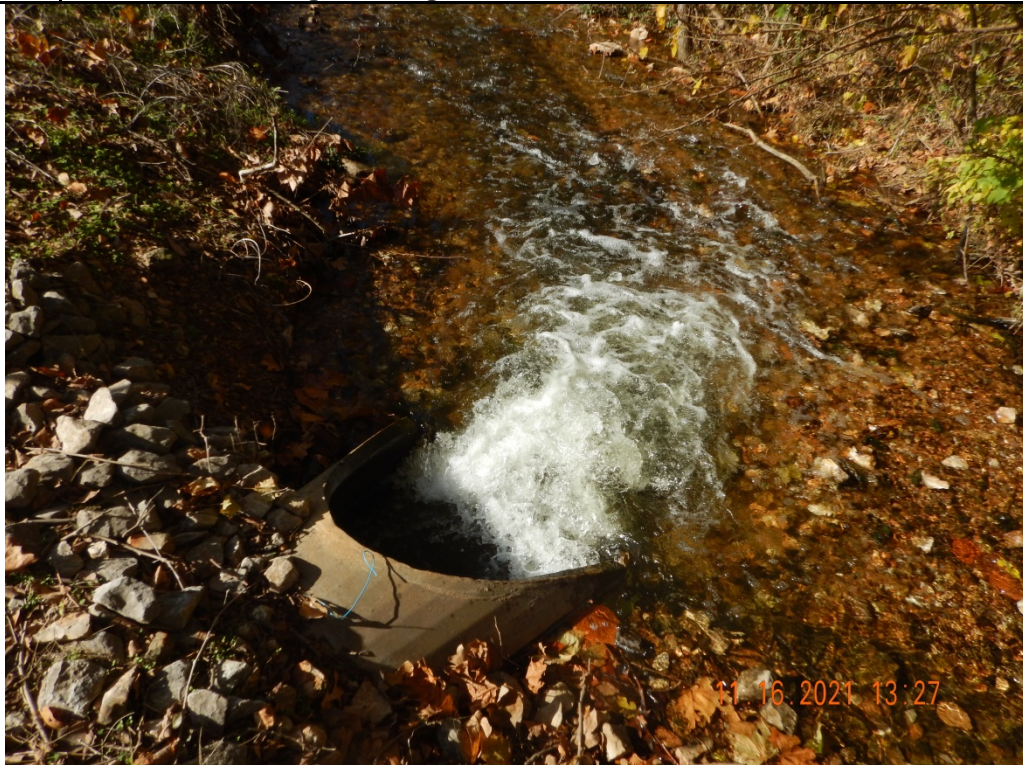
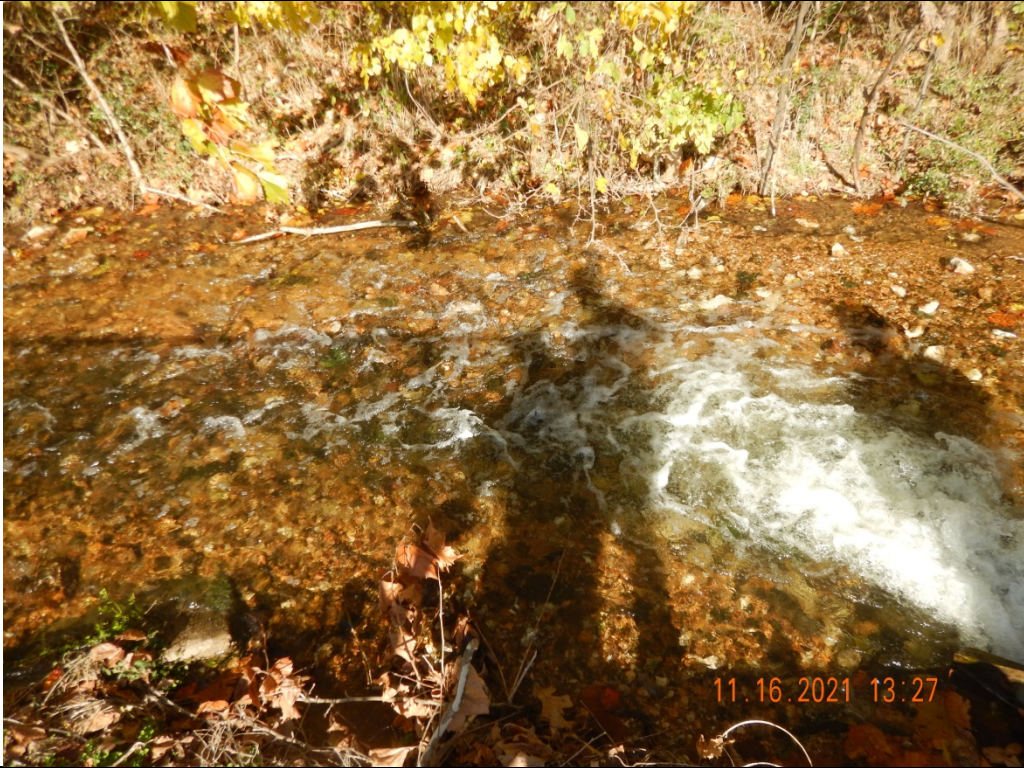
Photographer:	Garrett Grimes, District 1 Inspector	Date:	11/16/2021
Witness:		Time:	13:27
		Photo #:	22
Description:	Outfall 001 showing discharge.

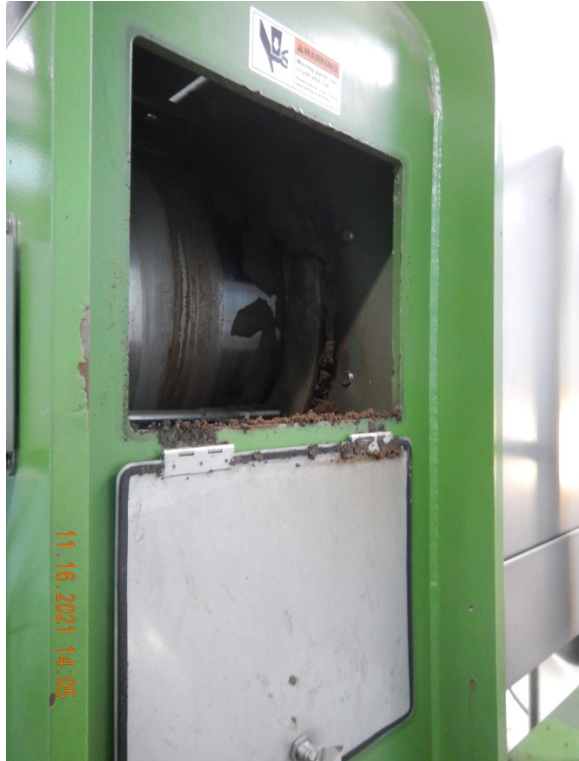
A screw press is utilized for processing sludge. This press appeared operation and in good working condition at the time of the inspection (Photo #24). A sludge storage pond is located west of the main building. Freeboard was low in this pond at the time of the inspection and the City was in the process of installing a pump to begin removing liquid from the pond (Photos #25 - #26). Furthermore, there was some evidence of possible leakage from the berms into a previously used treatment pond which is now filled with stormwater (Photos #27 - #29).

Photographer:	Garrett Grimes, District 1 Inspector	Date:	11/16/2021
Witness:		Time:	14:05
		Photo #:	24
Description:	Sludge press.

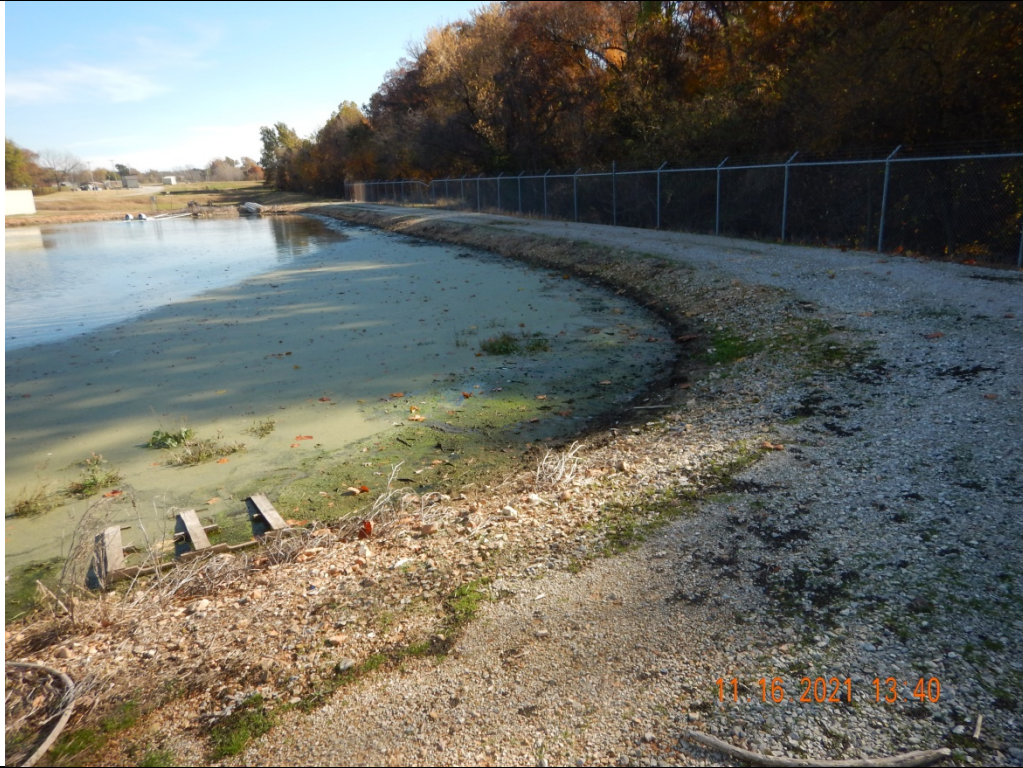
- e. **A sludge holding pond was lacking freeboard and there was no way to expediently remove wastewater from this pond. A pump was in the process of being installed at the time of the inspection.**

Location:	City of Decatur WWTP		
Photographer:	Garrett Grimes, District 1 Inspector	Date:	11/16/2021
Witness:		Time:	13:40
		Photo #:	25
Description:	Sludge holding pond showing a lack of freeboard.

6. **The permit does not include a sludge storage pond. This pond was used during renovations at the facility and last used several months prior to the inspection, according to Mr. Boston. Should the City wish to continue using this pond, the DEQ Office of Water Quality-Permits Branch must be contacted. If this pond is no longer intended for use, then wastes should be removed and the pond closed.**

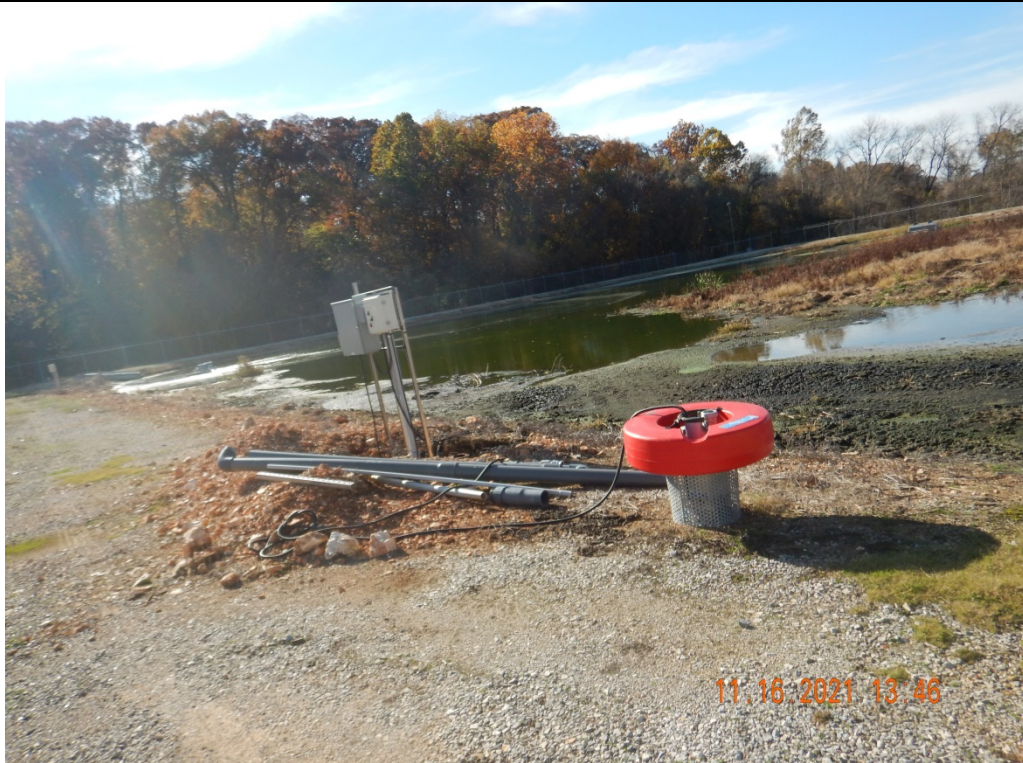
Photographer:	Garrett Grimes, District 1 Inspector	Date:	11/16/2021
Witness:		Time:	13:45
		Photo #:	26
Description:	Location of planned pump installation.

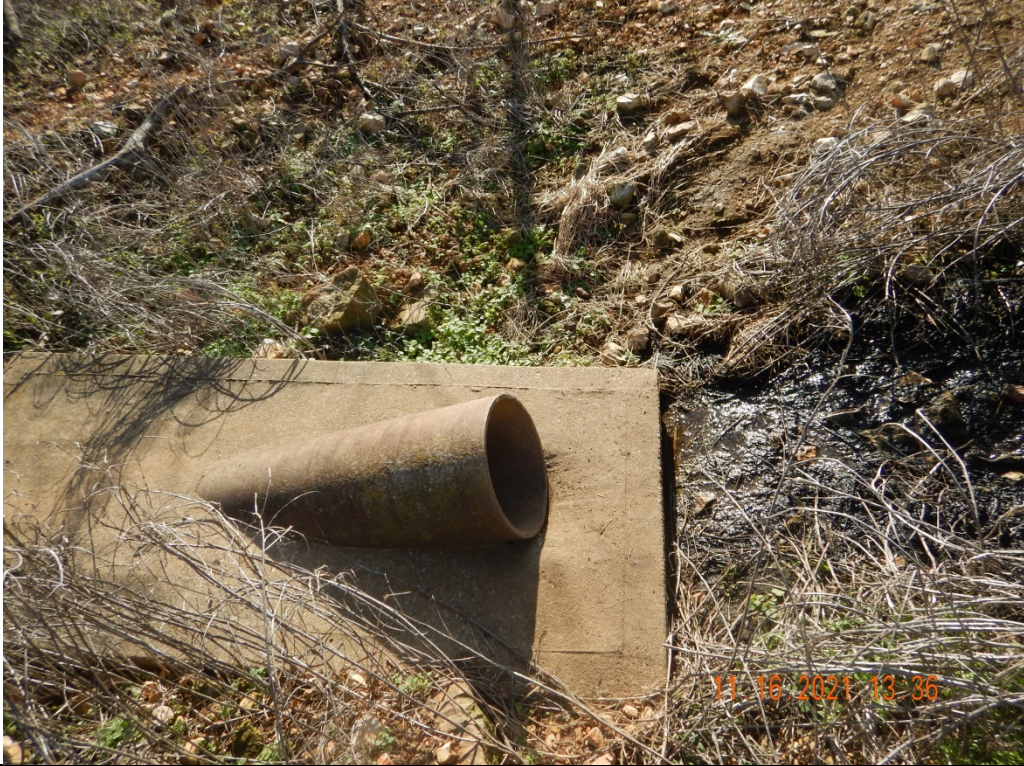
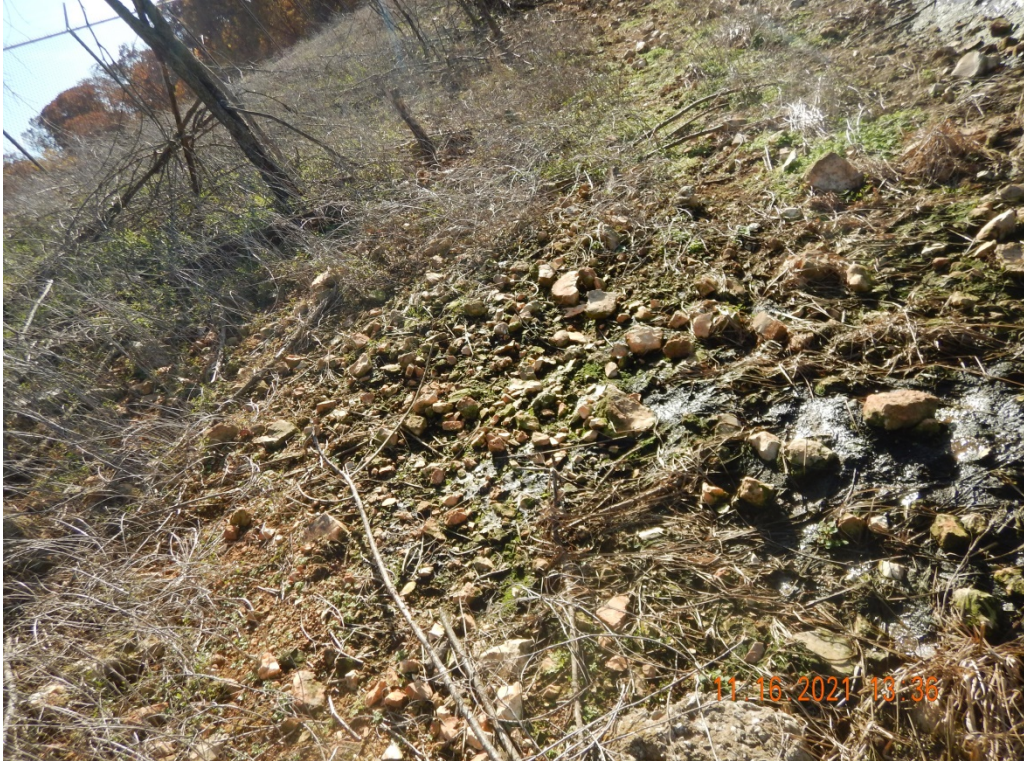
- f. **Wastewater from the above noted sludge storage pond was observed leaking from the berms on the on the north face of the pond into a former treatment pond containing stormwater.**

Location:	City of Decatur WWTP		
Photographer:	Garrett Grimes, District 1 Inspector	Date:	11/16/2021
Witness:		Time:	13:36
		Photo #:	27
Description:	Area along the north berm of the sludge holding pond showing suspected leak.
