RE: City of Decatur WWTP Inspection
AFIN: 04-00052 **Permit No.: AR0022292**

<p>ENVIRONMENTAL QUALITY</p>	OFFICE OF WATER QUALITY INSPECTION REPORT				
	AFIN: 04-00052	PERMIT #: AR0022292	DATE: 11/16/2021		
	COUNTY: 04 Benton	PDS #: 123277	MEDIA: WN		
	GPS LAT: 36.34417 LONG: -94.47271 LOCATION: General Area				
FACILITY INFORMATION		INSPECTION INFORMATION			
NAME: City of Decatur WWTP LOCATION: 985 Austin Avenue CITY: Decatur		FACILITY TYPE: 1 - Municipal INSPECTOR ID#: 104111 S - State FACILITY EVALUATION RATING: 1 - Unsatisfactory INSPECTION TYPE: Compliance Evaluation			
RESPONSIBLE OFFICIAL		DATE(S): 11/16/2021 ENTRY TIME: 10:34 EXIT TIME: 15:00 PERMIT EFFECTIVE DATE: 11/30/2020 PERMIT EXPIRATION DATE: 11/30/2025			
NAME: / TITLE Robert Tharp / Mayor COMPANY: City of Decatur MAILING ADDRESS: PO Box 247 CITY, STATE, ZIP: Decatur AR 72722 PHONE & EXT: / FAX: 479-752-3912 / EMAIL: bobtharp@decaturarkansas.us & james.boston@decaturarkansas.us		FAYETTEVILLE SHALE RELATED: N FAYETTEVILLE SHALE VIOLATIONS: N

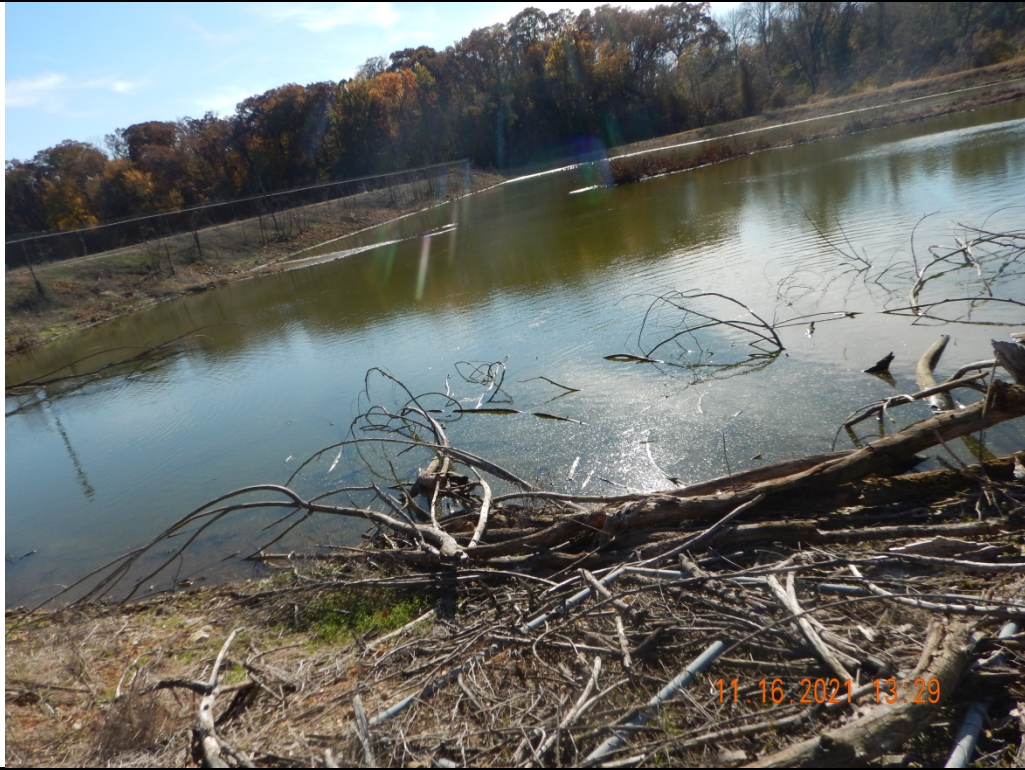
- f. **Wastewater from the above noted sludge storage pond was observed leaking from the berms on the on the north face of the pond into a former treatment pond containing stormwater.**

Location:	City of Decatur WWTP				
Photographer:	Garrett Grimes, District 1 Inspector	Date:	11/16/2021	Time:	13:29
Witness:				Photo #:	29
Description:	Former treatment pond showing the north berm of the sludge storage pond on the left.

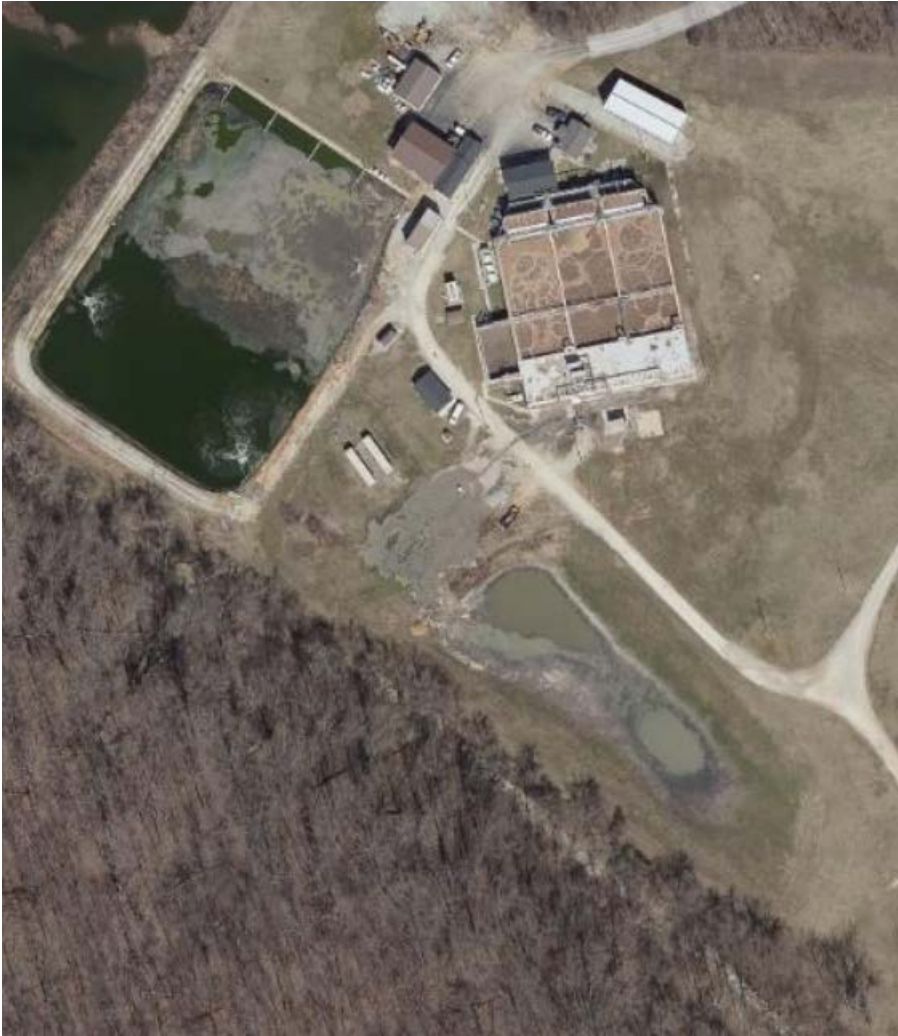
5. **At the time of the inspection, an overflow had occurred recently within the plant at the MBR unit. This was due to a failure at the fine mesh screen where wastewater enters the unit. When a failure occurs at this screen, the screen becomes impassible to wastewater resulting in overflow from the unit onto the surrounding ground. From the MBR unit, wastewater flows downstream to the remains of a former treatment pond. At the time of the inspection, wastewater was observed within the former treatment pond. The City of Decatur did not note discharges from this pond off the boundaries of the site. However, this pond's ability to hold wastewater is not known. Therefore, all overflows from the unit to this pond must be reported as per Part III, Section D.6 of the permit. Furthermore, the City of Decatur must call the DEQ Office of Water Quality-Permits Branch concerning the use of this former pond and any possible required modifications to the permit.**

Attachment 3: Satellite image showing overflow from the MBR to the storage pond.

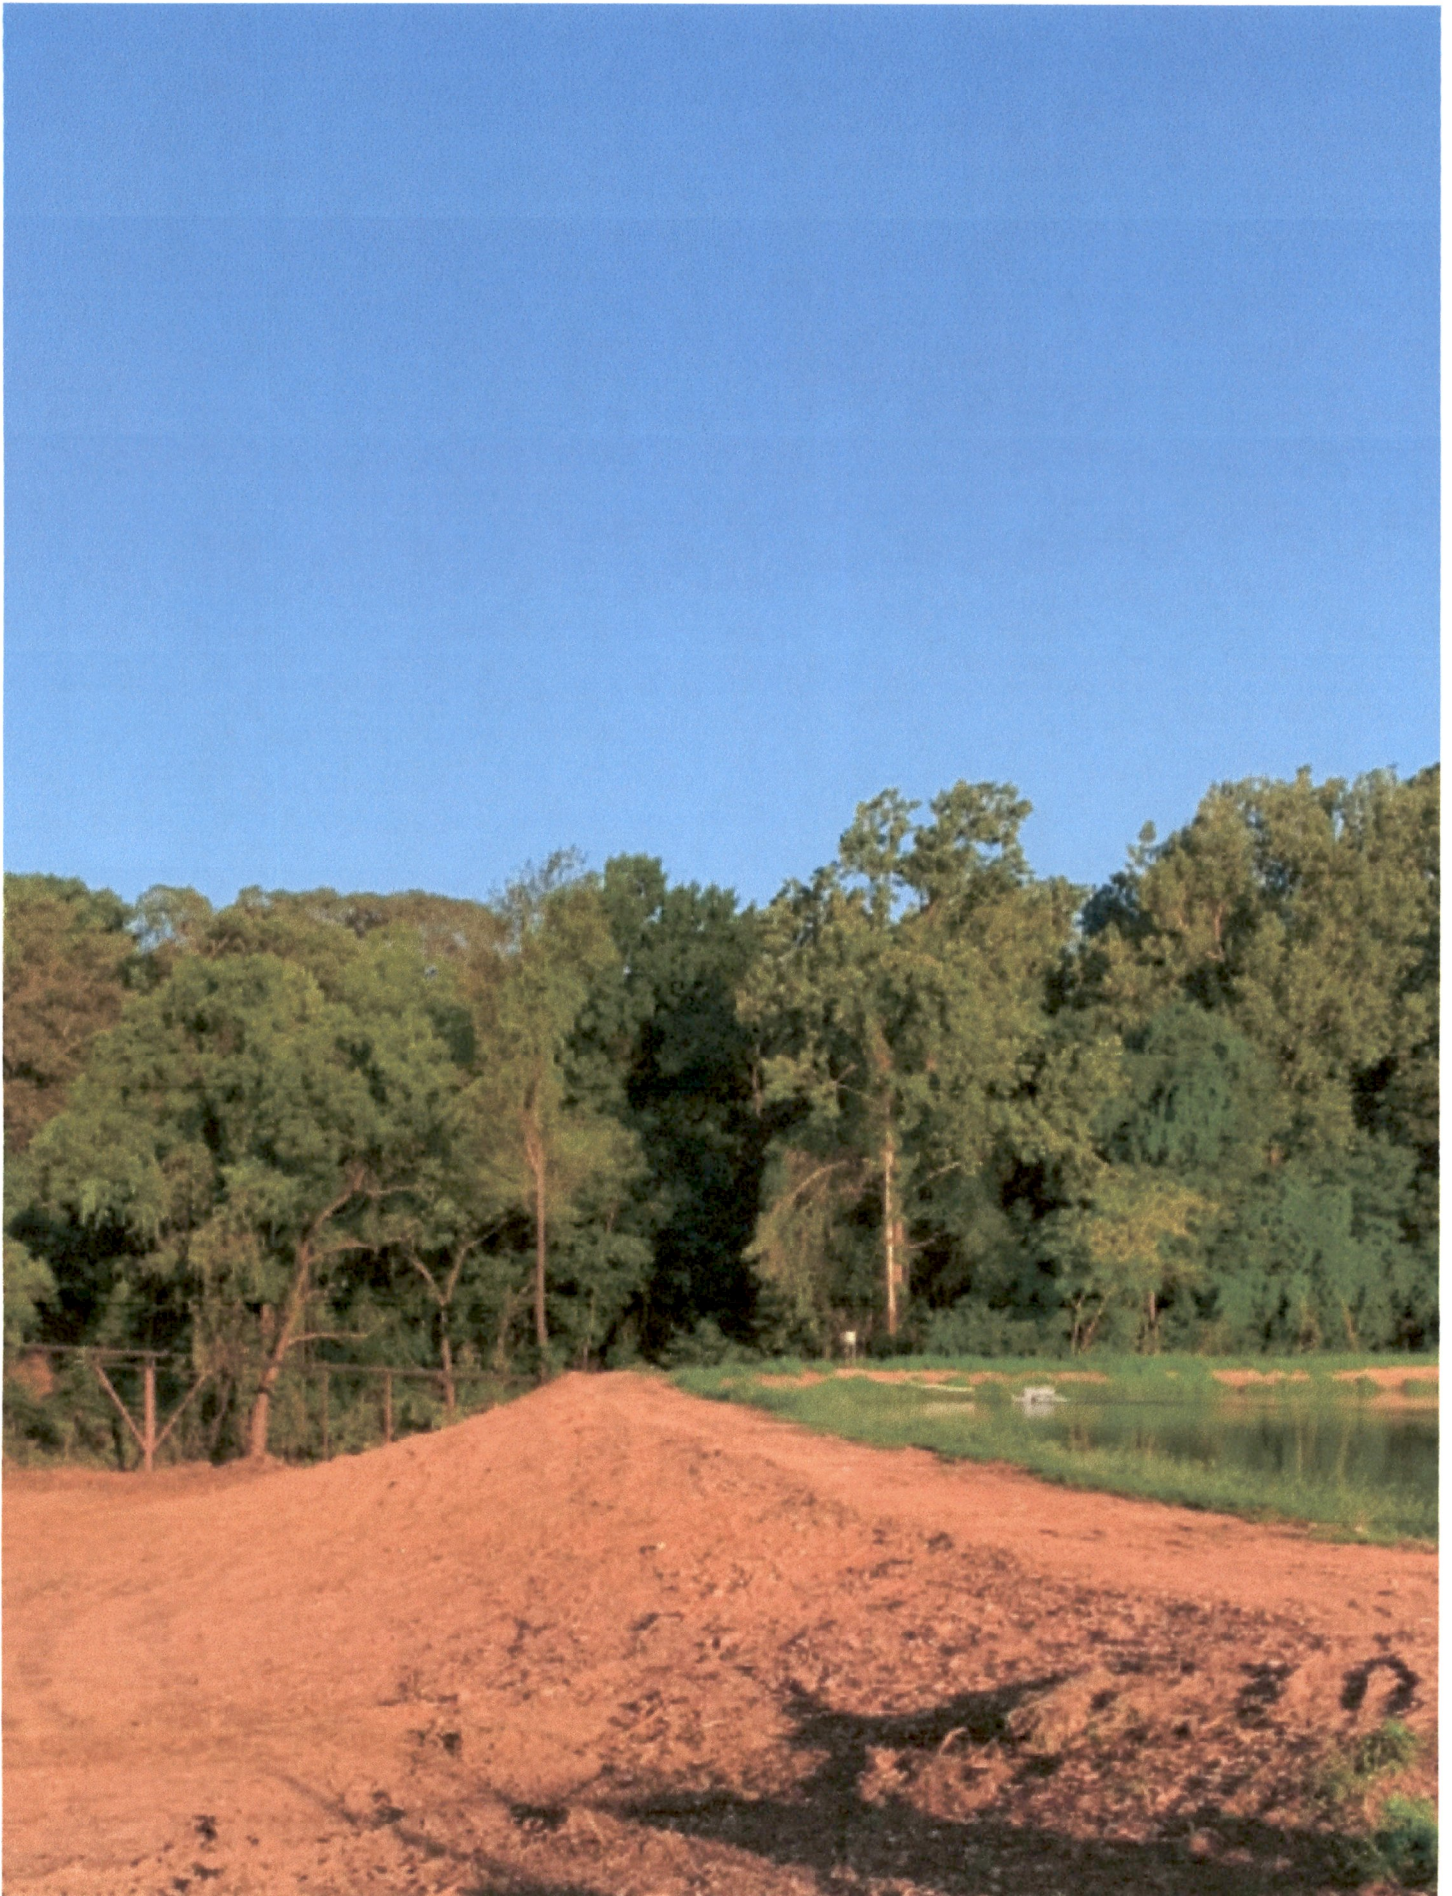
Decatur Equalization Pond

3. Item 3 dealt with the equalization pond that we still use on a daily basis. We did have a lot of vegetation that was grown up in a fence on the south side of the pond. Time and attention in other places had led it to be overgrown with vegetation in the fence, and pond bank. We have now cleaned this up and done work on the pond bank or berm. I have attached a photo of what it looks like now. We have been in the process of taking bids to replace the security fence along this pond, we should have a contractor to replace the fence next week. We are aerating the pond and adding bacteria to the pond from time to time to keep it healthy. Once the expansion occurs it should only be used for rainfall events or when the plant needs to be taken off line for a maintenance event. The aerator you saw the day you were there that was off was due to it being in shallow water, that end of the pond is not as deep.

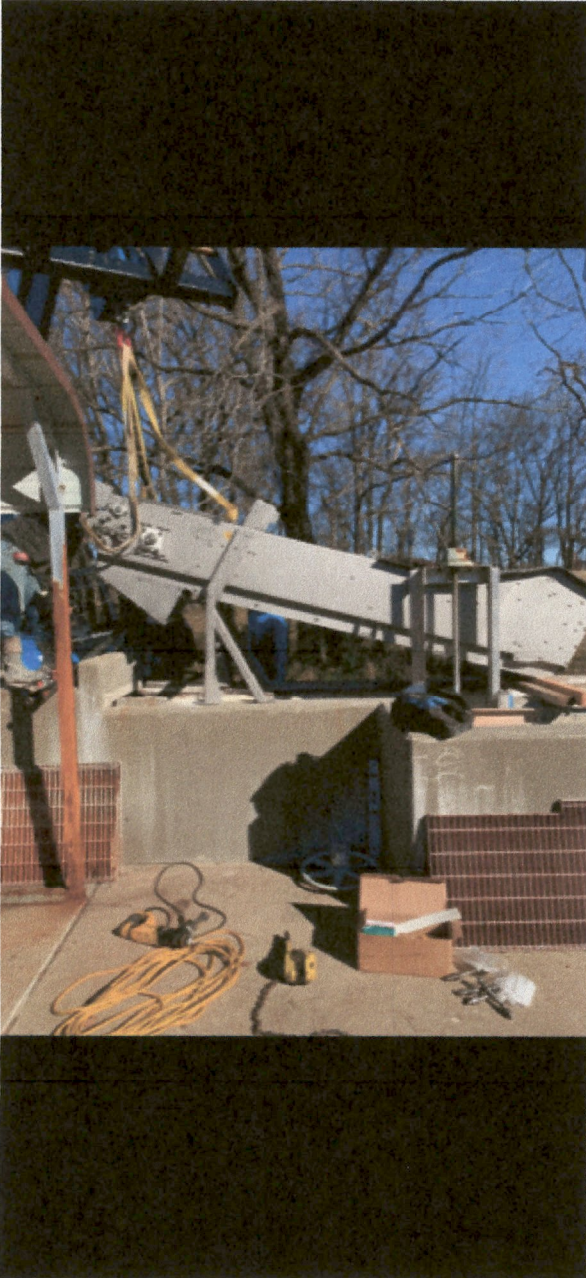
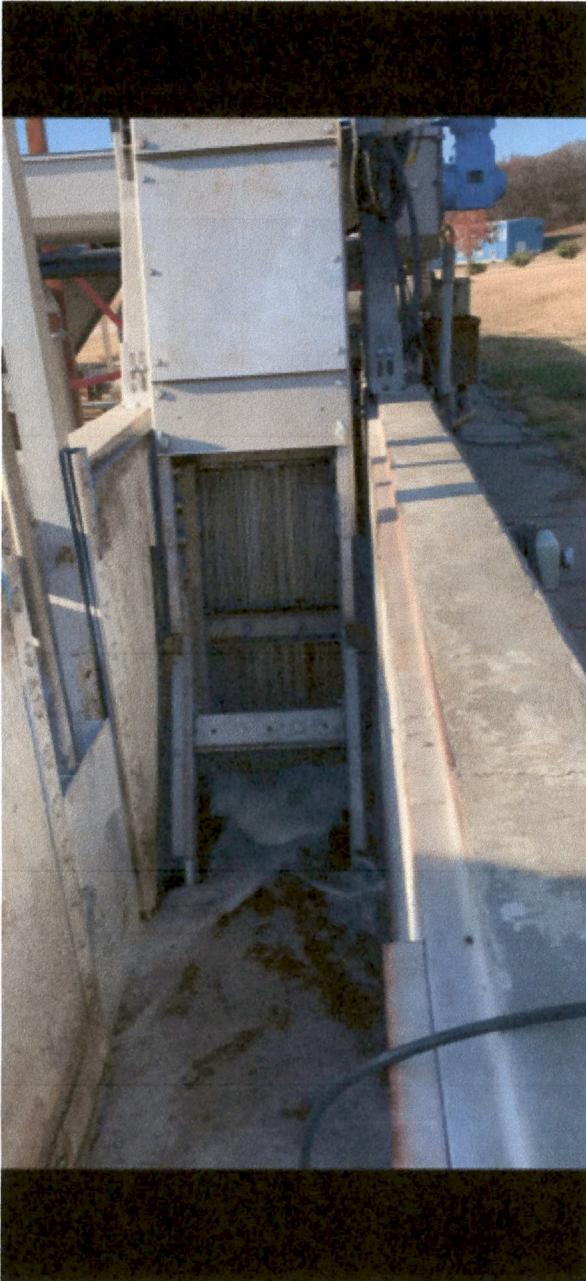
Decatur Aqualitec Screen

2. The other big item is we have replaced our Westec screen from your photo on page 7 of your report, with a Aqualitec brand screen, that is better equipped to catch wipes. So far it is working fantastic. I have attached a photo of the replacement screen, that replaced the Westec screen from your photo.
