RE: Malvern WWTF Inspection

AFIN: 30-00040 Permit No.: AR0034126

On March 8th 2022, I performed a Compliance Evaluation Inspection of the above referenced facility in accordance with the provisions of the Federal Clean Water Act, the Arkansas Water and Air Pollution Control Act, and the regulations promulgated thereunder. A copy of the inspection report is enclosed for your records.

OFFICE OF WATER QUALITY

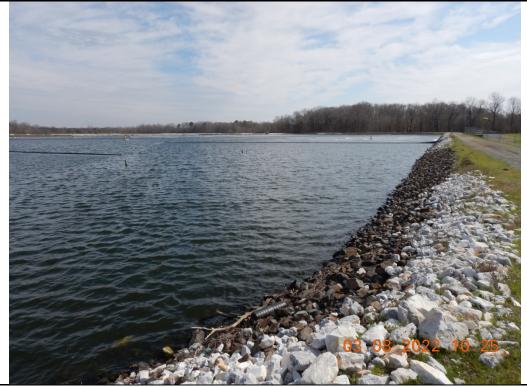
Office of Water Quality Photographic Evidence Sheet Location: Malvern WWTF Photographer: Blain Sanders Date: March 8, 2022 Time: 10:25 Witness: Photo #: 1

Description: View of the first of two partial mixed aerated lagoon.

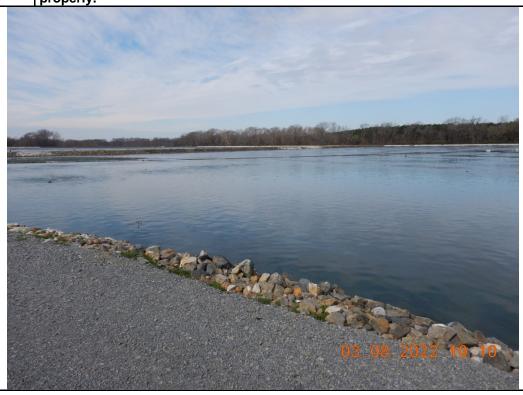
Office of Water Quality Photographic Evidence Sheet											
Location:	Mal	vern WWTF										
Photograp	Photographer: Blain Sanders Date: March 8, 2022				Time:	10:10						
Witness:					Photo #:	3						
Description	7. I	liew of the second partial m	nixed aerated lago	on; blowers and diff	iusers worki	ing

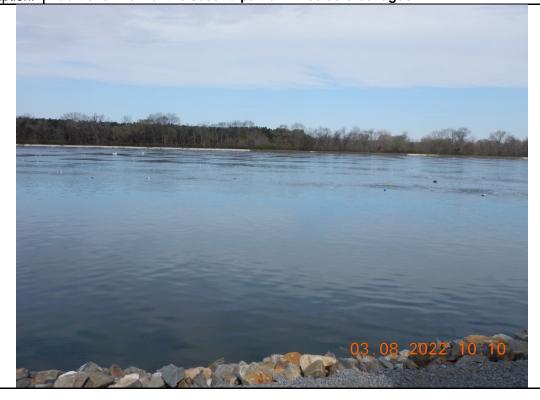
Photographer:	Blain Sanders	Date:	March 8, 2022	Time:	10:10
Witness:				Photo #:	4

Description: Additional view of the second partial mixed aerated lagoon.

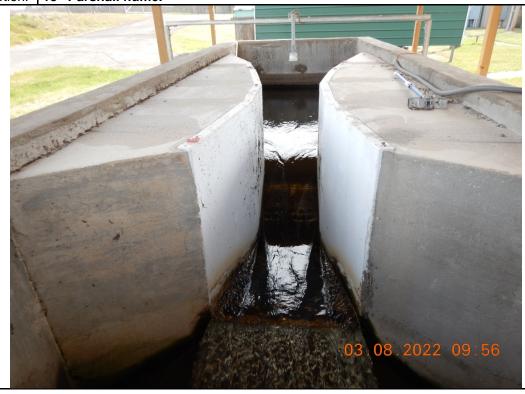
Office of Water Quality Photographic Evidence Sheet Location: Malvern WWTF Photographer: Blain Sanders Date: March 8, 2022 Time: 09:56 Witness: Photo #: 5 Description: 18" Parshall flume.

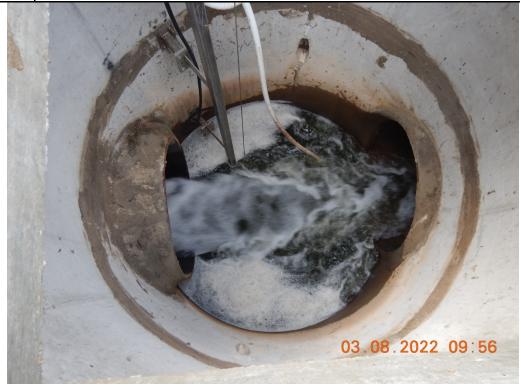
Coation: Malvern WWTF Photographer: Blain Sanders Witness: Date: March 8, 2022 Photo #: 7

Description: Chlorine contact chamber.
