RE: Inspection conducted on December 7, 2022
AFIN 63-00155
Permit Number 0261-S1-R3

Office of Land Resources
Regulated Waste Operations
Class 1 Landfill Inspection Form

Site Name	BFI Waste Systems of Arkansas	County	Saline	AFIN	63-00155
Facility Address	18511 W Sardis Road, Bauxite, AR	Phone #	859-227-3861 (Jerry Coleman) 901-873-8334 (Brad Zimmerman)	Permit #	0261-S1-R3
Permittee Address	18511 W Sardis Road, Bauxite, AR	Email Address	jcoleman2@republicservices.com Bzimmerman2@republicservices.com	PDS #	123939
Date	12/7/2022	Entry Time	1215	Exit Time	1530

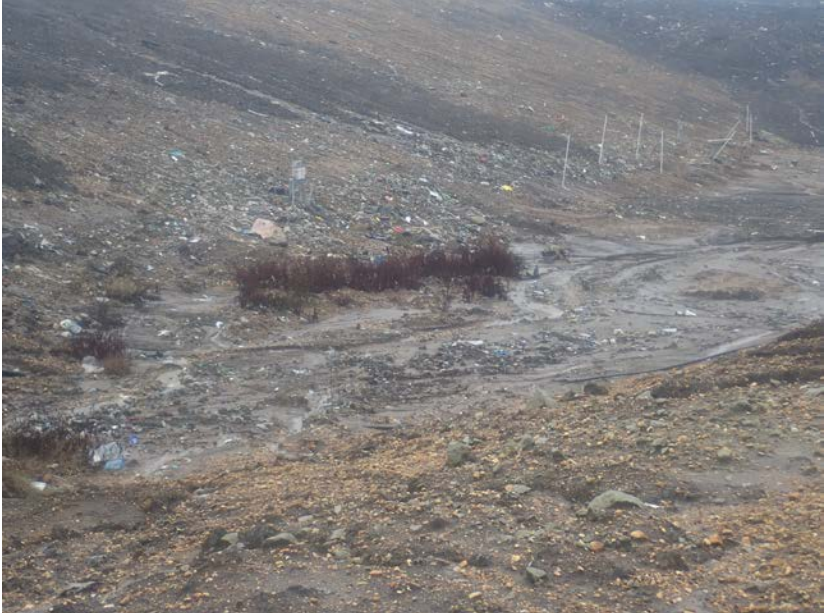
Regulation	Item Description	Comments
	413(a)(b)(c)	Satisfactory Daily/Alternate/Intermediate Cover	
	419(a)(5)	Cause Discharge/Leachate Leaving Landfill	
	411(f)(3)	Depositing Waste in Standing Water Prohibited	
X	411(o)	Erosion or Other Cover Defects Resulting in Exposed Refuse	Cover defects resulting in exposed waste observed on the interior north slope and along the southern upper access road. (Refer to Photos #1 & #2.)
	309(c)	Overfill/Off Lined Area

Witness	N/A		
Photo #	1	Of	2		Date	12/7/2022	Time	1248
Description	Exposed solid waste was observed on the interior north slope.

You should immediately initiate actions to correct the alleged violations cited. A written response of the corrective actions taken, or to be taken, must be submitted within thirty (30) calendar days from the date on this letter to the attention of Kim Davenport. The response may include, but is not limited to, photographs, copies of disposal receipts, records, or analytical results, as applicable. If you have any questions regarding the alleged violations, please do not hesitate to contact me at (501) 682-0586 or Kimberly.Davenport@adeq.state.ar.us.
