RE: City of Bentonville Inspection  
AFIN: 04-00154 Permit No.: AR0022403

<b>ENVIRONMENTAL QUALITY</b>	<b>OFFICE OF WATER QUALITY</b>		
	AFIN: <b>04-00154</b>		PERMIT #: <b>AR0022403</b>
	COUNTY: <b>04 Benton</b>	PDS #: <b>123941</b>	DATE: <b>1/31/2022</b>
	GPS LAT: <b>36.392413</b> LONG: <b>-94.191719</b> LOCATION: <b>General Area</b>

**Office of Water Quality Photographic Evidence Sheet**

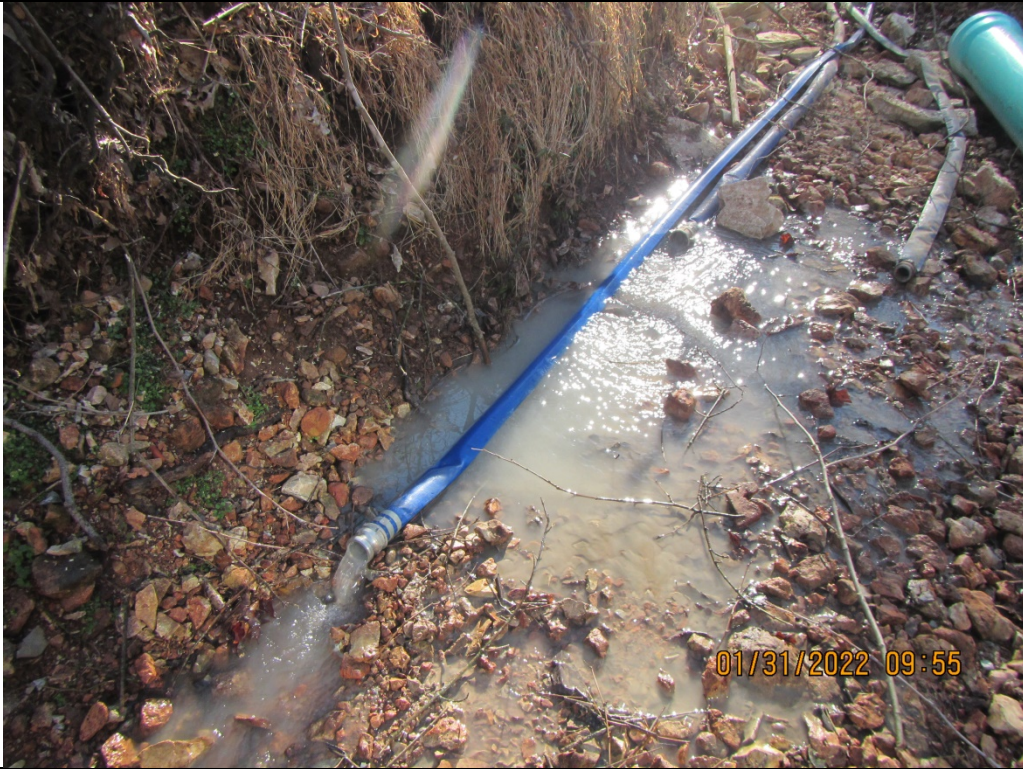
Location:	<b>City of Bentonville</b>				
Photographer:	<b>Cole Southerland</b>	Date:	<b>1/31/2022</b>	Time:	<b>9:55</b>
Witness:				Photo #:	<b>1</b>
Description:	<b>Dewatering of groundwater around the manhole construction.</b>

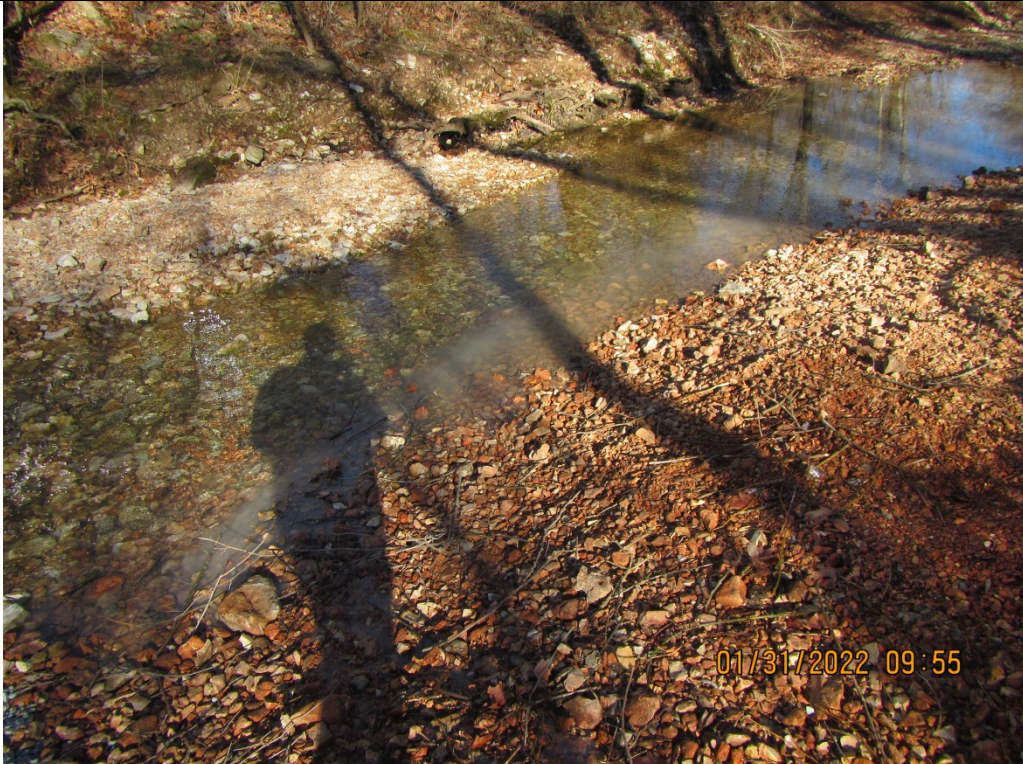
- Untreated wastewater was discharged from a diversion pipe while maintenance of manhole was being performed. This is an unpermitted discharge and is in violation of the Arkansas Water and Air Pollution Control Act - A.C.A. §8-4-217 (b)(1)(E).
- Wet concrete was observed within the manhole maintenance area actively being exposed to waters of the State (Photos #3 & #6). This is considered "placing waste" in a location likely to cause pollution to waters of the State and is in violation of the Arkansas Water and Air Pollution Control Act A.C.A. §8-4-217 (a)(2).

Photographer:	<b>Cole Southerland</b>	Date:	<b>1/31/2022</b>	Time:	<b>9:55</b>
Witness:				Photo #:	<b>2</b>
Description:	<b>Unnamed tributary to McKisic creek where dewatering pipe is discharging.</b>

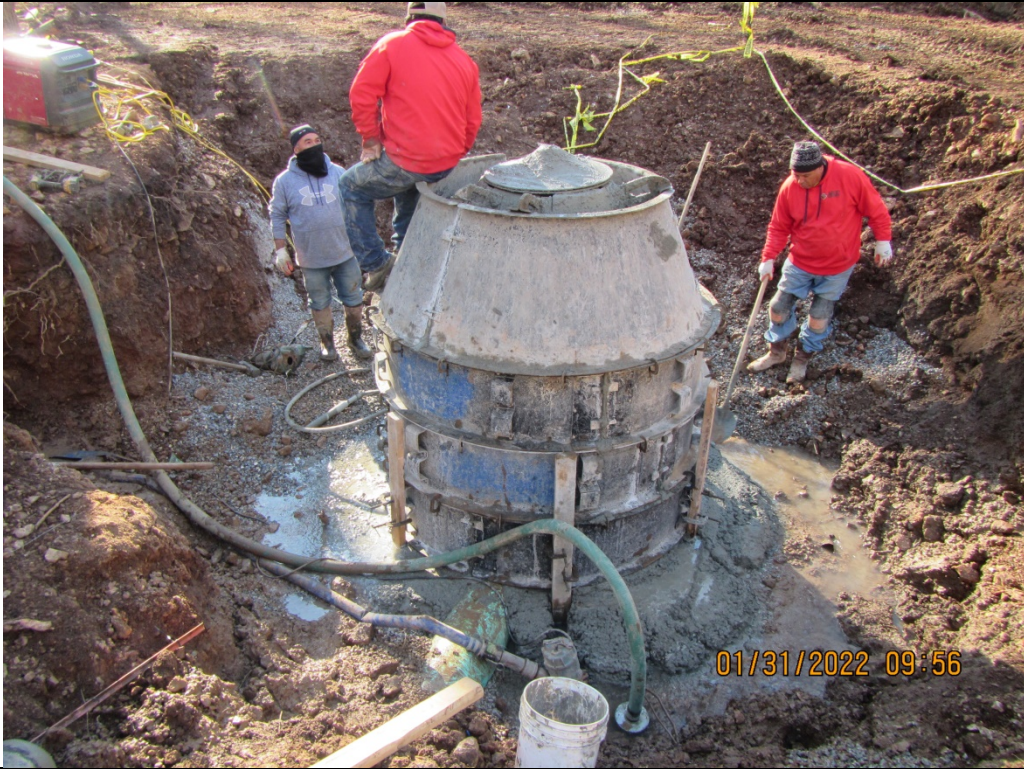
Location:	<b>City of Bentonville</b>				
Photographer:	<b>Cole Southerland</b>	Date:	<b>1/31/2022</b>	Time:	<b>9:56</b>
Witness:				Photo #:	<b>3</b>
Description:	<b>Concrete being molded for manhole.</b>

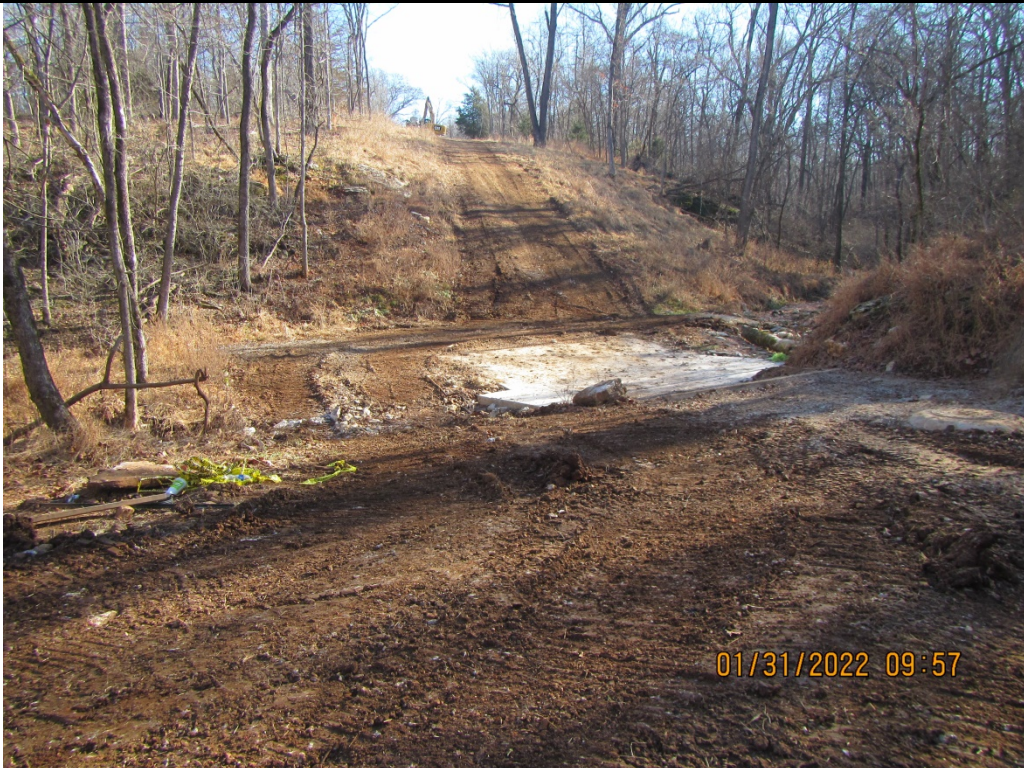
Location:	<b>City of Bentonville</b>				
Photographer:	<b>Cole Southerland</b>	Date:	<b>1/31/2022</b>	Time:	<b>9:57</b>
Witness:				Photo #:	<b>5</b>
Description:	<b>Equipment located near construction.</b>

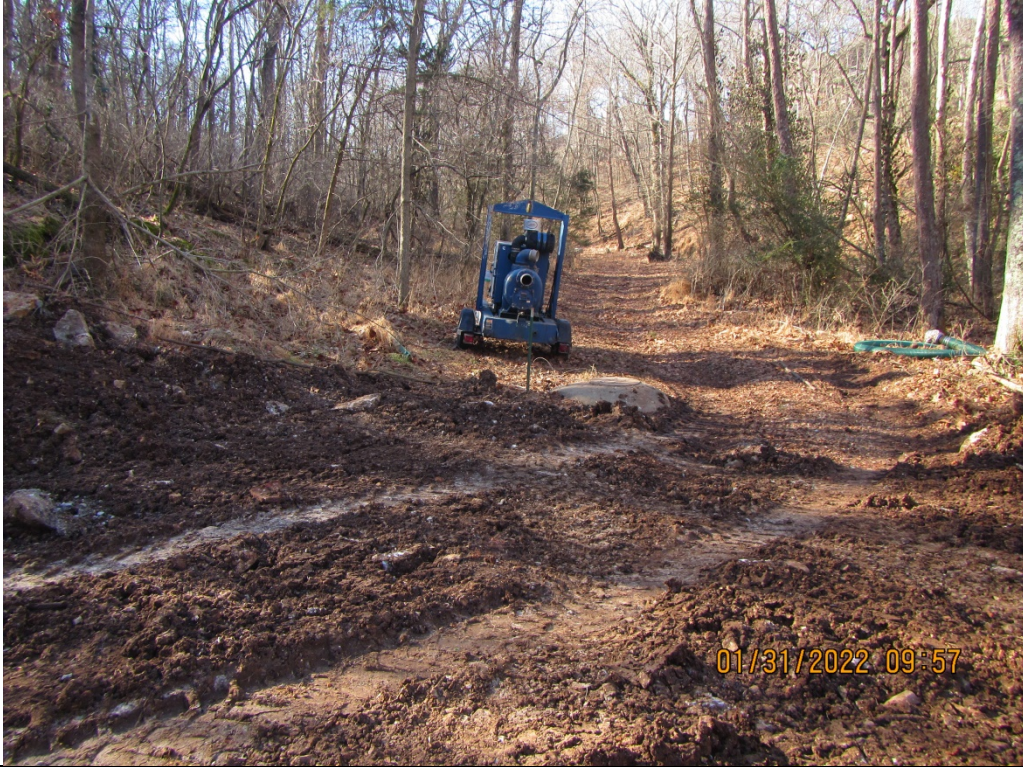
Photographer:	<b>Cole Southerland</b>	Date:	<b>1/31/2022</b>	Time:	<b>10:03</b>
Witness:				Photo #:	<b>6</b>
Description:	<b>Wet concrete washout near manhole.</b>
