RE: Inspection conducted on February 15, 2023
AFIN 60-01071
Permit Number 0266-S4J

**Office of Land Resources
Regulated Waste Operations
Class 4 Landfill Inspection Form**

Site Name	City of Little Rock Class 4 Landfill	County	Pulaski	AFIN	60-01071
Facility Address	10803 Ironton Road, Little Rock, AR	Phone #	501-888-4493	Permit #	0266-S4J
Permittee Address	10803 Ironton Road, Little Rock, AR	Email Address	ncharles@littlerock.gov	PDS #	124933
Date	2/15/2023	Entry Time	1240	Exit Time	1520

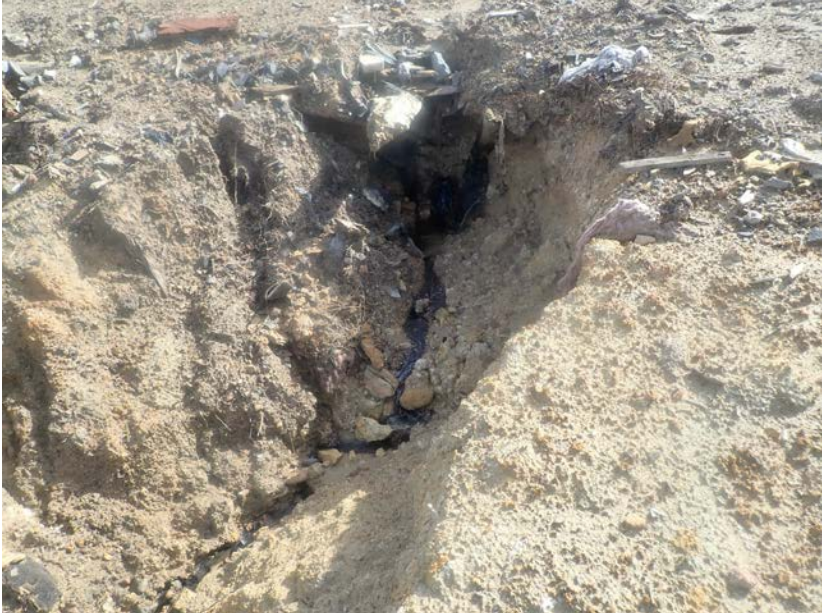
Regulation	Item Description	Comments
607(a)	Operations in Accordance with Permit Documents	
613(c)	Adequate All Weather Operational Roads	
607(c)(d)	Smallest Practical Area, Single Working Face	
607(b)	Operations by Licensed On-site Personnel at All Times	
607(g)	Litter Control Provisions Maintained	
622	Survey Controls	
623	Surface Water Controls	
607(h)(1)	Contouring Prevents Surface Water Flowing Into or Through Waste	
607(h)(2)	Surface Water Control Prevents Off-site Sediment Accumulation	
607(i)(o)	Adequate Maintenance of Intermediate/Final Cover Vegetation	
X	607(o) Leachate Leaks or Evidence of Leachate Seepage	Leachate was observed on the north slope of Cell 3. (Refer to Photo #1.)

Regulation	Item Description	Comments
608	Implementation of Hazardous Waste Exclusion Plan	
609(a)	Satisfactory Weekly or More Frequent Cover	
609(b)	Satisfactory Intermediate Cover	
615	Cause Discharge/Leachate Discharge Leaving Landfill	
X	607(o) Erosion or Other Cover Defects Resulting in Exposed Refuse	Cover defects resulting in exposed waste were observed across the eastern top deck and north slope of Cell 3. (Refer to Photos #1 - #3.)
	309(c) Overfill/Off Lined Area

Location	City of Little Rock Class 4			Permit	0266-S4J	AFIN	60-01071
Photographer	Kim Davenport, Inspector		<i>KD</i>	Witness	N/A		
Photo #	1	Of	3	Date	2/15/2023	Time	1354
Description	Leachate was observed on the south slope of Cell 3. Exposed waste observed.

You should immediately initiate actions to correct the alleged violations cited. A written response of the corrective actions taken, or to be taken, must be submitted within thirty (30) calendar days from the date on this letter to the attention of Kim Davenport. The response may include, but is not limited to, photographs, copies of disposal receipts, records, or analytical results, as applicable. If you have any questions regarding the alleged violations, please do not hesitate to contact me at (501) 682-0586 or Kimberly.Davenport@adeq.state.ar.us.

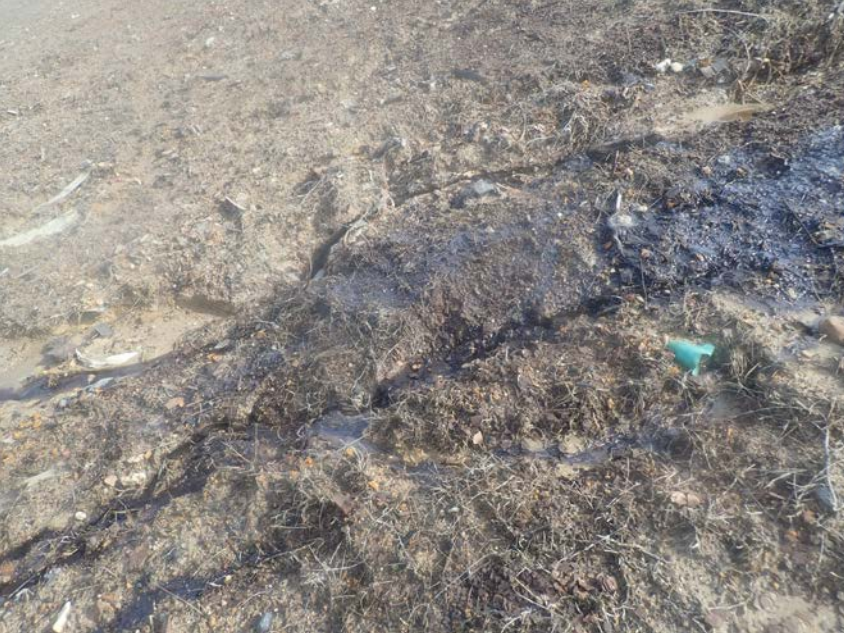
Location	City of Little Rock Class 4			Permit	0266-S4J	AFIN	60-01071
Photographer	Kim Davenport, Inspector		<i>KD</i>	Witness	N/A		
Photo #	2	Of	3	Date	2/15/2023	Time	1355
Description	Leachate was observed on the south slope of Cell 3. Exposed waste observed.
