**RE: City of Decatur WWTP Inspection (Benton Co)**

**AFIN: 04-00052**

**NPDES Permit No.: AR0022292**

**Office of Water Quality Photographic Evidence Sheet**

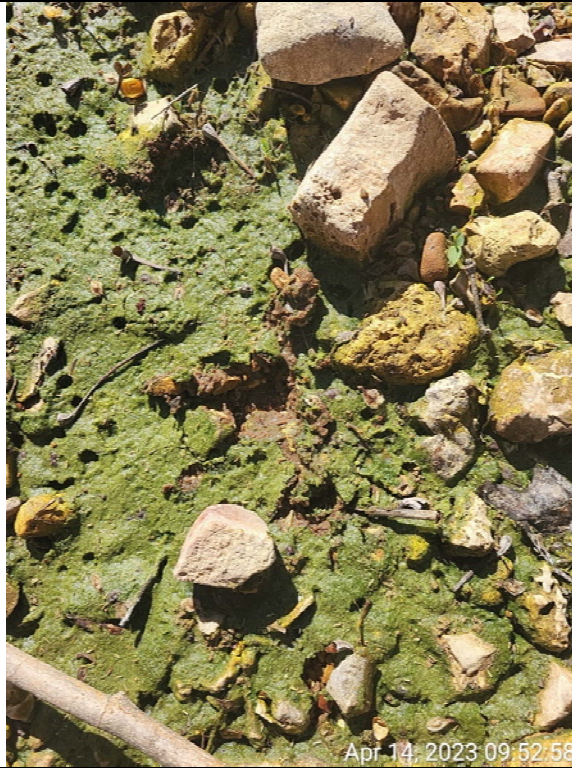
Location:	<b>City of Decatur WWTP</b>		
Photographer:	<b>Garrett Grimes, District 1 Inspector</b>	Date:	<b>4/14/2023</b>
Witness:		Time:	<b>9:52</b>
		Photo #:	<b>1</b>
Description:	<b>Wastewater treatment residuals accumulating adjacent to Columbia Hollow Creek downstream of the Decatur Wastewater Treatment Plant.</b>

**	SAMPLING	**	SLUDGE HANDLING/DISPOSAL	**	PRETREATMENT
**	OTHER:				
<b>SUMMARY OF FINDINGS</b>					
<p>The following violation was noted during the inspection:</p> <p>There has been an unpermitted discharge of wastewater treatment residuals (i.e., sludge) from the treatment plant. This is a violation of Part 1, A of the permit.</p>					
<b>GENERAL COMMENTS</b>					
<p>On April 14, 2023, I performed a reconnaissance inspection in response to a complaint alleging solids associated with wastewater treatment accumulating downstream of the City of Decatur WWTP. I observed treatment residuals accumulating near a bridge over Columbia Hollow Creek downstream of the treatment plant (Photos #1 - #4; Attachment 1). These were not observed upstream of the treatment plant (Photos #5 - #6; Attachment 1). I was unable to access the plant directly during the inspection due to the facility being closed and personnel absent, but a voicemail was left with the number posted at the facility with my contact information and reason for the site visit.</p> <p>Following my departure from the permitted area, I was contacted by James Boston with the City of Decatur. I explained my observations to Mr. Boston and he stated that the city was aware of a release that occurred due to a hydraulic overload during a heavy storm resulting in partially treated wastewater overflowing the plant and entering the receiving stream. Mr. Boston stated that this was reported electronically to the DEQ - Office of Water Quality - Enforcement Branch (Attachment 2). Previous observations of overflows at the City of Decatur WWTP have been referred to the Enforcement Branch and the City of Decatur is considering upgrades to the treatment plant in order to adequately address the flows received at the facility. Details from this inspection will be forwarded to the Enforcement Branch for further review.</p>

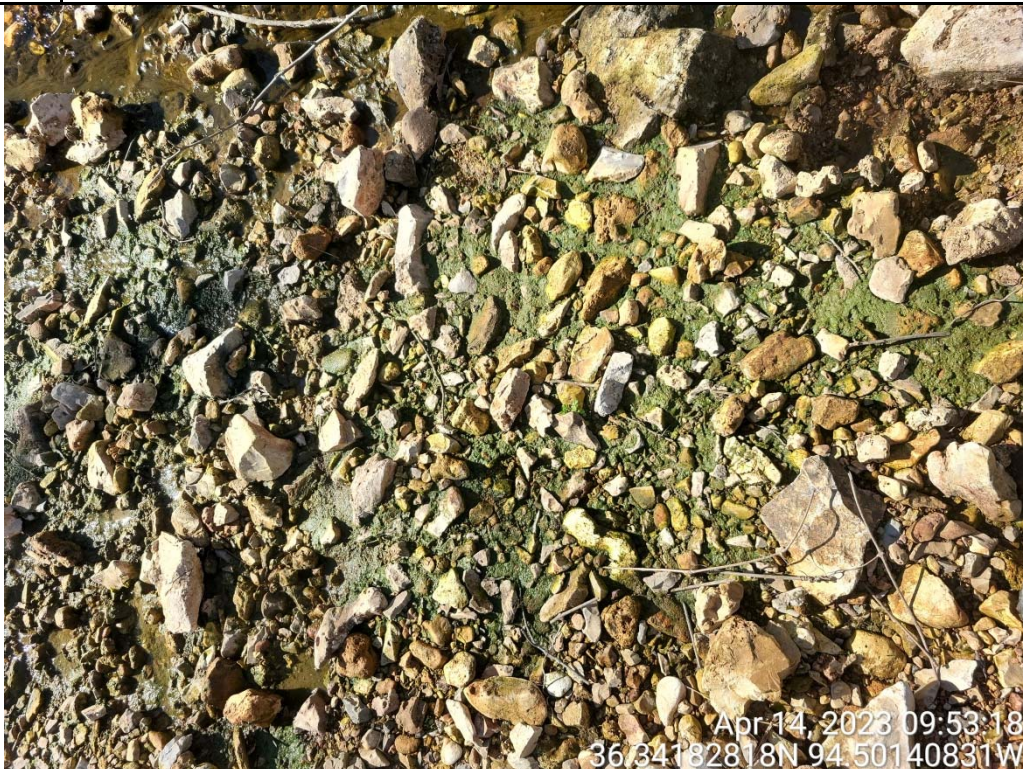
Photographer:	<b>Garrett Grimes, District 1 Inspector</b>	Date:	<b>4/14/2023</b>
Witness:		Time:	<b>9:53</b>
		Photo #:	<b>2</b>
Description:	<b>Continued from Photo #1.</b>

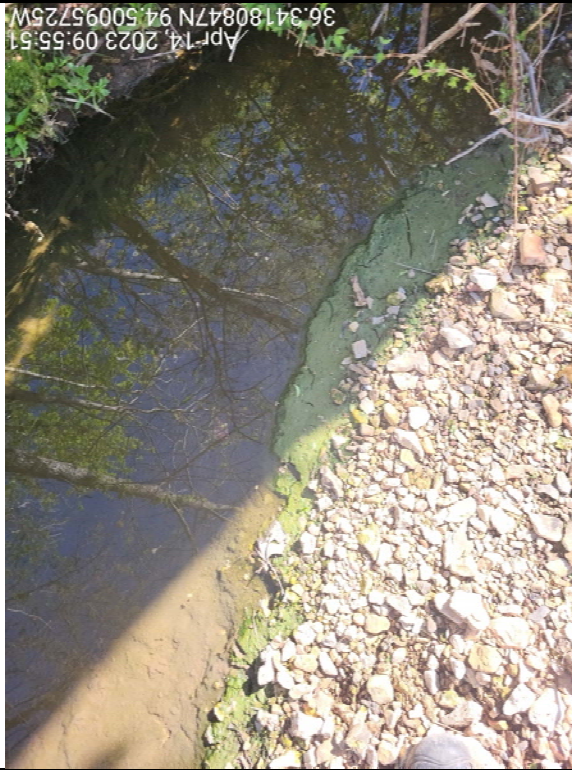
Location:	<b>City of Decatur WWTP</b>		
Photographer:	<b>Garrett Grimes, District 1 Inspector</b>	Date:	<b>4/14/2023</b>
Witness:		Time:	<b>9:55</b>
		Photo #:	<b>3</b>
Description:	<b>Continued from Photo #1.</b>

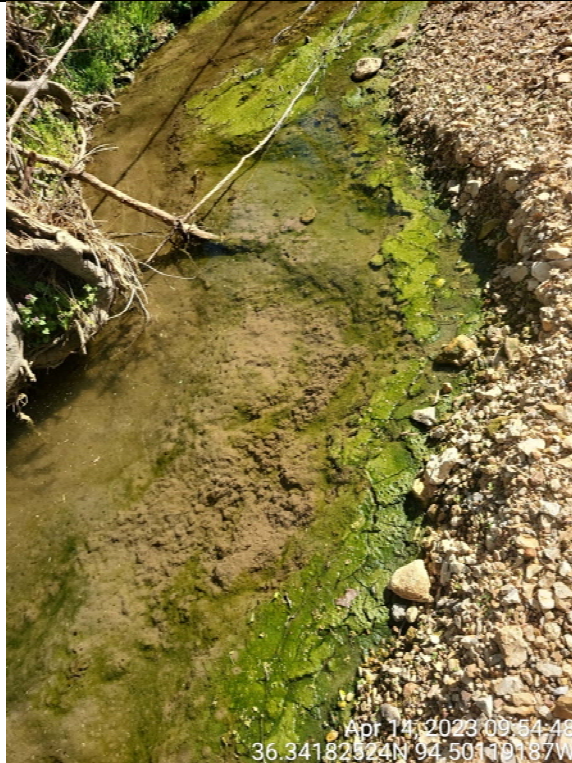
Photographer:	<b>Garrett Grimes, District 1 Inspector</b>	Date:	<b>4/14/2023</b>
Witness:		Time:	<b>9:54</b>
		Photo #:	<b>4</b>
Description:	<b>Continued from Photo #1.</b>

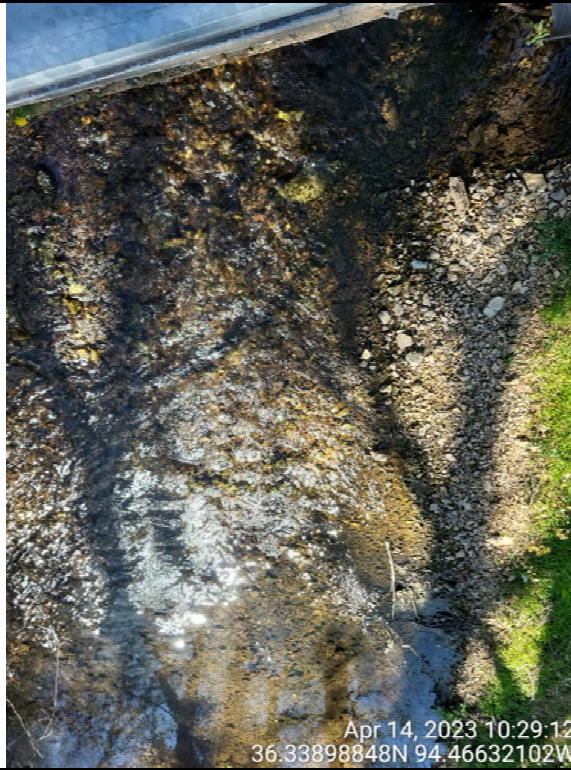
Location:	<b>City of Decatur WWTP</b>		
Photographer:	<b>Garrett Grimes, District 1 Inspector</b>	Date:	<b>4/14/2023</b>
Witness:		Time:	<b>10:29</b>
		Photo #:	<b>5</b>
Description:	<b>Upstream of the wastewater treatment plant.</b>

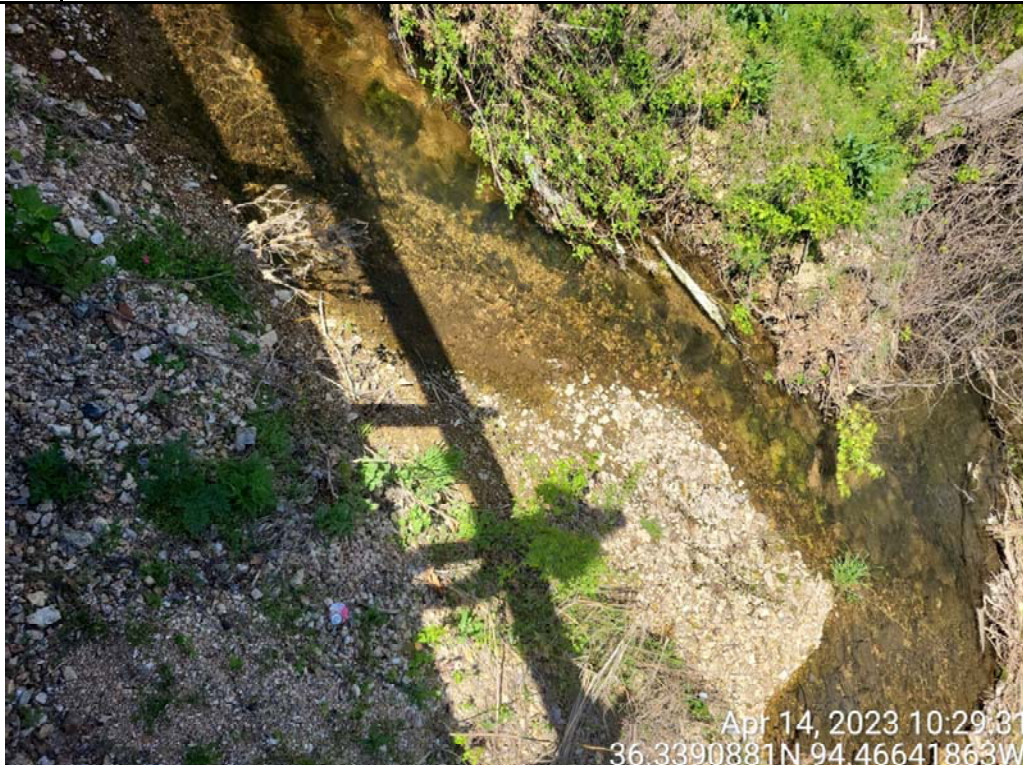
Photographer:	<b>Garrett Grimes, District 1 Inspector</b>	Date:	<b>4/14/2023</b>
Witness:		Time:	<b>10:29</b>
		Photo #:	<b>6</b>
Description:	<b>Continued from Photo #5.</b>
