**RE: Inspection conducted on May 10, 2023**  
**AFIN 60-01071**  
**Permit Number 0266-S4J**

**Office of Land Resources  
Regulated Waste Operations  
Class 4 Landfill Inspection Form**

<b>Site Name</b>	City of Little Rock Class 4 Landfill	<b>County</b>	Pulaski	<b>AFIN</b>	60-01071
<b>Facility Address</b>	10803 Ironton Road, Little Rock, AR	<b>Phone #</b>	501-888-4493	<b>Permit #</b>	0266-S4J
<b>Permittee Address</b>	10803 Ironton Road, Little Rock, AR	<b>Email Address</b>	<a href="mailto:ncharles@littlerock.gov">ncharles@littlerock.gov</a>	<b>PDS #</b>	125981
<b>Date</b>	5/10/2023	<b>Entry Time</b>	1152	<b>Exit Time</b>	1455

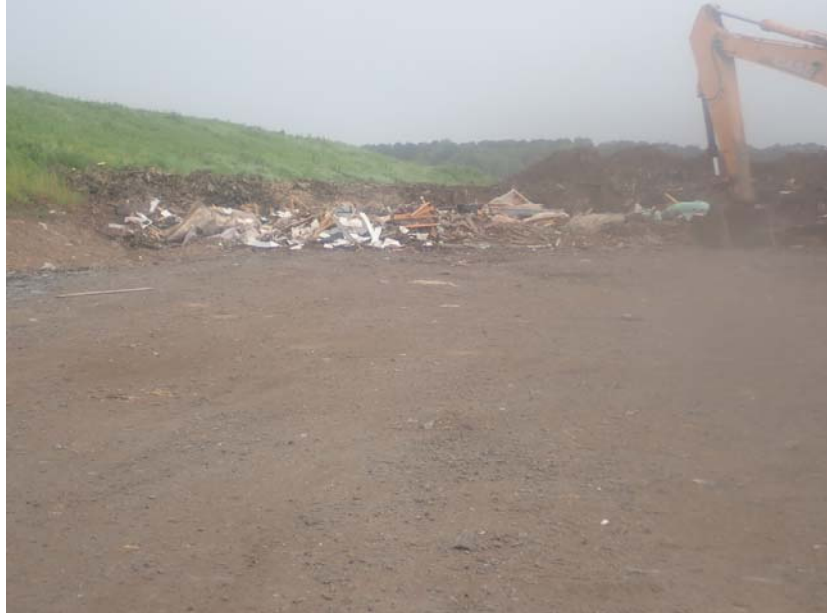
<b>Location</b>	City of Little Rock Class 4			<b>Permit</b>	0266-S4J	<b>AFIN</b>	60-01071
<b>Photographer</b>	Kim Davenport, Inspector	<i>KD</i>		<b>Witness</b>	N/A		
<b>Photo #</b>	1	<b>Of</b>	6	<b>Date</b>	5/10/2023	<b>Time</b>	1327
<b>Description</b>	The active working face and all available equipment for the Class 4 was observed.

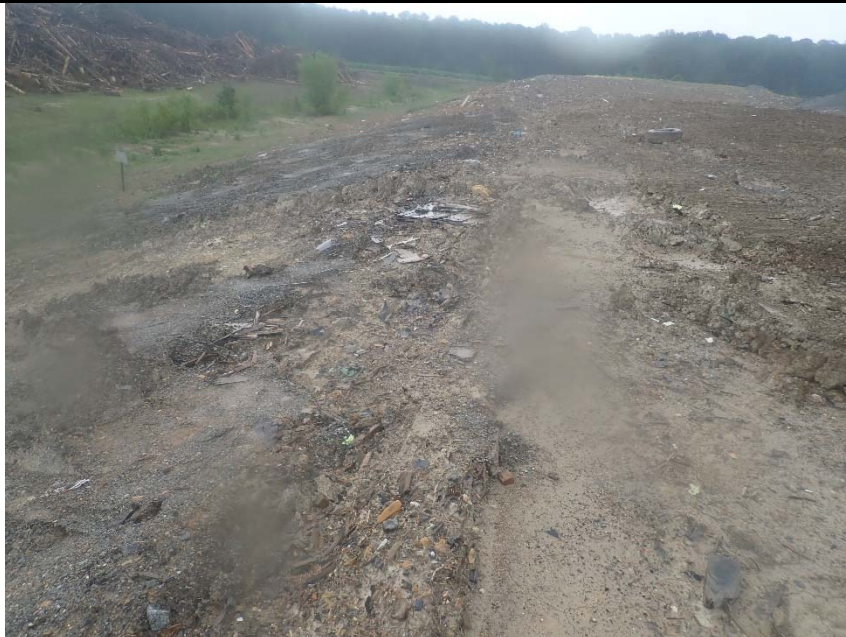
<b>Location</b>	City of Little Rock Class 4			<b>Permit</b>	0266-S4J	<b>AFIN</b>	60-01071
<b>Photographer</b>	Kim Davenport, Inspector	<i>KD</i>		<b>Witness</b>	N/A		
<b>Photo #</b>	2	<b>Of</b>	6	<b>Date</b>	5/10/2023	<b>Time</b>	1328
<b>Description</b>	Exposed waste was observed across the Class 4 landfill and on the northern slope, looking east.

You should immediately initiate actions to correct the alleged violations cited. A written response of the corrective actions taken, or to be taken, must be submitted within thirty (30) calendar days from the date on this letter to the attention of Kim Davenport. The response may include, but is not limited to, photographs, copies of disposal receipts, records, or analytical results, as applicable. If you have any questions regarding the alleged violations, please do not hesitate to contact me at (501) 682-0586 or [Kimberly.Davenport@adeq.state.ar.us](mailto:Kimberly.Davenport@adeq.state.ar.us).

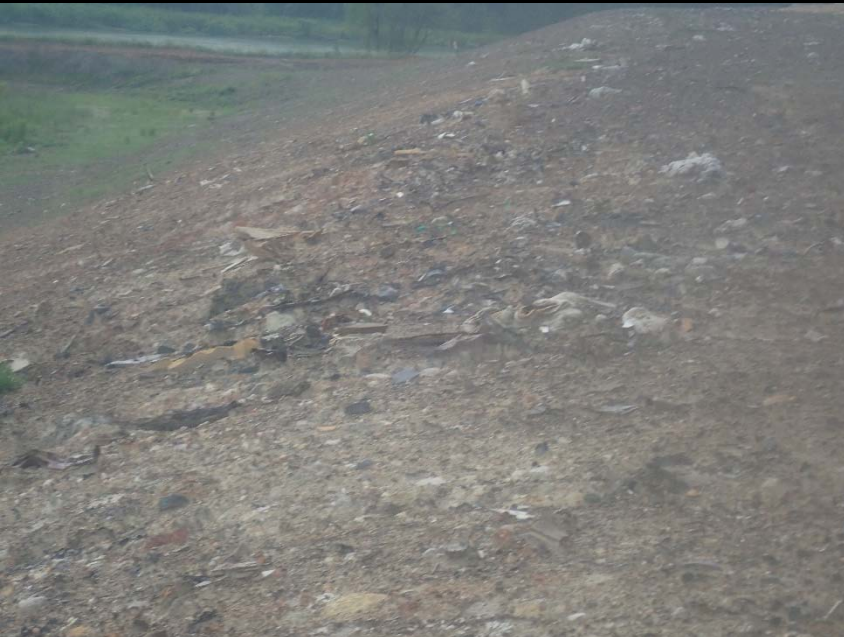
<b>Location</b>	City of Little Rock Class 4			<b>Permit</b>	0266-S4J	<b>AFIN</b>	60-01071
<b>Photographer</b>	Kim Davenport, Inspector	<i>KD</i>		<b>Witness</b>	N/A		
<b>Photo #</b>	4	<b>Of</b>	6	<b>Date</b>	5/10/2023	<b>Time</b>	1329
<b>Description</b>	A continued view of exposed waste observed on the northern slope is provided, looking east.

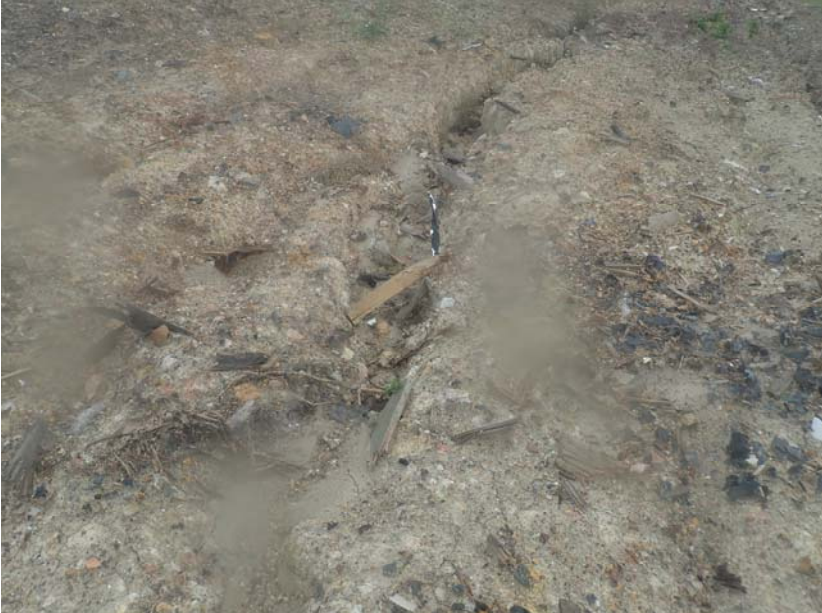
<b>Location</b>	City of Little Rock Class 4			<b>Permit</b>	0266-S4J	<b>AFIN</b>	60-01071
<b>Photographer</b>	Kim Davenport, Inspector	<i>KD</i>		<b>Witness</b>	N/A		
<b>Photo #</b>	5	<b>Of</b>	6	<b>Date</b>	5/10/2023	<b>Time</b>	1328
<b>Description</b>	An example of the erosion rills exposing waste on the northern slope is provided.
