DIVISION OF
ENVIRONMENTAL QUALITY

RE: Inspection conducted on July 31, 2023
AFIN 60-01071
Permit Number 0266-S4J

**Division of Environmental Quality
Office of Land Resources
Class 4 Landfill Inspection Form**

Site Name	City of Little Rock Class 4 Landfill	County	Pulaski	AFIN	60-01071
Facility Address	10803 Ironton Road, Little Rock, AR	Phone #	501-888-4493	Permit #	0266-S4J
Permittee Address	10803 Ironton Road, Little Rock, AR	Email Address	ncharles@littlerock.gov	PDS #	127014
Date	7/31/2023	Entry Time	0938	Exit Time	1225

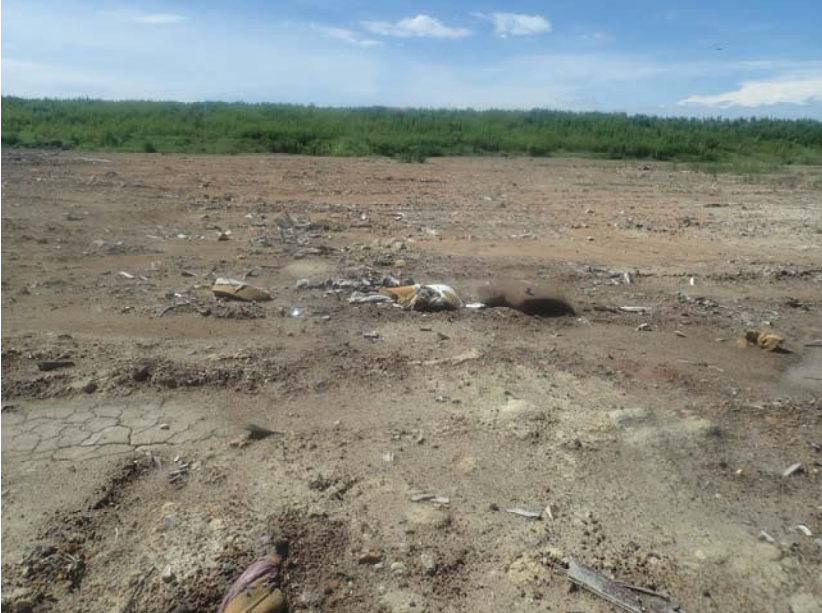
Location	City of Little Rock Class 4			Permit	0266-S4J	AFIN	60-01071
Photographer	Kim Davenport		<i>KD</i>	Witness	N/A		
Photo #	1	Of	2	Date	7/31/2023	Time	1103
Description	Cover defects resulting in exposed waste were observed across the top deck of the landfill.

Regulation	Item Description	Comments
	608	Implementation of Hazardous Waste Exclusion Plan	
	609(a)	Satisfactory Weekly or More Frequent Cover	
	609(b)	Satisfactory Intermediate Cover	
	615	Cause Discharge/Leachate Discharge Leaving Landfill	
X	607(o)	Erosion or Other Cover Defects Resulting in Exposed Refuse	Cover defects resulting in exposed waste were observed across the top deck of the landfill. Erosion with exposed waste observed on the north slope of Cell 3. (Refer to Photos #1 & #2.)
	309(c)	Overfill/Off Lined Area
