DIVISION OF ENVIRONMENTAL QUALITY

RE: Intimidator Group - Industrial User Inspection AFIN: 32-00530 Permit No.: AR0020702 (Batesville Water Utilities)

111 - 400 - 110 12	ENVIRONMENTAL QUALITY	OFFICE OF WATER QUALITY INSPECTION REPORT     AFIN: 32-00530   PERMIT #: AR0020702   DATE: 8/10/2023						
LNO7		CC	COUNTY: 32 Independence PI		PDS	#: 127038		MEDIA: WN
		GF	GPS LAT: 35.79741 LONG: -91.63580 LOCATION: General Area				rea	
	FACILITY INFORMAT	ION		IN	SPEC	TION INFO	RMATIO	N
Intimidator Group				FACILITY TYPE: 2 - Industrial	INSPECTOR ID#: 83321 S - State			
1 Bad Boy Blvd.				FACILITY EVALUATION RATING: INSPECTION TYPE:   4 - Satisfactory Industrial User			ser	
Batesville			==(=).	TRY TIME:		PERMIT E	FFECTIVE DATE:	
RESPONSIBLE OFFICIAL						PERMIT E	XPIRATION DATE:	
NAME: / TITLE Mr. David Langley / EHS Manager								
COMF	PANY:			FAYETTEVILLE SHALE RELATED: N				
				FAYETTEVILLE SHALE VIOLATIONS: N				
	Bad Boy Blvd.			INSPECTION PARTICIPANTS				
CITY, STATE, ZIP: Batesville AR 72501 PHONE & EXT: / FAX: 870-569-5019 / EMAIL:				NAME/TITLE/PHONE/FAX/EMAIL/ETC.: Steven Smith, Paint Supervisor, Intimidator Colton Britt, Paint Lead, Intimidator Steve Bateman, Operations Manage

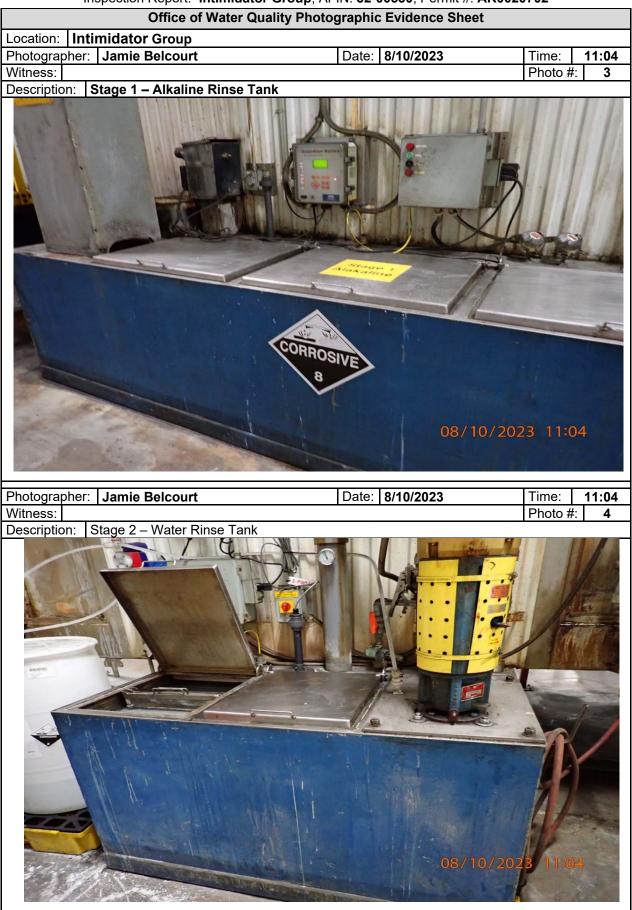
lity Photographic Evidence Sheet				
Location: Intir	midator Group					
Photographer:	Jamie Belcourt	Date: 8/10/2023	Time: <b>11:00</b>			
Witness:	Antals ontranco to the coatin	a stago	Photo #: 1			
<image/> Description: Metals entrance to the coating stage.						
Photographer: Witness:	Jamie Belcourt	Date: 8/10/2023	Time:     11:01       Photo #:     2			
	Acids used for metal cleaning	g located opposite of Photo #1. Acids a				
C	containment.	090-003 198554
