RE: City of Dumas WWTF Inspection

OFFICE OF WATER QUALITY INSPECTION REPORT

AFIN: **21-00045** | PERMIT #: **AR0033987** | DATE: **8/2/2023**

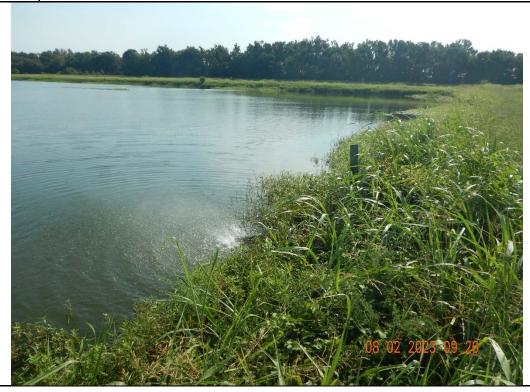
2. TREATMENT UNITS PROPERLY MAINTAINED: Aeration system in Basins 2 and 4 required maintenance.	□S ☑M □U □NA □NE
3. STANDBY POWER OR OTHER EQUIVALENT PROVIDED: No permanent stand-by power but they could have access to a	ØS □M □U ØNA □NE
 generator if needed. 4. ADEQUATE ALARM SYSTEM FOR POWER OR EQUIPMENT FAILURES AVAILABLE: No alarm system is in place. The staff che the plant daily. 	CK OS ØM OU ONA ONE

Photographer:Jason BolenbaughDate:08/02/2023Time:09:27Witness:Malcolm JacksonPhoto #:10Description:DSCN6108: Floated aeration line in basin #4

After leaving chlorine disinfection, we walked to a nearby building that contained the blower units. All 3 blower units were functional. We then drove around the aerated lagoons. As mentioned in the Summary of Findings, some portions of the levees were well maintained but, others were not mowed and grass had become overgrown. All the lagoons tended to have the characteristic green tint of algae. We witnessed malfunctioning aeration line at lagoon #2 (see photo 9) along with a floated aeration line in Lagoon #4 (see photo 10). According to Mr. Brooks, both are scheduled for maintenance this month.

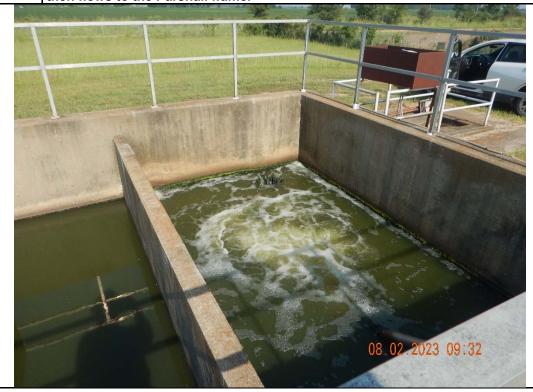
Photographer:Jason BolenbaughDate:08/02/2023Time:09:32Witness:Malcolm JacksonPhoto #:12

Description: DSCN6111: Mixing zone in chlorine contact chamber where treated wastewater then flows to the Parshall flume.
