RE: City of De Queen WWTP Inspection

AFIN: 67-00023 Permit No.: AR0021733

OFFICE OF WATER QUALITY INSPECTION REPORT

AFIN: 67-00023 PERMIT #: AR0021733 DATE: 4/6/2023

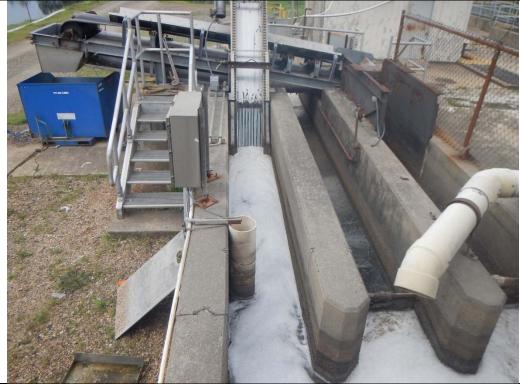
Office of Water Quality Photographic Evidence Sheet Location: City of De Queen WWTP Photographer: Michael Young Date: 04/06/2023 Time: 10:44 Witness: Trey Butler Photo #: 3

Description: Foaming at the bar screen area following the screw pump.

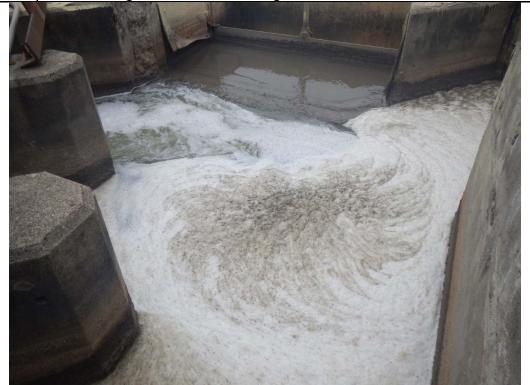
Photographer:Michael YoungDate:04/06/2023Time:10:44Witness:Trey ButlerPhoto #:4

Description: Foam entering after the bar screening.

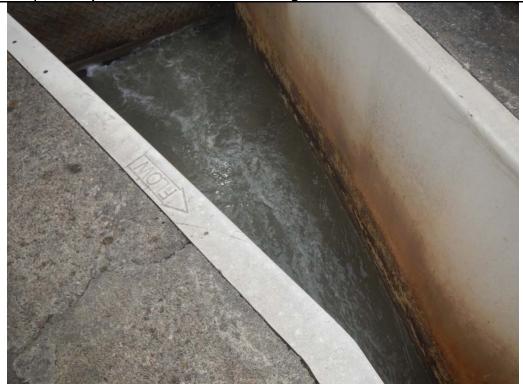
Office of Water Quality Photographic Evidence Sheet Location: City of De Queen WWTP Photographer: Michael Young Date: 04/06/2023 Time: 10:45 Witness: Trey Butler Photo#: 5 Description: Influent parshall flume with little foaming on surface.

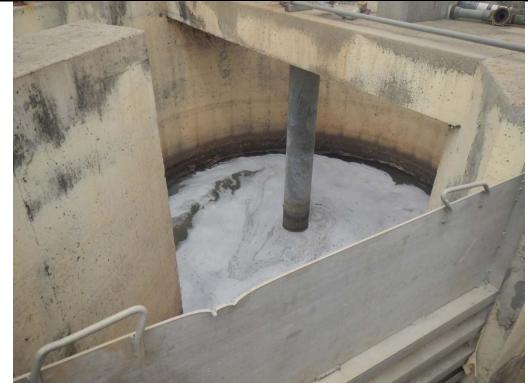
Photographer: Michael Young Date: 04/06/2023 Time: 10:47
Witness: Trey Butler Photo #: 6

1.) Grit collection was not occurring because the motor for the grit collector was not in operation (see photos 6-7).

This is in response to the grit chamber that was down. It has been completely rebuilt and is in proper working order. I have attached photos of the complete rebuilding process all the way up to working order.

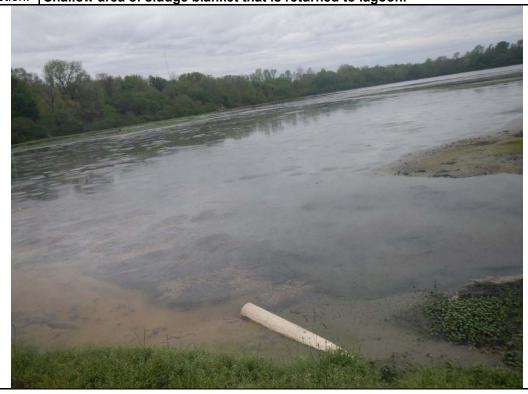
Office of Water Quality Photographic Evidence Sheet							
Location: C	ity of De Queen WWTP						
Photographer: Michael Young Date: 04/06/2023 Time: 11:11							
Witness: Tr	Witness: Trey Butler Photo #: 2						
Description:	Description: Shallow area of sludge blanket that is returned to lagoon.

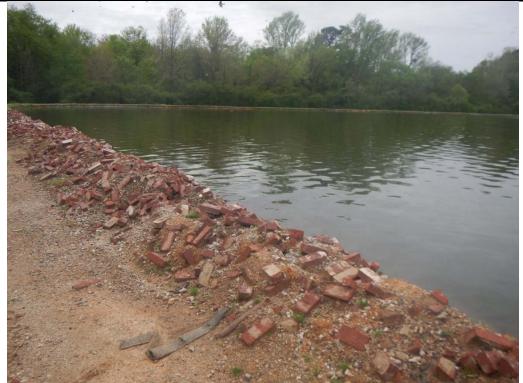
Inspection Report: City of De Queen WWTP,	AFIN: 67-00023 , Permit #: AR (0021733			
Office of Water Quality Photographic Evidence Sheet					
Location: City of De Queen WWTP					
Photographer: Michael Young	Date: 04/06/2023	Time:	11:21		
Witness: Trey Butler		Photo #:	26		
Description: Discharge from lagoon to the treatment	nt units.

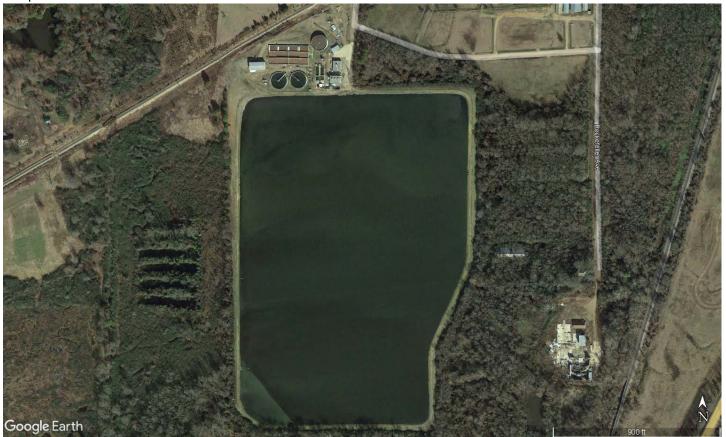
Figure 1. Overview of City of De Queen wastewater treatment plant with the equalization basin and treatment components.

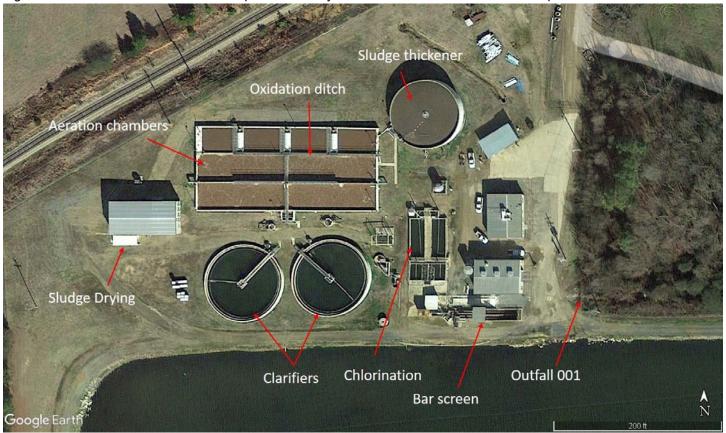
Figure 2. Overview of the treatment components of City of De Queen wastewater treatment plant.
