RE: Clinton East WWTF Inspections - PDS 127698 & 127699

AFIN: 71-00018 NPDES Permit No.: AR0048836 / ARR000060

OFFICE OF WATER QUALITY INSPECTION REPORT

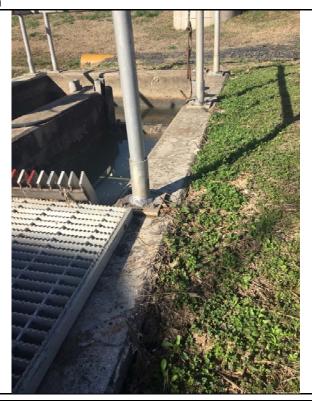
Office of Water Quality Photographic Evidence Sheet								
Location:	Clinton East WWTF							
Photograp	her: Kerri McCabe	Date:	Feb 28, 2023	Time:	0919			
Witness: Trinity Mitchell Photo #: 1								
Description	Description: Bar screen

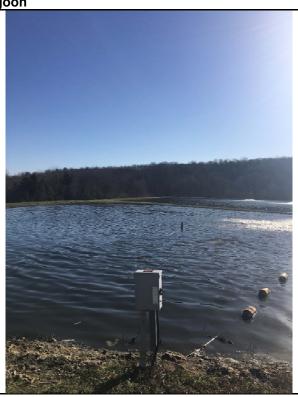
Office of Water Quality Photographic Evidence Sheet							
Location:	Clinton East WWTF						
Photograp	her: Kerri McCabe	Date:	Feb 28, 2023	Time:	0921		
Witness:	Witness: Trinity Mitchell Photo #: 3						
Description	n: Primary Lagoon

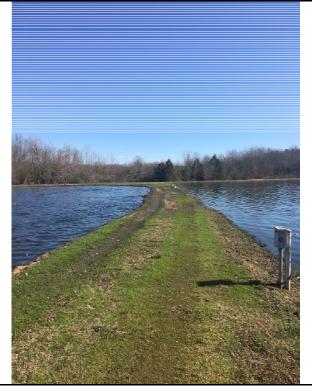
Photograp	oher: Kerri McCabe	Date:	Feb 28, 2023	Time:	1001
Witness:	Trinity Mitchell			Photo #:	4

Description: Levee between primary and secondary lagoons.

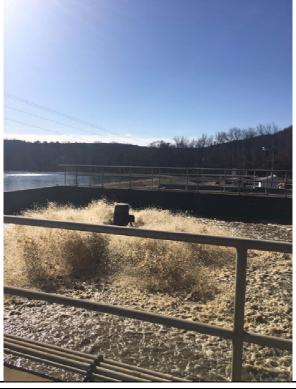
Office of Water Quality Ph	otographic	Evidence Sheet		
Location: Clinton East WWTF				
Photographer: Kerri McCabe	Date:	Feb 28, 2023	Time:	0931
Witness: Trinity Mitchell			Photo #:	5

Description: Activated sludge basin (1 of 2)

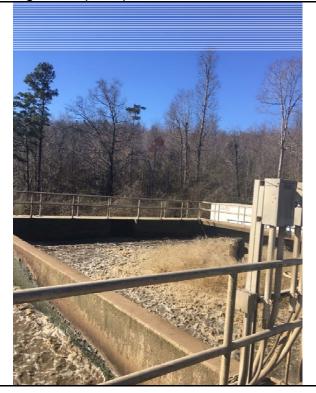
Photographer: Kerri McCabe	Date:	Feb 28, 2023	Time:	0931
Witness: Trinity Mitchell			Photo #:	6

Description: Activated sludge basin (2 of 2)

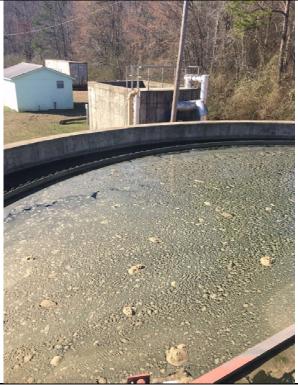
Office of Water Quality Photographic Evidence Sheet							
Location:	Clin	ton East WWTF					
Photograp	her:	Kerri McCabe	Date:	Feb 28, 2023	Time:	0933	
Witness:	Witness: Trinity Mitchell Photo #: 7

Description: Final clarifier with floating scum outside center baffle

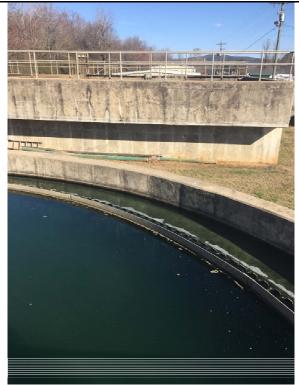
_
Photographer:	Kerri McCabe	Date:	Feb 28, 2023	Time:	0933]
Witness: Trin	ity Mitchell			Photo #:	8

Description: Final clarifier with scum contained to one side

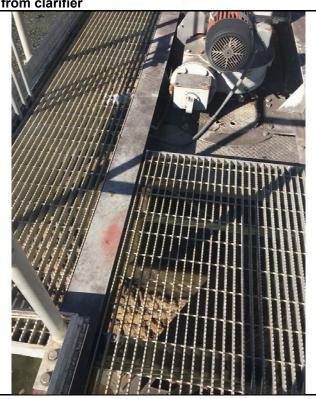
Office of Water Qua	lity Photographic	Evidence Sheet			
Location: (Clinton East WWTF					
Photograph	er: Kerri McCabe	Date:	Feb 28, 2023	Time:	0934	
Witness: T	Witness: Trinity Mitchell Photo #: 9					
Description	RAS/WAS from clarifier

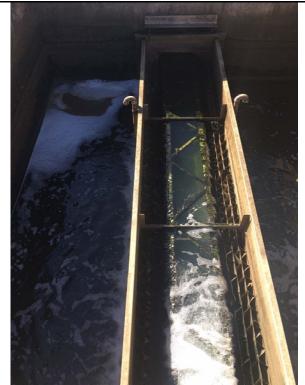
Photographer: Kerri McCabe	Date:	Feb 28, 2023	Time:	0941
Witness: Trinity Mitchell			Photo #:	10

Description: Rapid sand filter after clarifier

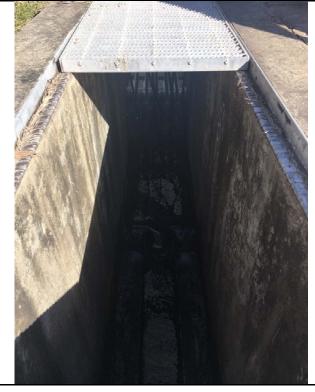
Office of Water Quality Photographic Evidence Sheet							
Location:	Clin	ton East WWTF					
Photograp	her:	Kerri McCabe	Date:	Feb 28, 2023	Time:	0949	
,						13

Description: Parshall flume (primary) and totalizer (secondary)

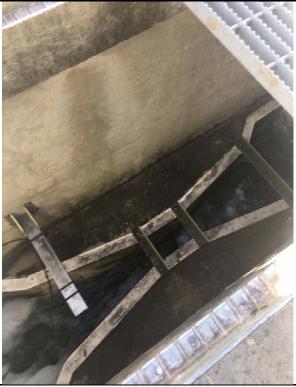
1. PRIMARY FLOW MEASUREMENT DEVICE PROPERLY INSTALLED AND MAINTAINED: YES TYPE OF DEVICE: 6" Parsha	all Flume
2. FLOW MEASURED AT EACH OUTFALL AS REQUIRED:	☑Y □N □NA □NE
 SECONDARY INSTRUMENTS (TOTALIZERS, RECORDERS, ETC.) PROPERLY OPERATED AND MAINTAINED: <u>HydroRang</u>((totalizer) 	er 200

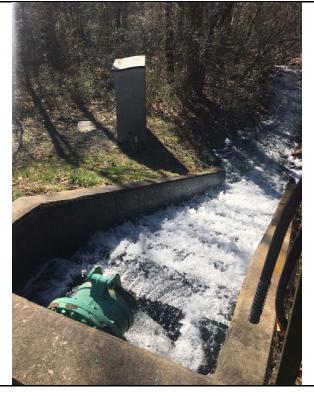
Photographer: Kerri McCabe	Date: Feb 28, 2023	Time:	0954
Witness: Trinity Mitchell		Photo #:	14

Description: Post-aeration at outfall

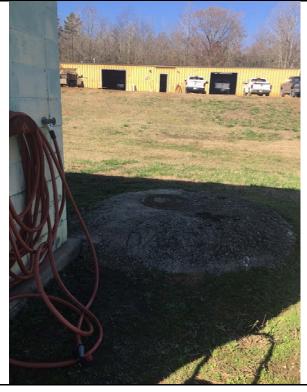
Photographer: Kerri McCabe	Date:	Feb 28, 2023	Time:	1003
Witness: Trinity Mitchell			Photo #	16

Description: Manhole for irrigation distribution

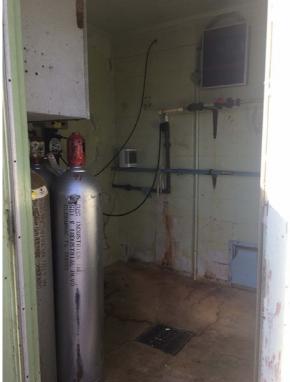
Office of Water Quality Photographic Evidence Sheet								
Location: (Clin	on East WWTF						
Photographe	er:	Kerri McCabe		Date:	Feb 28	, 2023	Time:	1003
Witness: Ti	Witness: Trinity Mitchell Photo #: 17

Description: Chlorine disinfection for wastewater routed to irrigation fields

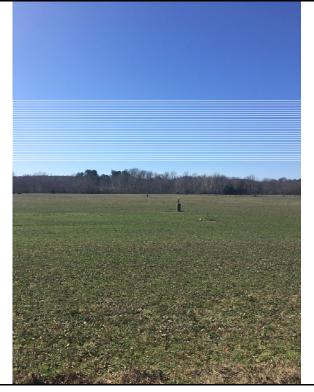
Photographer: Kerri McCabe	Date:	Feb 28, 2023	Time:	1022
Witness: Trinity Mitchell			Photo #	: 18

Description: **Example of irrigation field**
