RE: Eco-Vista, LLC Inspection – PDS# 128544 (Washington Co.)  
AFIN: 72-00144 NPDES Permit No.: ARR000231

<p><b>ENVIRONMENTAL QUALITY</b></p>	<b>OFFICE OF WATER QUALITY INSPECTION REPORT</b>		
	AFIN: <b>72-00144</b>	PERMIT #: <b>ARR000231</b>	DATE: <b>12/6/2023</b>
	COUNTY: <b>72 Washington</b>	PDS #: <b>128544</b>	MEDIA: <b>WN</b>
	GPS LAT: <b>36.144100</b> LONG: <b>-94.255822</b> LOCATION: <b>Entrance</b>		
<b>FACILITY INFORMATION</b>		<b>INSPECTION INFORMATION</b>	
NAME: <b>Eco-Vista, LLC</b> LOCATION: <b>2210 Waste Management Dr.</b> CITY: <b>Springdale</b>		FACILITY TYPE: <b>2 - Industrial</b> INSPECTOR ID#: <b>142257 S - State</b> FACILITY EVALUATION RATING: <b>***</b> INSPECTION TYPE: <b>Reconnaissance</b>	
<b>RESPONSIBLE OFFICIAL</b>		DATE(S): <b>12/6/2023</b>	ENTRY TIME: <b>09:15</b> EXIT TIME: <b>09:42</b> PERMIT EFFECTIVE DATE: <b>8/25/2021</b> PERMIT EXPIRATION DATE: <b>6/30/2024</b>
NAME / TITLE: <b>Charles Gillian / Director of Landfill Operation</b> COMPANY: <b>Eco-Vista, LLC</b> MAILING ADDRESS: <b>2210 Waste Management Dr.</b> CITY, STATE, ZIP: <b>Springdale AR 72762</b> PHONE & EXT: / FAX: <b>501-993-8966 /</b> EMAIL: <b>jreyno10@wm.com</b>		<b>INSPECTION PARTICI

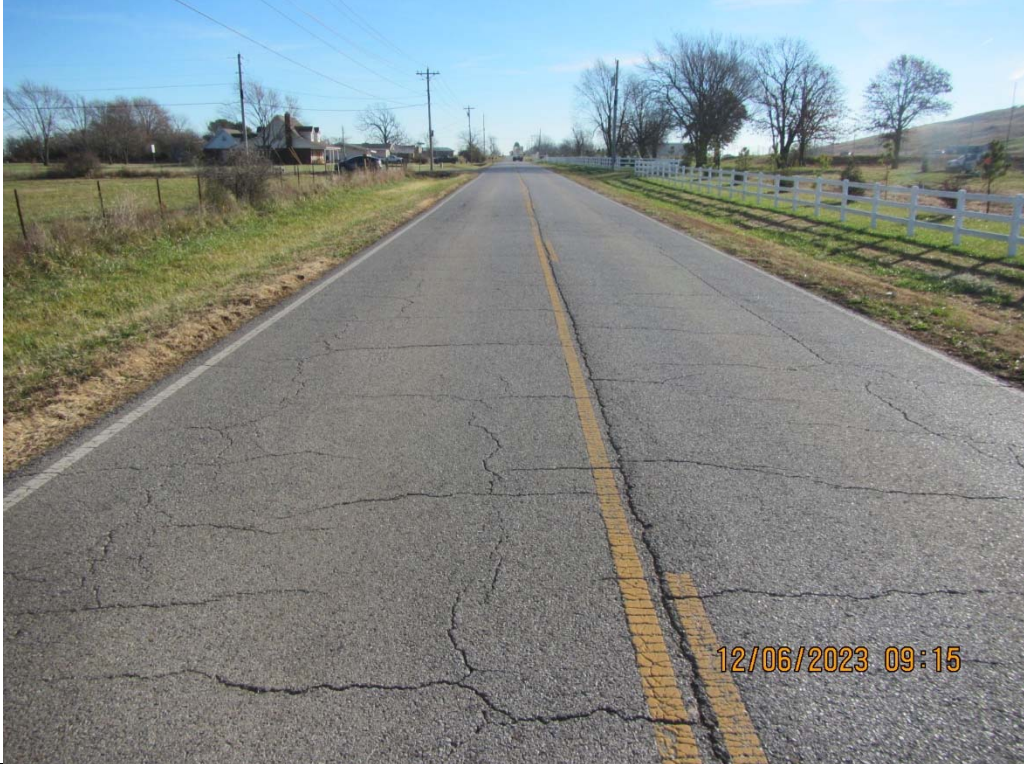
Location:	<b>Eco-Vista, LLC</b>		
Photographer:	<b>William Cody</b>	Date:	<b>12/6/2023</b>
Witness:	<b>N/A</b>	Time:	<b>09:15</b>
		Photo #:	<b>1</b>
Description:	<b>Arbor Acres Dr. just west of the facility entrance.</b>

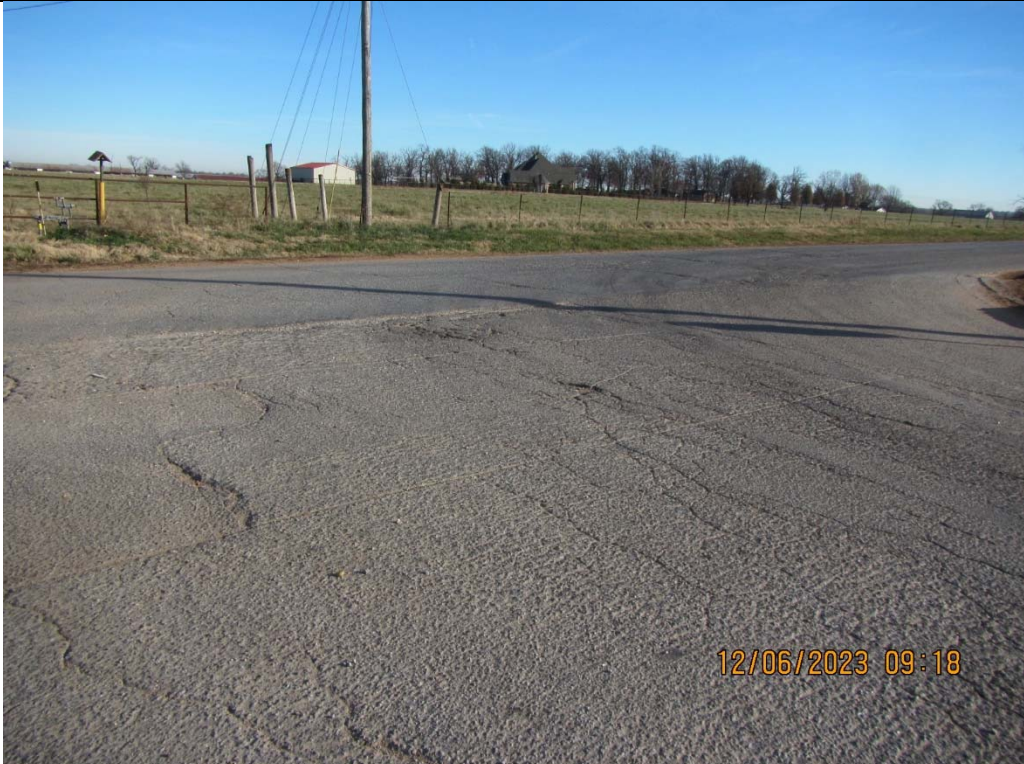
Photographer:	<b>William Cody</b>	Date:	<b>12/6/2023</b>
Witness:	<b>N/A</b>	Time:	<b>09:18</b>
		Photo #:	<b>2</b>
Description:	<b>View of the west-side entrance/exit of the facility.</b>

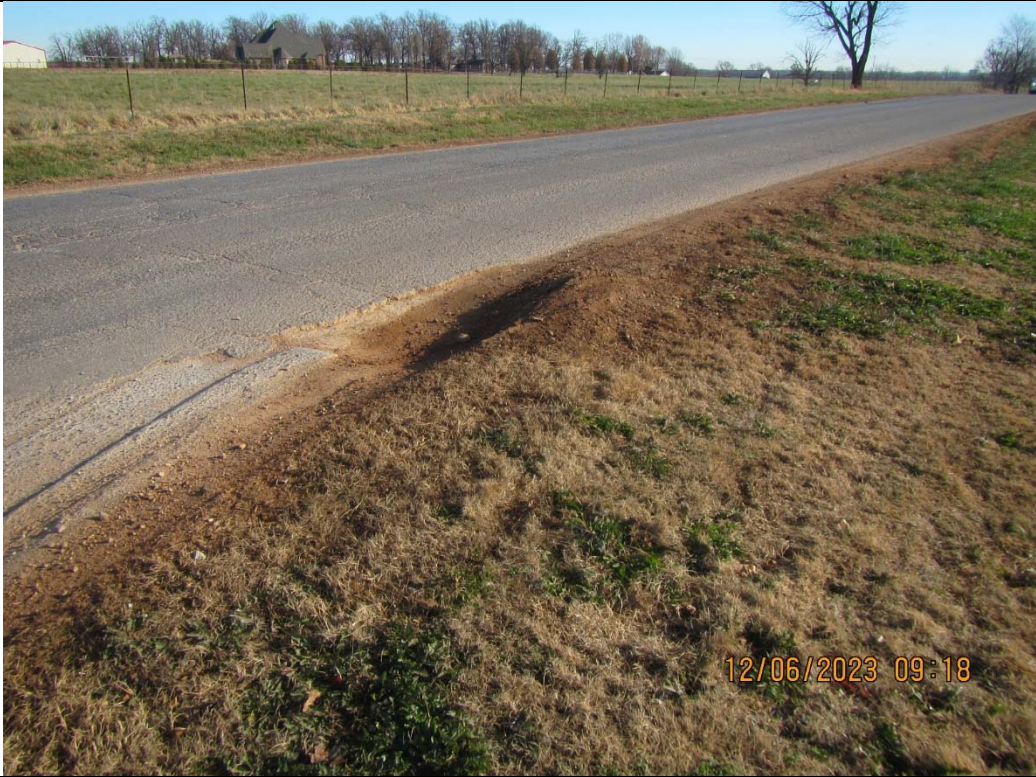
Location:	<b>Eco-Vista, LLC</b>		
Photographer:	<b>William Cody</b>	Date:	<b>12/6/2023</b>
Time:	<b>09:18</b>	Witness:	<b>N/A</b>
Photo #:	<b>3</b>	Description:	<b>Minimal off-site tracking at west side entrance/exit.</b>

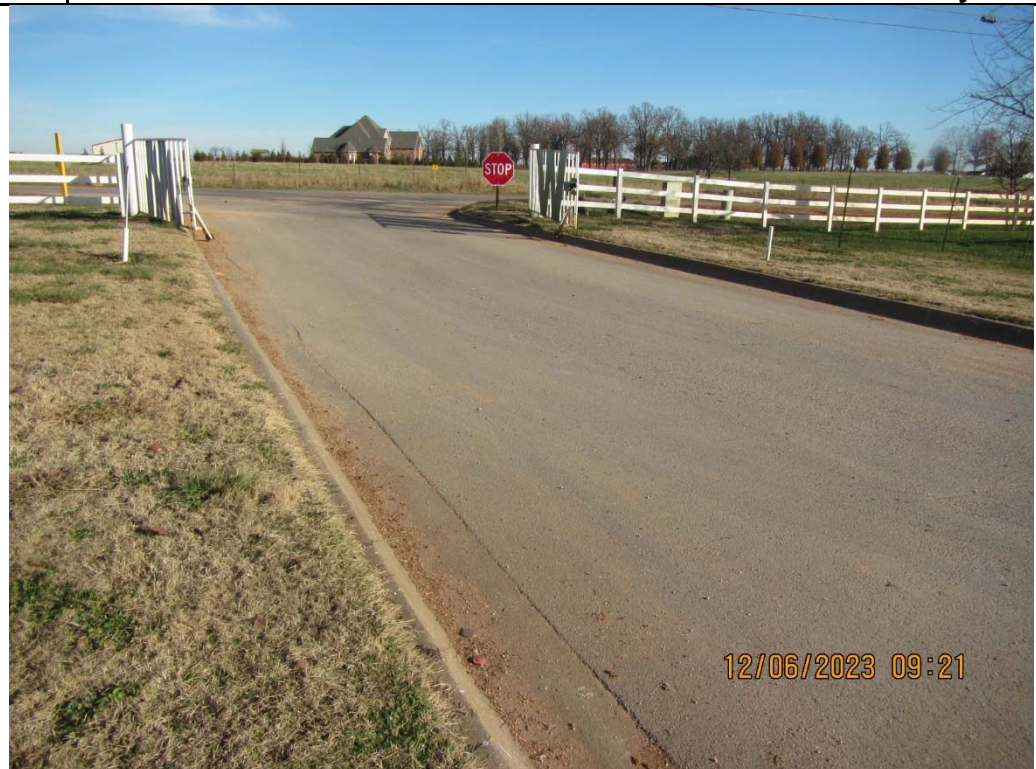
Photographer:	<b>William Cody</b>	Date:	<b>12/6/2023</b>
Time:	<b>09:21</b>	Witness:	<b>N/A</b>
Photo #:	<b>4</b>	Description:	<b>Some evidence of sediment at the east-side entrance/exit of the facility.</b>

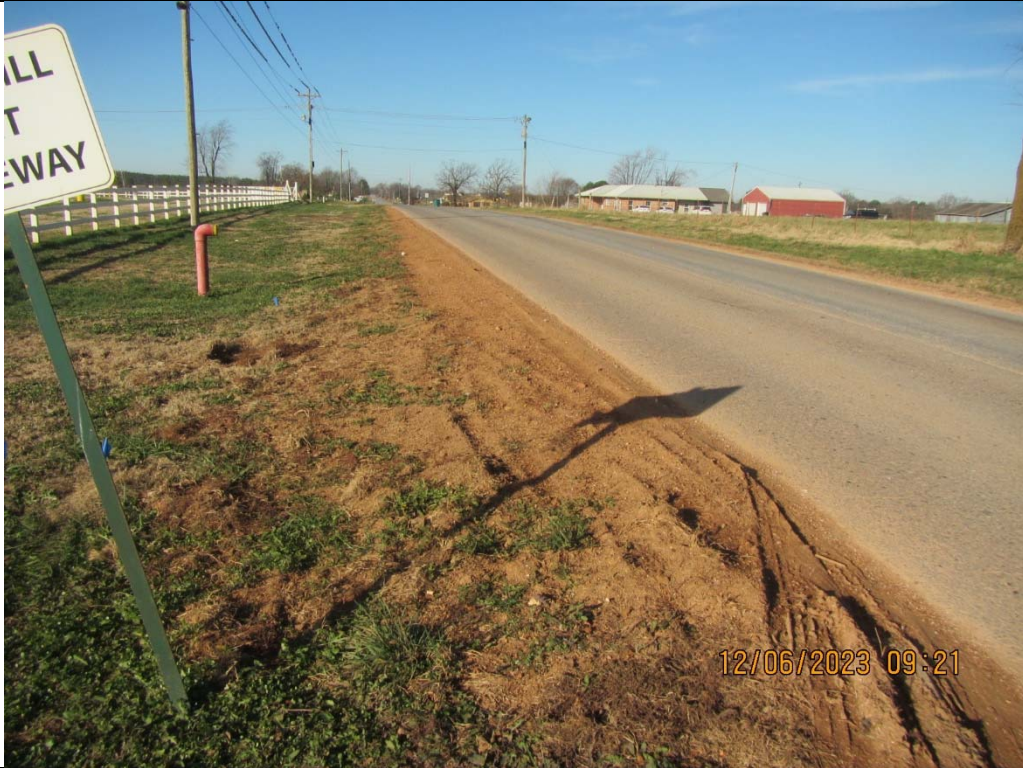
1. Loose sediment was observed along the side of Arbor Acres Drive in the east direction. Please ensure sediment tracked from your facility is properly cleaned up, removed or relocated where it will not contribute to off-site tracking and become a potential source of pollution to a waters of the State in accordance with Part 3.1.5 of the permit and A.C.A. § 8-4-217 (a) (2).

Location:	<b>Eco-Vista, LLC</b>		
Photographer:	<b>William Cody</b>	Date:	<b>12/6/2023</b>
Witness:	<b>N/A</b>	Time:	<b>09:21</b>
Description:	<b>Loose sediment on the side of the road in front of the facility.</b>

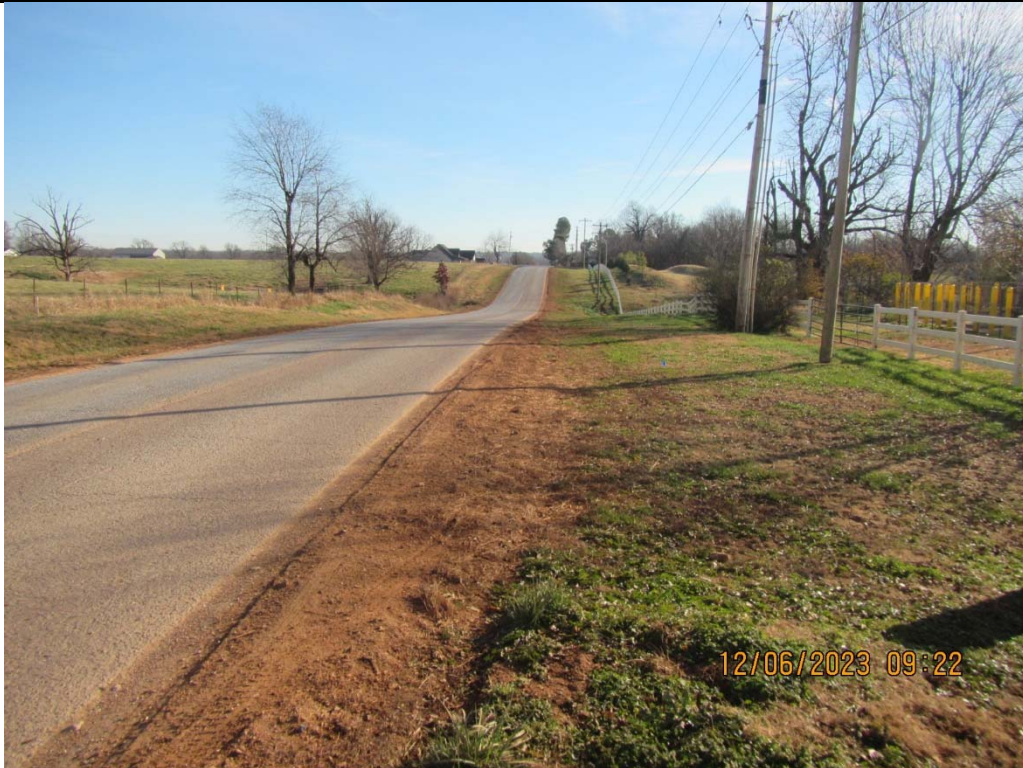
Photographer:	<b>William Cody</b>	Date:	<b>12/6/2023</b>
Witness:	<b>N/A</b>	Time:	<b>09:22</b>
Description:	<b>Additional loose sediment next to Arbor Acres Dr., minimal accumulation on road.</b>

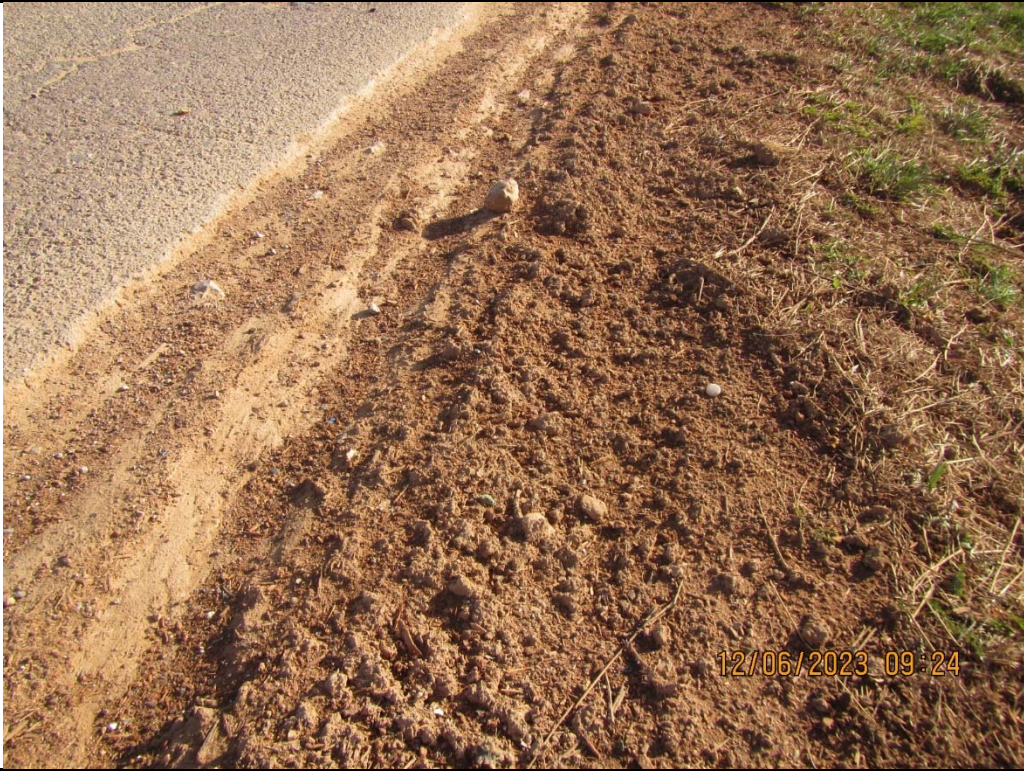
Location:	<b>Eco-Vista, LLC</b>		
Photographer:	<b>William Cody</b>	Date:	<b>12/6/2023</b>
Witness:	<b>N/A</b>	Time:	<b>09:24</b>
		Photo #:	<b>7</b>
Description:	<b>Close-up view of the loose sediment on the side of Arbor Acres Dr.</b>

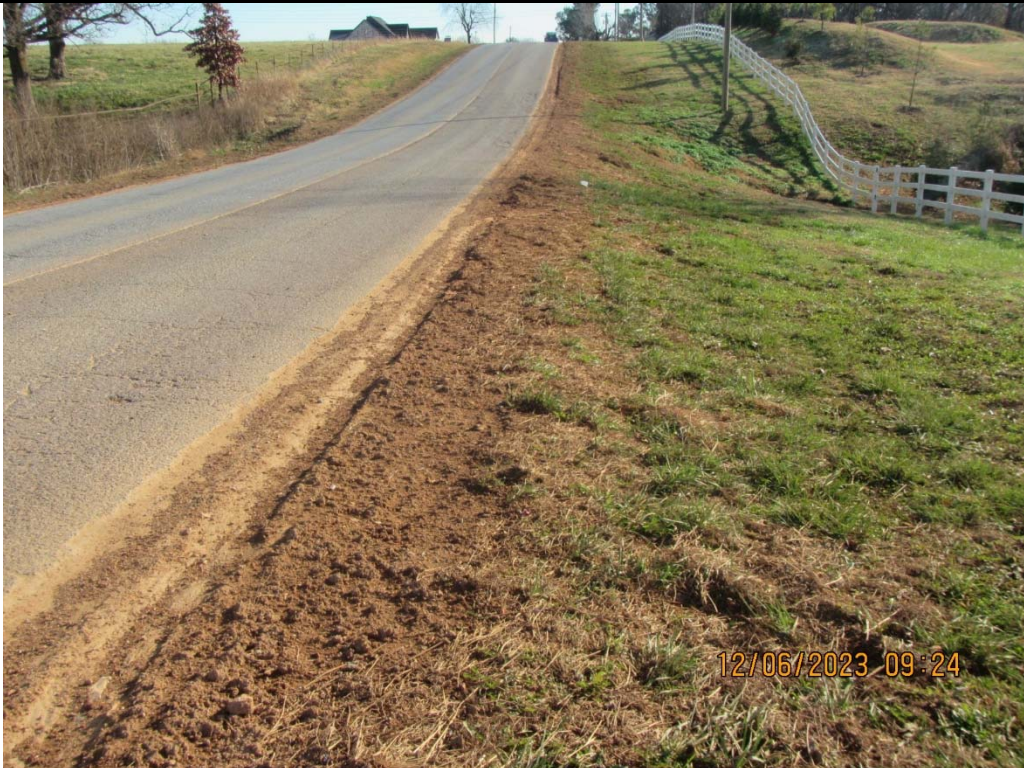
Photographer:	<b>William Cody</b>	Date:	<b>12/6/2023</b>
Witness:	<b>N/A</b>	Time:	<b>09:24</b>
		Photo #:	<b>8</b>
Description:	<b>Loose sediment continues along Arbor Acres Dr.</b>

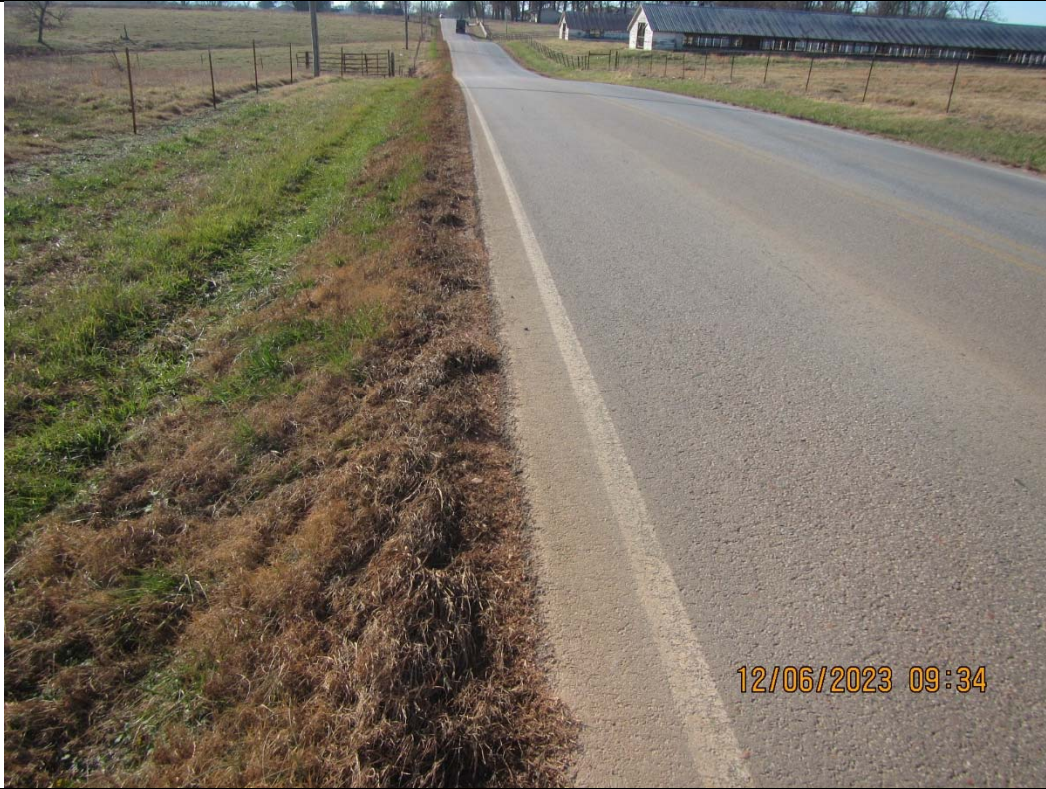
Location:	<b>Eco-Vista, LLC</b>				
Photographer:	<b>William Cody</b>	Date:	<b>12/6/2023</b>	Time:	<b>09:34</b>
Witness:	<b>N/A</b>			Photo #:	<b>9</b>
Description:	<b>Minimal off-site tracking on Dowell Rd, although present on the road.</b>

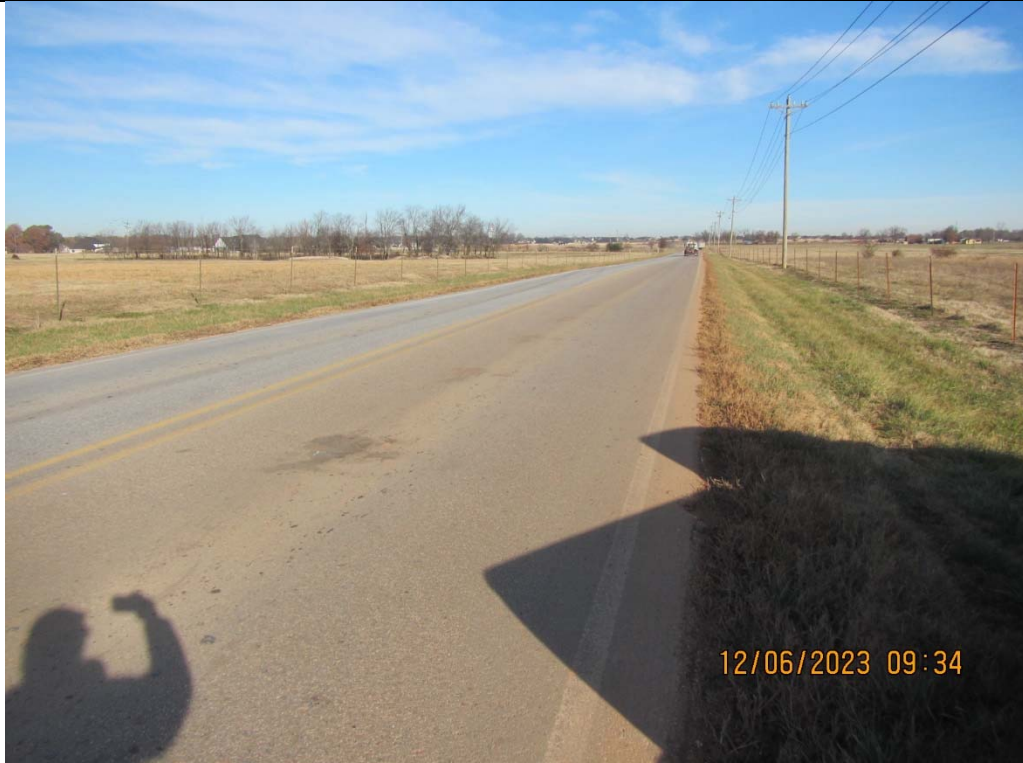
Photographer:	<b>William Cody</b>	Date:	<b>12/6/2023</b>	Time:	<b>09:34</b>
Witness:	<b>N/A</b>			Photo #:	<b>10</b>
Description:	<b>View of Dowell Rd. towards Hwy 412 with evidence of past off-site tracking.</b>
