RE: Clarksville Connected Utilit. Inspection PDS# 128672 (Johnson County)

AFIN: 36-00038 Permit No.: AR0022187

OFFICE OF WATER QUALITY INSPECTION REPORT

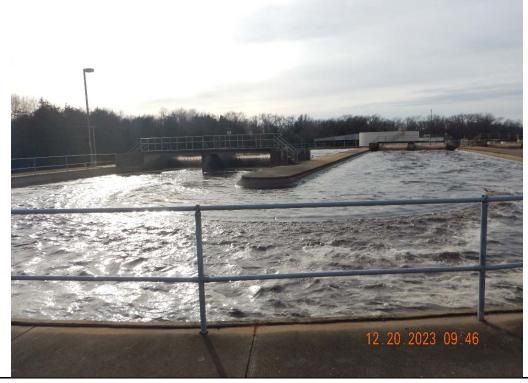
Office of Water Quality Photographic Evidence Sheet									
Location: Clarksville Connected Utilit.									
Photographer: Travis Harmon Date: December				December 20, 2023	Time:	0946			
Witness:	Witness: None Photo #: 3								
Descriptio	Description: First of two oxidation ditches.

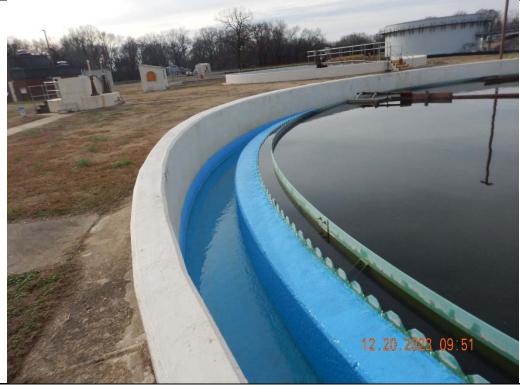
Office of Water Quality Photographic Evidence Sheet Location: Clarksville Connected Utilit. Photographer: Travis Harmon Date: December 20, 2023 Time: 0951 Witness: None Photo #: 5 Description: First of two secondary clarifiers and view of effluent

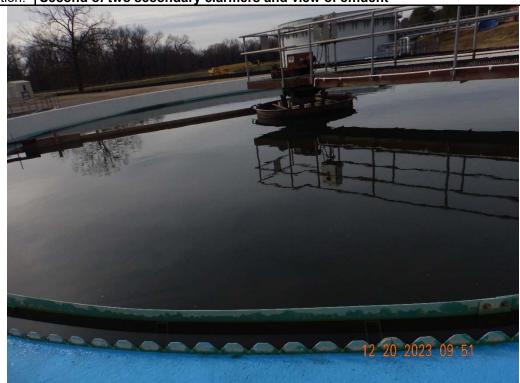
Photographer: Travis Harmon Date: December 20, 2023 Time: 0951
Witness: None Photo #: 6

Description: Second of two secondary clarifiers and view of effluent

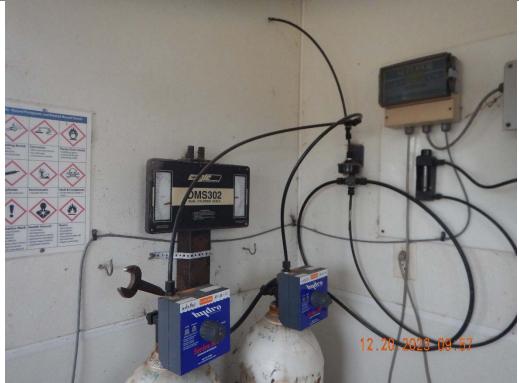
Photographer: Travis Harmon Date: December 20, 2023 Time: 0957
Witness: None Photo #: 11

Description: SO2 de-chlorination

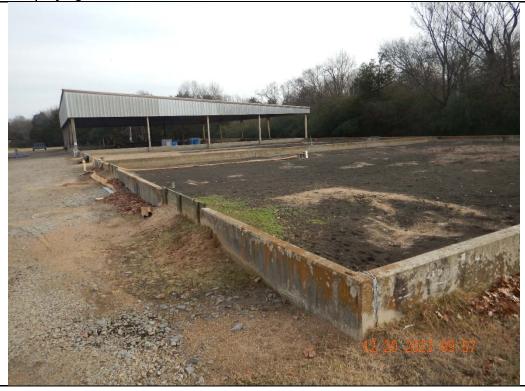
Office of Water Quality Photographic Evidence Sheet									
Location:	Location: Clarksville Connected Utilit.								
Photographer: Travis Harmon Date: December 20, 2023 Time: 095						0957			
Witness:	Witness: None Photo #: 17								
Description	Description: Drying beds
