RE: Inspection conducted on February 7, 2024
AFIN 18-00094
Permit Number 0245-S1-R2

**Division of Environmental Quality
Office of Land Resources
Class 1 Landfill Inspection Form**

Site Name	Crittenden County Class 1	County	Crittenden	AFIN	18-00094
Facility Address	1299 Khun Rd. West Memphis, AR 72301	Phone #	LF: 870-732-4290 Off: 870-732-6580	Permit #	0245-S1-R2
Permittee Address	100 Court Street Marion, AR 72364	Email Address	judgewheeless@crittco.com	PDS #	129190
Date	2/7/2024	Entry Time	1240	Exit Time	1404

Division of Environmental Quality **Official Photograph Sheet**

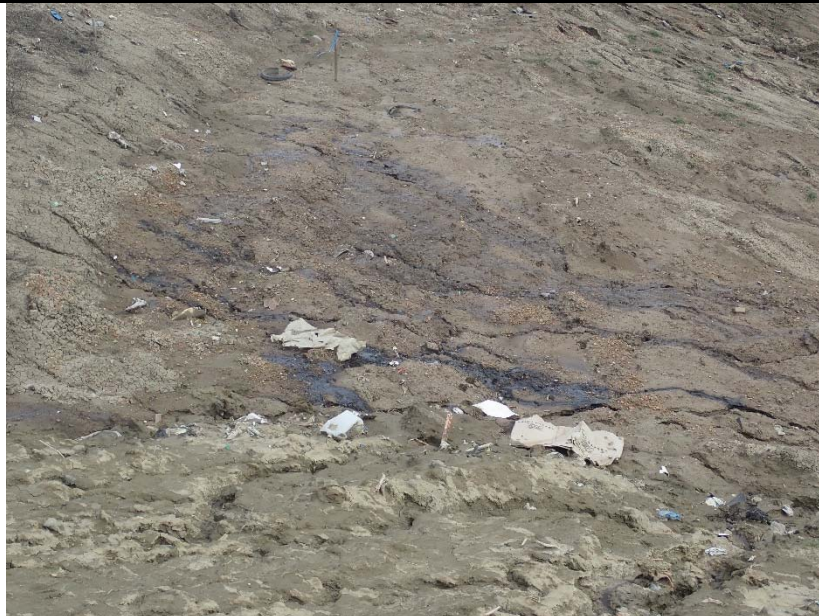
Regulation	Item Description	Comments
	411(a)	Operations in Accordance with Permit Documents	
	411(c)	Smallest Practical Area, Unloading Supervised, Single Working Face	
	411(b)	Operations by Licensed On-site Personnel at All Times	
	411(g)	Litter Control Provisions Maintained	
	427	Surface Water Controls	
	411(h)(1)	Contouring Prevents Surface Water Flowing Into or Through Waste	
	418(a)(b)	Run-on/off Control System Present and Adequate	
	411(h)(2)	Surface Water Control Prevents Off-site Sediment Accumulation	
	411(i)	Adequate Maintenance of Intermediate/Final Cover Vegetation	
	415	Gas Monitoring Program	
X	411(o)	Leachate Leaks or Evidence of Leachate Seepage	Leachate leaks observed below the working face in Cell 5. (Refer to Photos #1- #3.)
	429	Leachate Collection System

Location	Crittenden County Class 1 Landfill			Permit	0245-S1-R2	AFIN	18-00094
Photographer	Tobin Baker, Inspector			Witness	N/A		
Photo #	1	Of	3	Date	2/7/2024	Time	1316
Description	Leachate leaks observed below the working face in Cell 5.

You should immediately initiate actions to correct the alleged violations cited. A written response of the corrective actions taken, or to be taken, must be submitted within thirty (30) calendar days from the date on this letter to the attention of Tobin Baker. The response may include, but is not limited to, photographs, copies of disposal receipts, records, or analytical results, as applicable. If you have any questions regarding the alleged violations, please do not hesitate to contact me at (501) 837-2097 or Tobin.Baker@adeq.state.ar.us.

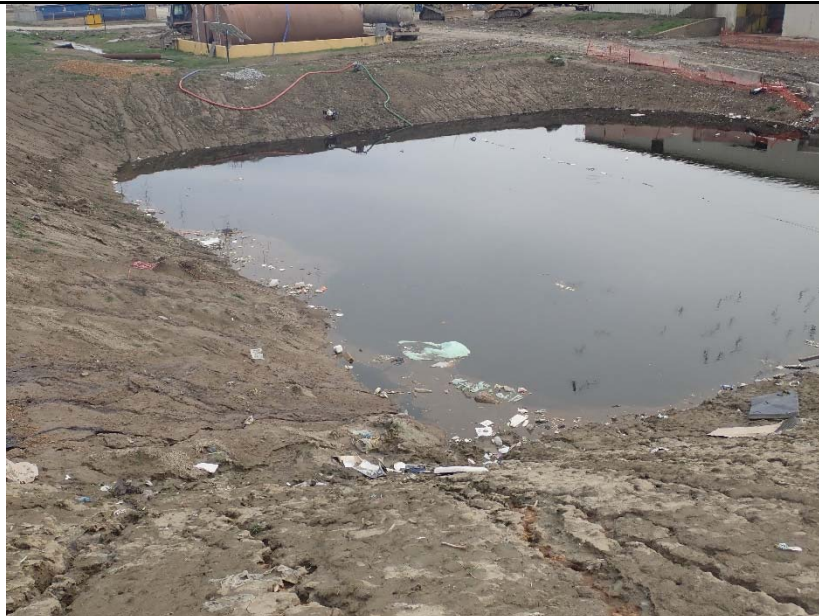
Regulation	Item Description	Comments
	413(a)(b)(c)	Satisfactory Daily/Alternate/Intermediate Cover	
	419(a)(5)	Cause Discharge/Leachate Leaving Landfill	
X	411(f)(3)	Depositing Waste in Standing Water Prohibited	Leachate observed discharging from Cell 5 below the working face to an unlined area beside the cell. (Refer to Photos #1 - #3.)
	411(o)	Erosion or Other Cover Defects Resulting in Exposed Refuse	
	309(c)	Overfill/Off Lined Area

Location	Crittenden County Class 1 Landfill			Permit	0245-S1-R2	AFIN	18-00094
Photographer	Tobin Baker, Inspector			Witness	N/A		
Photo #	2	Of	3	Date	2/7/2024	Time	1316
Description	Leachate and solid waste observed discharging from Cell 5 below the working face to an unlined area beside the cell.
