DIVISION OF  
ENVIRONMENTAL QUALITY

**RE: Inspection conducted on May 7, 2024**  
**AFIN 60-01071**  
**Permit Number 0266-S1**

**Division of Environmental Quality  
Office of Land Resources  
Class 1 Landfill Inspection Form**

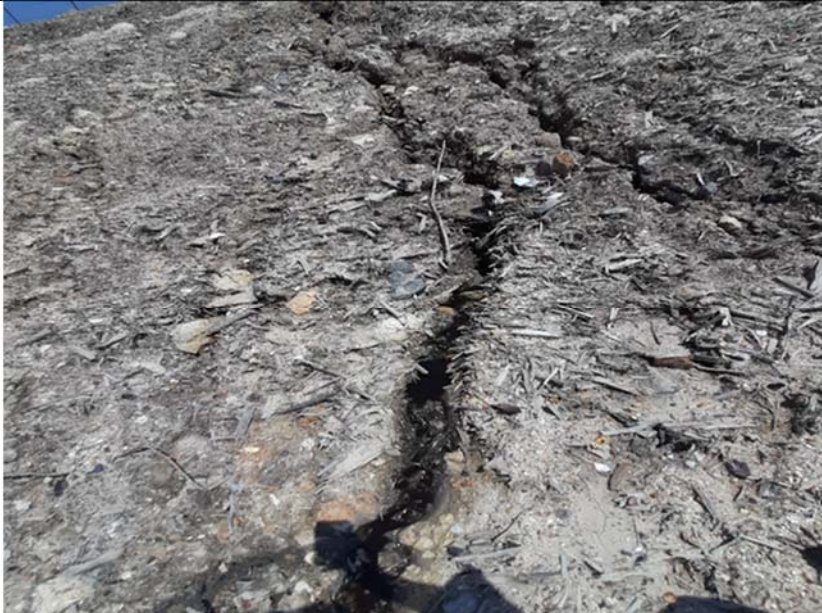
<b>Location</b>	City of Little Rock Class 1			<b>Permit</b>	0266-S1	<b>AFIN</b>	60-01071
<b>Photographer</b>	Casey Jackson		<i>CSS</i>	<b>Witness</b>	N/A		
<b>Photo #</b>	1	<b>Of</b>	10	<b>Date</b>	5/7/2024	<b>Time</b>	1347
<b>Description</b>	Leachate was observed on the west side of Cell 5. The view is from the west looking east.

You should immediately initiate actions to correct the alleged violations cited. A written response of the corrective actions taken, or to be taken, must be submitted within thirty (30) calendar days from the date on this letter to the attention of Casey Jackson. The response may include, but is not limited to, photographs, copies of disposal receipts, records, or analytical results, as applicable. If you have any questions regarding the alleged violations, please do not hesitate to contact me at (501) 682-0832 or [casey.jackson@adeq.state.ar.us](mailto:casey.jackson@adeq.state.ar.us).

<b>Regulation</b>	<b>Item Description</b>	<b>Comments</b>
X	411(a)	Operations in Accordance with Permit Documents	The last approved Operating Plan (OP) is dated 1996 and requires updating. (Refer to Doc #3716, dated July 26, 1996)
	411(c)	Smallest Practical Area, Unloading Supervised, Single Working Face	
	411(b)	Operations by Licensed On-site Personnel at All Times	
X	411(g)	Litter Control Provisions Maintained	Litter was observed in the storm water collection ditch, located west of Cell 5w. (Refer to Photos #3 - #4.)
	427(a)(b)(d)	Surface Water Controls	
	411(h)(1)	Contouring Prevents Surface Water Flowing Into or Through Waste	
	418(a)(b)	Run-on/off Control System Present and Adequate	
	411(h)(2)	Surface Water Control Prevents Off-site Sediment Accumulation	
	411(i)	Adequate Maintenance of Intermediate/Final Cover Vegetation	
	415	Gas Monitoring Program	
X	411(o)	Leachate Leaks or Evidence of Leachate Seepage	Leachate was observed on the west side of Cell 5w. (Refer to Photos # 1 - #2 & #9).

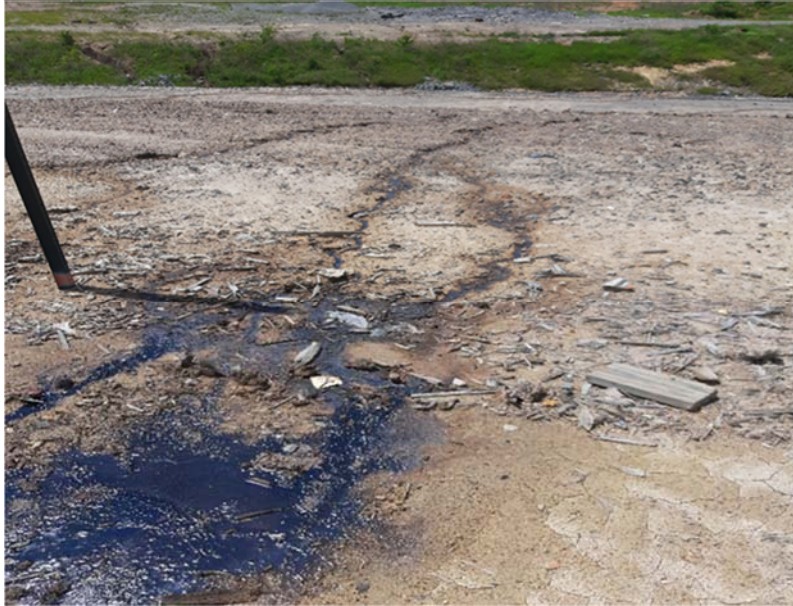
<b>Location</b>	City of Little Rock Class 1			<b>Permit</b>	0266-S1	<b>AFIN</b>	60-01071
<b>Photographer</b>	Casey Jackson		<i>CSS</i>	<b>Witness</b>	N/A		
<b>Photo #</b>	2	<b>Of</b>	10	<b>Date</b>	5/7/2024	<b>Time</b>	1352
<b>Description</b>	Leachate was observed on the west side of Cell 5. The view is from the east looking west.

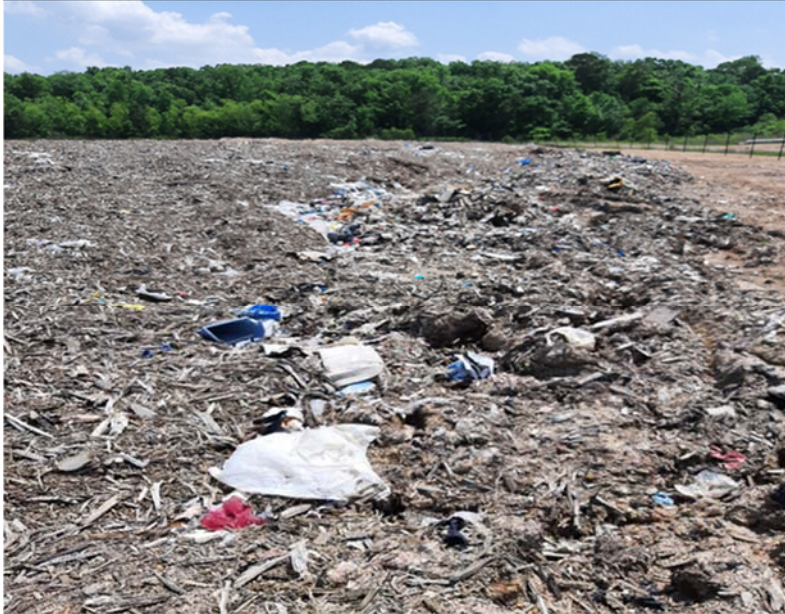
<b>Location</b>	City of Little Rock Class 1			<b>Permit</b>	0266-S1	<b>AFIN</b>	60-01071
<b>Photographer</b>	Casey Jackson		<i>CSS</i>	<b>Witness</b>	N/A		
<b>Photo #</b>	5	<b>Of</b>	10	<b>Date</b>	5/7/2024	<b>Time</b>	1354
<b>Description</b>	Exposed solid waste was observed in the active portion of the landfill (Cell 5W) where ADC was used. The view is from the north looking south.

<b>Regulation</b>	<b>Item Description</b>	<b>Comments</b>
X	413(a)(b)(c)	Satisfactory Daily/Alternate/Intermediate Cover	Exposed solid waste was observed in the south portion of cell 5W, where ADC had been utilized. (Refer to Photos #5 - #8).
	419(a)(5)	Cause Discharge/Leachate Leaving Landfill	
	411(f)(3)	Depositing Waste in Standing Water Prohibited	
	411(o)	Erosion or Other Cover Defects Resulting in Exposed Refuse	
	309(c)	Overfill/Off Lined Area

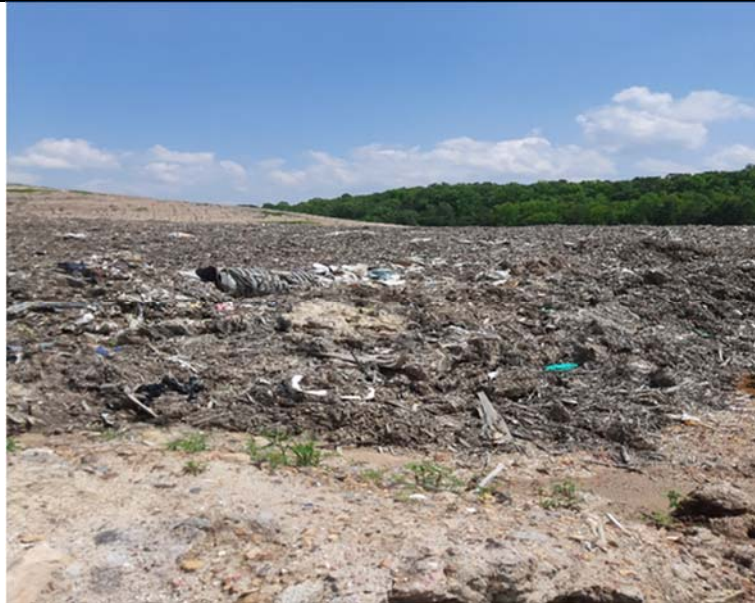
<b>Location</b>	City of Little Rock Class 1			<b>Permit</b>	0266-S1	<b>AFIN</b>	60-01071
<b>Photographer</b>	Casey Jackson		<i>CSS</i>	<b>Witness</b>	N/A		
<b>Photo #</b>	6	<b>Of</b>	10	<b>Date</b>	5/7/2024	<b>Time</b>	1354
<b>Description</b>	Exposed solid waste was observed in the active portion of the landfill (Cell 5W) where ADC was used. The view is from the southwest looking northeast.

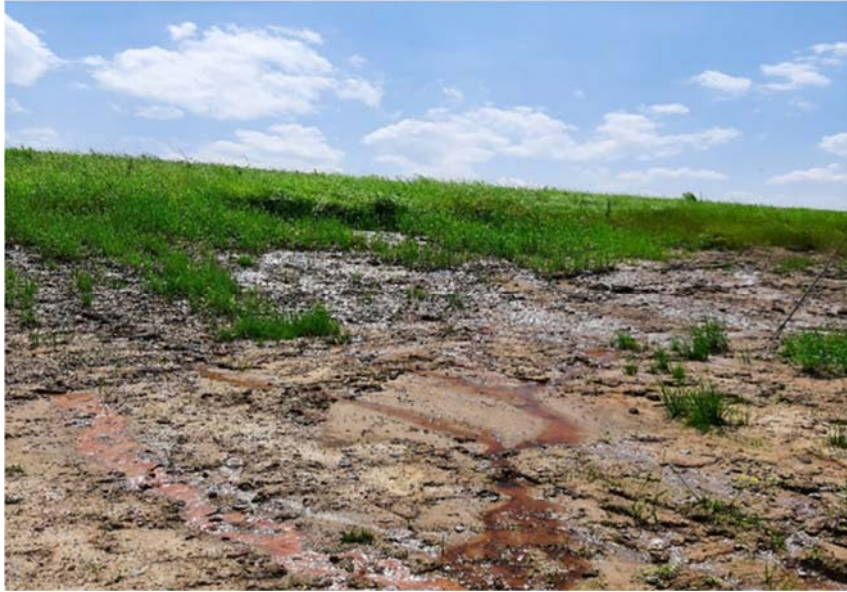
<b>Location</b>	City of Little Rock Class 1			<b>Permit</b>	0266-S1	<b>AFIN</b>	60-01071
<b>Photographer</b>	Casey Jackson		<i>CSS</i>	<b>Witness</b>	N/A		
<b>Photo #</b>	9	<b>Of</b>	10	<b>Date</b>	5/7/2024	<b>Time</b>	1410
<b>Description</b>	Leachate was observed on the north side of Cell 2. The view is from the north looking south.
