ENVIRONMENTAL QUALITY	OFFICE OF WATER QUALITY INSPECTION REPORT		
	AFIN: 19-00071		PERMIT #: AR0021903
	COUNTY: 19 Cross		PDS #: 131934
	GPS LAT: 35.224121 LONG: -90.793967		LOCATION: Entrance
FACILITY INFORMATION		INSPECTION INFORMATION	
NAME: Wynne Water Utilities		FACILITY TYPE: 1 - Municipal	
LOCATION: 706 W. Martin Drive		INSPECTOR ID#: 112347 S - State	
CITY: Wynne		FACILITY EVALUATION RATING: N	
		INSPECTION TYPE: Reconnaissance	
		DATE(S): 9/11/2024	ENTRY TIME: 10:25
		EXIT TIME: 11:34	PERMIT EFFECTIVE DATE: 2/1/2024
		PERMIT EXPIRATION DATE: 1/31/2029	
RESPONSIBLE OFFICIAL			
NAME: / TITLE Blake Marotti / General Manager		FAYETTEVILLE SHALE RELATED: N	
COMPANY: Wynne Water Utilities		FAYETTEVILLE SHALE VIOLATIONS: N	
MAILING ADDRESS: 121 E. Merriman		INSPECTION PARTICIPANTS	
CITY, STATE, ZIP: Wynne AR 72396		NAME/TITLE/PHONE/FAX/EMAIL/ETC.: None	
PHONE & EXT: / FAX: /			
EMAIL:			
CONTACTED DURING INSPECTION: No

SUMMARY OF FINDINGS

This reconnaissance inspection was performed in response to a complaint alleging large amounts of green algae in Williams Creek.

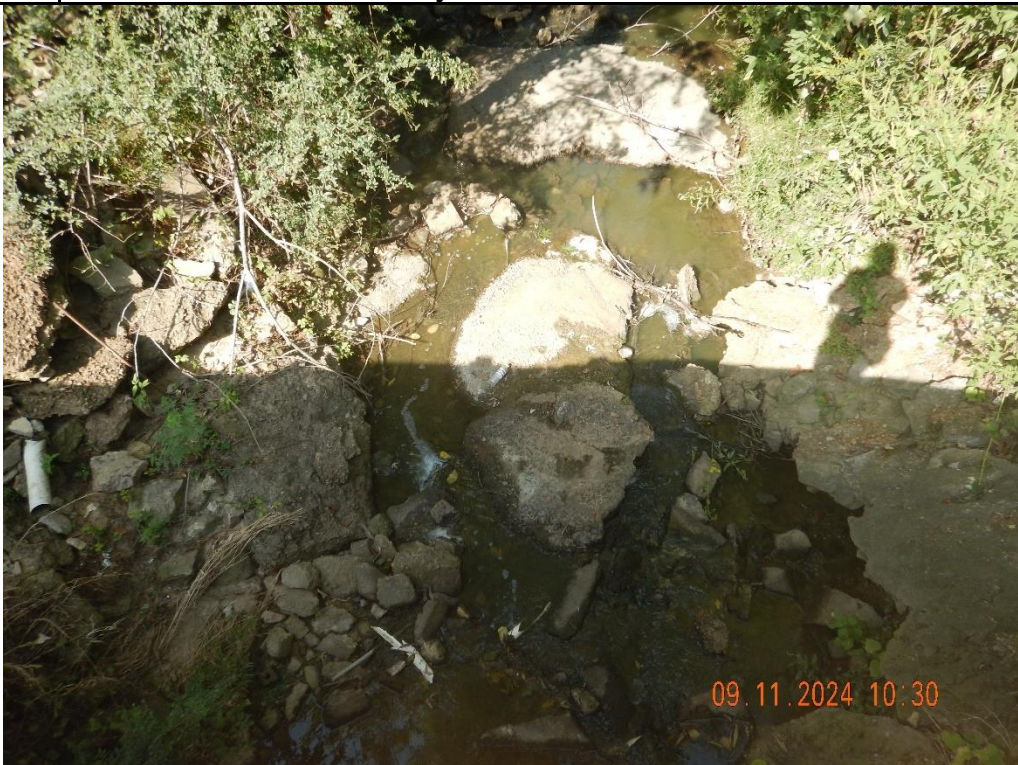
Location:	Wynne Water Utilities		
Photographer:	Sarah Frasher	Date:	9/11/2024
Witness:	Walter Kincade	Time:	10:30
		Photo #:	1
Description:	View of the unnamed tributary of Williams Creek. Note the color of the water.

- Green colored water was observed at the Bowden Street crossing (Photo 1).
- The previous WWTP was examined for any evidence of a possible discharge, in which none was observed (Photo 2).
- The Ellis Street crossing is downstream from the temporary Wynne WWTP and was observed with algae present (Photo 3).
- The temporary WWTP was inspected for evidence of green algae. Cell 2 was observed with algae (Photos 4-6) that was also observed discharging into the receiving stream (Photo 8).
- The area upstream of the discharge was observed for any other possible source and was noted to be a dry creek bed (Photo 9).
- The area of concern by the complainant was inspected and green algae was also observed at this location (Photo 10).

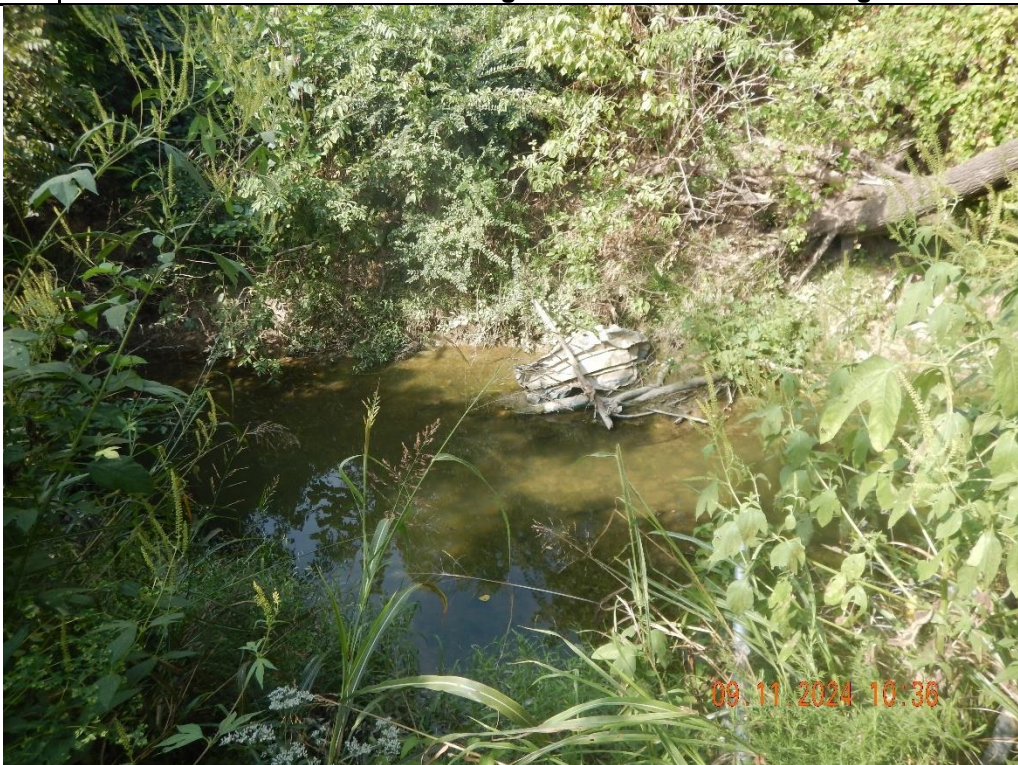
Photographer:	Sarah Frasher	Date:	9/11/2024
Witness:	Walter Kincade	Time:	10:36
		Photo #:	2
Description:	View of the old outfall to the damaged WWTP. Note no discharge was observed.

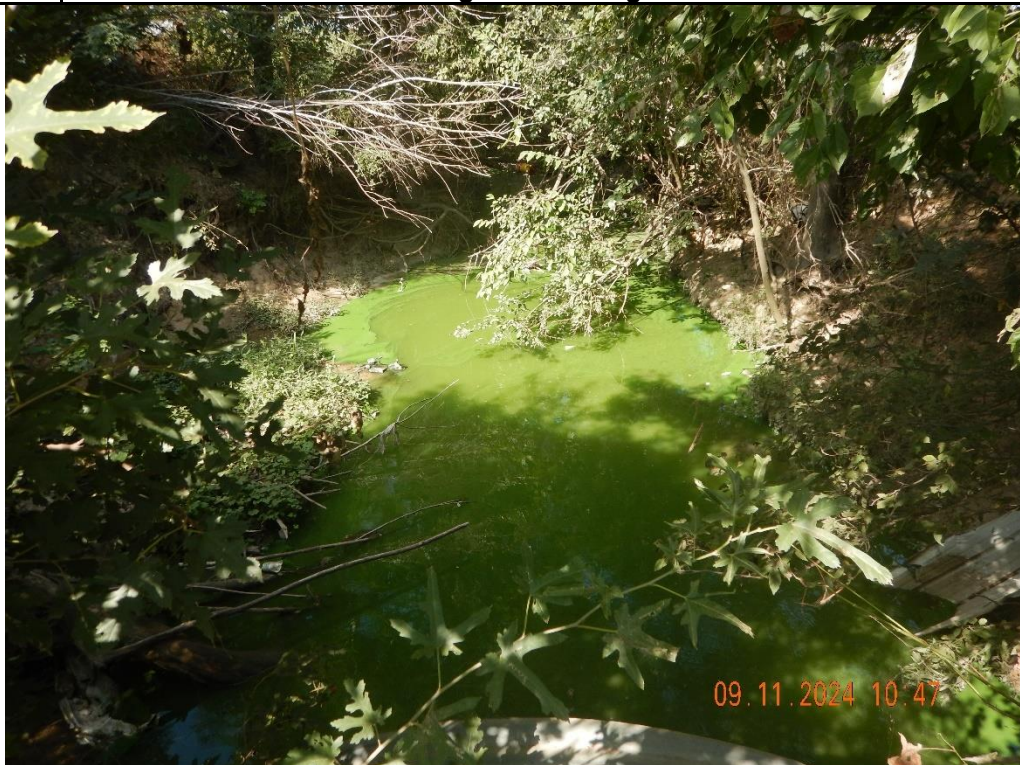
Location:	Wynne Water Utilities		
Photographer:	Sarah Frasher	Date:	9/11/2024
Witness:	Walter Kincade	Time:	10:47
		Photo #:	3
Description:	View of the Ellis Street crossing. Note the algae.

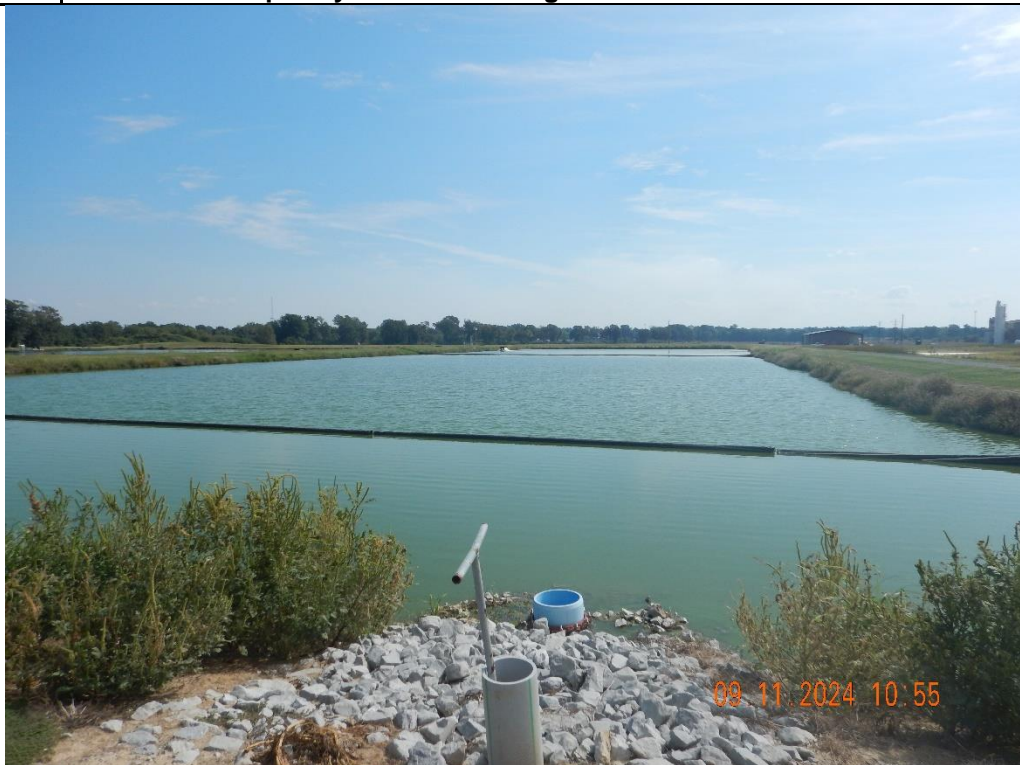
Photographer:	Sarah Frasher	Date:	9/11/2024
Witness:	Walter Kincade	Time:	10:54
		Photo #:	4
Description:	View of the temporary WWTP cell 2 lagoon. Note the color of the water.

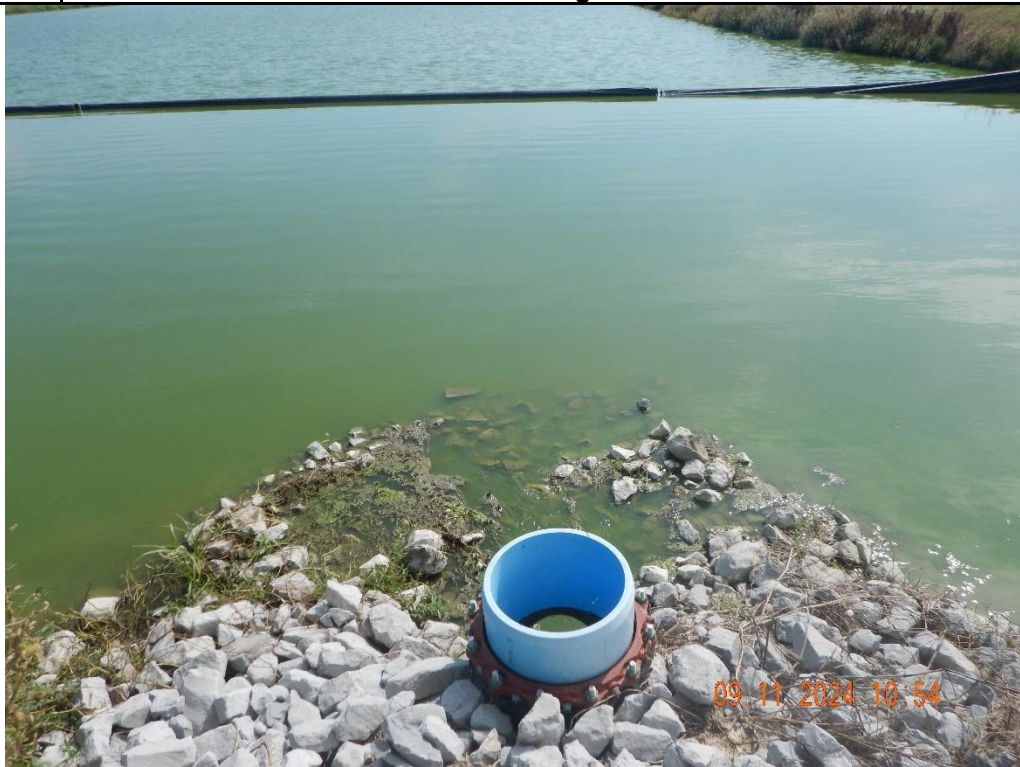
Location:	Wynne Water Utilities		
Photographer:	Sarah Frasher	Date:	9/11/2024
Witness:	Walter Kincade	Time:	10:54
		Photo #:	5
Description:	View of outfall structure to the WWTP lagoon. Note the color of the effluent.

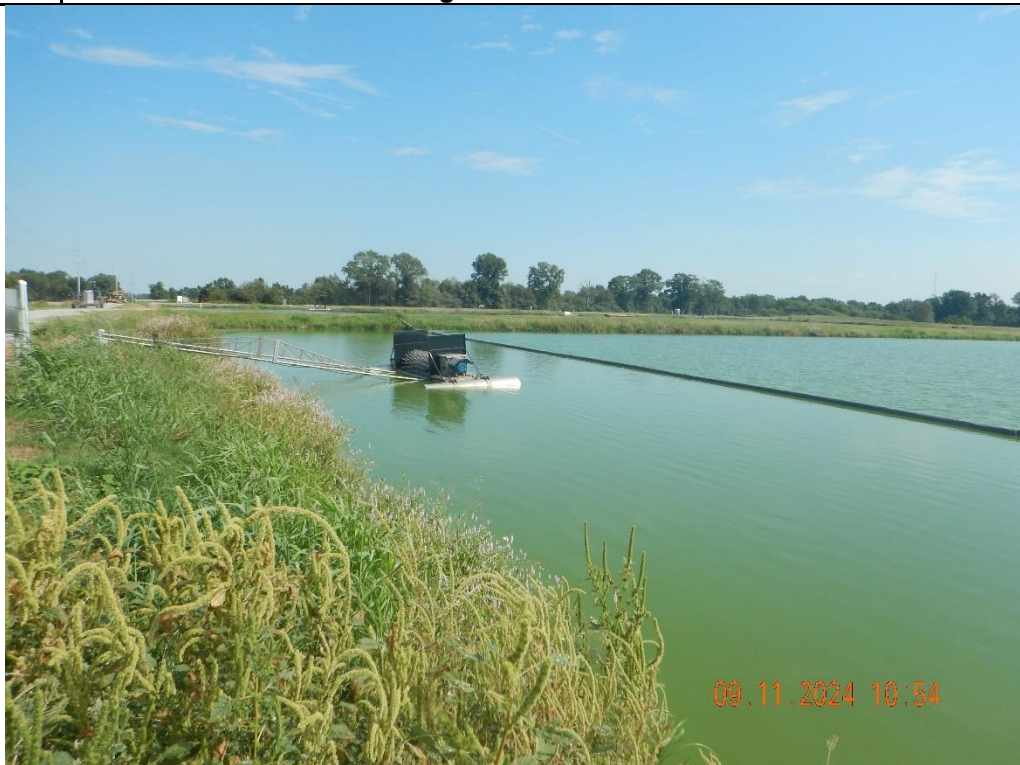
Photographer:	Sarah Frasher	Date:	9/11/2024
Witness:	Walter Kincade	Time:	10:54
		Photo #:	6
Description:	View of cell 2 of the WWTP lagoons.

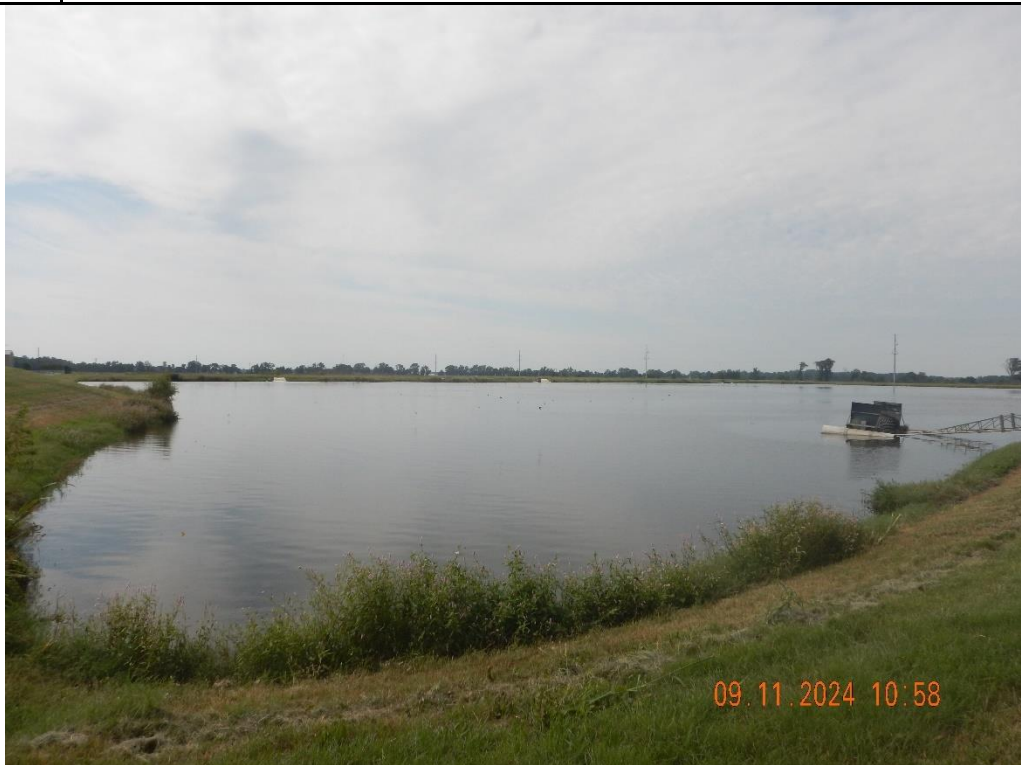
Location:	Wynne Water Utilities		
Photographer:	Sarah Frasher	Date:	9/11/2024
Witness:	Walter Kincade	Time:	10:58
		Photo #:	7
Description:	View of cell 1 of the WWTP.

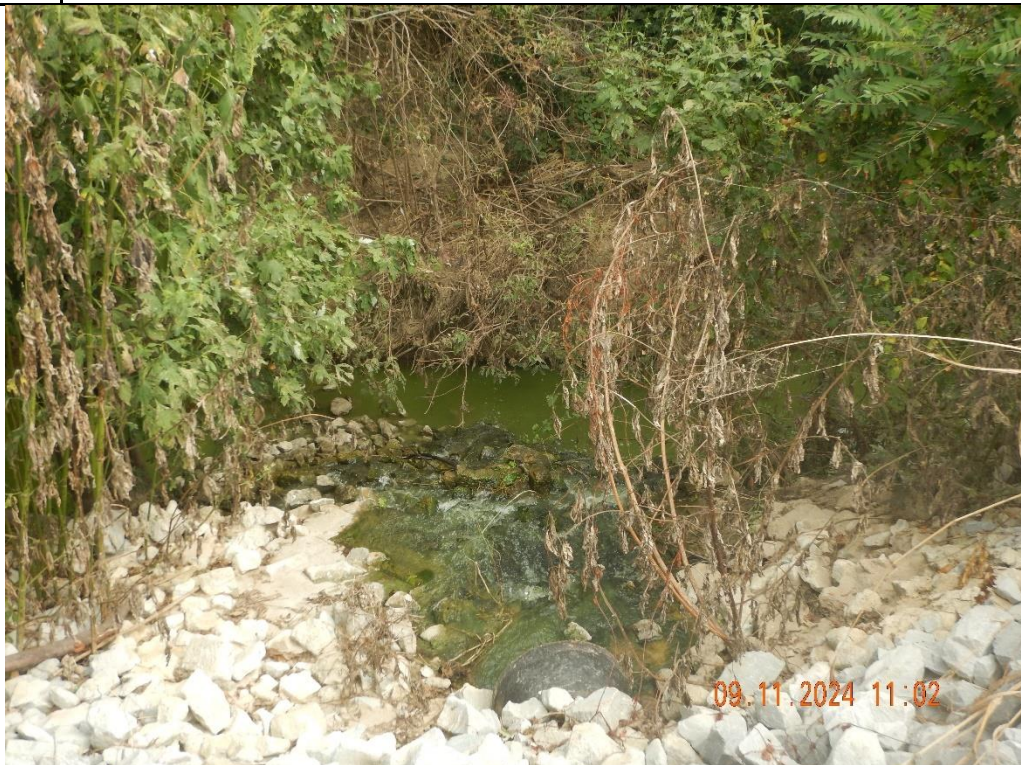
Photographer:	Sarah Frasher	Date:	9/11/2024
Witness:	Walter Kincade	Time:	11:02
		Photo #:	8
Description:	View of the effluent from Outfall 001 of the WWTP. Note the color of the discharge.

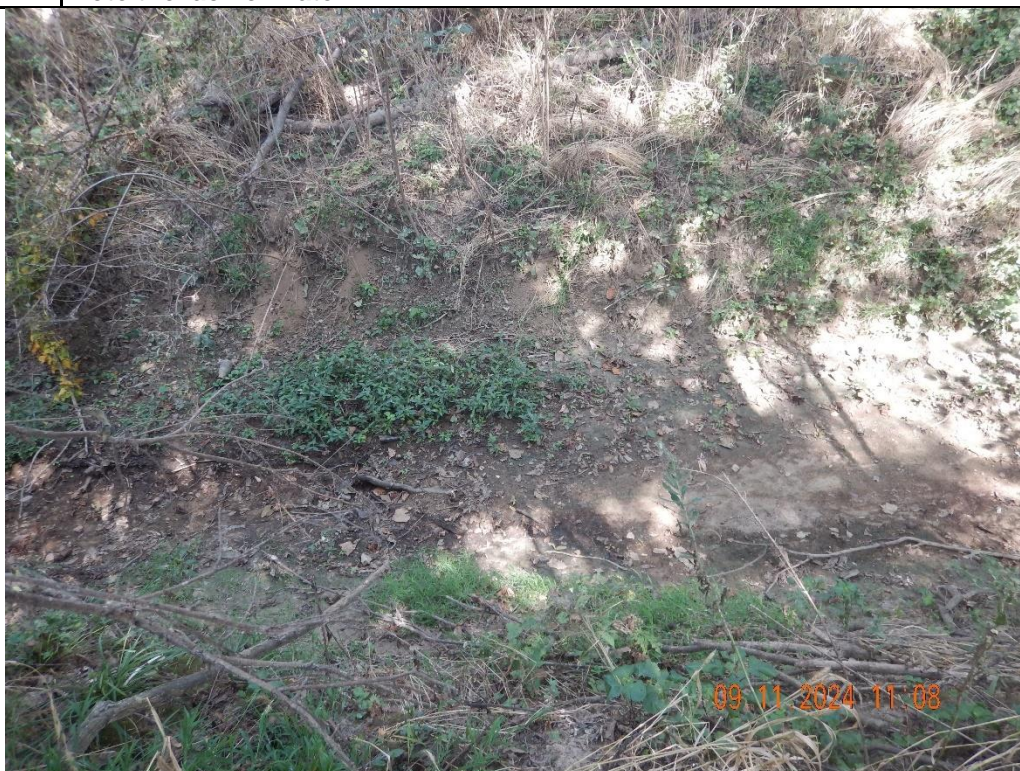
Location:	Wynne Water Utilities		
Photographer:	Sarah Frasher	Date:	9/11/2024
Witness:	Walter Kincade	Time:	11:08
		Photo #:	9
Description:	View of upstream of the receiving stream, unnamed tributary of Williams Creek. Note the lack of water.

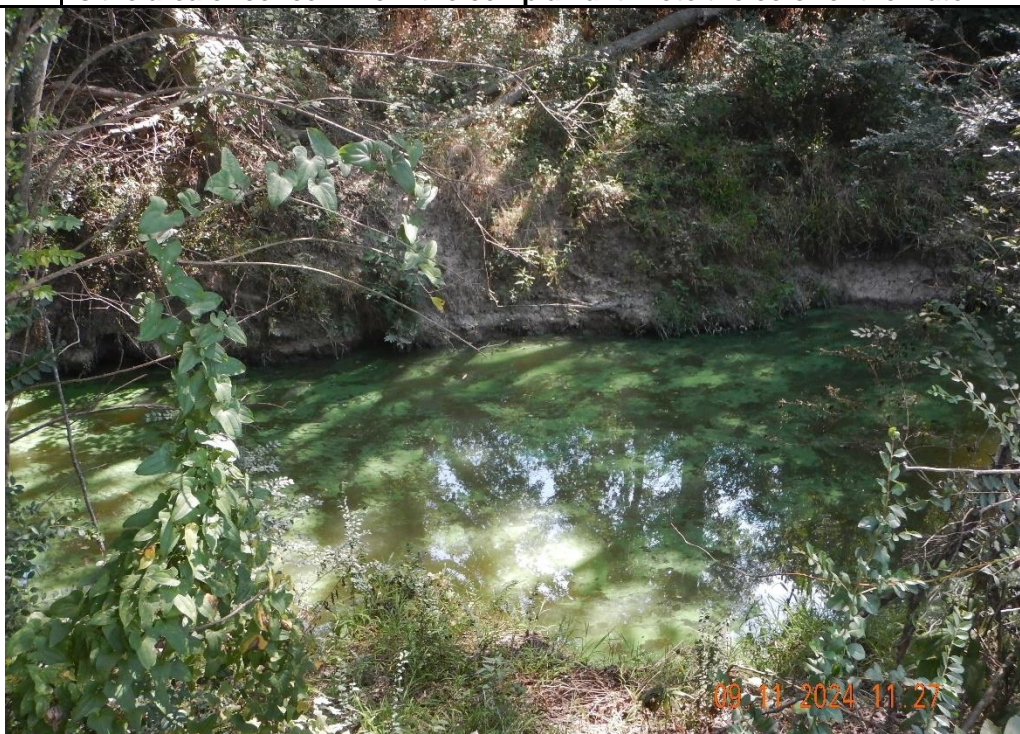
Photographer:	Sarah Frasher	Date:	9/11/2024
Witness:	Walter Kincade	Time:	11:27
		Photo #:	10
Description:	View of the unnamed tributary of Williams Creek downstream of the old WWTP that is the area of concern from the complainant. Note the color of the water.
