RE: Inspection conducted on February 3, 2025
AFIN 60-01071
Permit Number 0266-S1

**Division of Environmental Quality
Office of Land Resources
Class 1 Landfill Inspection Form**

Site Name	City of Little Rock	County	Pulaski	AFIN	60-01071
Facility Address	10801 Ironton Cut-Off Rd. Little Rock, AR	Phone #	501-888-6751	Permit #	0266-S1
Permittee Address	10801 Ironton Cut-Off Rd. Little Rock, AR	Email Address	sowens@littlerock.gov	PDS #	133079
Date	2/3/2025	Entry Time	0930	Exit Time	1130

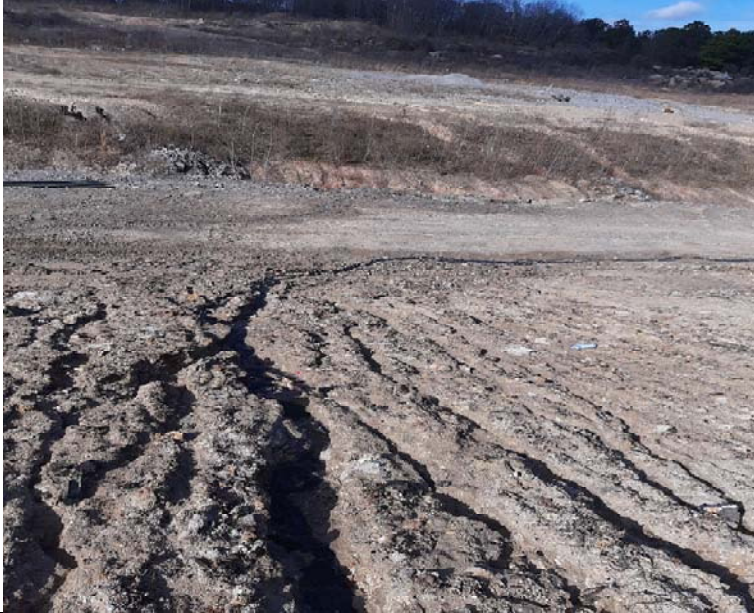
Regulation	Item Description	Comments
422(c)	Operations in Accordance with Permit Documents	The last approved Operating Plan (OP) is dated 1996 and requires updating. (Refer to Doc #3716, dated 7/26/1996). A New draft OP was submitted 2/1/2024 (Doc #85107).
411(c)	Smallest Practical Area, Unloading Supervised, Single Working Face	
411(b)	Operations by Licensed On-site Personnel at All Times	
411(g)	Litter Control Provisions Maintained	
427	Surface Water Controls	
411(h)(1)	Contouring Prevents Surface Water Flowing Into or Through Waste	
418(a)(b)	Run-on/off Control System Present and Adequate	
411(h)(2)	Surface Water Control Prevents Off-site Sediment Accumulation	
411(i)	Adequate Maintenance of Intermediate/Final Cover Vegetation	
415	Gas Monitoring Program	
X	411(o) Leachate Leaks or Evidence of Leachate Seepage	Leachate was observed emerging from the west side of cell 5 into the storm water ditch and the unlined storm water pond located west of the active area. (Refer to Photos #1-#9.)

Location	City Of Little Rock Class 1 Landfill			Permit	0226-S1	AFIN	60-01071
Photographer	Casey Jackson		<i>CSS</i>	Witness	N/A		
Photo #	1	of	12	Date	2/3/2025	Time	1049
Description	Leachate was observed flowing into an unlined stormwater collection area.

The City of Little Rock should immediately initiate actions to correct the alleged violations cited. A written response of the corrective actions taken, or to be taken, must be submitted within thirty (30) calendar days from the date on this letter to the attention of Casey Jackson. The response may include, but is not limited to, photographs, copies of disposal receipts, records, or analytical results, as applicable. If you have any questions regarding the alleged violations, please do not hesitate to contact me at (501) 682-0832 or casey.jackson@arkansas.gov.

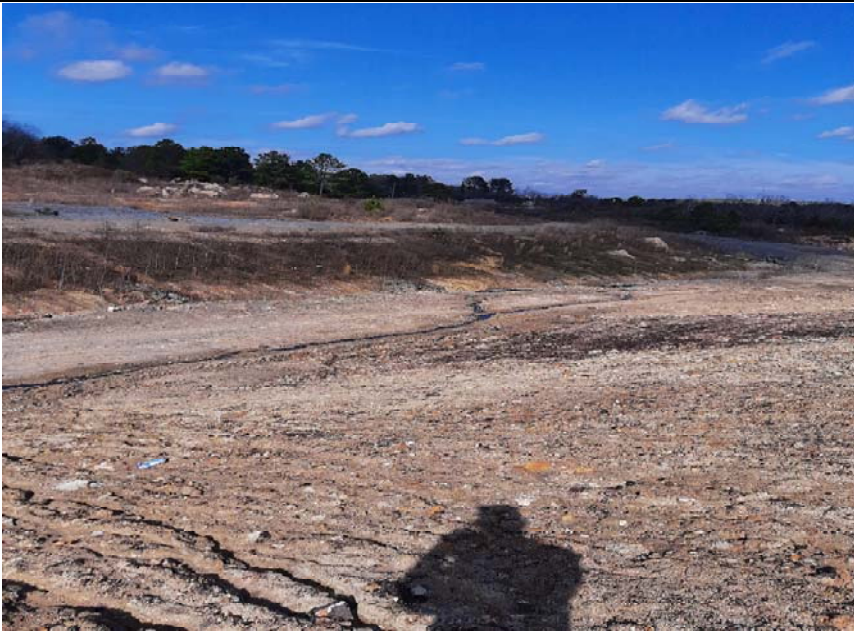
Location	City Of Little Rock Class 1 Landfill			Permit	0226-S1	AFIN	60-01071
Photographer	Casey Jackson		<i>CSS</i>	Witness	N/A		
Photo #	2	of	12	Date	2/3/2025	Time	1049
Description	Leachate was observed flowing into an unlined stormwater collection area.

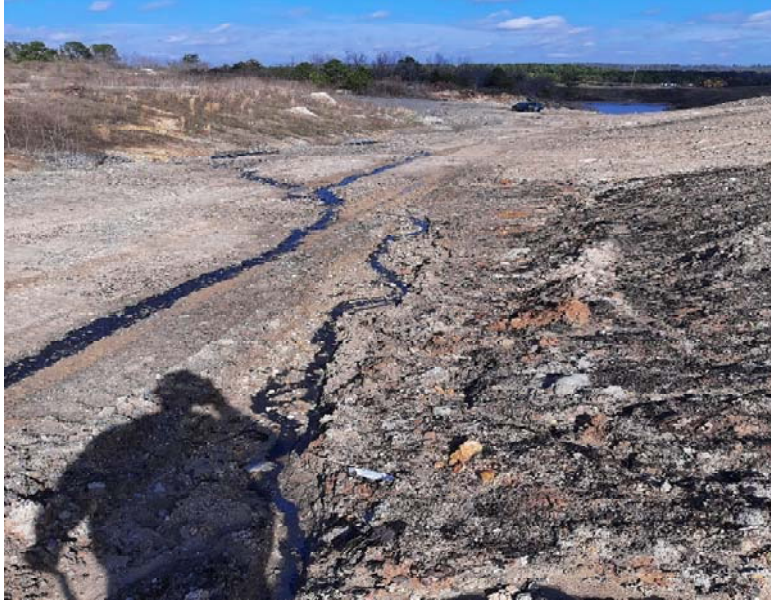
Location	City Of Little Rock Class 1 Landfill	Permit	0226-S1	AFIN	60-01071
Photographer	Casey Jackson	<i>CSS</i>	Witness	N/A	
Photo #	3	of	12	Date	2/3/2025
Description	Leachate was observed flowing into an unlined stormwater collection area.

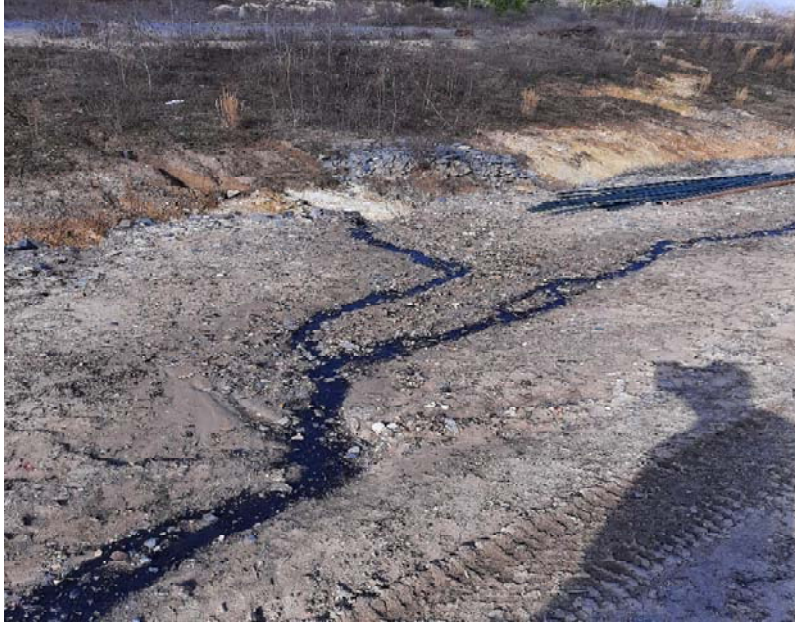
Location	City Of Little Rock Class 1 Landfill	Permit	0226-S1	AFIN	60-01071
Photographer	Casey Jackson	<i>CSS</i>	Witness	N/A	
Photo #	4	of	12	Date	2/3/2025
Description	Leachate was observed flowing into an unlined stormwater collection area.

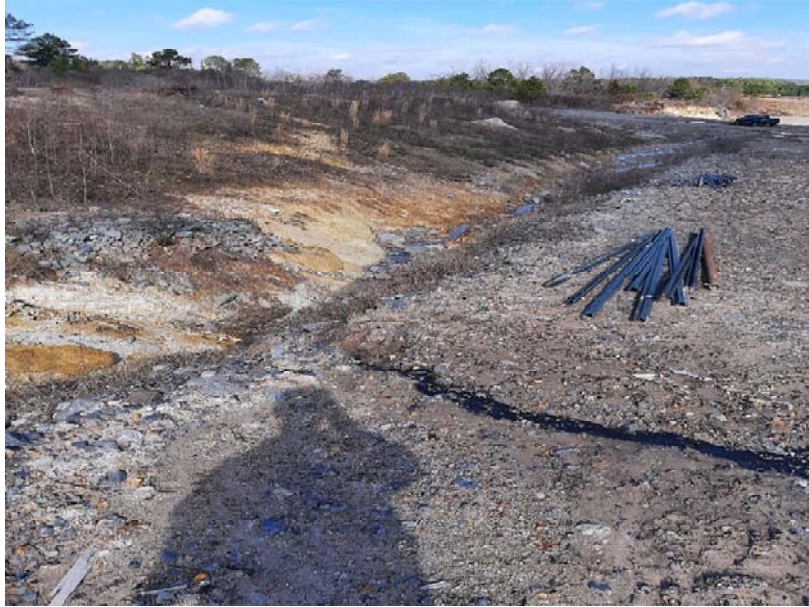
Location	City Of Little Rock Class 1 Landfill	Permit	0226-S1	AFIN	60-01071
Photographer	Casey Jackson	<i>CSS</i>	Witness	N/A	
Photo #	5	of	12	Date	2/3/2025
Description	Leachate was observed flowing into an unlined stormwater collection area.

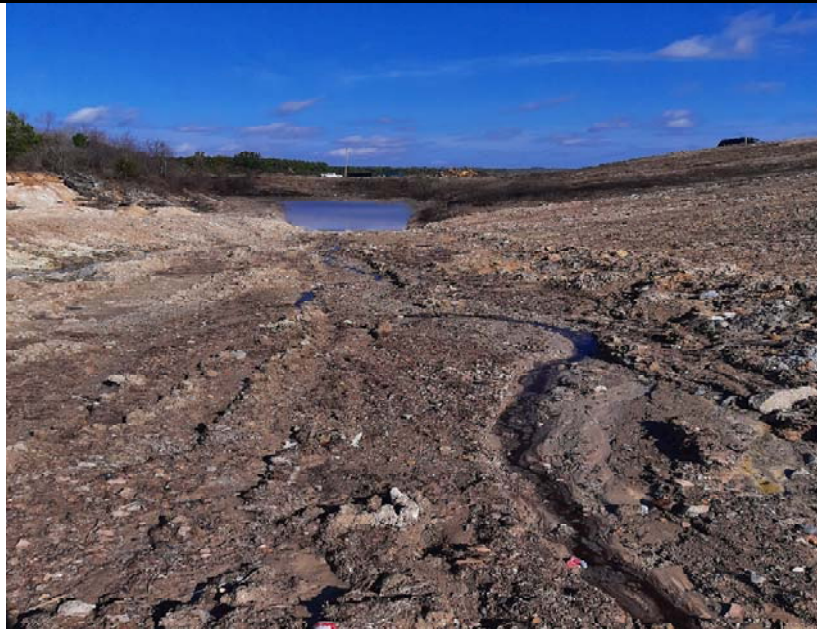
Location	City Of Little Rock Class 1 Landfill	Permit	0226-S1	AFIN	60-01071
Photographer	Casey Jackson	<i>CSS</i>	Witness	N/A	
Photo #	6	of	12	Date	2/3/2025
Description	Leachate was observed flowing into an unlined stormwater collection area.

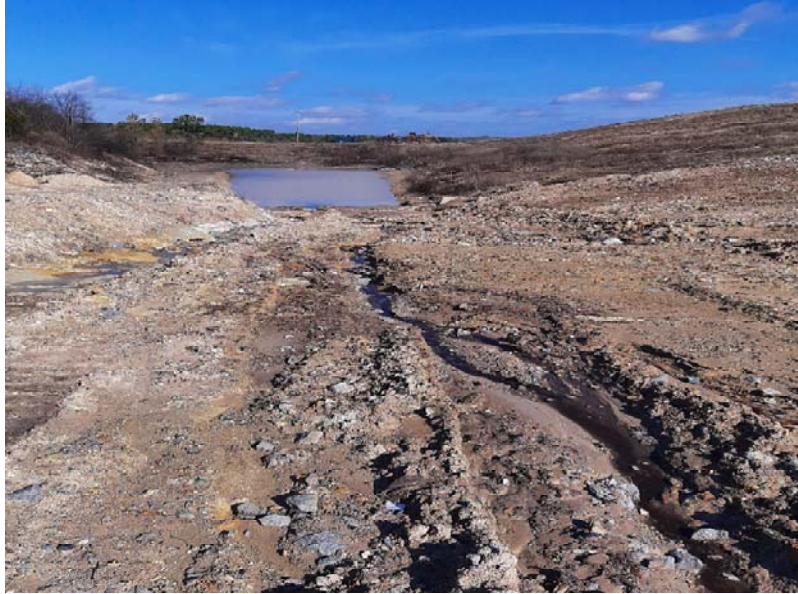
Location	City Of Little Rock Class 1 Landfill			Permit	0226-S1	AFIN	60-01071
Photographer	Casey Jackson		<i>CSS</i>	Witness	N/A		
Photo #	7	of	12	Date	2/3/2025	Time	1053
Description	Leachate was observed flowing into an unlined stormwater collection area.

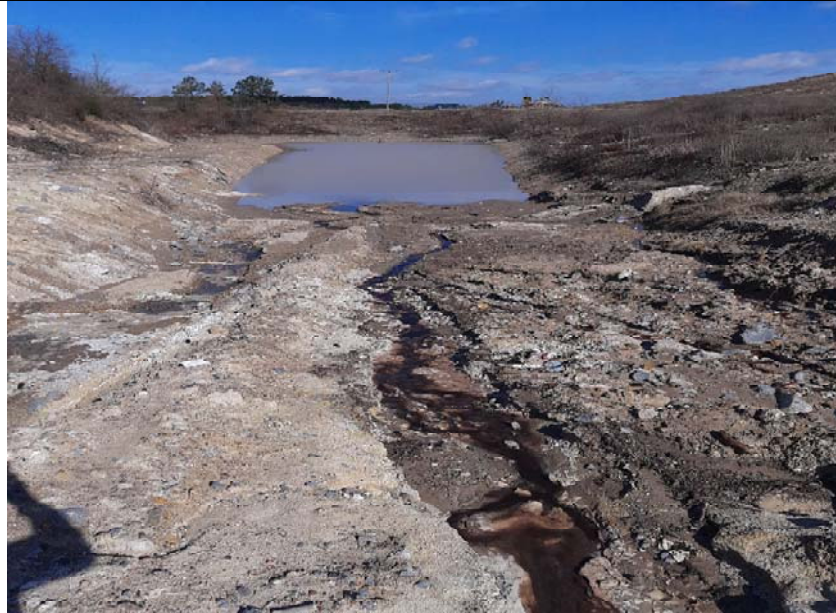
Location	City Of Little Rock Class 1 Landfill			Permit	0226-S1	AFIN	60-01071
Photographer	Casey Jackson		<i>CSS</i>	Witness	N/A		
Photo #	8	of	12	Date	2/3/2025	Time	1053
Description	Leachate was observed flowing into an unlined stormwater collection area.

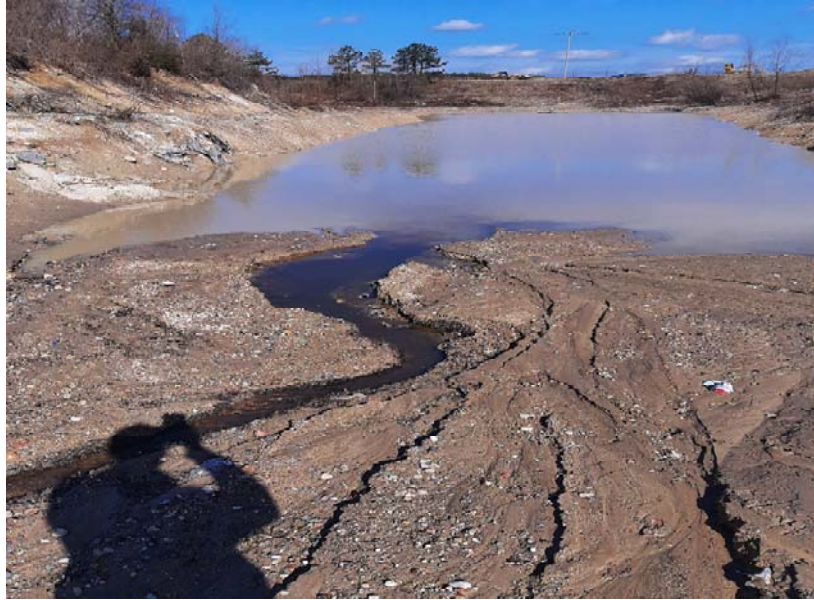
Location	City Of Little Rock Class 1 Landfill			Permit	0226-S1	AFIN	60-01071
Photographer	Casey Jackson		<i>CSS</i>	Witness	N/A		
Photo #	9	of	12	Date	2/3/2025	Time	1054
Description	Leachate was observed flowing into an unlined stormwater collection area.

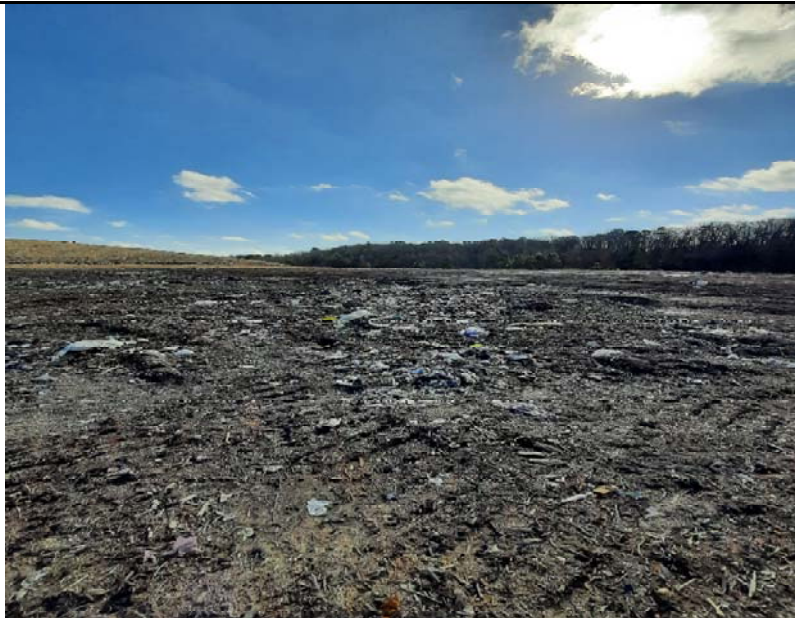
Regulation	Item Description	Comments
X	413(c) Satisfactory Interim Cover	Exposed solid waste was observed in the southeast portion of Cell 5W. This area is observed to have less than 12" of compacted soil functioning as interim cover as required. This facility is not approved to use alternate material as interim cover (shredded wood/wood chips). (Refer to Photos #10 - #12.)
	419(a)(5) Cause Discharge/Leachate Leaving Landfill	
	411(f)(3) Depositing Waste in Standing Water Prohibited	
	411(o) Erosion or Other Cover Defects Resulting in Exposed Refuse	
	309(c) Overfill/Off Lined Area

Location	City Of Little Rock Class 1 Landfill			Permit	0226-S1	AFIN	60-01071
Photographer	Casey Jackson		<i>CSS</i>	Witness	N/A		
Photo #	10	of	12	Date	2/3/2025	Time	1045
Description	Exposed solid waste was observed in the southeast portion of Cell 5W where ADC was used. The view is Northwest to southeast.
