RE: Inspection conducted on June 16, 2025
AFIN 60-01071
Permit Number 0266-S1

Division of Environmental Quality - Office of Land Resources
Class 1 Landfill Inspection Form

Site Name	City of Little Rock	County	Pulaski	AFIN	60-01071
Facility Address	10801 Ironton Cut-Off Rd Little Rock, AR	Phone #	501-888-6751	Permit #	0266-S1
Permittee Address	10801 Ironton Cut-Off Rd Little Rock, AR	Email Address	sowens@littlerock.gov	PDS #	133698
Date	6/16/2025	Entry Time	0930	Exit Time	1121

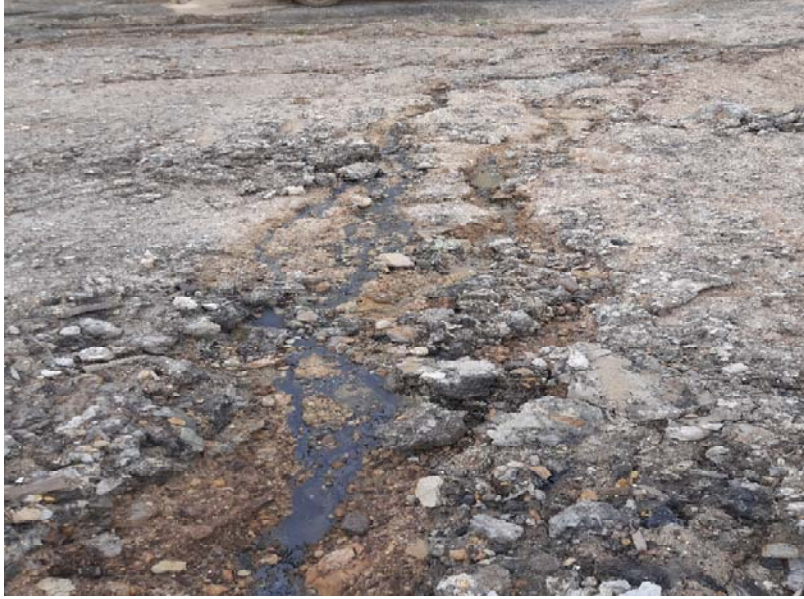
Location	City of Little Rock Class 1 Landfill			Permit	0266-S1	AFIN	60-01071
Photographer	Casey Jackson		<i>CSS</i>	Witness	N/A		
Photo #	1	of	12	Date	6/16/2025	Time	1022
Description	Leachate was observed flowing from the west side slope of Cell 5 west. This view is east to west.

Citation	Description	Comments
	8 CAR § 60-411(a)	Operations in Conformance with Permit Documents	The last approved Operating Plan (OP), dated 1996, requires updating. (Refer to Doc #3716, dated 7/26/1996). A new draft OP was submitted 2/1/2024. (Doc #85107 Refer to Doc #85107.)
	8 CAR § 60-411(c)	(Working Face)	
	8 CAR § 60-411(b)	Operations by Licensed On-site Operators at All Times	
	8 CAR § 60-411(g)	Litter Control	
	8 CAR § 60-427	Surface Water Controls	
	8 CAR § 60-411(h)(1)	Contouring Prevents Surface Water Flowing into or Through Waste	
	8 CAR § 60-418	Run-On/Run-Off Control System Present and Adequate	
	8 CAR § 60-411(h)(2)	Surface Water Control Prevents Off-site Sediment Accumulation	
	8 CAR § 60-411(i)	Final Cover Vegetation and Maintenance	
	8 CAR § 60-415(b)(3)	Gas Monitoring Program	
X	8 CAR § 60-411(o)(2)	Leachate Leaks or Evidence of Leachate Seepage	Leachate was observed emerging from the west side of cell 5 and entering the storm water ditch and the unlined stormwater collection area located west of Cell 2 and northwest of Cell 5 west. (Refer to Photos #1-#9.)

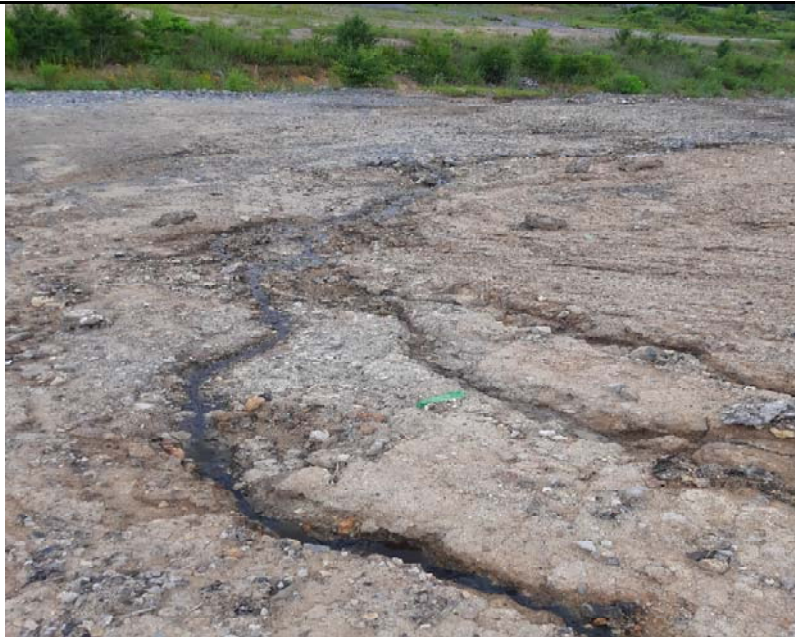
Location	City of Little Rock Class 1 Landfill			Permit	0266-S1	AFIN	60-01071
Photographer	Casey Jackson		<i>CSS</i>	Witness	N/A		
Photo #	2	of	12	Date	6/16/2025	Time	1023
Description	Leachate was observed flowing down the west side slope of Cell 5 west. This view is east to west.

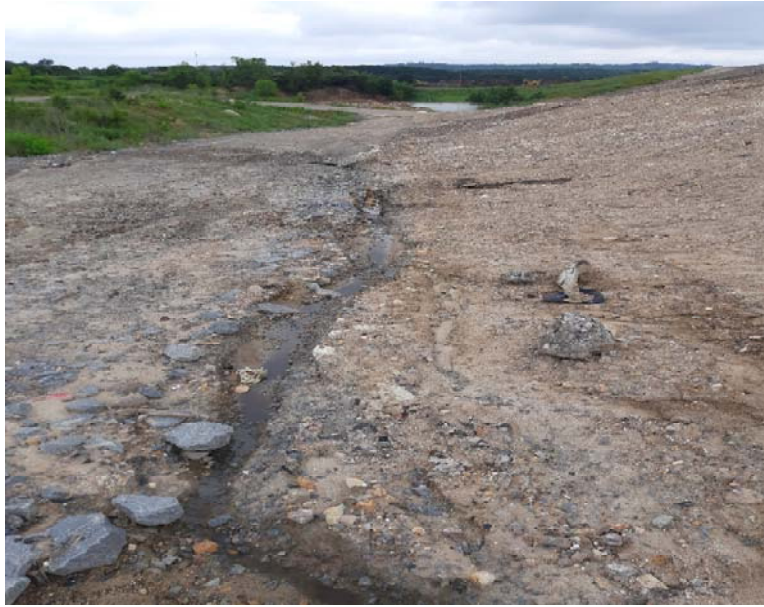
Location	City of Little Rock Class 1 Landfill			Permit	0266-S1	AFIN	60-01071
Photographer	Casey Jackson		<i>CSS</i>	Witness	N/A		
Photo #	3	of	12	Date	6/16/2025	Time	1023
Description	Leachate was observed flowing toward an unlined stormwater collection area on the west side of Cell 5 west. This view is from south to north.

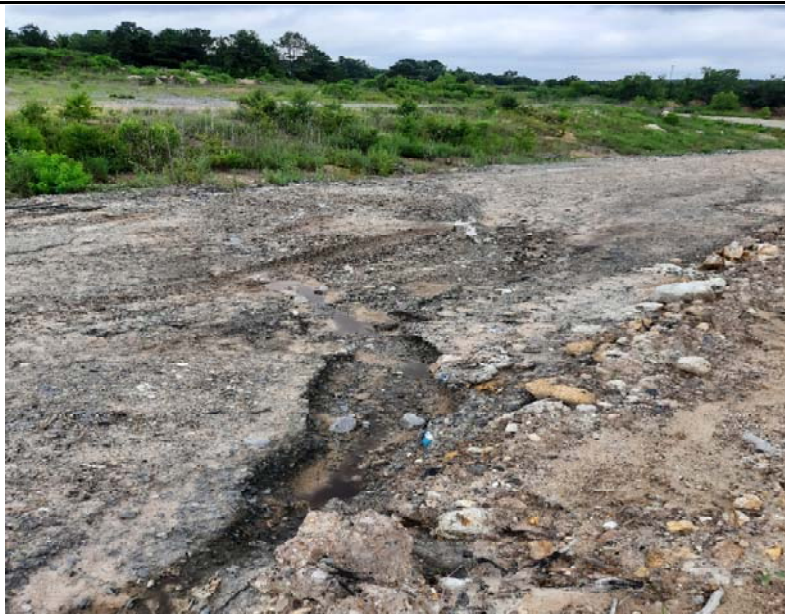
Location	City of Little Rock Class 1 Landfill			Permit	0266-S1	AFIN	60-01071
Photographer	Casey Jackson		<i>CSS</i>	Witness	N/A		
Photo #	4	of	12	Date	6/16/2025	Time	1023
Description	Leachate was observed flowing toward an unlined stormwater collection area on the west side of Cell 5 west. This view is east to west.

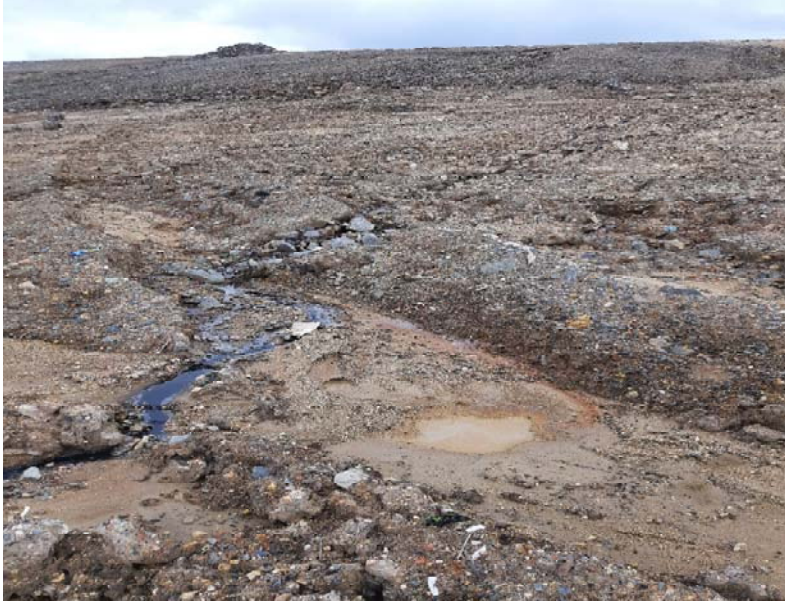
Location	City of Little Rock Class 1 Landfill			Permit	0266-S1	AFIN	60-01071
Photographer	Casey Jackson		<i>CSS</i>	Witness	N/A		
Photo #	5	of	12	Date	6/16/2025	Time	1035
Description	Leachate was observed flowing from the west side slope of Cell 5 West toward an unlined stormwater collection area. This view is from west to east.

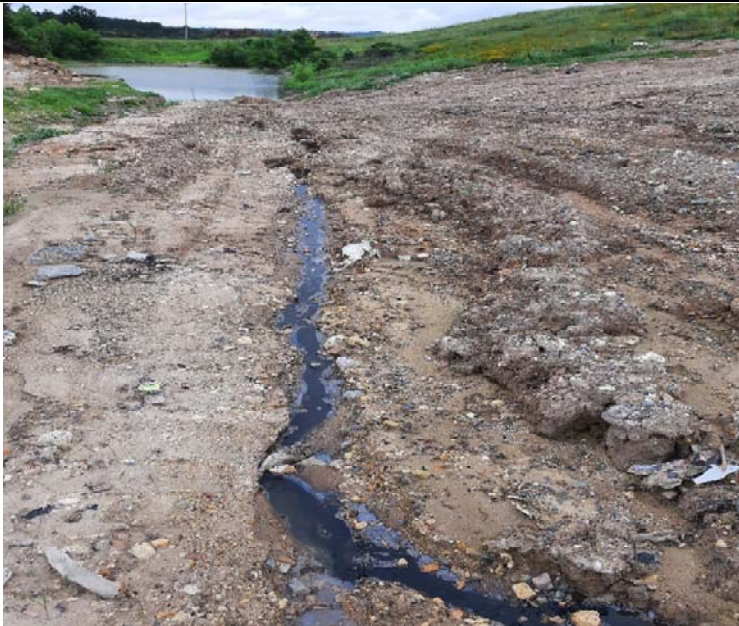
Location	City of Little Rock Class 1 Landfill			Permit	0266-S1	AFIN	60-01071
Photographer	Casey Jackson		<i>CSS</i>	Witness	N/A		
Photo #	6	of	12	Date	6/16/2025	Time	1035
Description	Leachate was observed flowing from the west side of Cell 5 West into an unlined stormwater collection area. This view is from south to north.

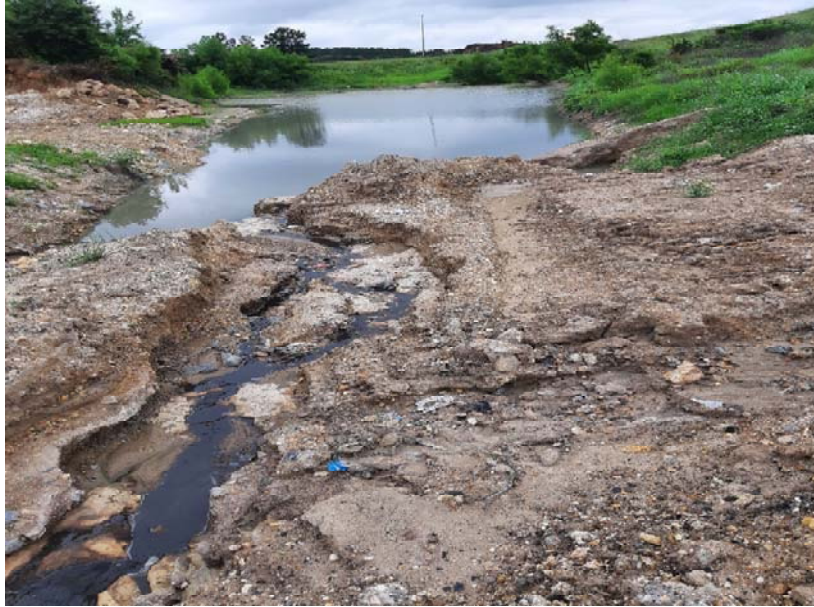
Location	City of Little Rock Class 1 Landfill	Permit	0266-S1	AFIN	60-01071
Photographer	Casey Jackson	<i>CSS</i>	Witness	N/A	
Photo #	7	of	12	Date	6/16/2025
Time	1037				
Description	Leachate was observed flowing from the west side of Cell 5 West into an unlined stormwater collection area. This view is from south to north.

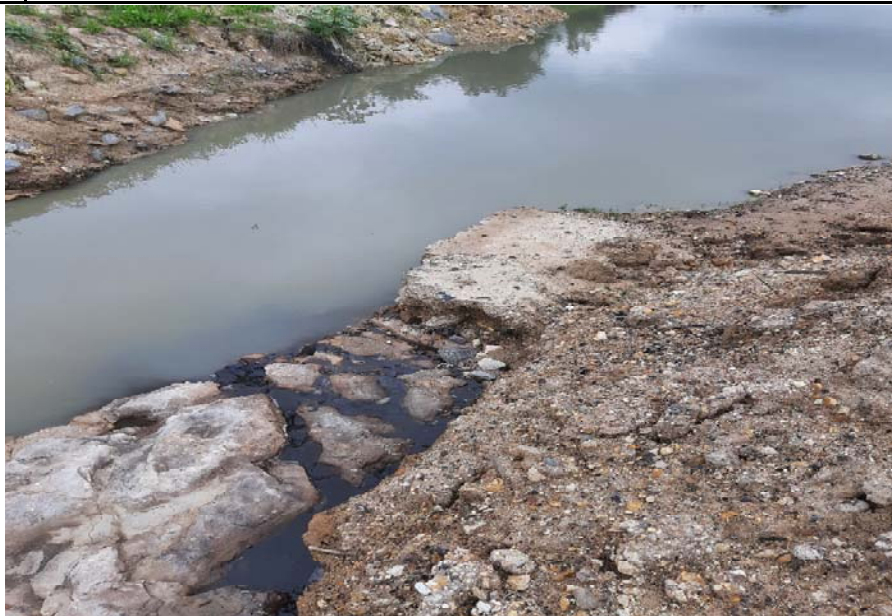
Location	City of Little Rock Class 1 Landfill	Permit	0266-S1	AFIN	60-01071
Photographer	Casey Jackson	<i>CSS</i>	Witness	N/A	
Photo #	8	of	12	Date	6/16/2025
Time	1037				
Description	Leachate was observed flowing from the west side of Cell 5 West into an unlined stormwater collection area.

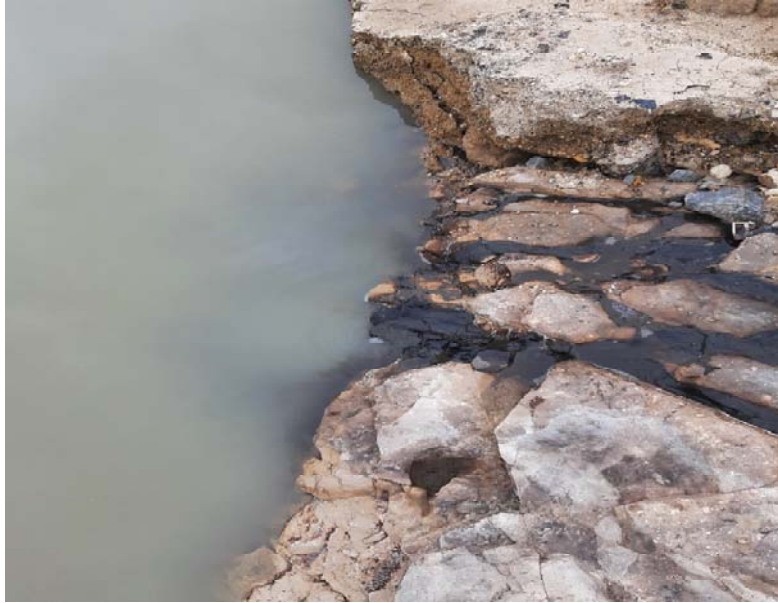
Location	City of Little Rock Class 1 Landfill	Permit	0266-S1	AFIN	60-01071
Photographer	Casey Jackson	<i>CSS</i>	Witness	N/A	
Photo #	9	of	12	Date	6/16/2025
Description	Leachate was observed flowing into an unlined stormwater collection area.

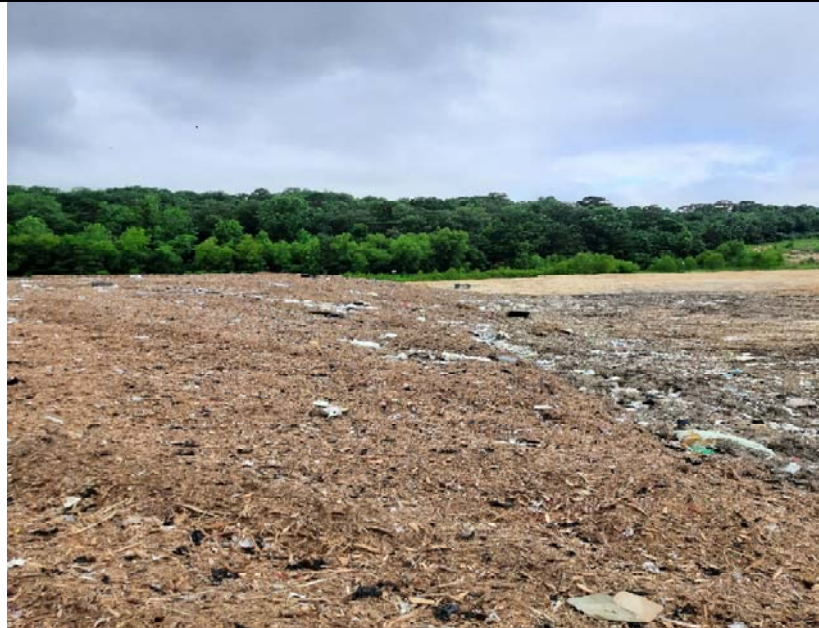
Citation	Description	Comments
X	8 CAR § 60-413(c)	Satisfactory Interim Cover	Exposed solid waste was observed in the southeast portion of Cell 5W where alternate daily cover consisting of shredded wood waste was used. This area was observed to have less than 12" of compacted soil functioning as interim cover as required. This facility is not approved to use alternate daily cover material (shredded wood/wood chips) as interim cover. (Refer to Photos #10 - #12.)
	8 CAR § 60-419(a)(5)	Allow Leachate not permitted under NPDES to Leave Landfill	
	8 CAR § 60-413(f)(3)	Depositing Waste in Standing Water is Prohibited	
	8 CAR § 60-411(o)(1)	Erosion or Other Cover Defects Resulting in Exposed Refuse	
	8 CAR § 60-309(c)	Overfill/Off Lined Area

Location	City of Little Rock Class 1 Landfill	Permit	0266-S1	AFIN	60-01071
Photographer	Casey Jackson	<i>CSS</i>	Witness	N/A	
Photo #	10	of	12	Date	6/16/2025
Description	Exposed solid waste was observed in Cell 5W where Alternate Daily Cover of shredded wood waste was used as interim cover. The view is north to south.

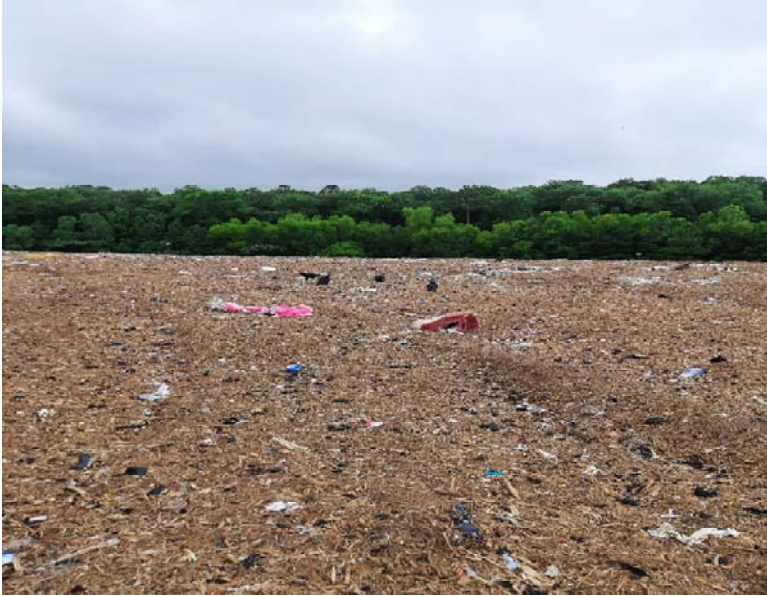
Location	City of Little Rock Class 1 Landfill	Permit	0266-S1	AFIN	60-01071
Photographer	Casey Jackson	<i>CSS</i>	Witness	N/A	
Photo #	11	of	12	Date	6/16/2025
Time	0955				
Description	Exposed solid waste was observed in Cell 5W where Alernate Daily Cover of shredded wood waste was used as interim cover. The view is north to south.
