CITY OF BLYTHEVILLE

COMPREHENSIVE COLLECTION SYSTEM

EVALUATION

PREPARED BY: **SSR ELLERS, INC.**

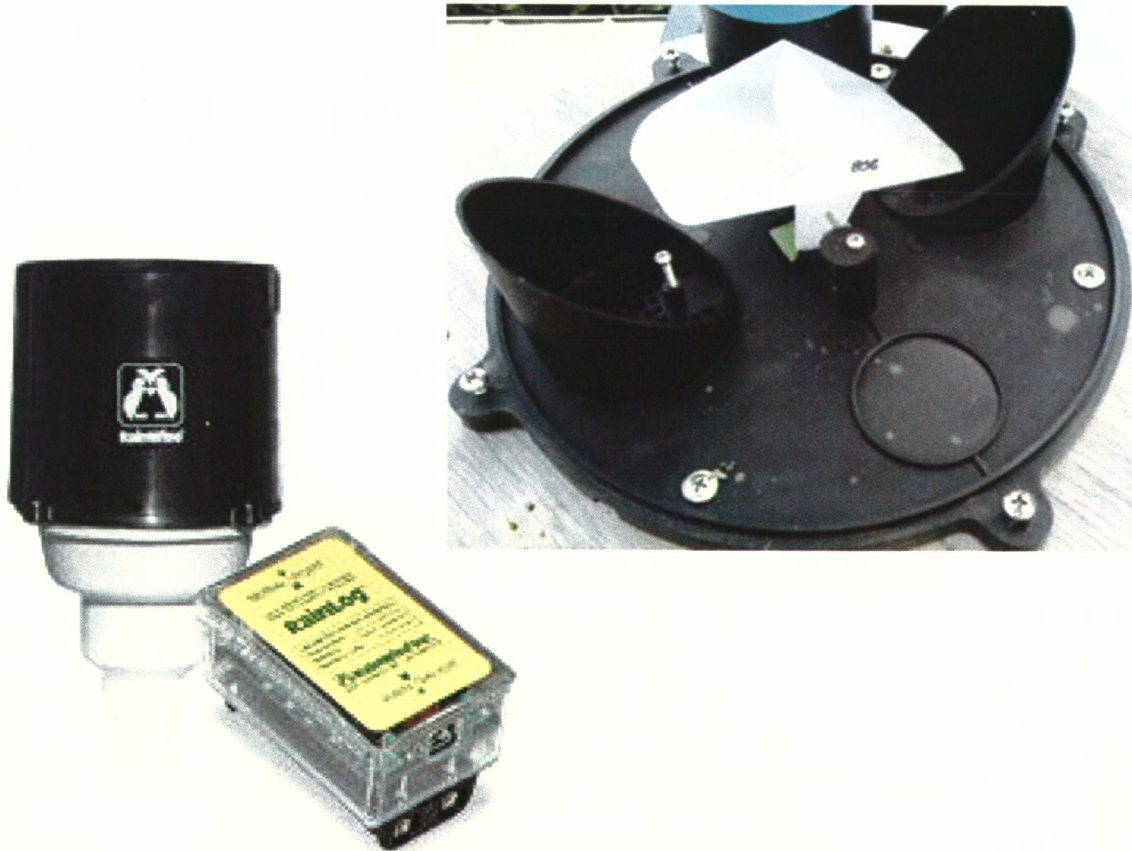
A critical component for I/I investigations is rainfall data. Tipping bucket rain gauges (manufactured by RainWise, Inc.) were selected for this evaluation, as they not only record depth of rainfall, but also the times at which increments of rainfall occurred. The rainfall data logger was set to record and report the rainfall depth that occurred in every five (5) minute interval. Two (2) rain gauges were used in order to provide a comparison between the two (2) data sets and provide a back up data set if one of the rain gauges were rendered inoperable during a rain event.

One rain gauge was installed in the vicinity of the Shop Pump Station and the other rain gauge was installed in the vicinity of the Division Street Pump Station. *Figure 7 – Rain Gauge Comparison* displays rainfall data from the two rain gauges with accumulating sums resetting every twenty-four (24) hours. In general, the two gauges provided relatively consistent data.

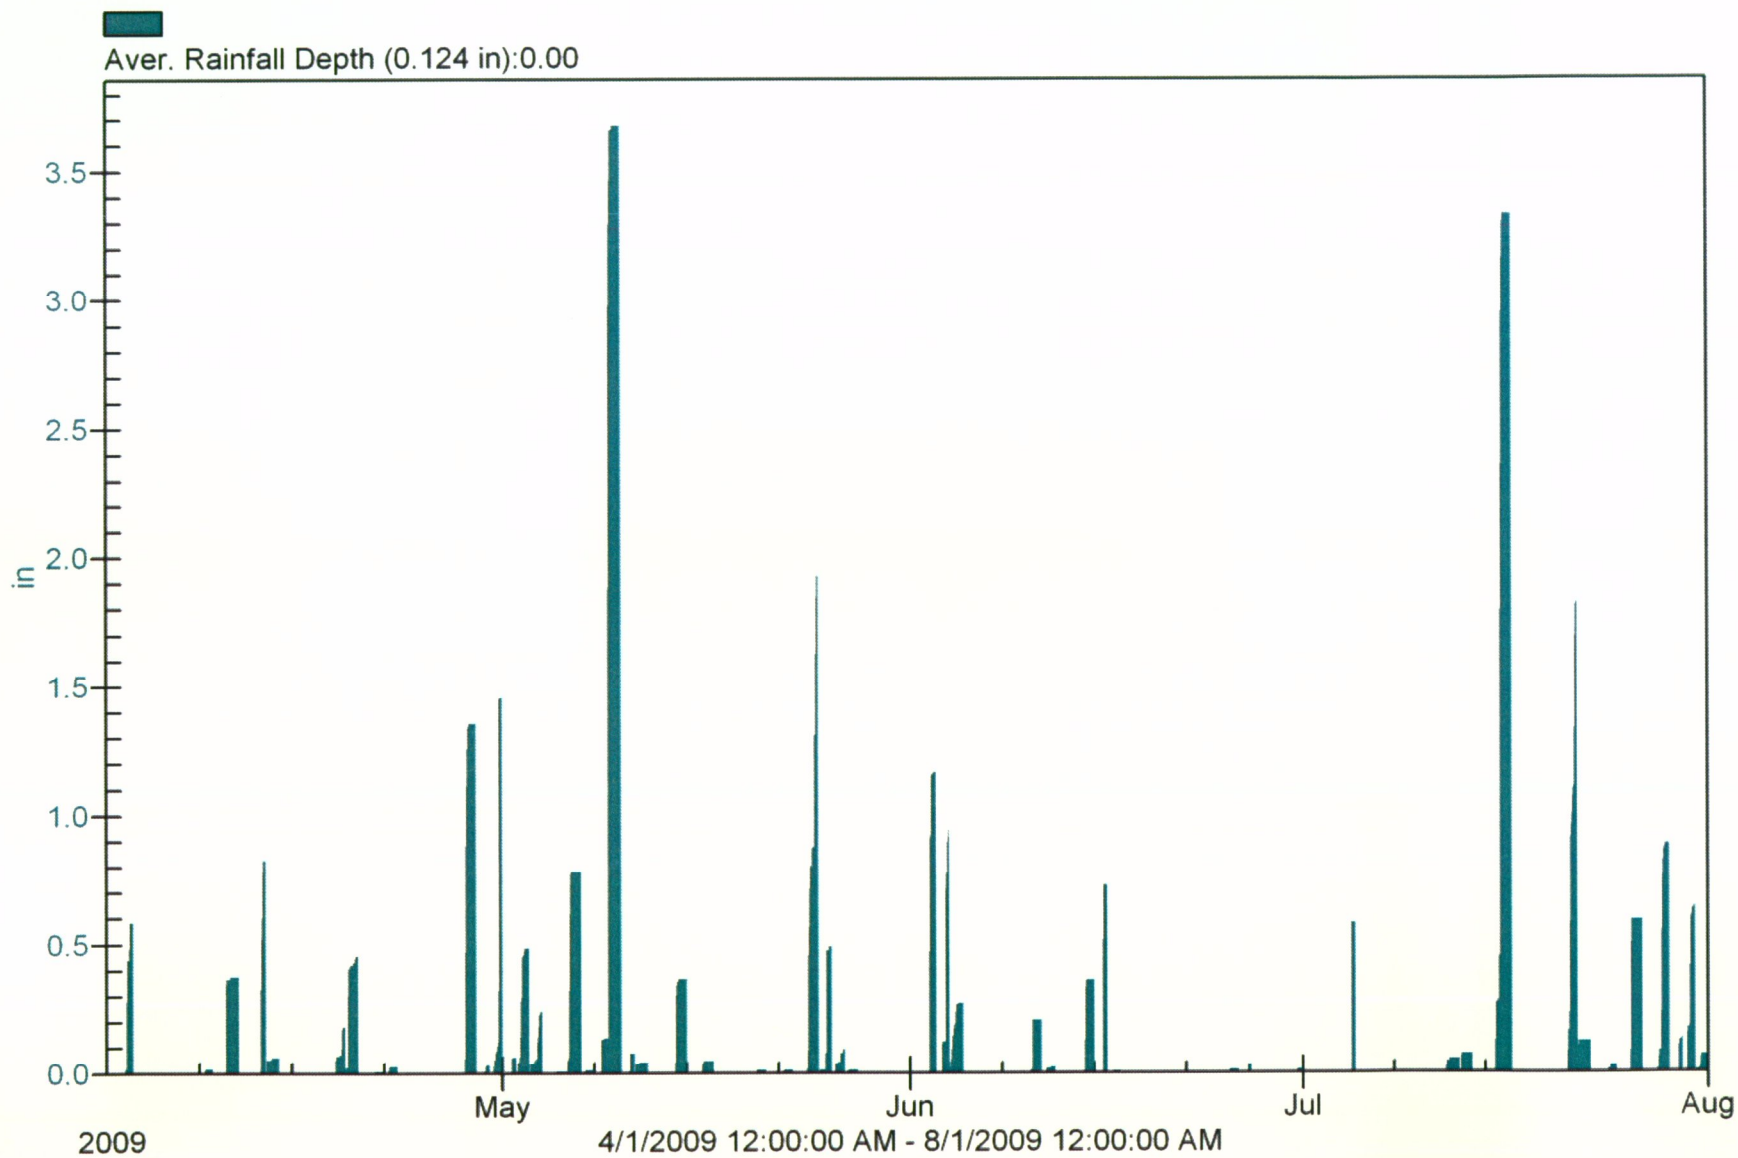
FIGURE 8
AVERAGED RAINFALL DATA

The rainfall data from both rain gauges was combined into a single rainfall data set to be compared with monitored flow characteristics and pump station data. This single rainfall data set was calculated by averaging the rainfall data from the Division Street rain gauge and the Shop rain gauge. The averaged rainfall data set was used for all I/I analysis with the exception of a one month period from June 25th to July 25th. The Shop pump station rain gauge was found to be clogged; Division street rain gauge data was used exclusively for this one month period. *Figure 8 – Averaged Rainfall Data* displays the averaged rainfall data with accumulating sums resetting every twenty-four (24) hours; this data was used for I/I analysis.

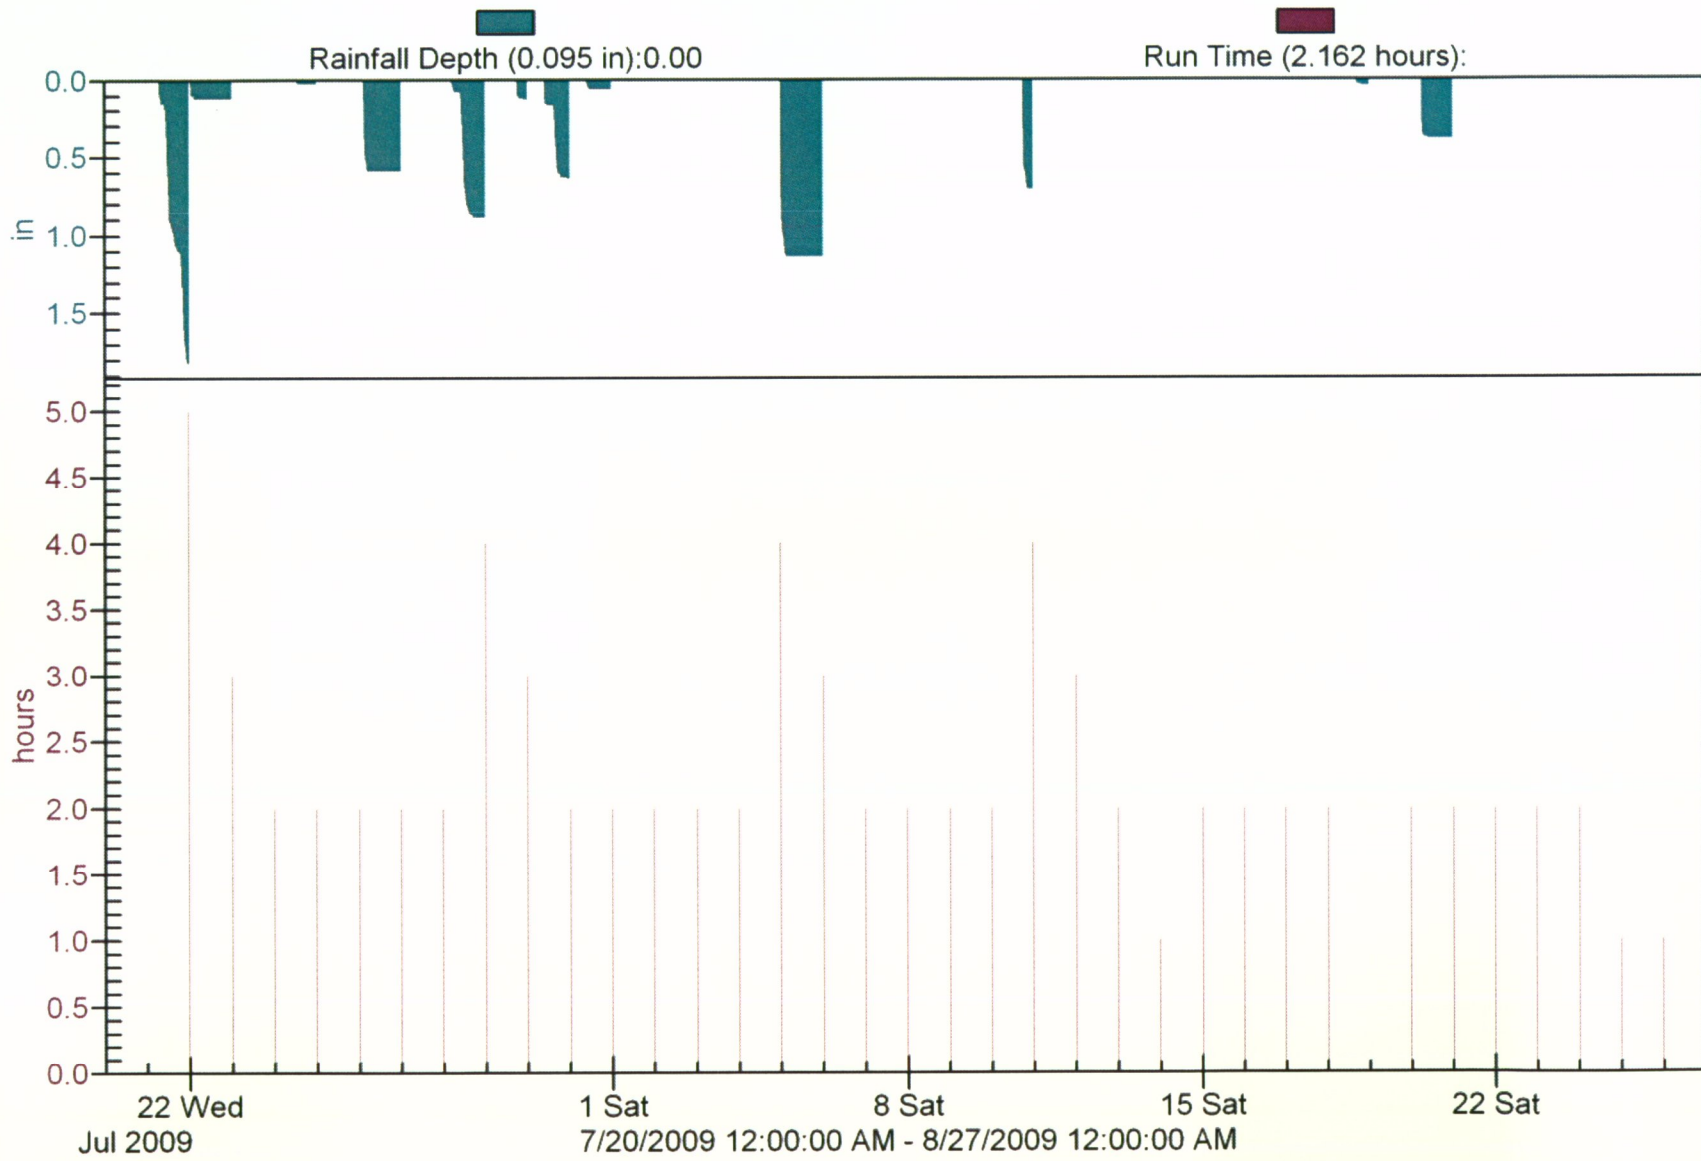
FIGURE 9
21ST STREET PUMP STATION RUN TIME

- See *Figure 9 – 21st Street Pump Station Run Time* for a graph of the run times plotted with rainfall events.
- Notes: flow monitoring data did not indicate excessive I/I, and the pump station run times do not appear excessive for dry weather or wet weather conditions. The pump station appears to have adequate capacity.
- Determination: **ADEQUATE CAPACITY**

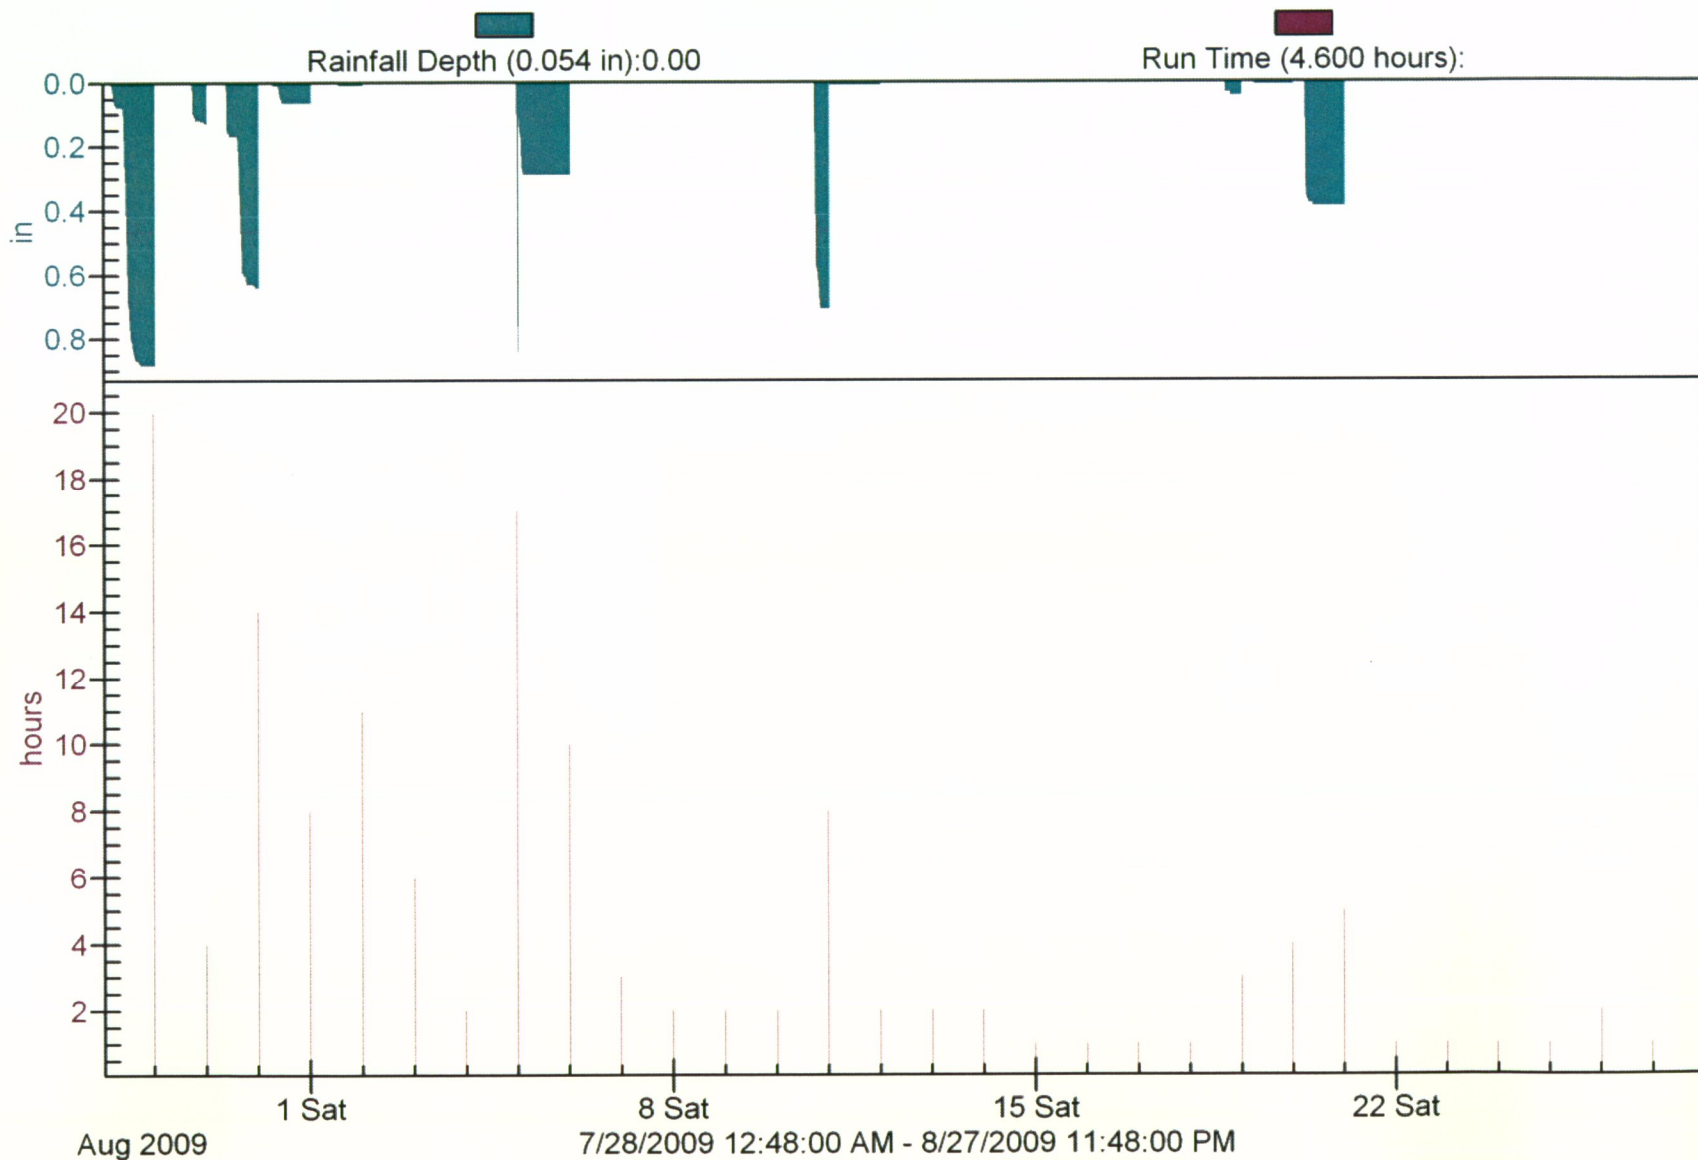
FIGURE 10
705 PUMP STATION RUN TIME

- See *Figure 10 – 705 Pump Station Run Time* for a graph of the run times plotted with rainfall events.
- Notes: It appears that the pump station is used minimally during dry-weather flows, typically less than 2 hours a day. This means there is minimal sanitary flow in the contributing network. During moderate rain events of 0.8" to 1.0", the pump run times increase drastically to 20 hours. This indicates severe I/I throughout the contributing system. The pump station appears to be more than adequate for dry-weather, sanitary flows, but undersized for wet weather flows. It is recommended, that capacity insufficiencies should be addressed by eliminating I/I rather than upsizing the capacity of the pump station. Based on the monitoring sites and run time meters on the Eaker Air Force Base, the Base's collection system appears to be a major source of I/I.

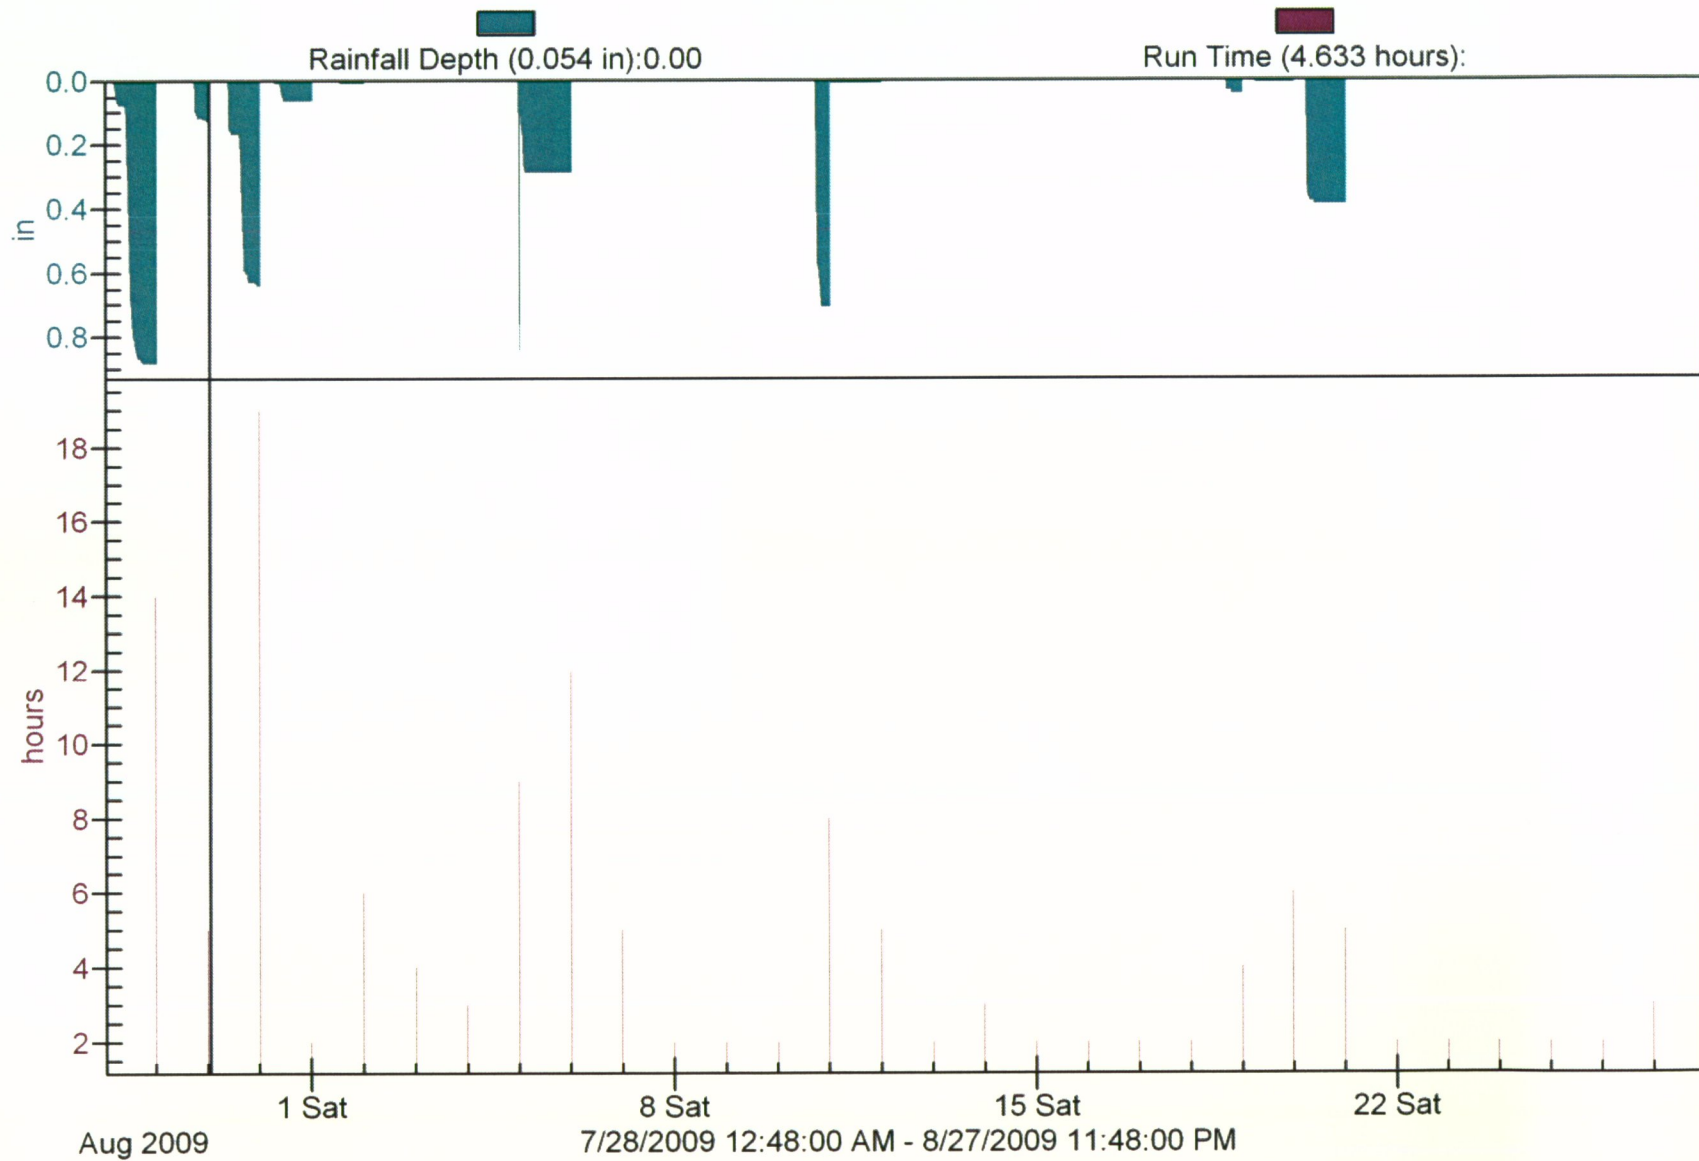
FIGURE 11
820 PUMP STATION RUN TIME

- See *Figure 11 – 820 Pump Station Run Time* for a graph of the run times plotted with rainfall events.
- Notes: It appears that the pump station is used minimally during dry-weather flows, typically less than 2 hours a day. This means there is minimal sanitary flow in the contributing network. During moderate rain events of 0.8" to 1.0", the pump run times increase drastically to 19 hours. This indicates severe I/I throughout the contributing system. The pump station appears to be more than adequate for dry-weather, sanitary flows, but undersized for wet weather flows. It is recommended,

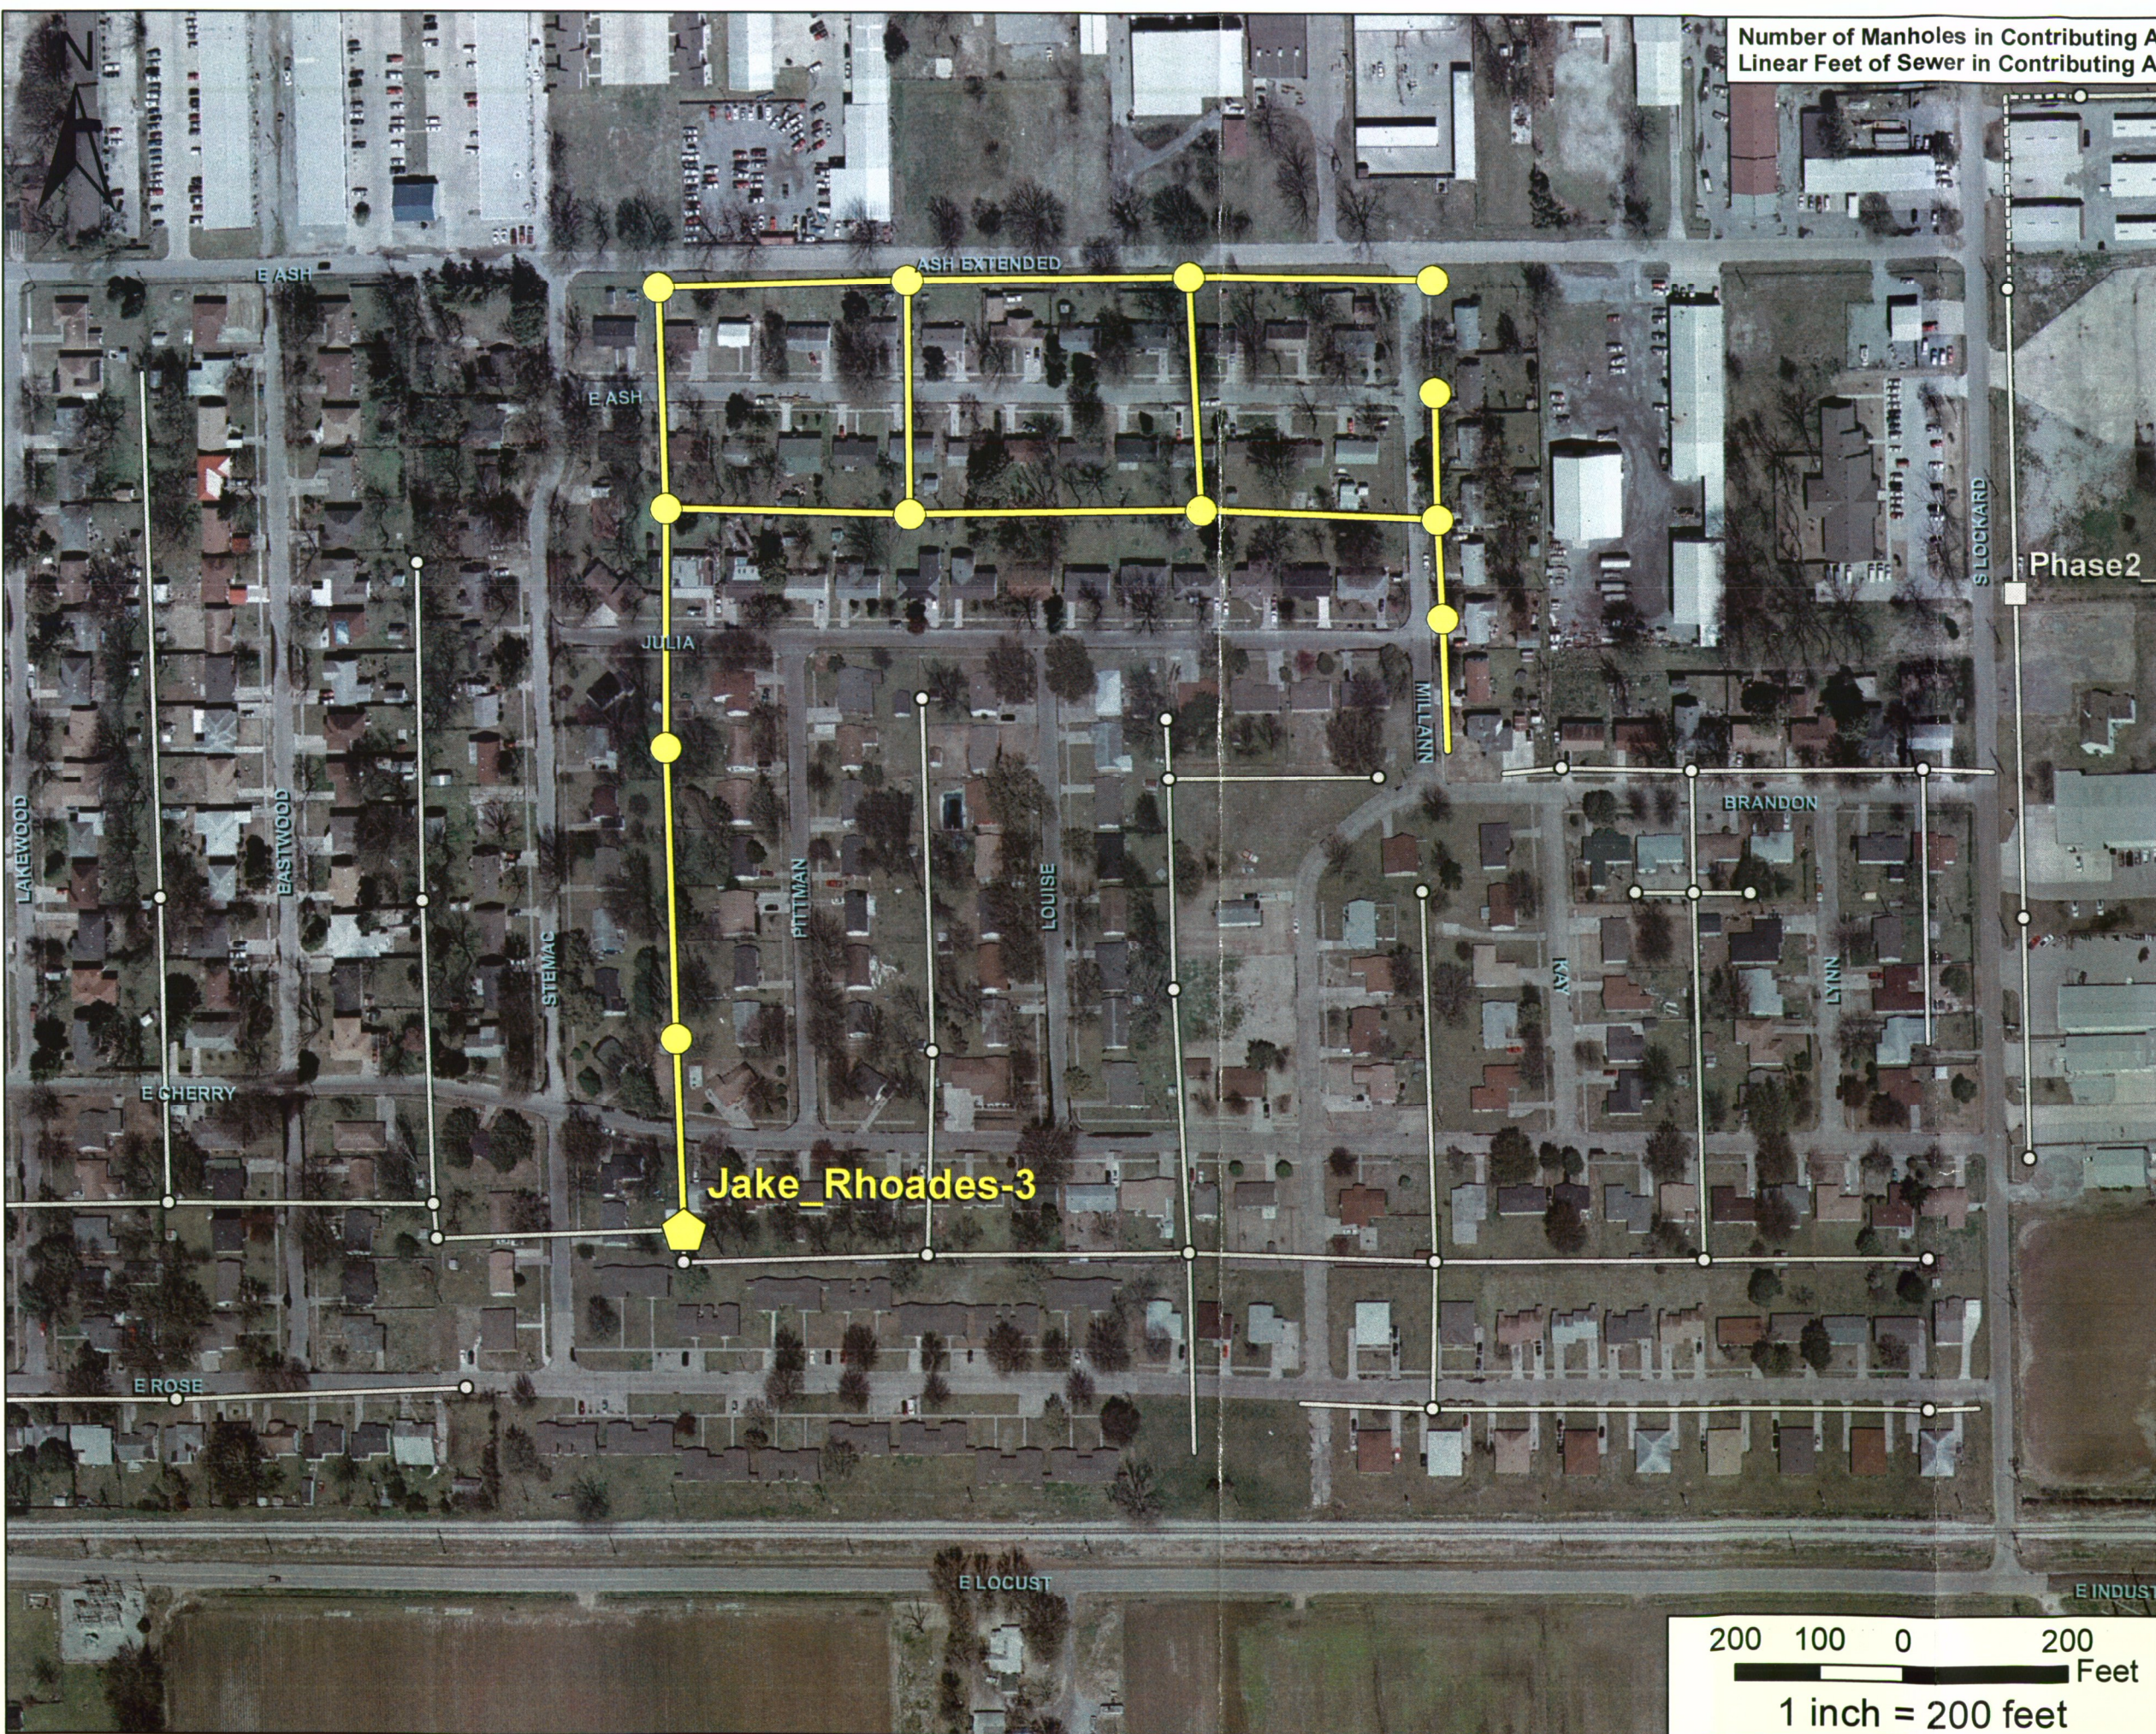
Number of Manholes in Contributing Area: 13
 Linear Feet of Sewer in Contributing Area: 4001 LF

- See *Figure 63 – Jake Rhoades-3 Monitoring Location and Contributing Area* for the location of the monitoring site and contributing area.
- Number of Manholes in Contributing Area: 13
- Linear Feet of Sewer in Contributing Area: 4001 LF
- Notes: Dry-weather flow depths reached 87% of the pipe's diameter, but there does not appear to be significant I/I in upstream area.
- Determination: **INADEQUATE CAPACITY**

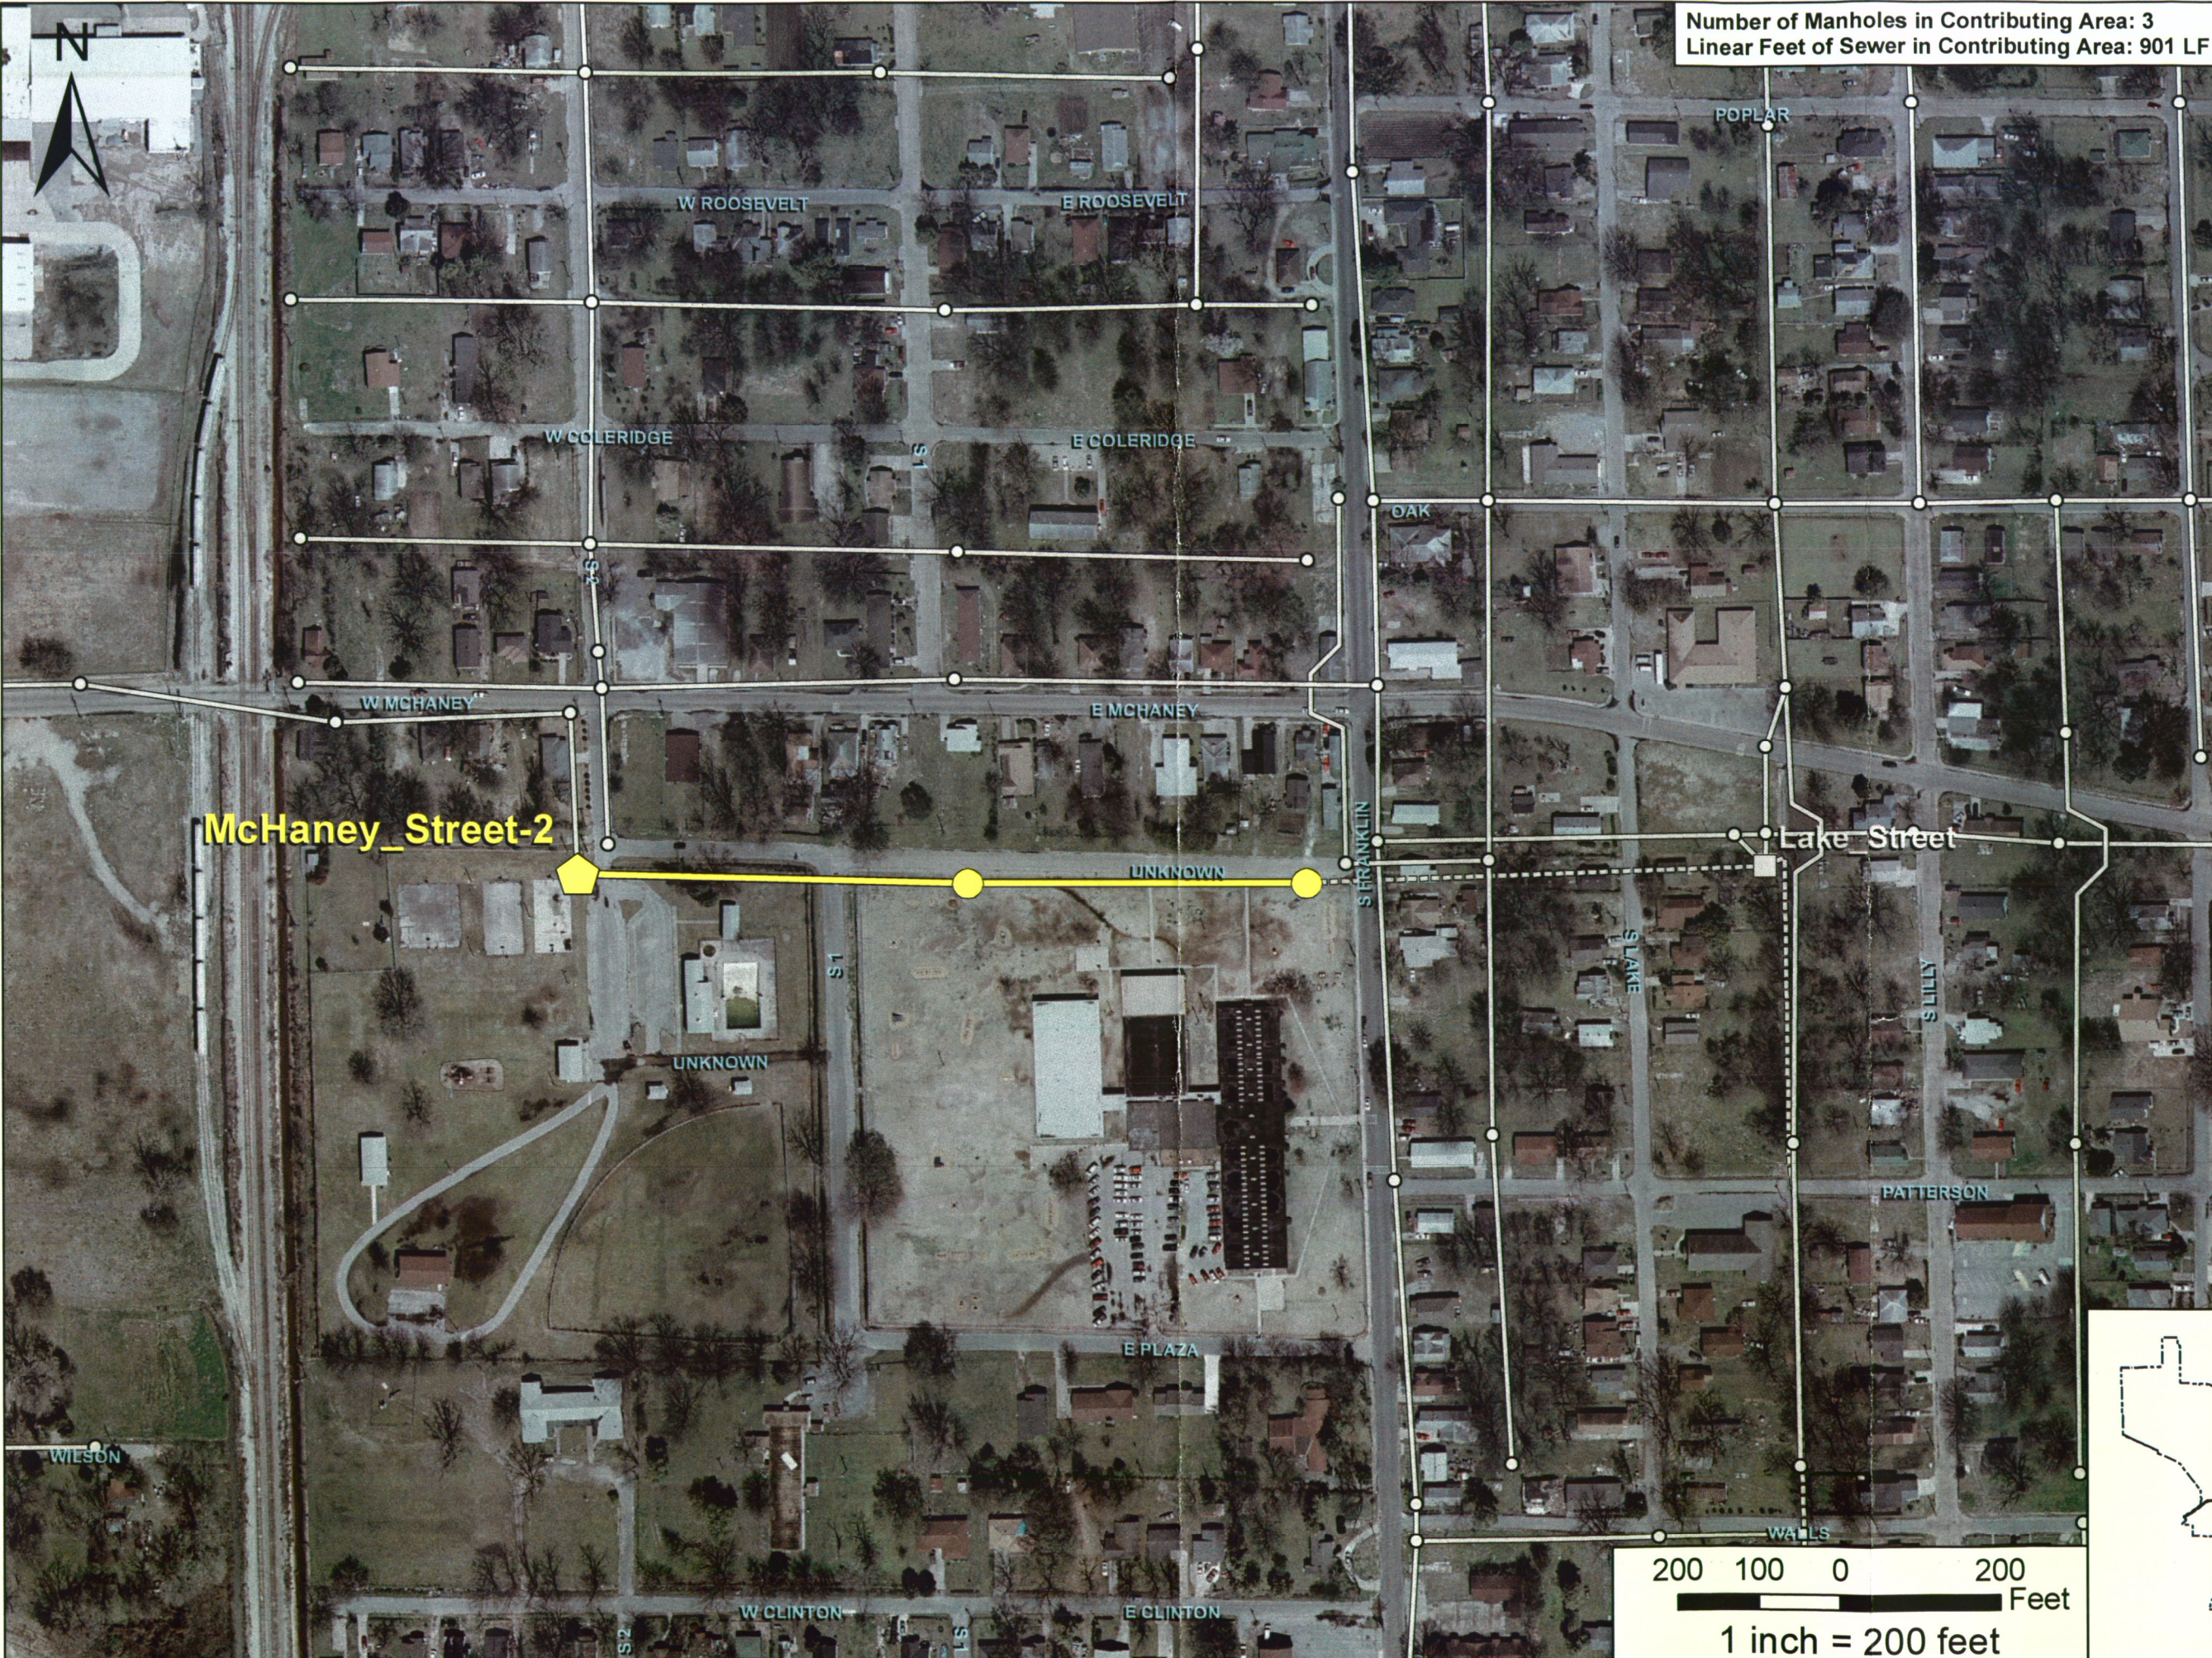
Figure 69

- See *Figure 69 – Ruddle-1 Monitoring Location and Contributing Area* for the location of the monitoring site and contributing area.
- Number of Manholes in Contributing Area: 23
- Linear Feet of Sewer in Contributing Area: 6535 LF
- Notes: Monitored pipe was found to have adequate dry-weather capacity, but excessive I/I. Majority of upstream, contributing area will probably require flushing, CCTV, and rehabilitation. Note that several SSO's were reported in this contributing area.
- Determination: **INADEQUATE CAPACITY**
