Subject: City of Helena WWTP and Collection Sysrtem Inspections, NPDES Permit AR0043889 **Attachments:** AR0043389_Helena Collection System Inspection March 2 2022.pdf; AR0043389_Helena

RE: Helena WWTP Inspections (Phillips Co)

OFFICE OF WATER QUALITY INSPECTION REPORT

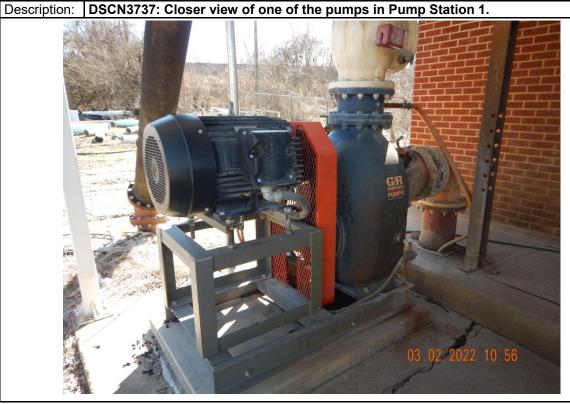
- Pump Station 1 only had a single seventy-five horsepower pump that was operational at the time of the
 inspection. The control box for Pump 1 had failed, was removed from the wall, and was on the pump
 station floor at the time of the inspection. Failure to replace the control box is in violation of Part III,
 Section B.1.A of the permit.

City of Helena Photographer: Jason Bolenbaugh Witness: Description: DSCN3741: Pump station control panel and boxes (one missing). The control box (black box) for Pump 1 has been removed from the wall.

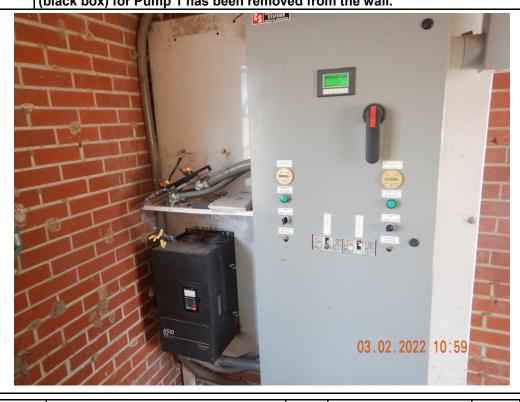
Photographer:	Jason Bolenbaugh	Date:	3/2/2022	Time:	1055
Witness:				Photo #	±: 4

Description: DSCN3736: Pump 1 control box on the floor of the pump station.

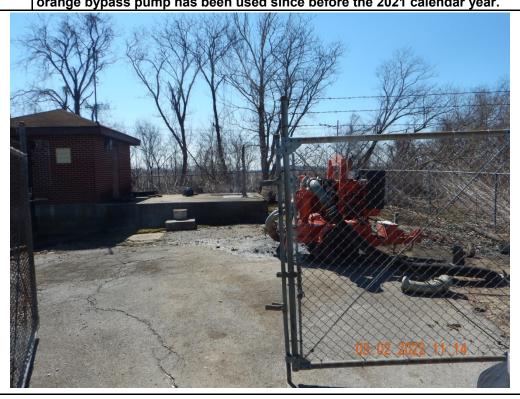
Photographer: Jason Bolenbaugh	Date: 3/2/2022	Time:	1114
Witness:		Photo #:	8

- The bypass pumps require operations staff to fill with diesel fuel twice per day so the pumps will continue to run over a 24-hour period. On average it requires 180 gallons of diesel fuel per day to operate a single 8-inch bypass pump. The permittee currently operates 4 bypass pumps in the City of Helena and one bypass pump in the City of West Helena. Those bypass pumps range in size from 4-inch to 10-inch.

Description: DSCN3744: Bypass pump used to pump wastewater from Pump Station 5 to the treatment plant.

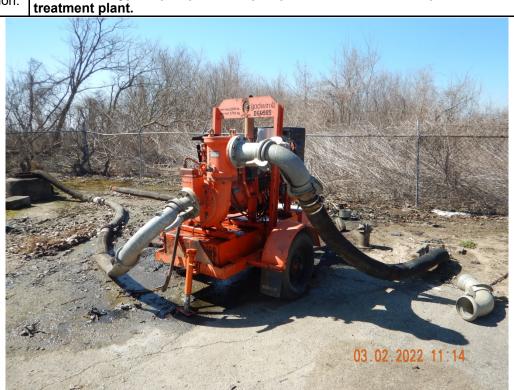
Office of Water Quality Photographic Evidence Sheet						
Location: C	ity	of Helena				
Photographe	er:	Jason Bolenbaugh	Date:	3/2/2022	Time:	1118
Witness:					Photo #:	9

Description: DSCN3746: Visual alarm not in operation.

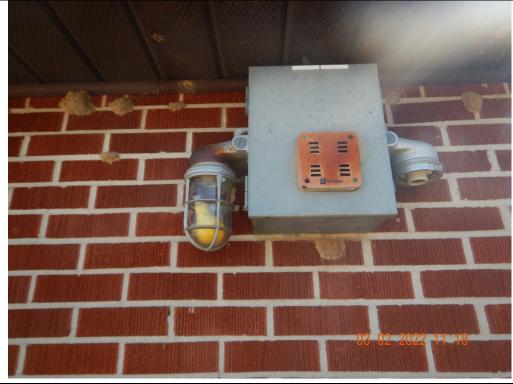
Photographe	r: Jason Bolenbaugh	Date:	3/2/2022	Time:	1138
Witness:				Photo #	: 10

Description: DSCN3748: View of Pump Station 3.

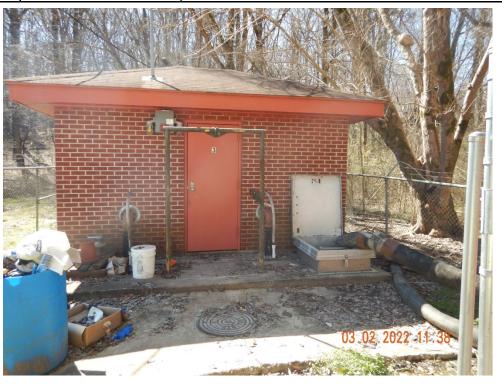
Office of Water Quality Photographic Evidence Sheet					
Location: City	of Helena				
Photographer:	Jason Bolenbaugh	Date:	3/2/2022	Time:	1138
Witness:				Photo #:	11

- According to Mr. Patterson, Pump Stations 3, 4, 5, and 6 all have bypass pumps installed at them
 because none of the two pumps located at each pump station are operational. The bypass pumps have
 been in place and used as the primary pumping mechanism for these pump stations for 1-2 years. The
 permittees failure to properly operate and maintain the pump stations is in violation of Part III, Section
 B.1.A of the permit.

Description: DSCN3749: View of the bypass pump at Pump Station 3.

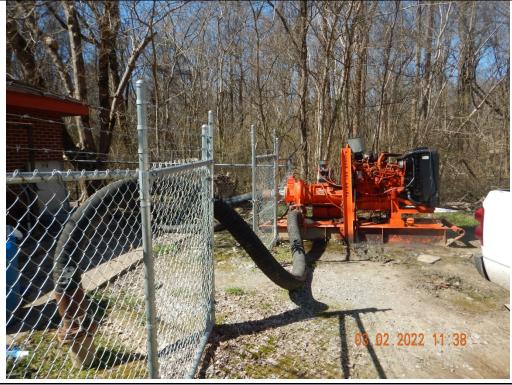
Photographer:	Jason Bolenbaugh	Date:	3/2/2022	Time:	1144
Witness:				Photo #:	: 12

Description: DSCN3750: Wastewater being pumped from the wet well (background) over to the pipe (foreground) sending wastewater to Pump Station 5.
