BOTO-AR Properties, LLC

CAO LIS 17-20 Quarterly Progress Report #3 – Due December 15, 2017

Emerald Mountain 6:

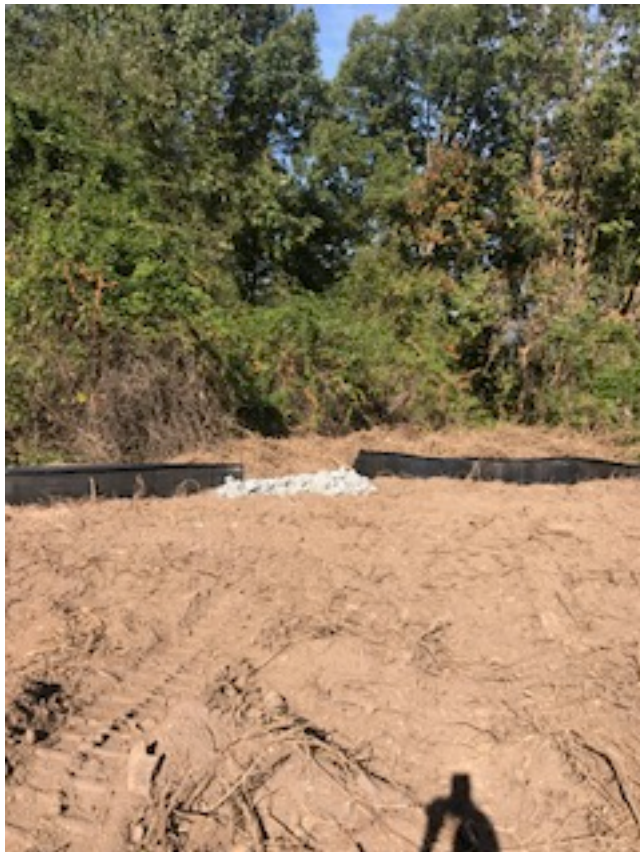
Picture of Silt Fence and Rock Check behind lot 29, Emerald Mountain 6 taken 10-1-2017:

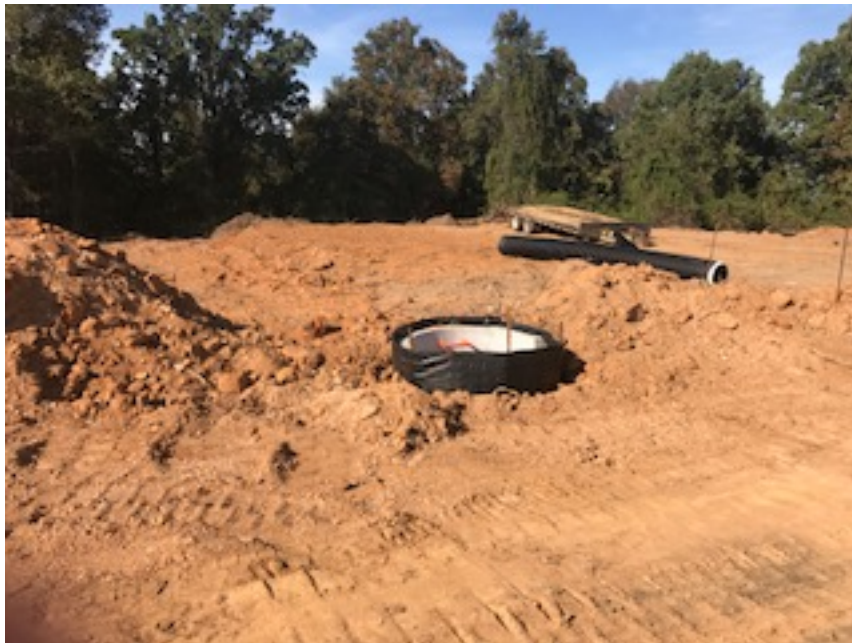
Picture Date was 10-17-2017.

Storm Water Catch Basin was under construction as of October 17th. Note it is protected by silt fence to prevent silt from entering the storm drain.

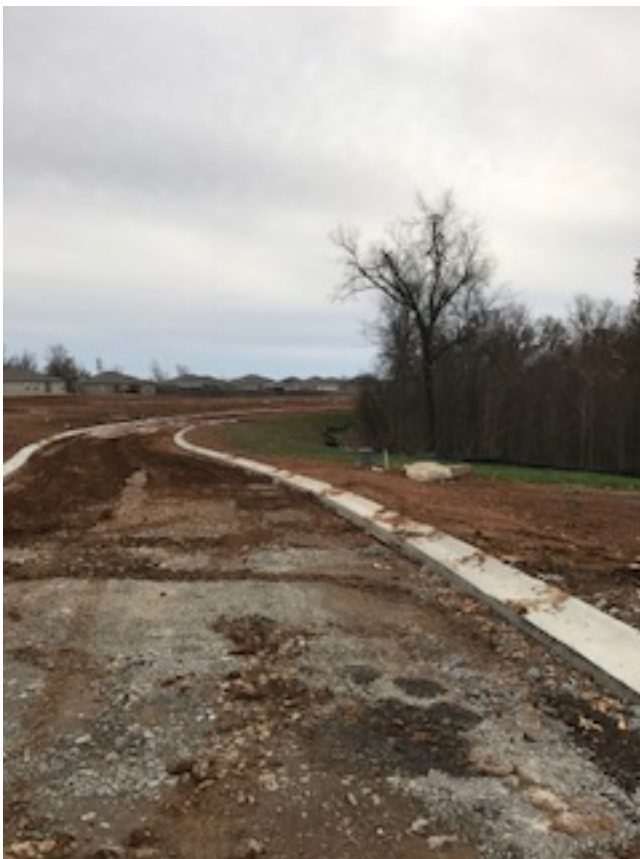
Curbs were installed the week of 12-1-17 all potential runoff from the road bed is being contained within the curbs. Storm drains are currently closed to prevent water from entering. You can see on the down slope that the entire perimeter has been protected by Silt Fence as well as a buffer of fresh grass. The storm water plan calls for the disbursement and release of runoff that is captured in the storm drain system onto highly vegetated areas.

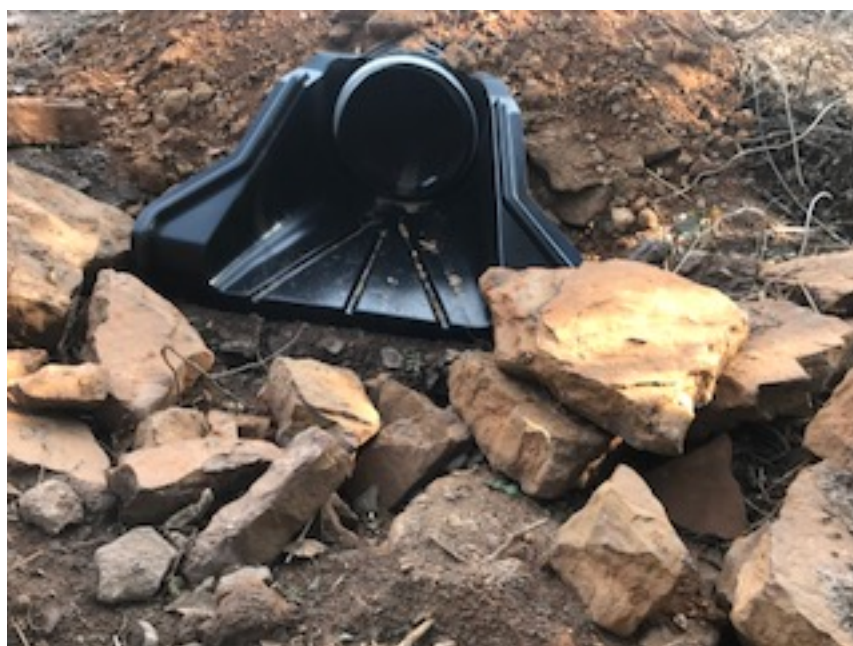
Storm drain outflow is temporarily protected with native rocks to disburse the water and prevent erosion as it enters the vegetated drainage basin.
