FROM: Arkansas Farm Bureau Federation
Mr. Evan A. Teague, P.E.

RE: Comments on permit 5264-W

Previous Studies of Hog Farms in the Buffalo River Watershed

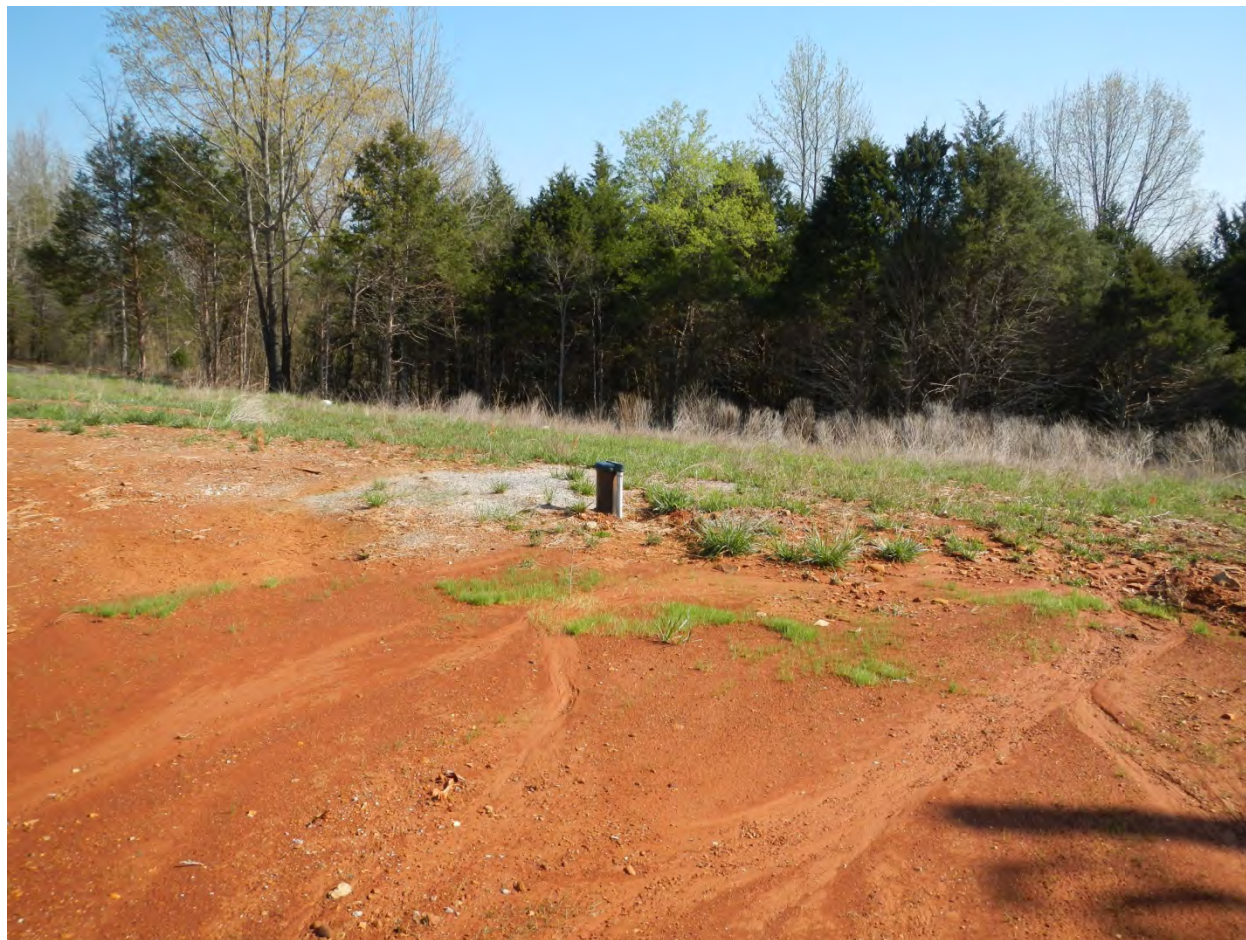
Photo No. 1

The facility uses water from an on-site well (Photo 1, 320 feet total depth, depth to water 280 feet below ground level. A septic system is utilized to handle sanitary waste generated at the site (Photo 2).

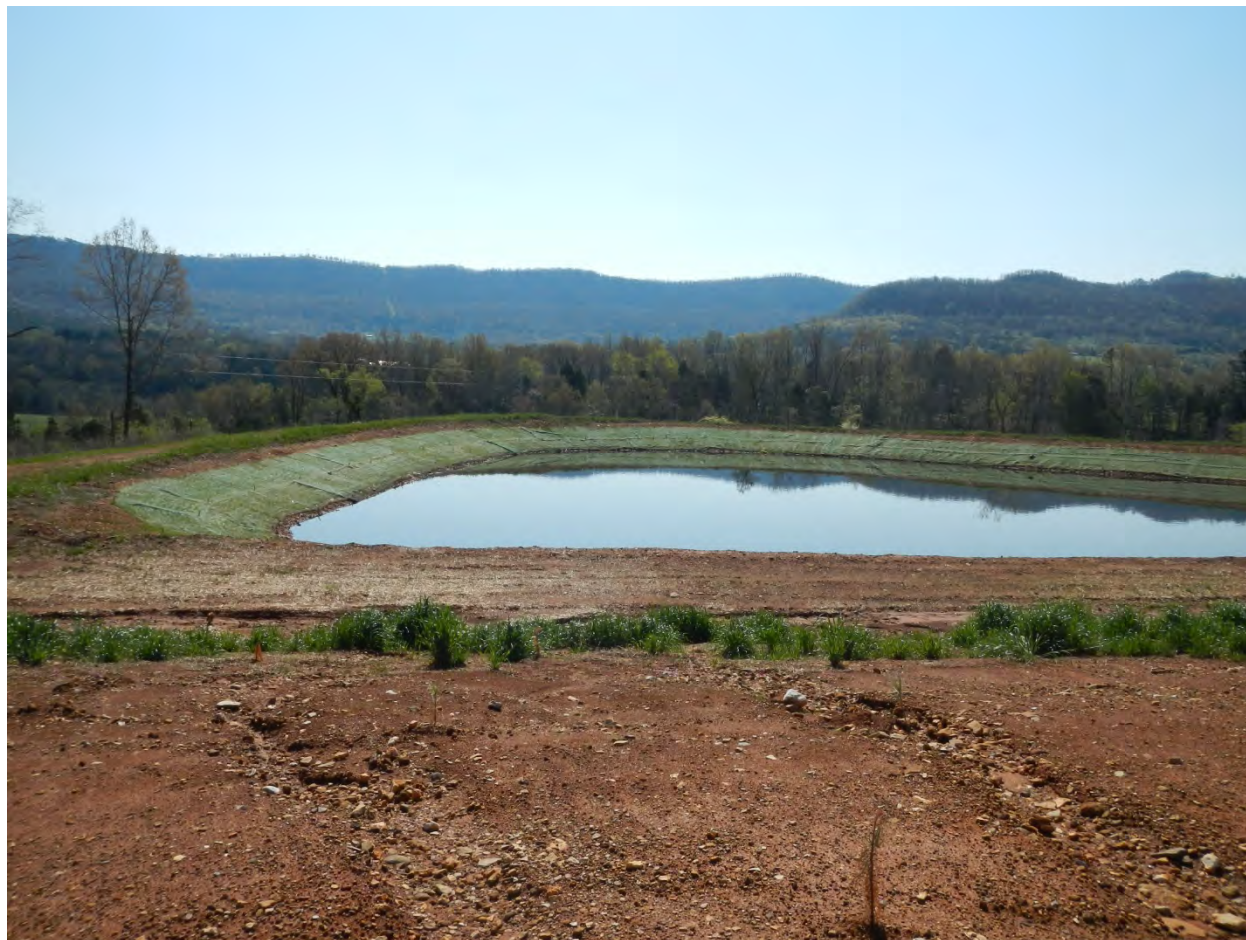
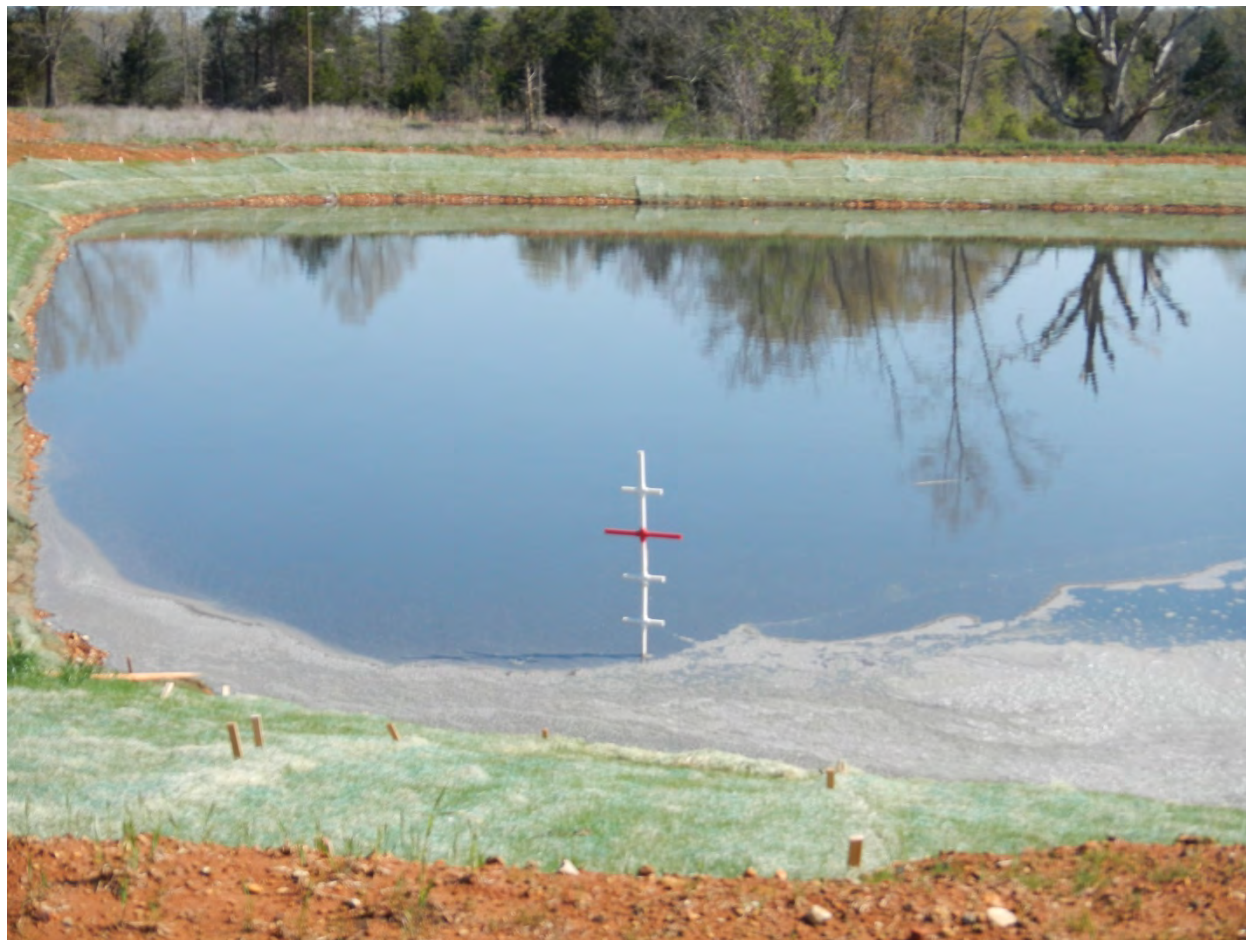
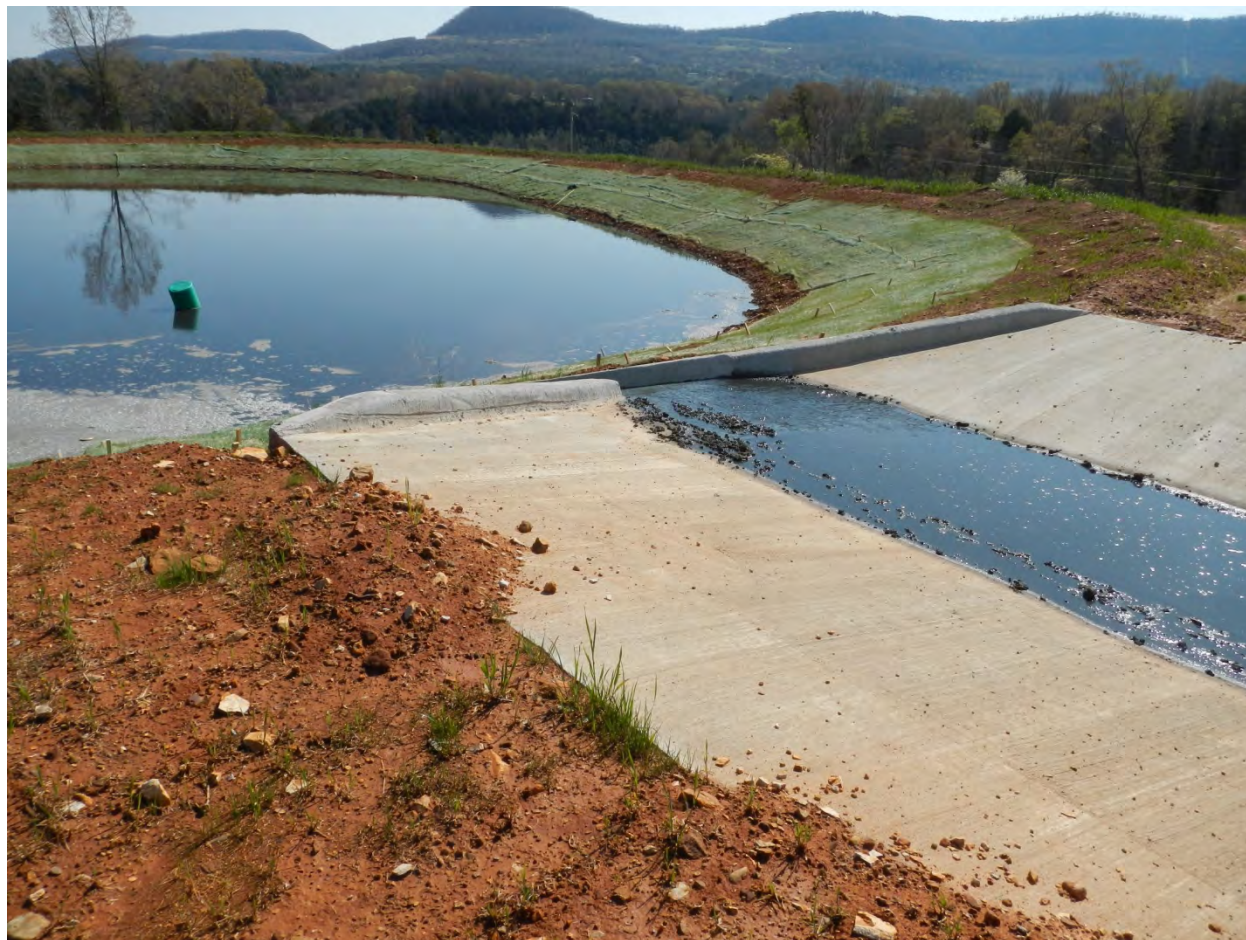
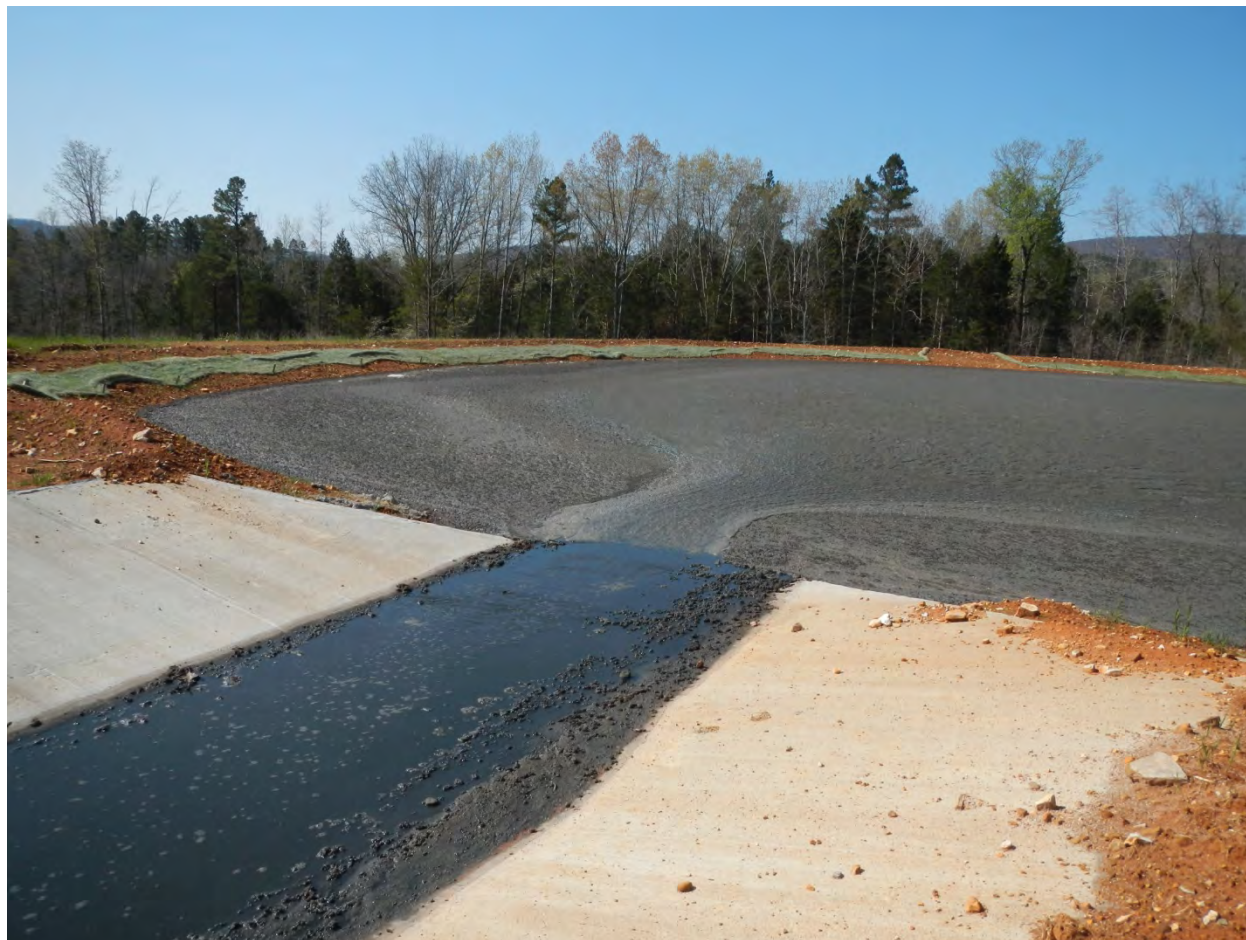
freeboard to contain a 25 year 24 hour storm event as indicated by the staff gauge in place (Photos 3 – 6). Mortalities at the facility are disposed of using two diesel fired incinerators which appeared to be in good operating condition, ashes are then buried on site (Photos 7 – 8).

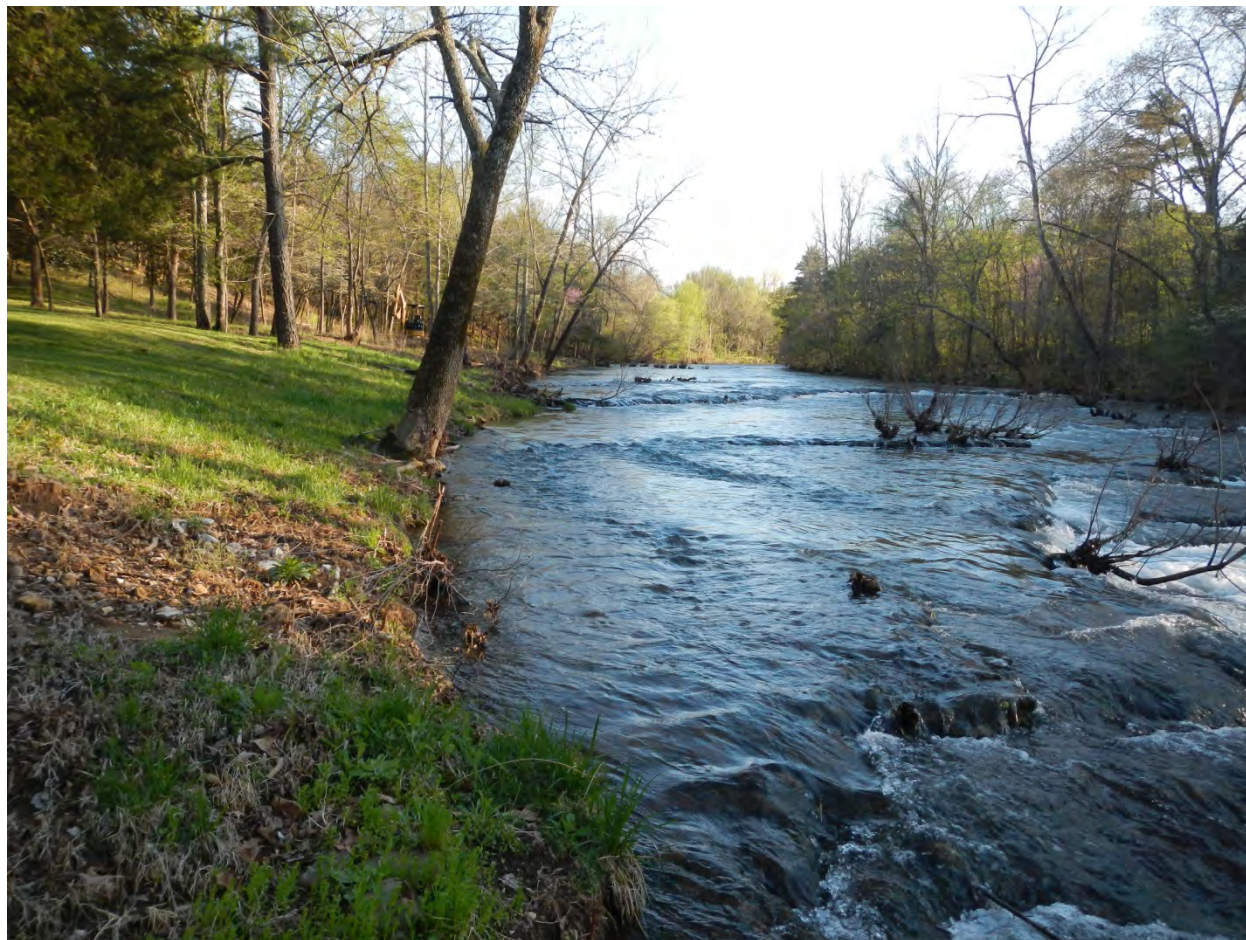
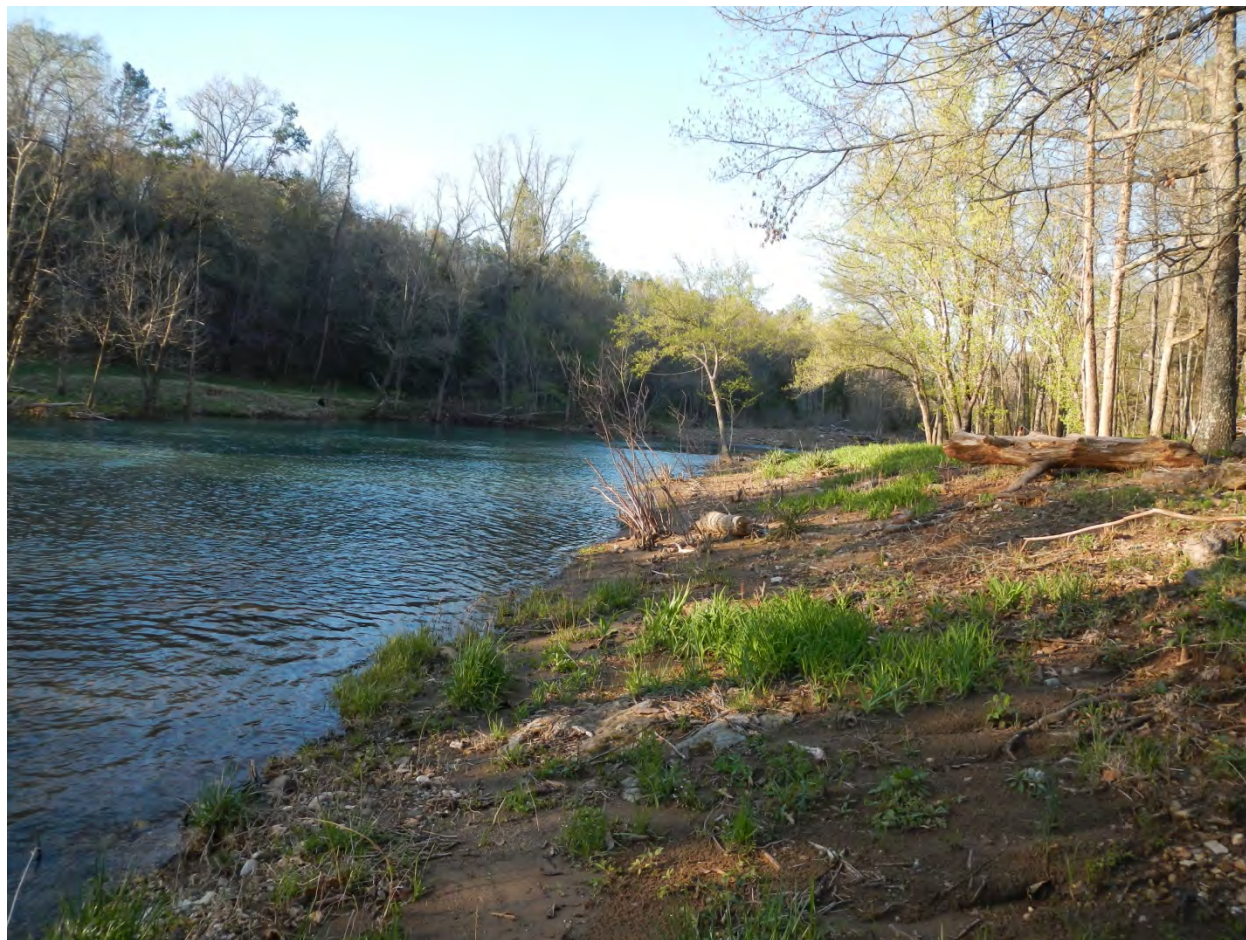
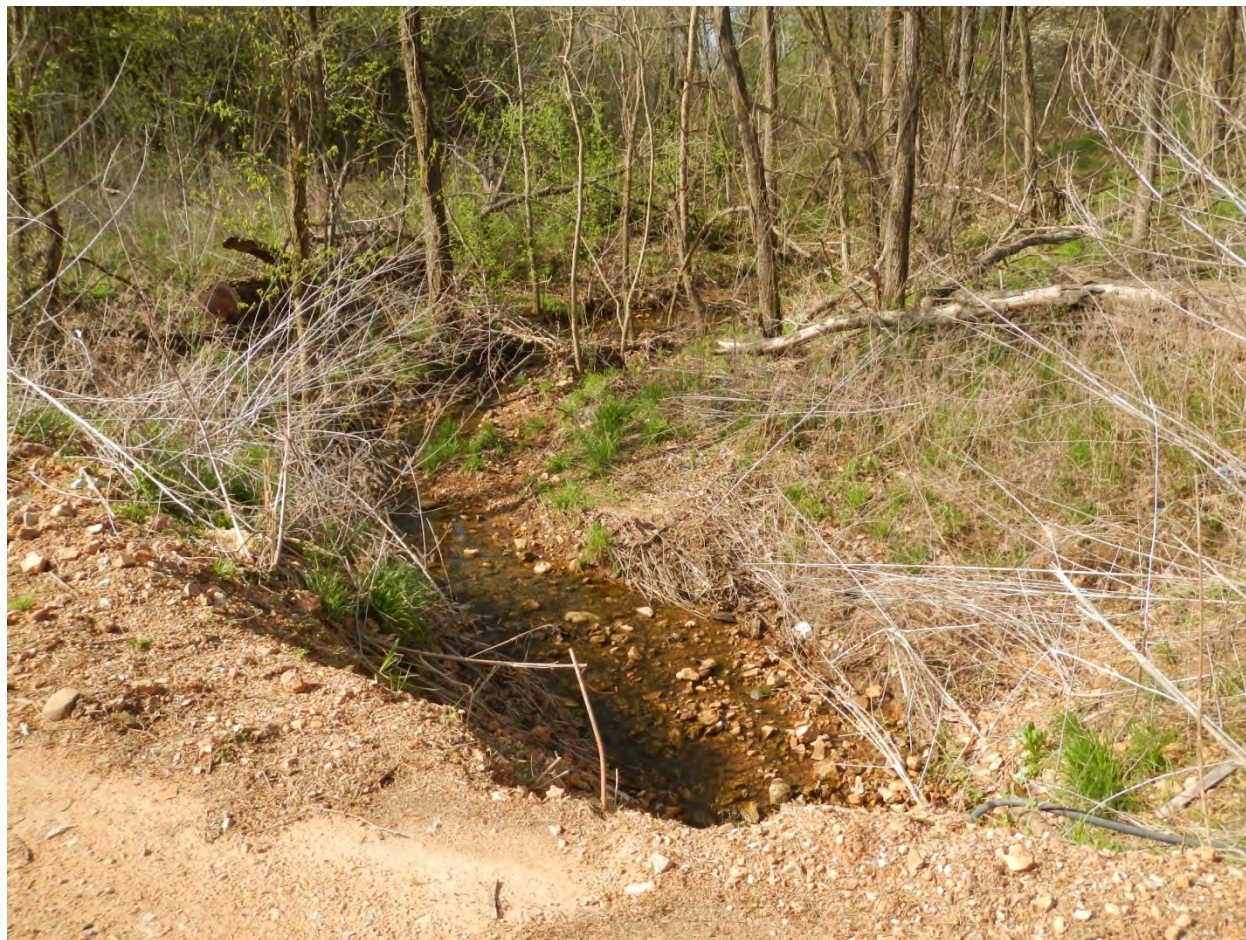
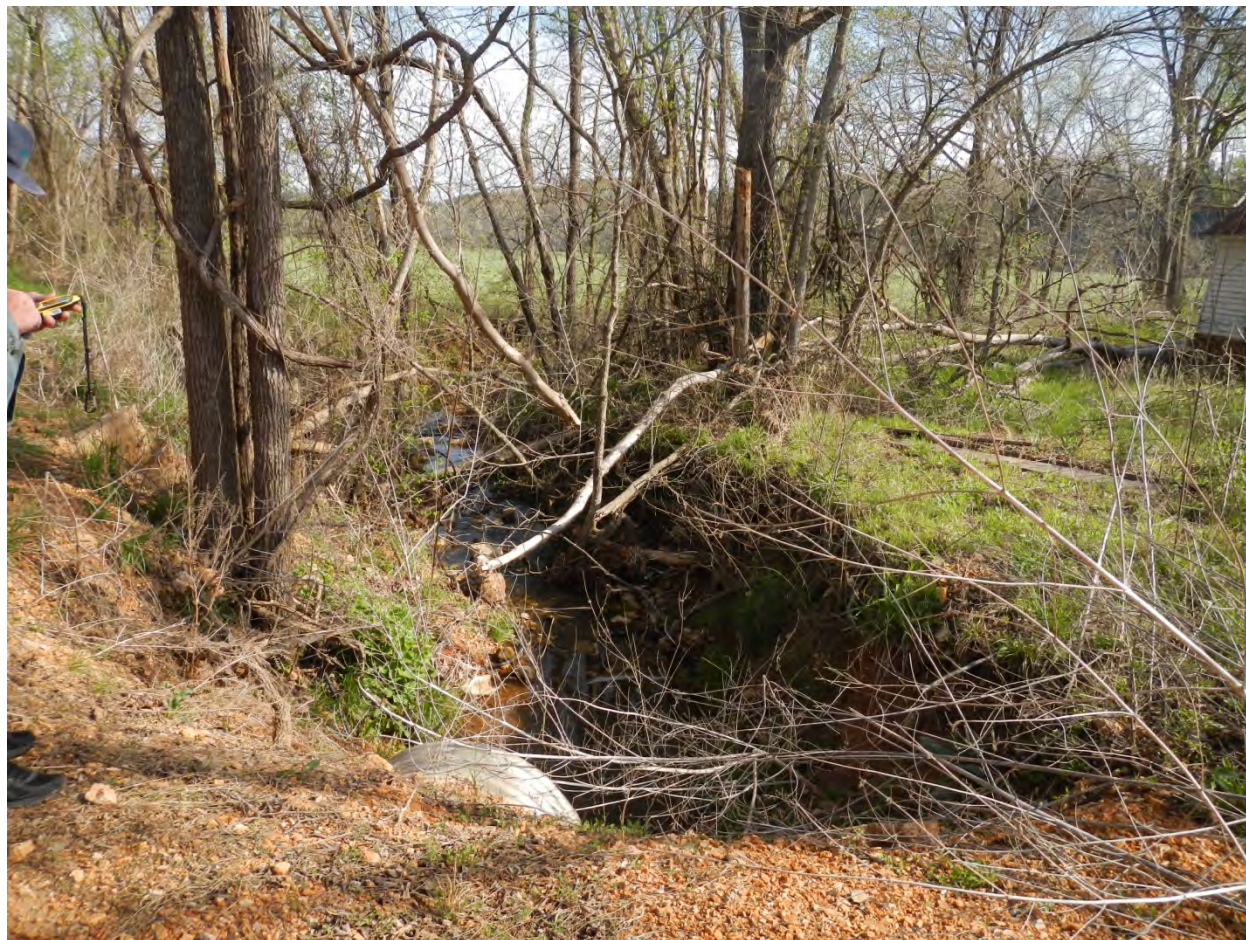
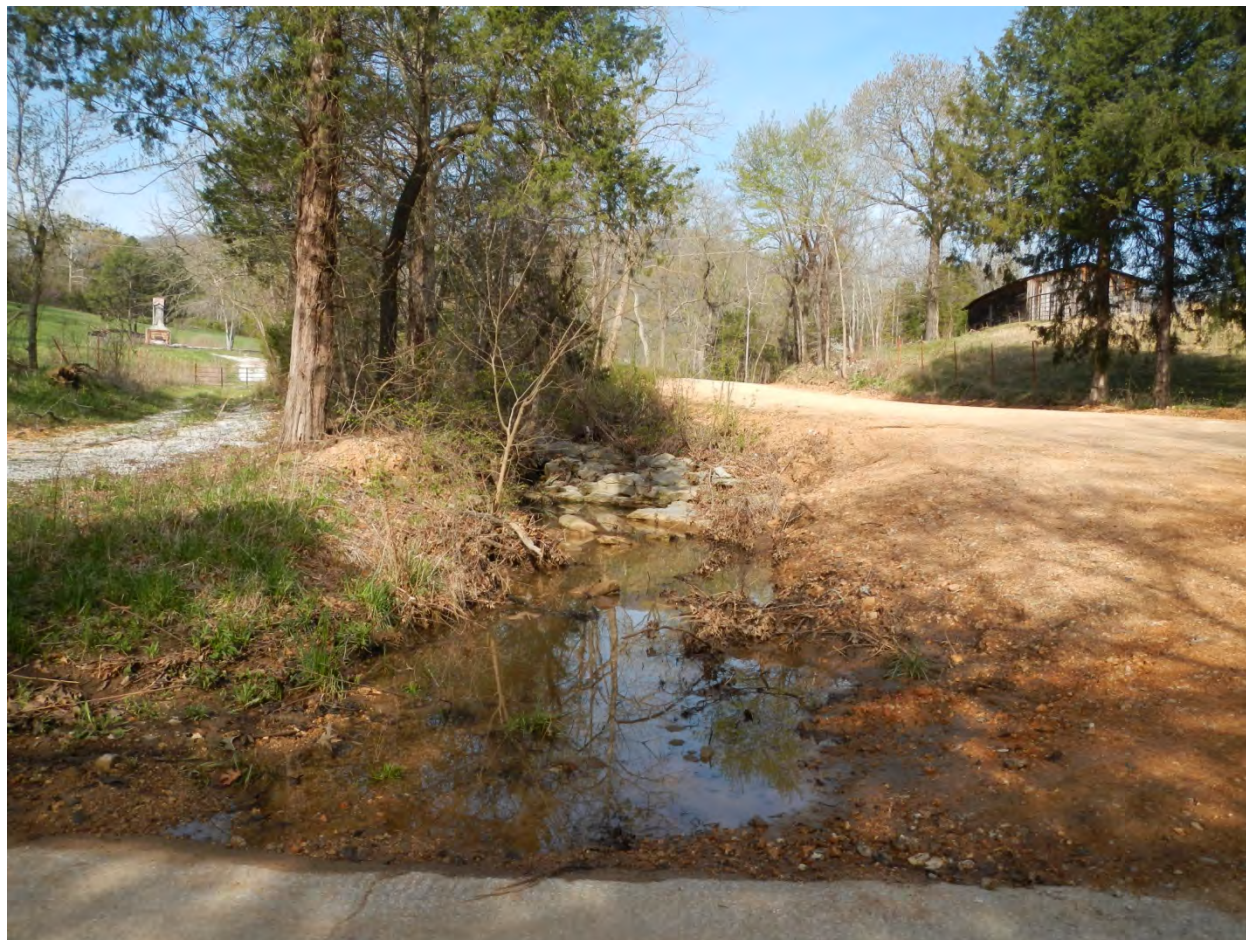
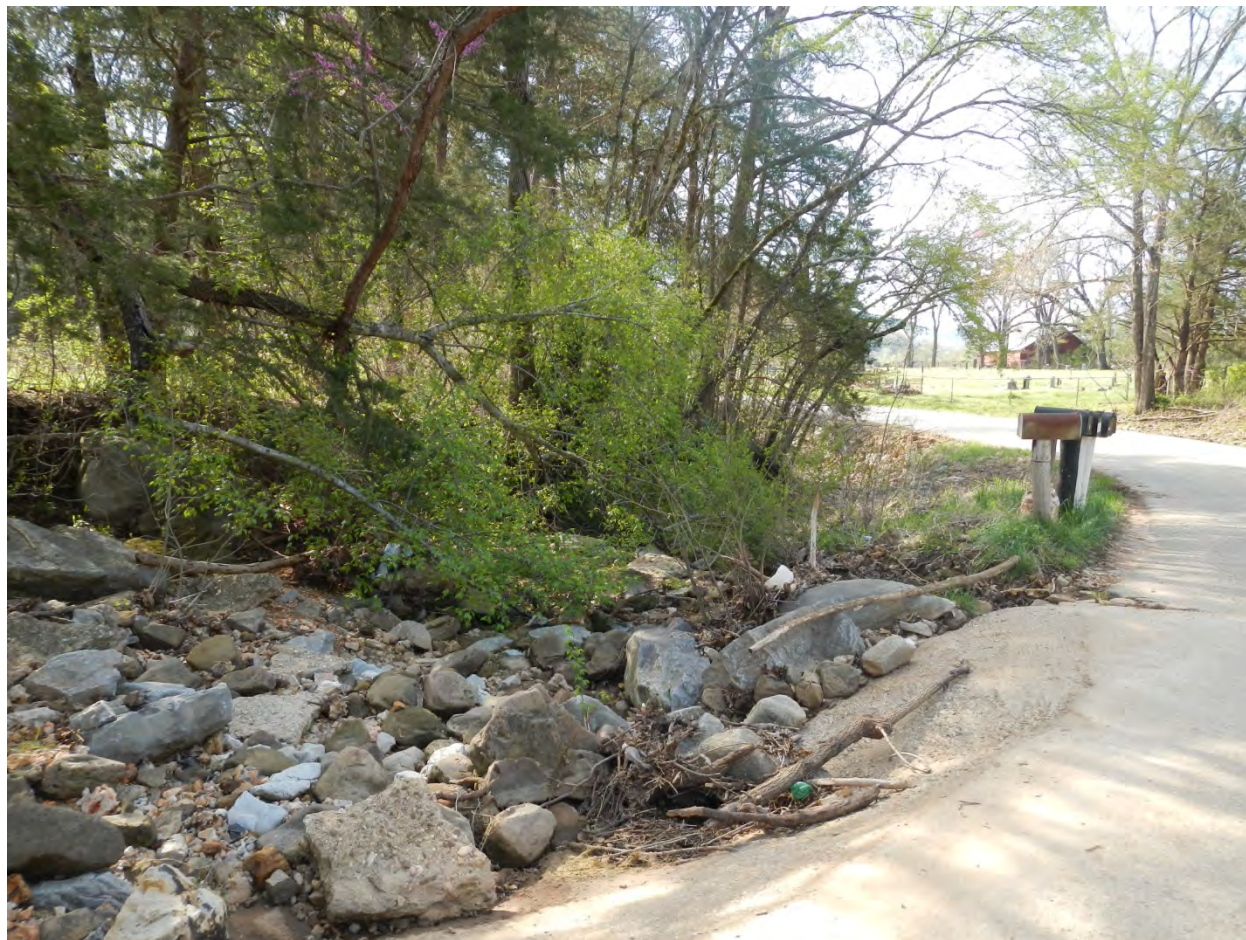
Water samples (Photos 9 – 33) were collected from various streams up-gradient and down-gradient of the facility. Samples were analyzed for E. coli, 5-day BOD (Environmental Services Company, Inc., Springdale, AR), cations, anions, EC, NH₄-N, ICAP-P and other analytes (Oklahoma State University Soil, Water & Forage Analytical Laboratory). The facility had 1.1 inches of rain on April 13 and as a result most of the small streams did have flowing water at the time of the inspection. Results and a map of the sample locations can be found in Appendix 2.

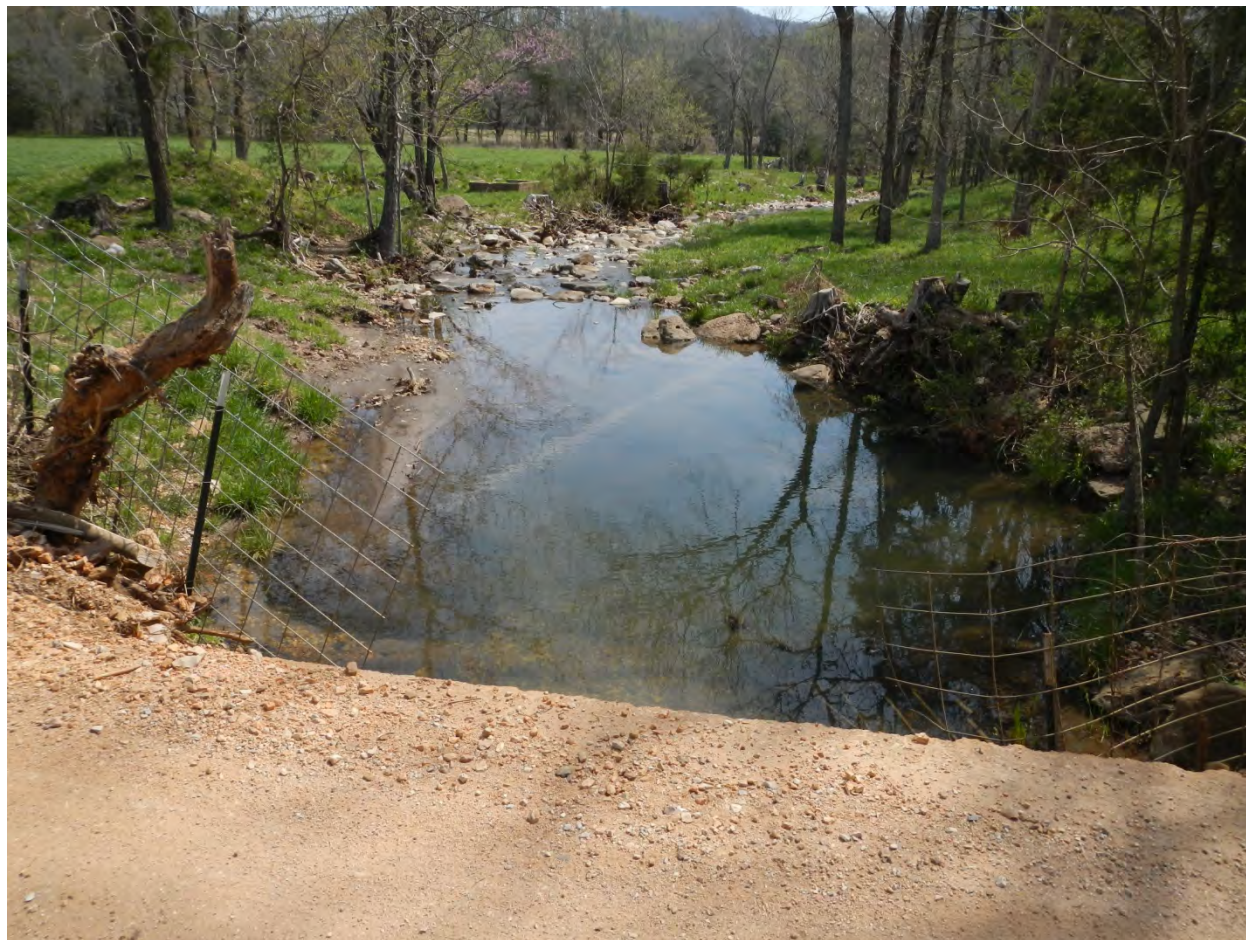
Photo No. 34

The farm has planted approximately 1,000 loblolly pine trees around the perimeter of the facility. While these trees are currently only 12” – 14” tall they may, in the future, provide a measure of odor control (Photo 34).
