ARKANSAS
Department of Environmental Quality

INTEROFFICE MEMORANDUM

RE: Site visit at Cooper Tire, Permit No. AR0038822

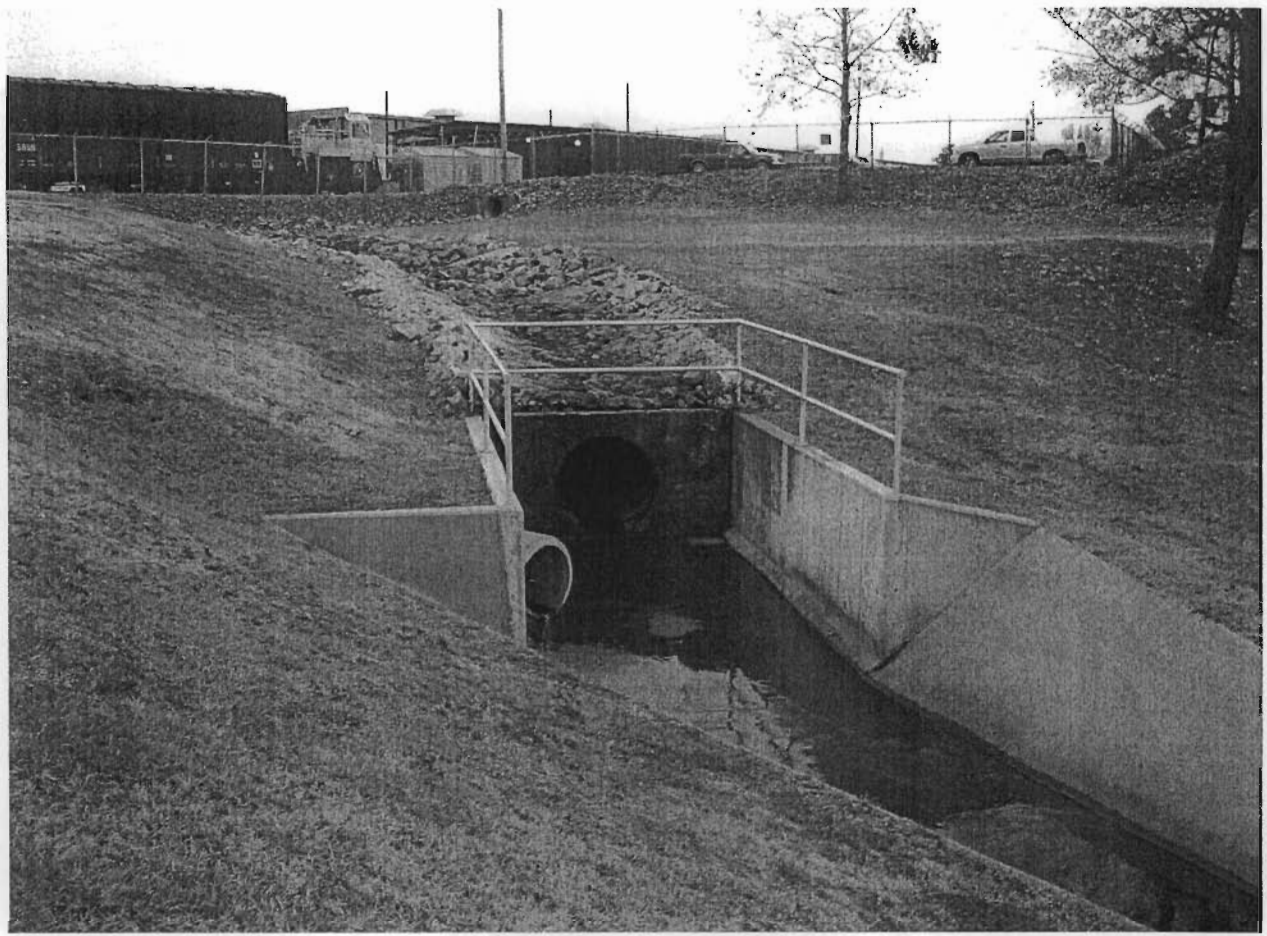
This is the junction upstream of outfall 001 which leads to a trapezoidal concrete open channel.

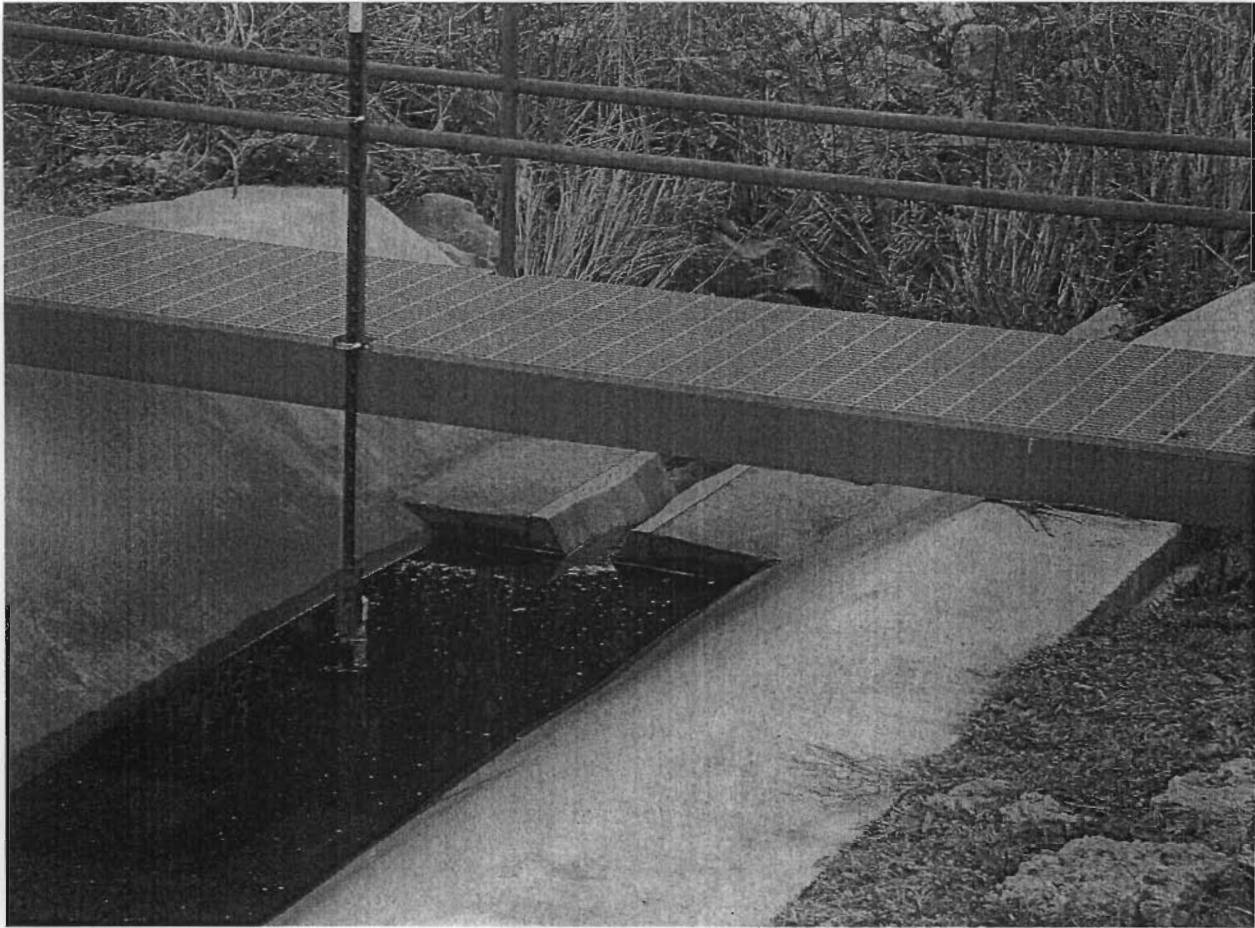
This shows the 60° v-notch weir which is at the end of the trapezoidal open channel.

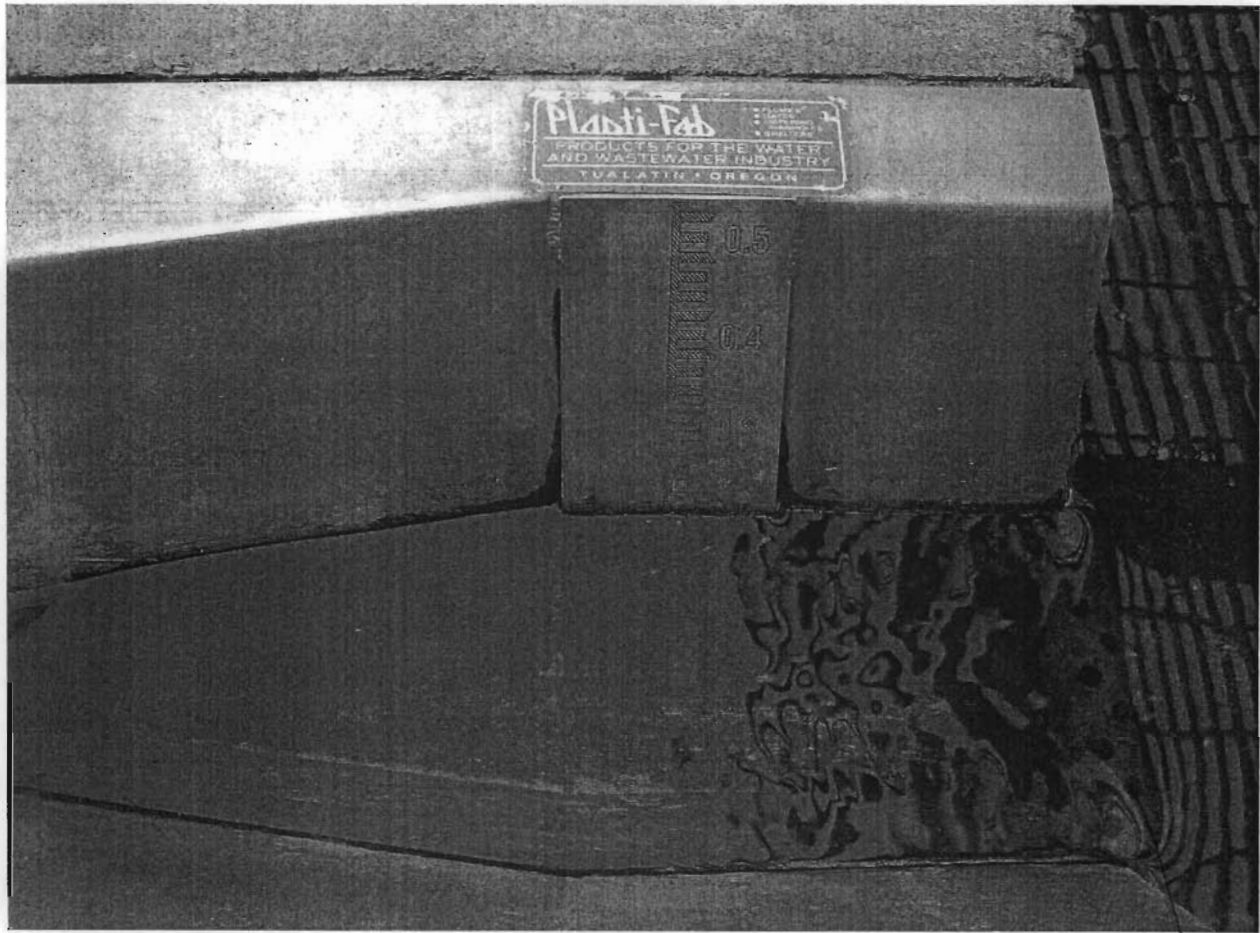
Close up view of V-notch weir. At time of site visit the flow rate indicated by this weir was 12 gpm (0.01728 mgd). The maximum flow this weir can measure is 122.4 gpm (0.17632 mgd). At the inlet of the weir you can see the automated sample collection probe with perforated holes. This is the sample location for all parameters required by the permit.

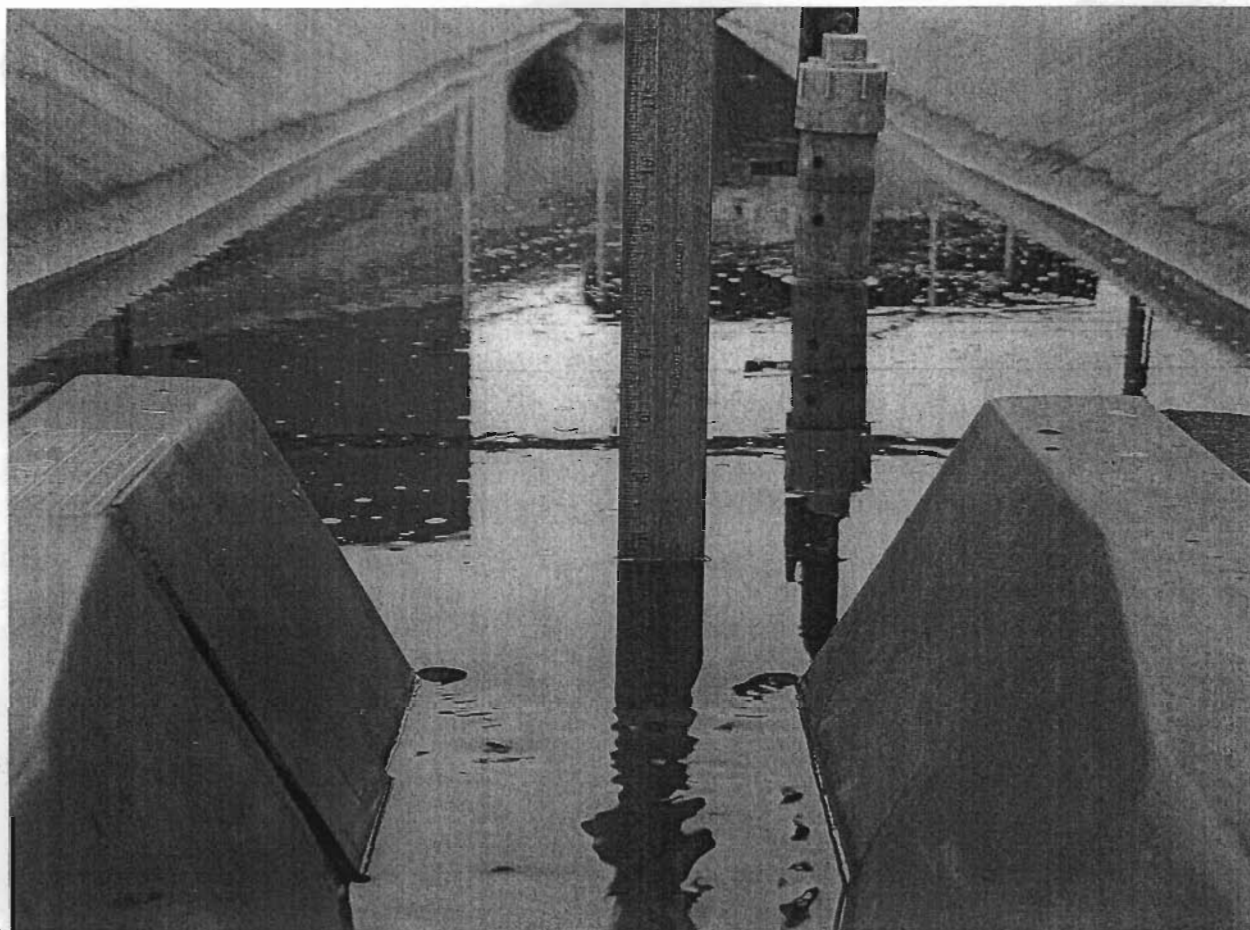
← Flow

Sample probe

This photo is taken after the weir looking upstream toward the facility.

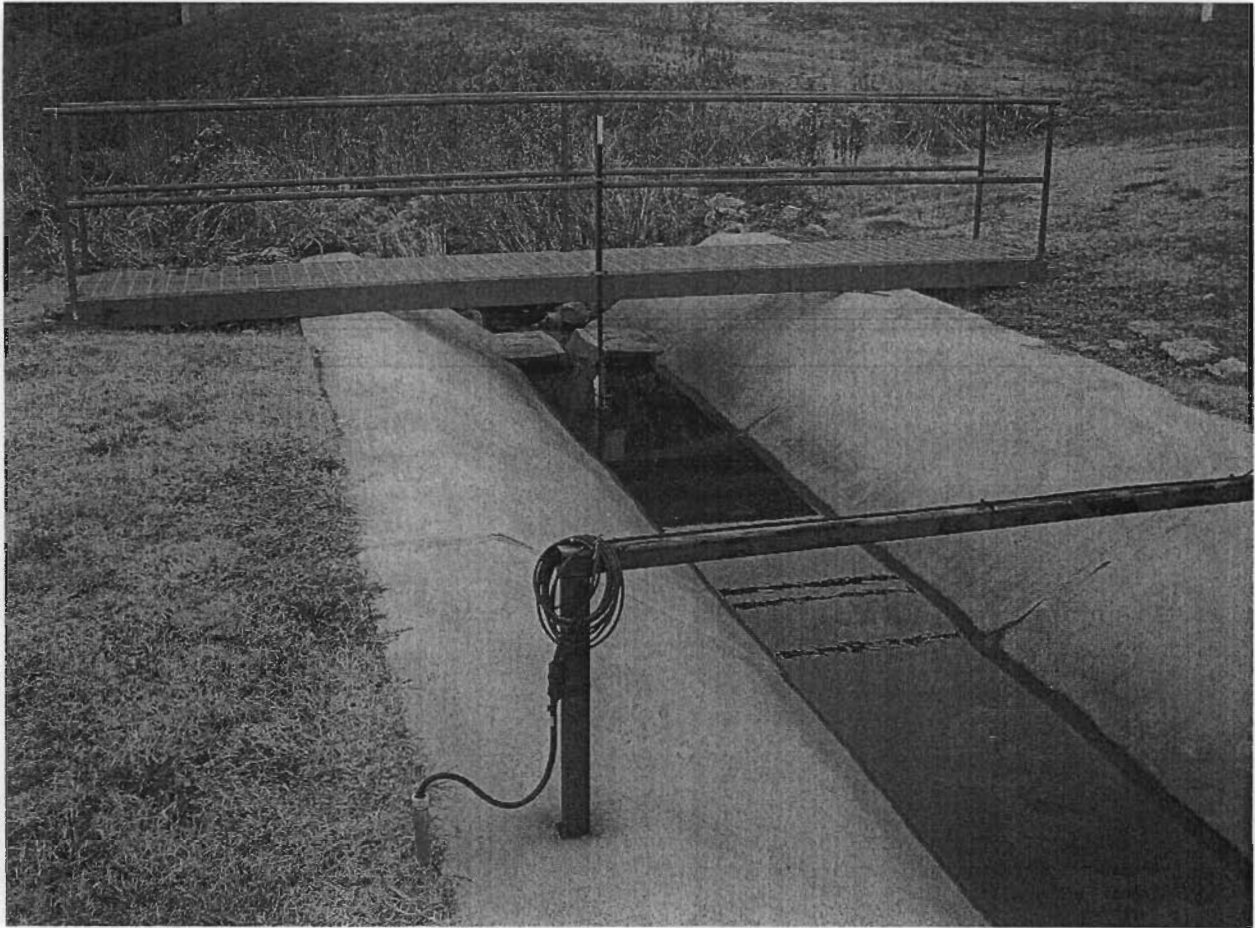
Water depth @ this location was 3.75 inches

This photo shows the location of the transducer that measures the depth of the water in the open channel

The flow rate at the outfall is determined using a transducer which measures the depth of the water at the midpoint of the open channel. This depth is sent to the totalizer for conversion to a flow rate based on Manning formula for open channel flow using the known geometry, slope, and roughness coefficient of the concrete channel. The depth of the water at the midpoint of the channel was approximately 2 inches on this day, while the depth of water at the end of the channel just prior to the weir was 3.75 inches. This indicates that the weir is causing the depth at the transducer location to be higher, which gives a flow reading that is higher than actual. On this particular day, the totalizer meter was indicating 400 gpm, while the V-notch weir at the end of the channel was indicating a flow rate of 12 gpm.

The flow rate being reported by the totalizer meter seems to be in error. This issue was discussed with Charles Allen at the time of the site visit. Mr. Allen stated that he attempts to make corrections for this difference when determining the flow number that is reported on the DMR. However, I suggested to him that he should look into removing the V-notch weir and relocating it on the upstream end of the open channel, and moving the transducer location to the downstream end of the channel. The total length of the open channel is approximately 60 feet, therefore moving the V-notch weir to the upstream end would still allow accurate low flow measurements and would remove the downstream obstruction currently caused by the weir being installed downstream of the transducer. He stated that they had talked about that solution before, but nothing had been done yet.

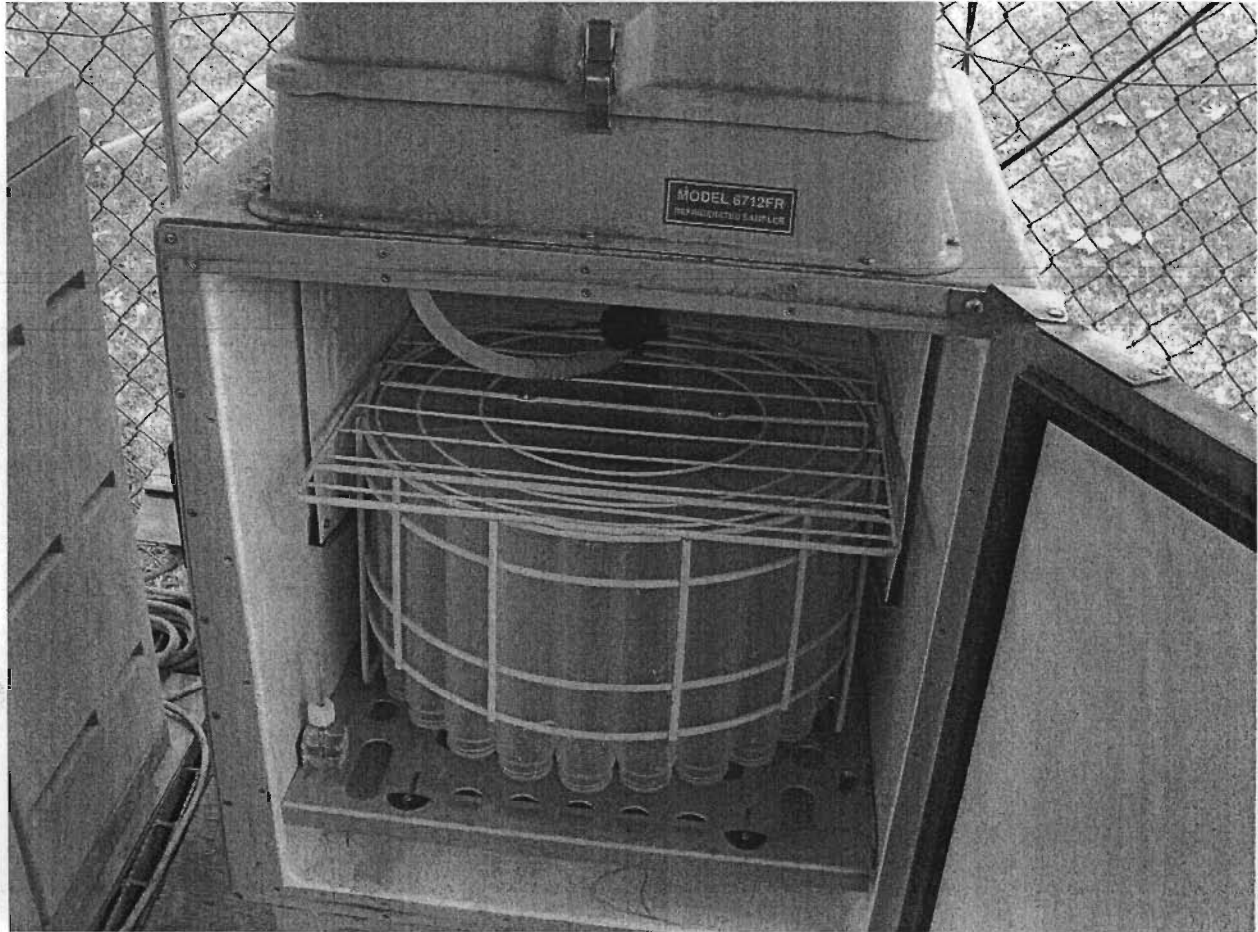
This is the refrigerated automated composite sampler. There are 24 bottles. A sample is pulled every 20 minutes so that each bottle is filled with 3 consecutive samples taken during each hour.

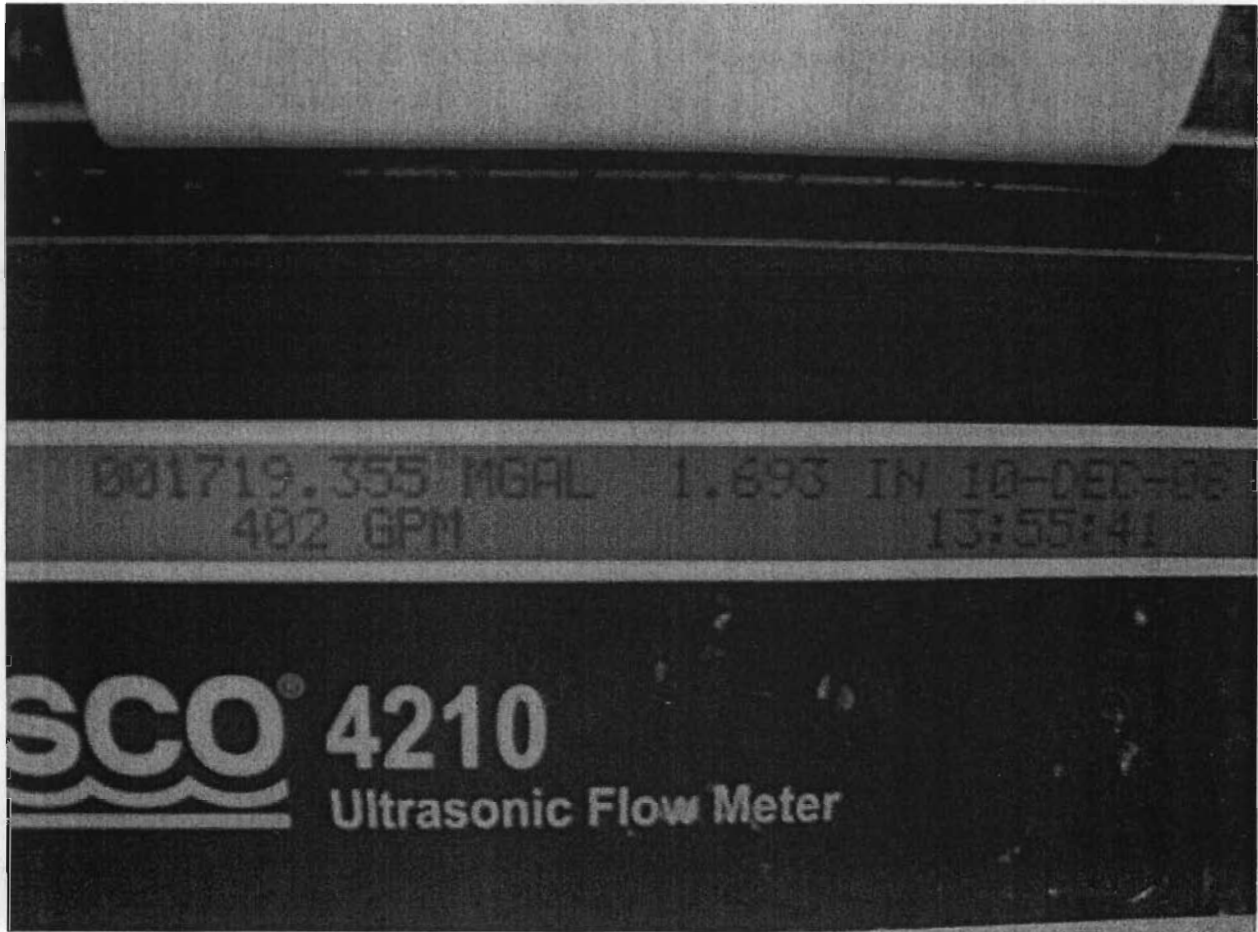
This is the totalizer meter. At the time of visit, it was recording a flow rate of 402 gpm. However, the V-notch weir indicated an actual flow of 12 gpm.

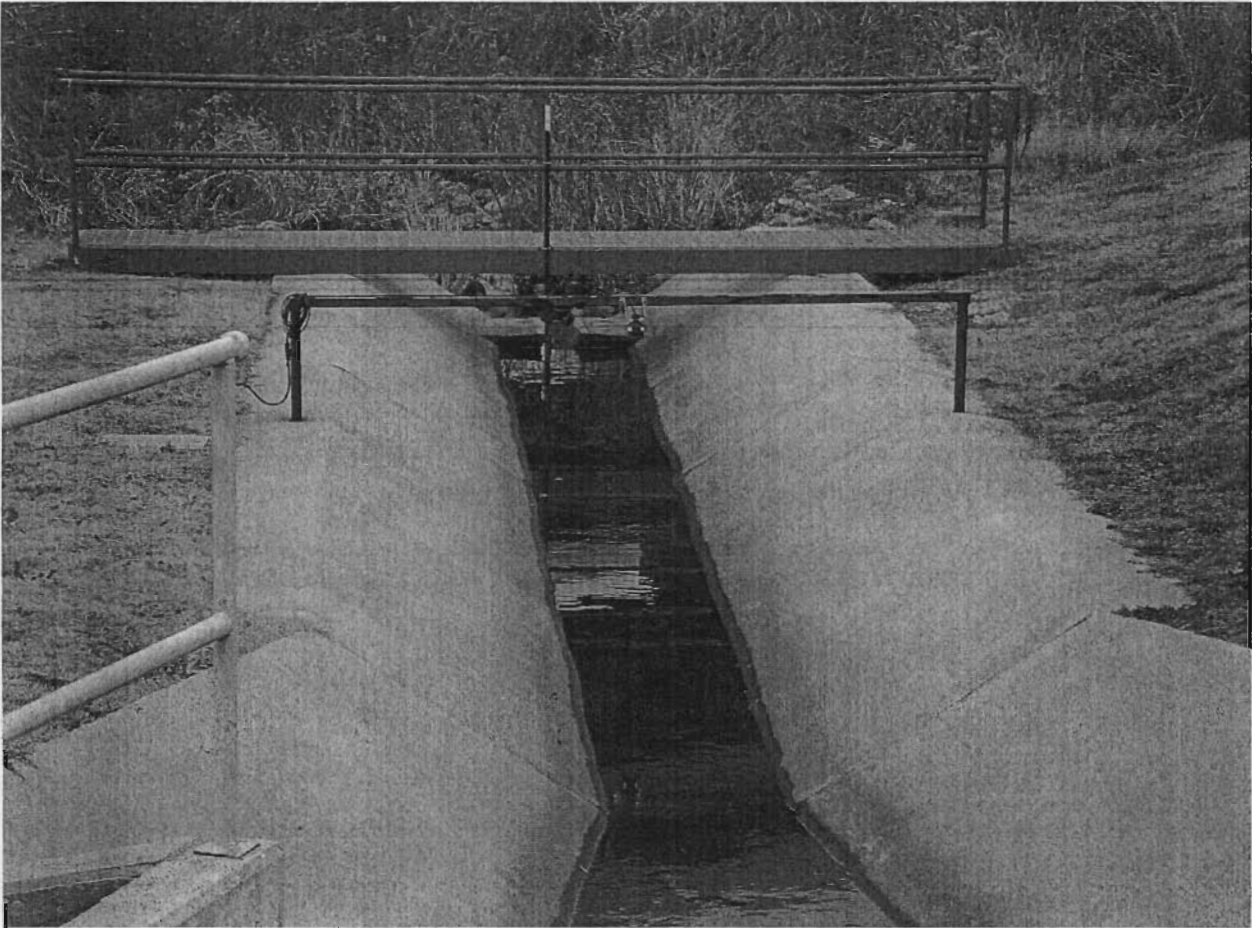
This shows the entire length of the trapezoidal open channel looking in the downstream direction.
