**Comments on the "Final Environmental Assessment For  
C&H Hog Farms Newton, Co. Arkansas"**

**Final Environmental Assessment  
C&H Hog Farms  
Newton County, Arkansas**

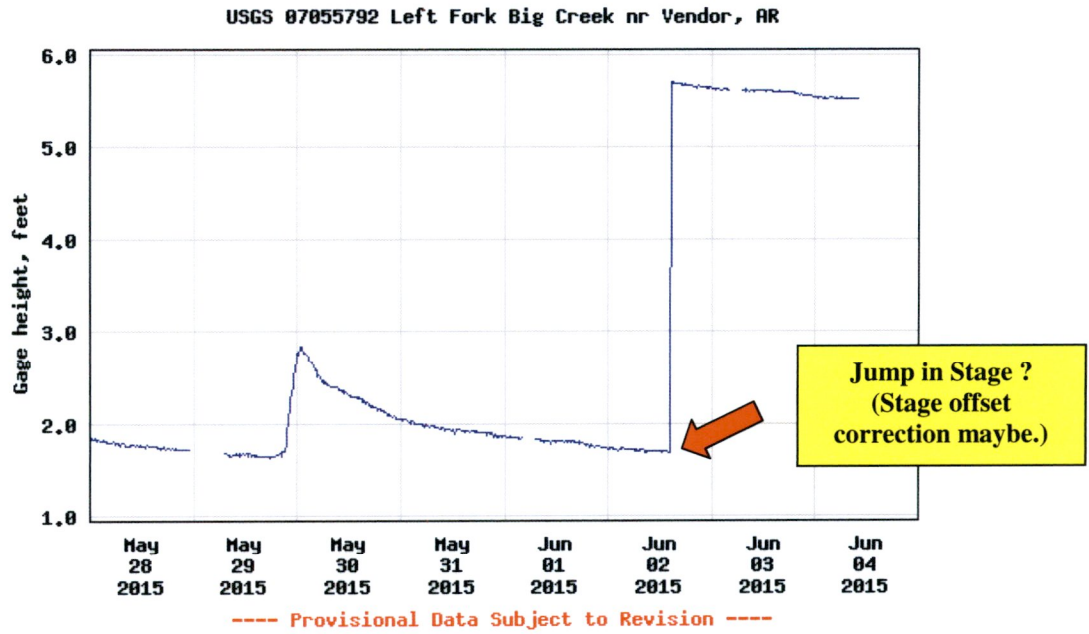
USGS 07055792 Left Fork Big Creek Near Vendor, AR had a few startup issues, but that could be expected. The station reported May 2015-June 2015. Where is that online “preliminary” data that as of today it is not available online? The image below are screen dumps from from when the station was operational and had data available.

**Instantaneous-data availability statement**

Gage height, feet

Most recent instantaneous value: 5.52 06-04-2015 10:00 CDT

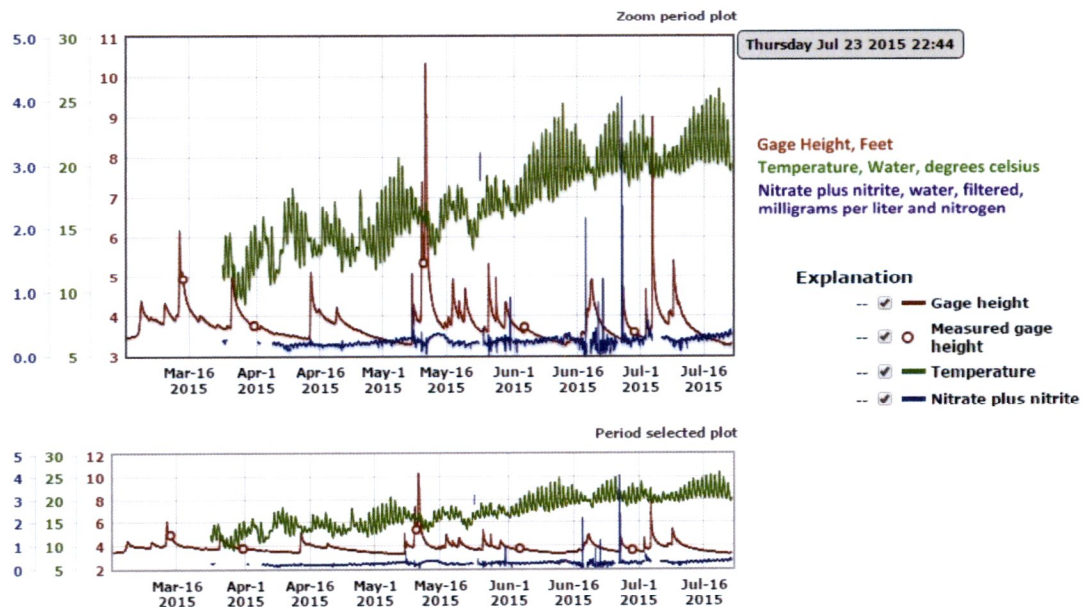
**Figure 3.1. USGS 07055790 Big Creek near Mt. Judea, AR**

**Streamflow, nitrate plus nitrite concentrations, and temperature from the site from January 1 through July 16, 2015 are shown in Figure 3-1 (USGS 2015a). As shown gage height relates to discharge, or flows. Nitrate-N concentrations increase with increasing temperatures. Nitrate levels are below the thresholds set to provide protection to aquatic species. Long-term trends can be assessed using a continuous monitor.**

**USGS 07055790 Big Creek near Mt. Judea, AR**

This station has provided useful information and would provide a very important point to keep an eye on parameters like “**Nitrate plus Nitrite**”, gauge height and precipitation for that fork of the Big Creek Tributary. It is in close proximity of the CAFO. Unfortunately there have been several issues that have been reported to the USGS office in Little Rock, AR about accuracy of some of the parameters and asking for information about calibration data for the sensors. It is clear to see that the field data available for establishing a rating curve to determine discharge is in progress, but the other parameters appear to be without calibration data. So there might be a lack of confidence by some questioning how meaningful this water quality aspect of this data truly is. These stations could provide precursors to threats to the surface and groundwater. Many feel that these stations are standing guard and there is nothing to worry about.

A recent attempt online to access USGS 07055790 Big Creek at Mt. Judea, AR gaging station, where are the water quality parameters like Nitrate plus Nitrite that the FONSI speaks of should be available? They have been available in the past. Some of the earlier “preliminary” data is not there as well.

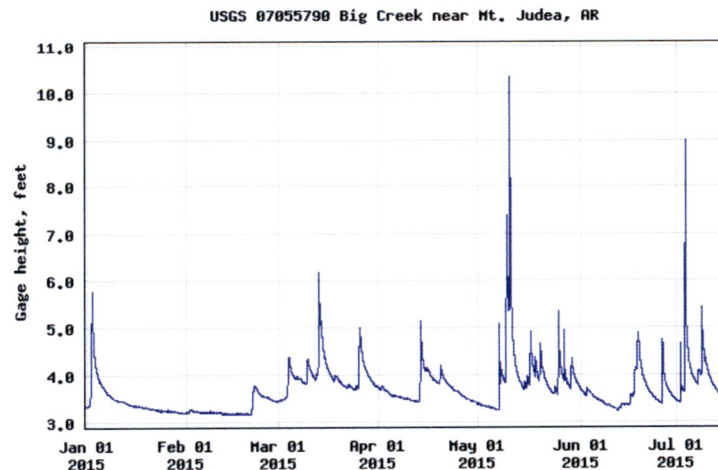
Where are the other “real-time” parameters like Nitrate plus Nitrite ?

Gage height, feet

Most recent instantaneous value: 3.19 01-25-2016 13:15 CST

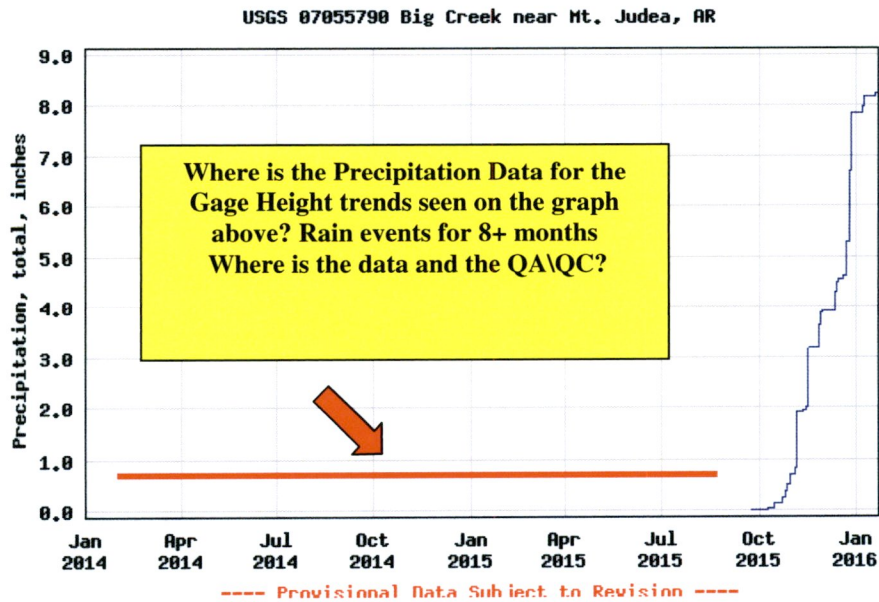
## Precipitation, total, inches

Most recent instantaneous value: 0.00 01-22-2016 16:15 CST

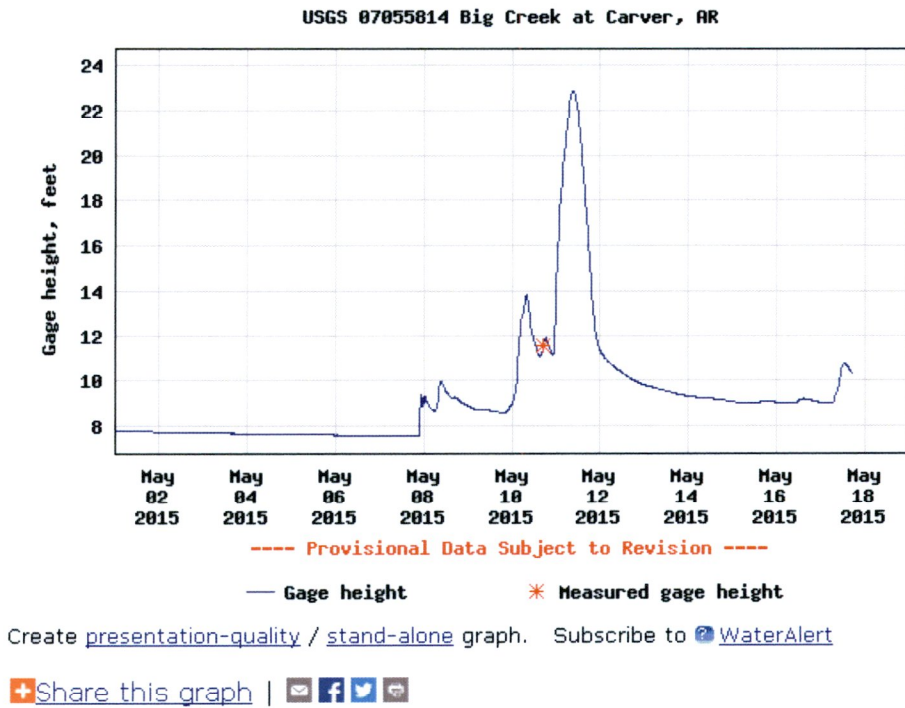
This is from USGS 07055814 Big Creek at Carver, AR monitoring station. This station was instrumented with Nitrate plus Nitrite, turbidity, DO sensors etc. I know there have been some high water issues as you can see, but the precipitation gauge was flat a long time and then he slow drip curve for many days?

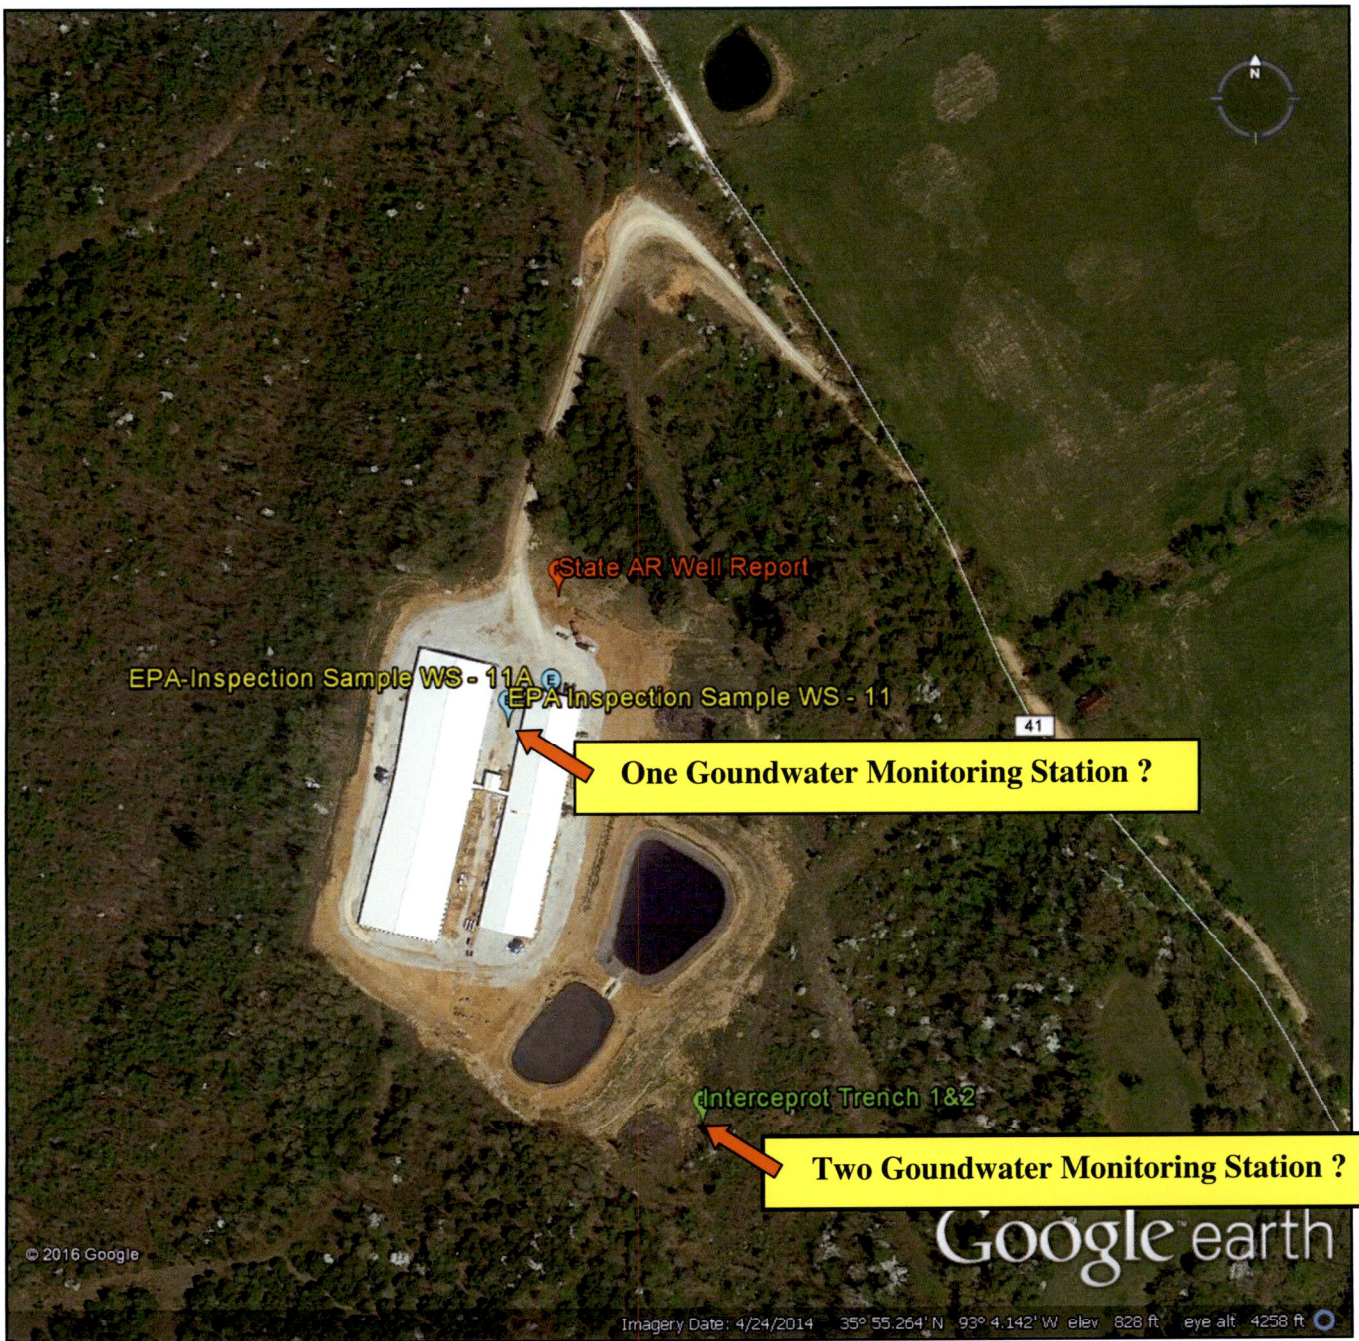
It appears the three groundwater monitoring stations are comprised of one house water well (supply), and two interceptor trenches both appear to be located somewhere below one side of the buildings and lagoon to the south. No comments on the interceptor trenches except, the trench might be useful in conjunction with a proper spatial groundwater network of true monitoring wells that would insure the groundwater may be protected. Considering that **“Outstanding National Resource Water and Extraordinary Resource Water and America’s First National River”** is at stake, **why gamble?**

The labels include questions marks “?” for this reason, I used the best information I could locate for Latitude and Longitudes to make the map for the monitoring stations. There is a lot of confusion as to where the actual water supply, water well, water and sampling collection actually are located. The “best guess” information came from one well that was included in the “State of Arkansas Reports on Well Construction & Pump Installation”. This well is located close to the CAFO buildings shown in the image above, so I feel it may be one well used? The EPA Region 6 Assurance and Enforcement Division Inspection Report”, dated 06/12/2014, supports this in their “photograph log”. There maybe BCRET Latitude and Longitude information concerning location of the well they are using and he actual sample collection location if it is not at the “Wellhead” of the well they consider the supply for groundwater monitoring. I have seen that are photographs from BCRET supporting that though. Some photos but I believe no coordinates were reported in some of their quarterly reports. Does this meet Mr. Beebe’s original quoted goals, is this an inadequate safe guard when money was available to do a more extensive site groundwater monitoring effort? I don’t think so. Why not use some of the money for Geophysical Surveys as seen on demonstration Field 5A and Spreading Field 12 to insure there are no known conduits?

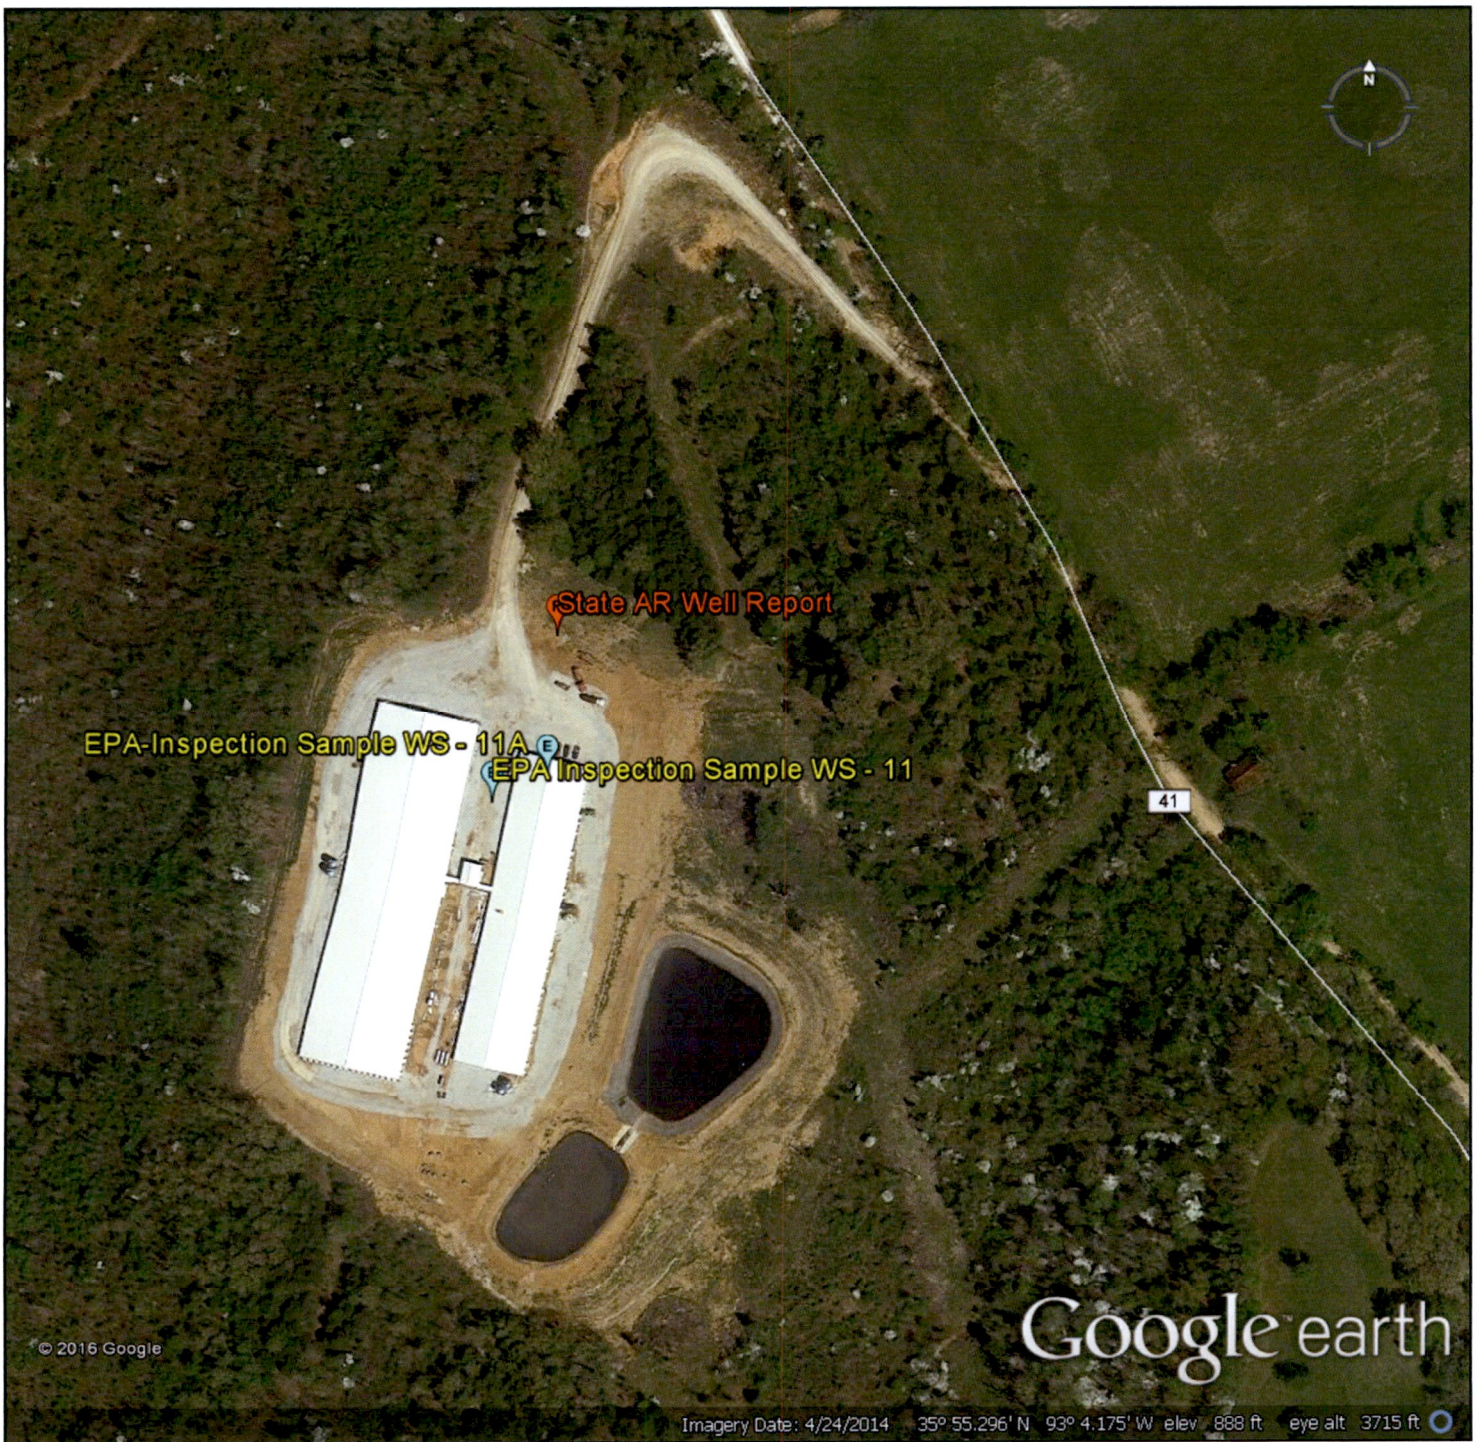
Best guess at the Groundwater Supply mentioned in comments

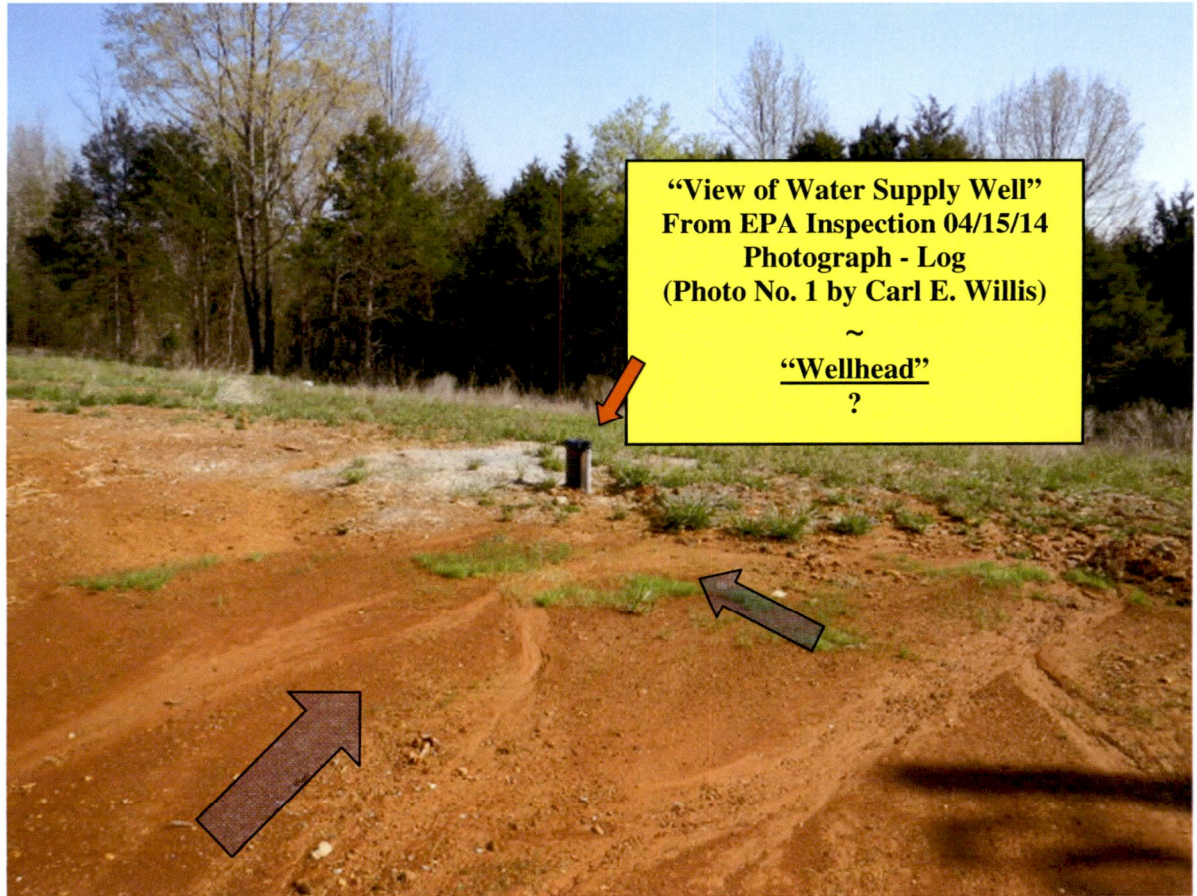
Photo No. 1

Description: View to the north of the water supply well. The well has a total depth of 320 feet with the depth of water being at approximately 280 feet.

**Please Note:**  
No concrete pad around well.  
(probably not required)  
Runoff across the red soil area in  
the direction of the well head

**Response:** Monitoring has identified *E. coli* in the water obtained from the on-site well. However, the well has not been sampled at the wellhead. The BCRET team was unaware that the well pump and pipe were removed and transported for repairs and then reinstalled, creating the opportunity for contamination. Since the water is also stored in a cistern, there is also potential for contamination. The BRCET team has been in the process of changing their sampling protocol by installing a new line to sample directly at the wellhead. The ADEQ has reviewed the data from the BCRET and found the current data do not show persistent contamination of groundwater (ADEQ 2015c).

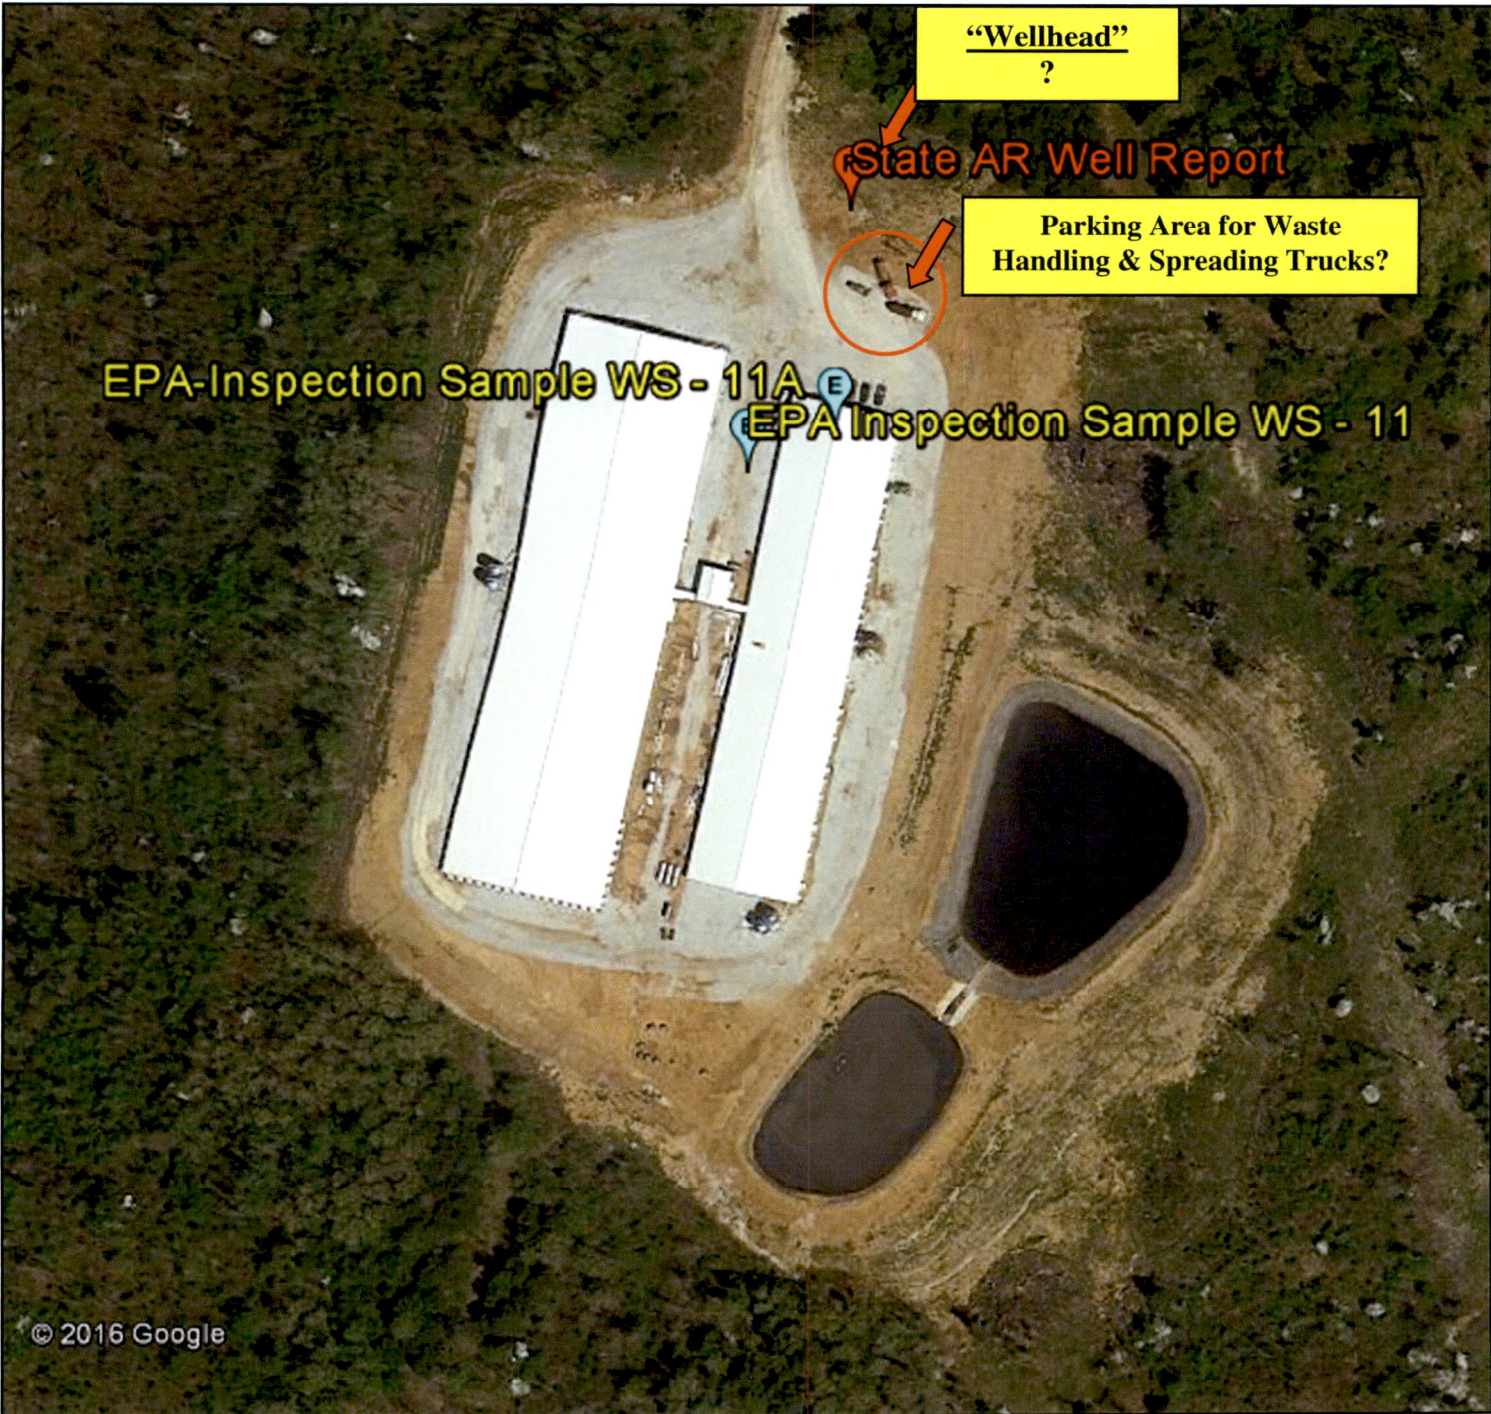
"Wellhead"  
?

State AR Well Report

Parking Area for Waste  
Handling & Spreading Trucks?

EPA-Inspection Sample WS - 11A

EPA Inspection Sample WS - 11

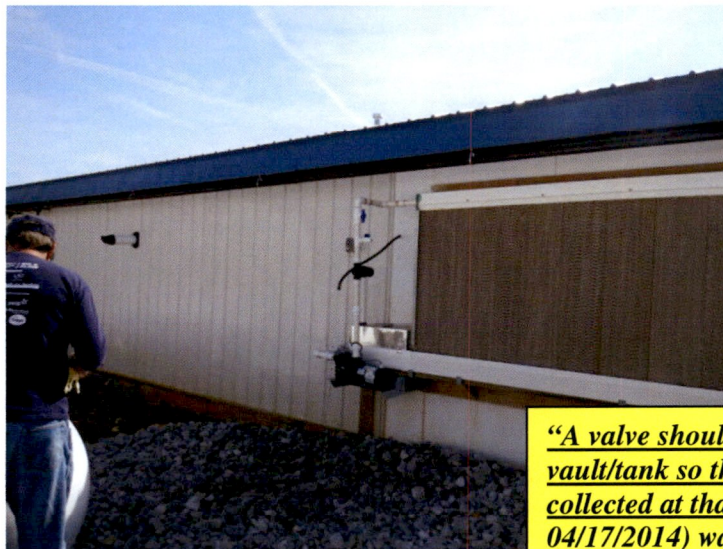
Photo No. 29

Description: View to the northeast of the northwest corner of the farrowing barn, under which a 55,000-gallon concrete tank holds water pumped from the facility's only water supply well onsite. The supply well pumps directly into this holding tank and another pump transfers water to a pressure tank, that then supplies water to the animals and employees. That pressure tank connects to the black hose, just to the left of the cool cell, which was where we collected WS-11 (@ 09:54 on 04/17/2014). The only other way to collect a sample from the well would be to shower in/out and dip the water out of the concrete vault/tank. A valve should be added inline prior to the vault/tank so that a fresh water sample could be collected at

that point. WS-11A (@ 10:14 on 04/17/2014) was collected from a refrigerator in the employee breakroom. That water (WS-11A) goes through a water softener and filtering system before it is dispensed.

***“A valve should be added inline prior to the vault/tank so that a fresh water sample could be collected at that point. WS-11A (@ 10:14 on 04/17/2014) was collected from a refrigerator in the employee breakroom. That water (WS-11A) goes through a water softener and filtering system before it is dispensed.”***

"BRCET team has been in the process of changing their sampling protocol by installing a new line to sample directly at the wellhead."
