ARKANSAS
Department of Environmental Quality

RE: PJ'S Tank Wash Inspection (Ashley Co)
AFIN: 02-00086 NPDES Permit No.: ARR000693

A R K A N S A S Department of Environmental Quality	WATER DIVISION INSPECTION REPORT				
	AFIN: 02-00086	PERMIT #: ARR000693	DATE: 1/26/2016		
	COUNTY: 02 Ashley	PDS #: 089228	MEDIA: WN		
	GPS LAT: 33.140609 LONG: -91.987122 LOCATION: Entrance				
FACILITY INFORMATION		INSPECTION INFORMATION			
NAME: PJ'S Tank Wash LOCATION: 2201 Hwy 82 West CITY: Crossett, AR 71635		FACILITY TYPE: 2 - Industrial INSPECTOR ID#: 101531 S - State FACILITY EVALUATION RATING: N INSPECTION TYPE: Industrial Stormwater			
RESPONSIBLE OFFICIAL		DATE(S): 1/26/2016 ENTRY TIME: 10:00 EXIT TIME: 10:57 PERMIT EFFECTIVE DATE: 1/11/2011 PERMIT EXPIRATION DATE: 6/30/2019			
NAME / TITLE: Randy Coats / Director of Operations COMPANY: PJ'S Tank Wash MAILING ADDRESS: 2201 Hwy 82 West CITY, STATE, ZIP: Crossett AR 71635 PHONE & EXT. / FAX: 870-364-7020 / EMAIL:		FAYETTEVILLE SHALE RELATED: N FAYETTEVILLE SHALE VIOLATIONS: N			
CONTACTED DURING INSPECTION: No		INSPECTION PARTICIPANTS

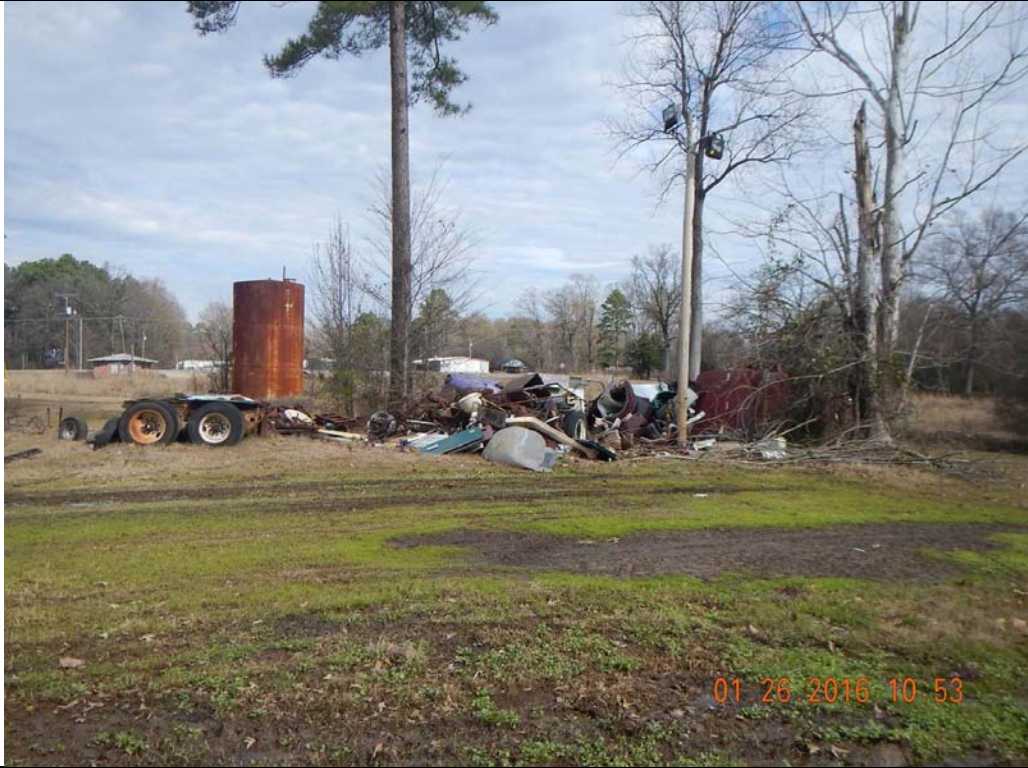
c. Are materials or products from past industrial activity exposed?	<input checked="" type="checkbox"/> Y <input type="checkbox"/> N
Comments: <u>Scrap metals, tanks, and unknown chemicals are stored exposed to stormwater.</u>

Location:	PJ'S Tank Wash		
Photographer:	Michael Young	Date:	01/26/2016
Time:	10:53		Photo #:
Witness:	Brian Hudson; Clark Reed; Cody Brickley		1
Description:	Scrap metal and old tanks exposed to stormwater.

The facility primarily sees a heavy amount of truck traffic as tankers await washing. However, it was stated that the previous owner left materials such as scrap metal, old tanks, decommissioned trailers, and some barrels of unknown liquids (see Photos 1-3). Having these items exposed to stormwater is a violation of the No Exposure condition of the IGP. These materials need to be placed in a covered area or disposed of properly. Additionally, the facility had barrels of Ferric Chloride used in the treatment of wash water that had no secondary containment (see Photo 4). Spills were also observed (see Photos 4-5) that had not been immediately cleaned up and properly remediated. The new treatment process adds additional exposure of materials that are prone to pollution (i.e., chemicals, overflows, releases, sludge storage, etc.), and these materials must be kept in secondary containment or not exposed to rainfall and stormwater. Spills are to be cleaned up immediately when observed or identified.

As a response to this inspection report, ADEQ Water Division Inspection Branch requires photographs of the areas where spills were observed are cleaned up and properly remediated. Photos of the piles of scrap metal no longer exposed are also needed with the response. A timeframe of when secondary containment will be reestablished in the clarifier area needs to also be included. Barrels of chemicals need to be in secondary containment or not exposed to stormwater. Photos of this corrective action are also required.

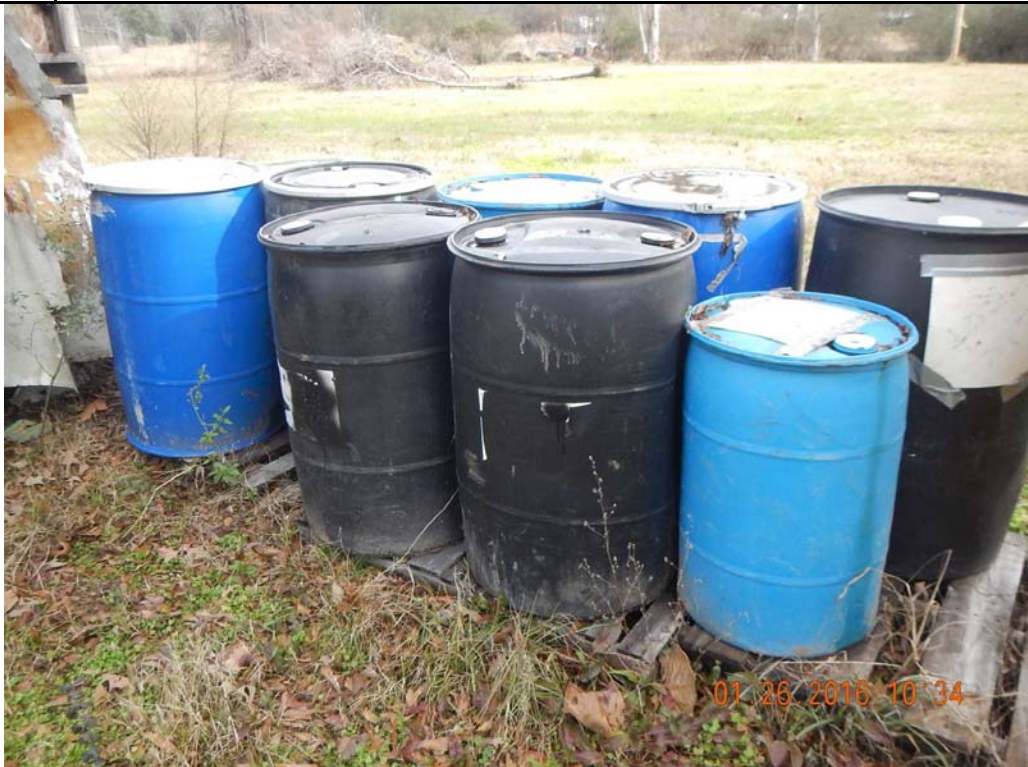
Photographer:	Michael Young	Date:	01/26/2016
Time:	10:34		Photo #:
Witness:	Brian Hudson; Clark Reed; Cody Brickley		2
Description:	Barrels with unknown contents exposed to stormwater with no secondary containment.

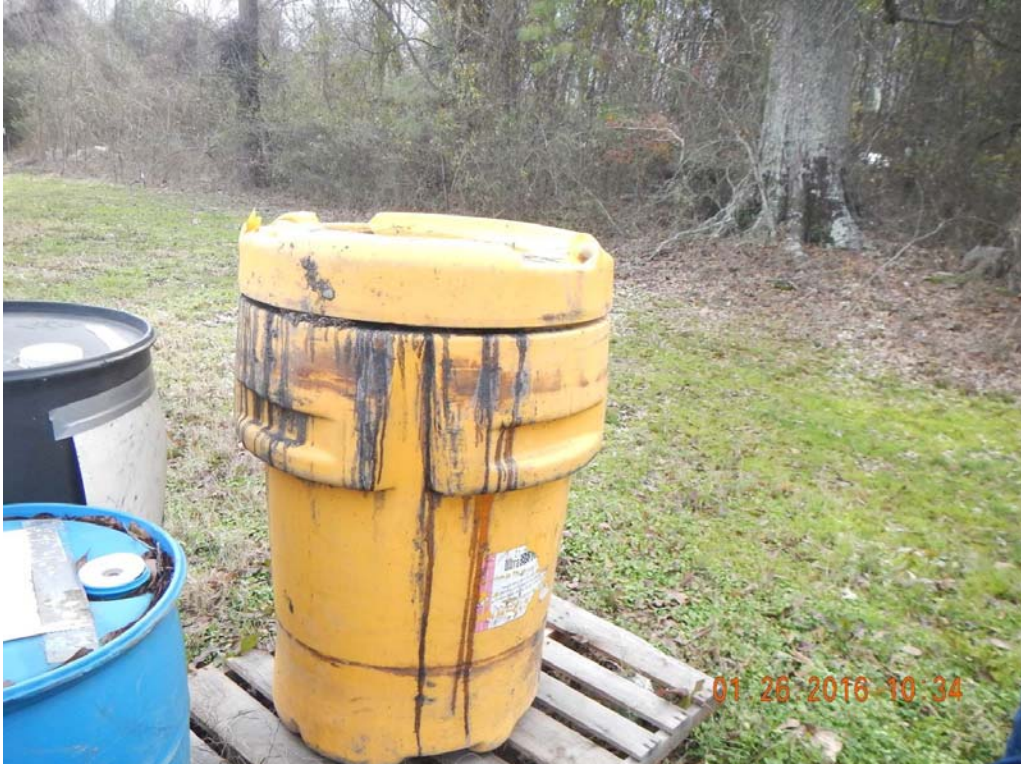
Location:	PJ'S Tank Wash		
Photographer:	Michael Young	Date:	01/26/2016
Time:	10:34	Witness:	Brian Hudson; Clark Reed; Cody Brickley
Photo #:	3	Description:	Barrel with unknown contents exposed to stormwater.

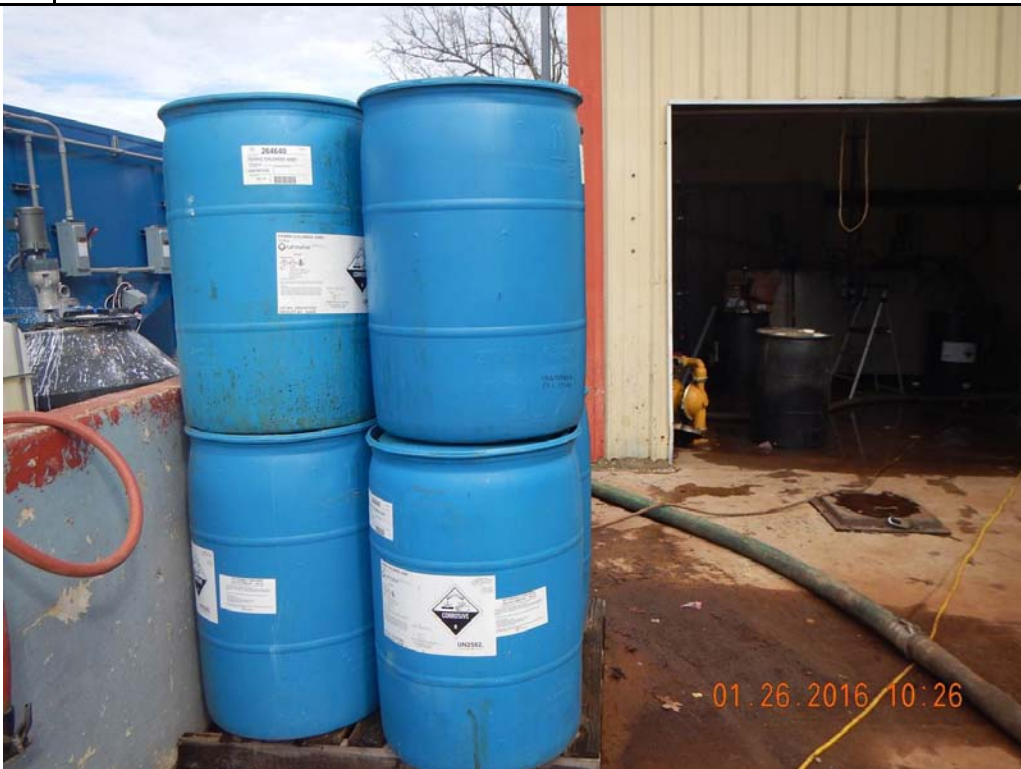
f. Materials or products stored outdoors except final products intended for outside use (e.g., new cars) where exposure to stormwater does not result in the discharge of pollutants?	<input checked="" type="checkbox"/> Y <input type="checkbox"/> N
Comments: <u>Chemicals for treatment are stored with no secondary containment.</u>

Photographer:	Michael Young	Date:	01/26/2016
Time:	10:26	Witness:	Brian Hudson; Clark Reed; Cody Brickley
Photo #:	4	Description:	Ferric Chloride 42BE stored outside secondary containment. Also note spilled materials around barrels.

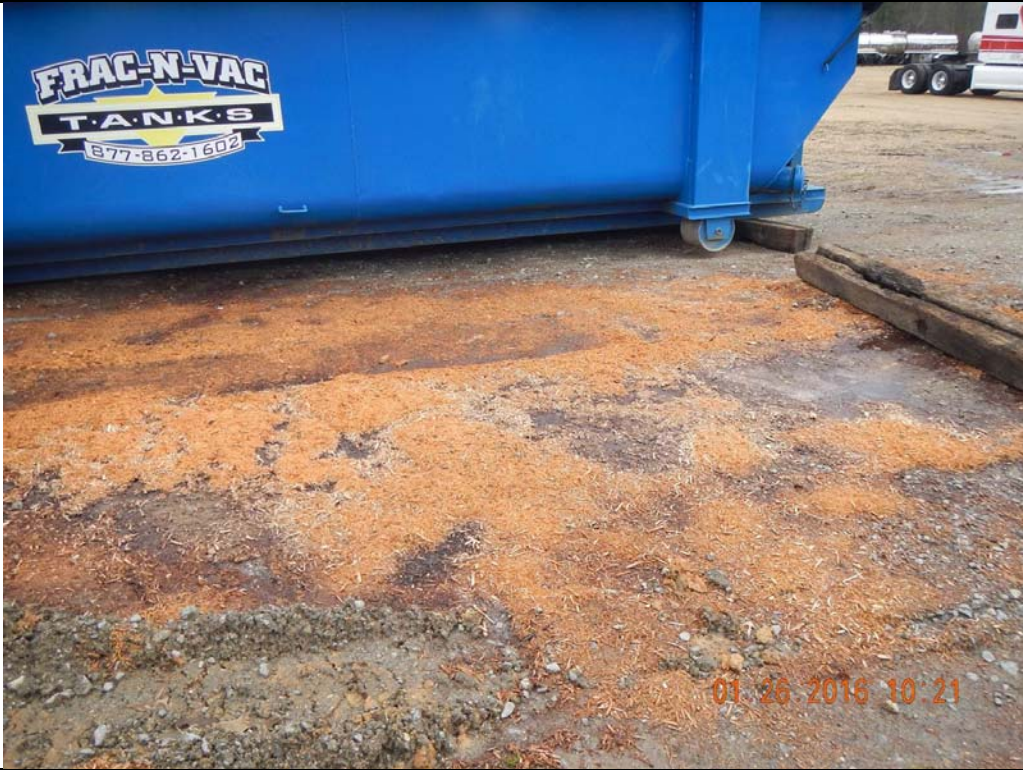
i. Waste materials exposed except waste in covered, non-leaking containers (e.g., dumpsters)?	<input checked="" type="checkbox"/> Y <input type="checkbox"/> N
Comments: <u>Sawdust on the ground around covered sludge storage container.</u>

Location:	PJ'S Tank Wash		
Photographer:	Michael Young	Date:	01/26/2016
Time:	10:21	Witness:	Brian Hudson; Clark Reed; Cody Brickley
Photo #:	5	Description:	Sawdust used as bulking material with sludge from wash water. Sawdust was spilled on ground and not immediately cleaned up.

I asked to be walked through the treatment system to identify any potential pollution issues with stormwater and to relay the information on the treatment process to Allen Gilliam. The process begins immediately after washing a tanker (see Photo 6). This water is treated with Sulfuric Acid for pH adjustment (see Photos 7-8). The room where this takes place is covered, and spilled materials are pumped back into the treatment unit. The wastewater leaves the pH adjustment and enters the clarifier (see Photos 12-16) where it is dosed with Ferric Acid as a coagulant and runs through mixing and settling processes. Any spilled materials or releases from the clarifier were stated to be routed back into the clarifier using a sump pump (see Photos 10-11). The secondary containment wall was not finished at the time of inspection. After coagulant treatment, the treated water is stored in tanks in the secondary containment area (see Photos 18-19). A sample of the wastewater was pulled from the mixing zone of the clarifier to demonstrate the settling (see Photo 17). Sludge from the treatment process is pumped into a storage container that is in a loading dock that is covered (see Photo 20). Any released material is captured in the loading dock and pumped back into the treatment unit (see Photo 21). I had concerns that this area could be prone to pollution and would need to be diligently checked to ensure there are no releases from this area. Storage containers of sludge are covered and remain until hauled off to be disposed of (see Photo 22). There was sawdust and other materials spilled in this area that needs to be immediately cleaned up.

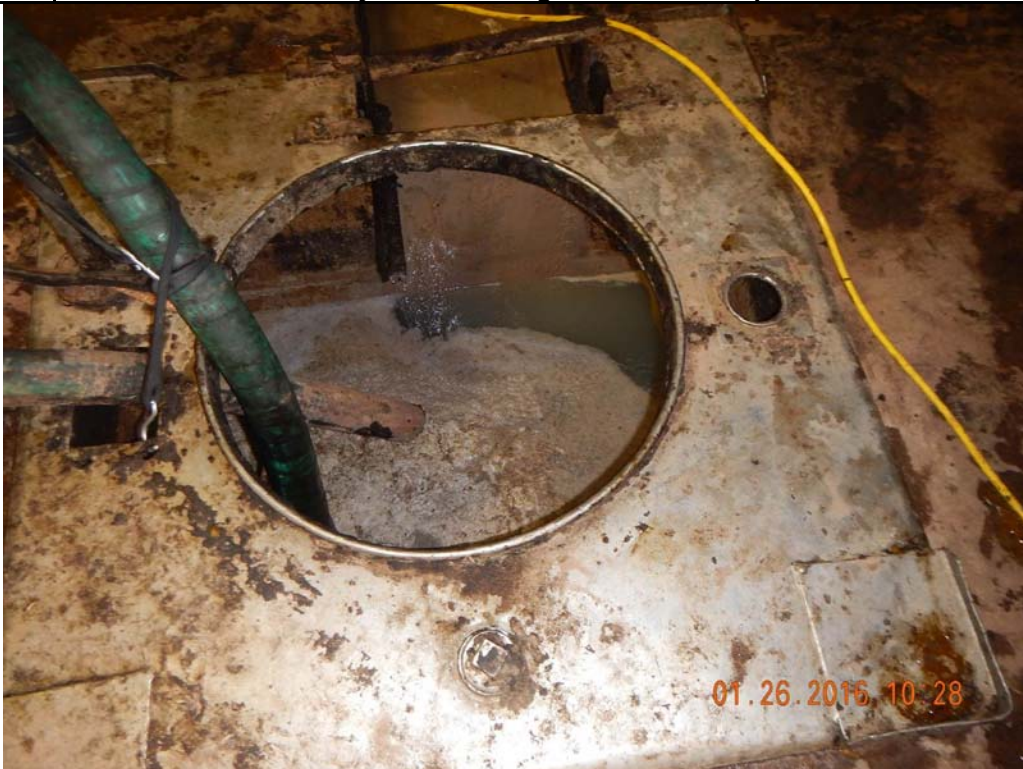
Photographer:	Michael Young	Date:	01/26/2016
Time:	10:28	Witness:	Brian Hudson; Clark Reed; Cody Brickley
Photo #:	6	Description:	Wash water immediately after washing tanks. Prior to pretreatment.

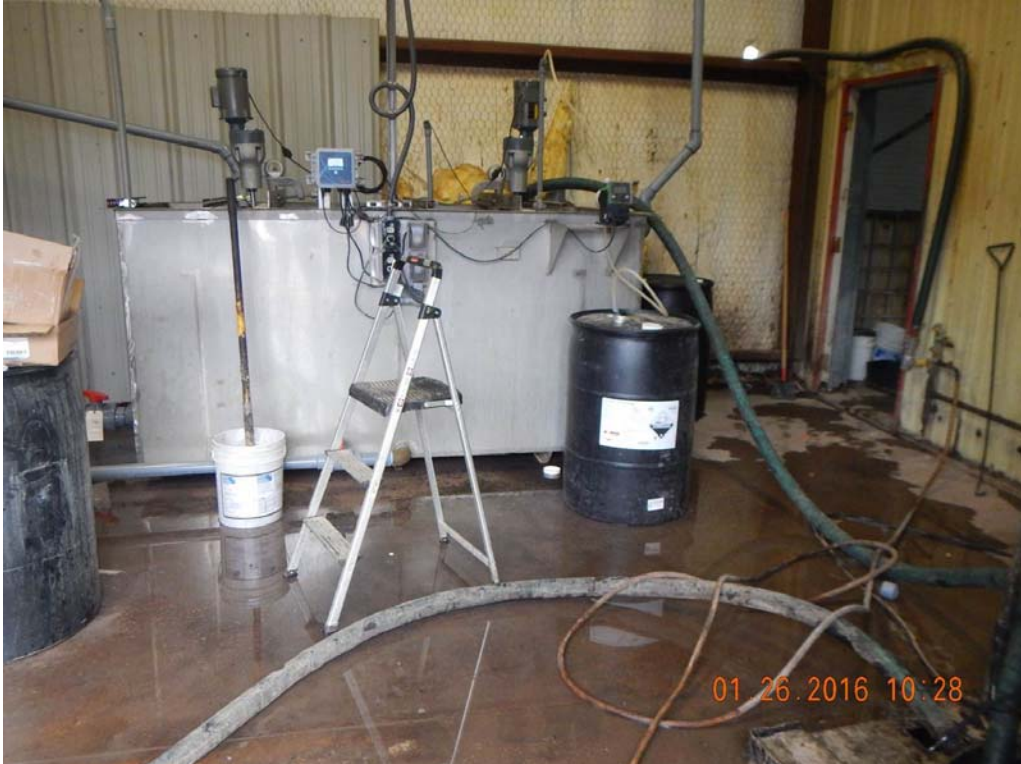
Location:	PJ'S Tank Wash		
Photographer:	Michael Young	Date:	01/26/2016
Time:	10:28	Witness:	Brian Hudson; Clark Reed; Cody Brickley
Photo #:	7	Description:	Initial unit used for pH adjustment. Sulfuric Acid is dosed into the water.

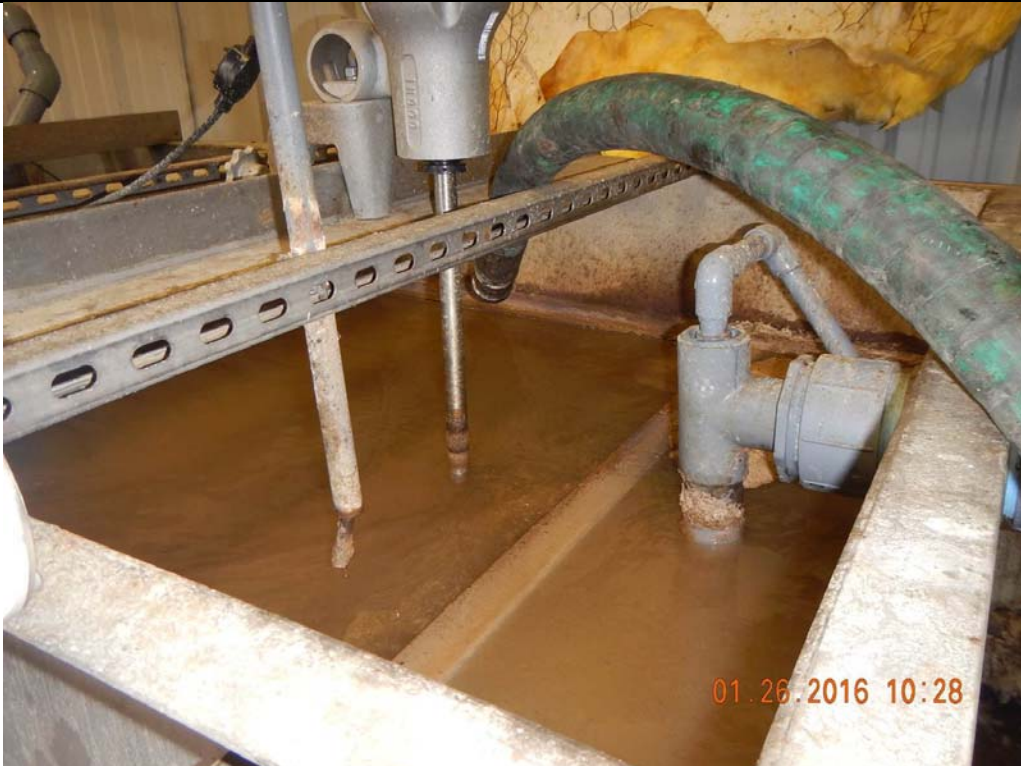
Photographer:	Michael Young	Date:	01/26/2016
Time:	10:28	Witness:	Brian Hudson; Clark Reed; Cody Brickley
Photo #:	8	Description:	Wash water in Sulfuric Acid dosing chamber. Wash water is stated to be alkaline.

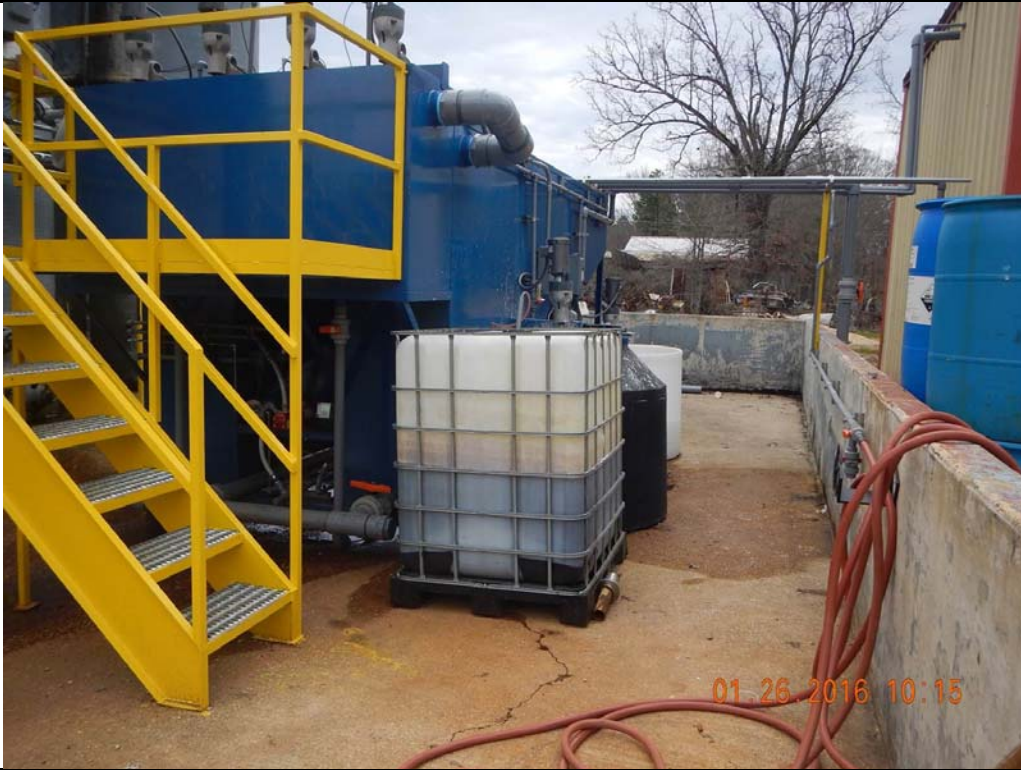
Location:	PJ'S Tank Wash		
Photographer:	Michael Young	Date:	01/26/2016
Time:	10:15	Witness:	Brian Hudson; Clark Reed; Cody Brickley
Photo #:	9	Description:	Wash water exits pH adjustment and enters clarifier where Ferric Chloride is dosed as coagulant. Secondary concrete containment contains sump pump.

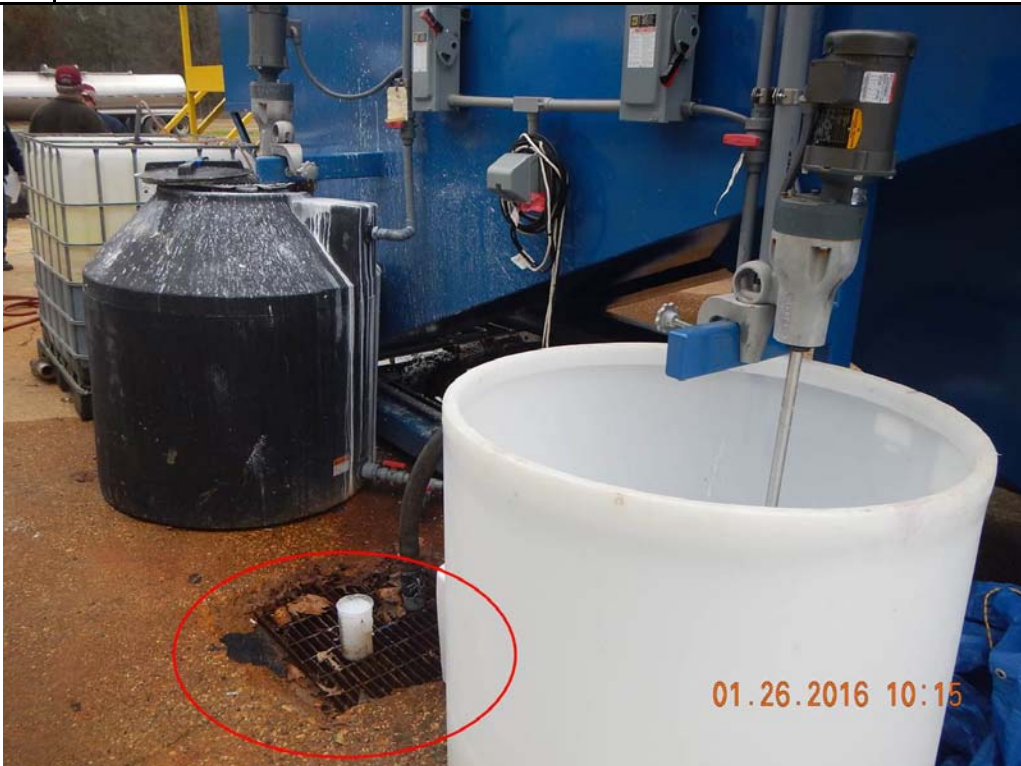
Photographer:	Michael Young	Date:	01/26/2016
Time:	10:15	Witness:	Brian Hudson; Clark Reed; Cody Brickley
Photo #:	10	Description:	Ferric Chloride dosing. Red circled area is sump pump for spills and releases in which water is routed back into the clarifier.

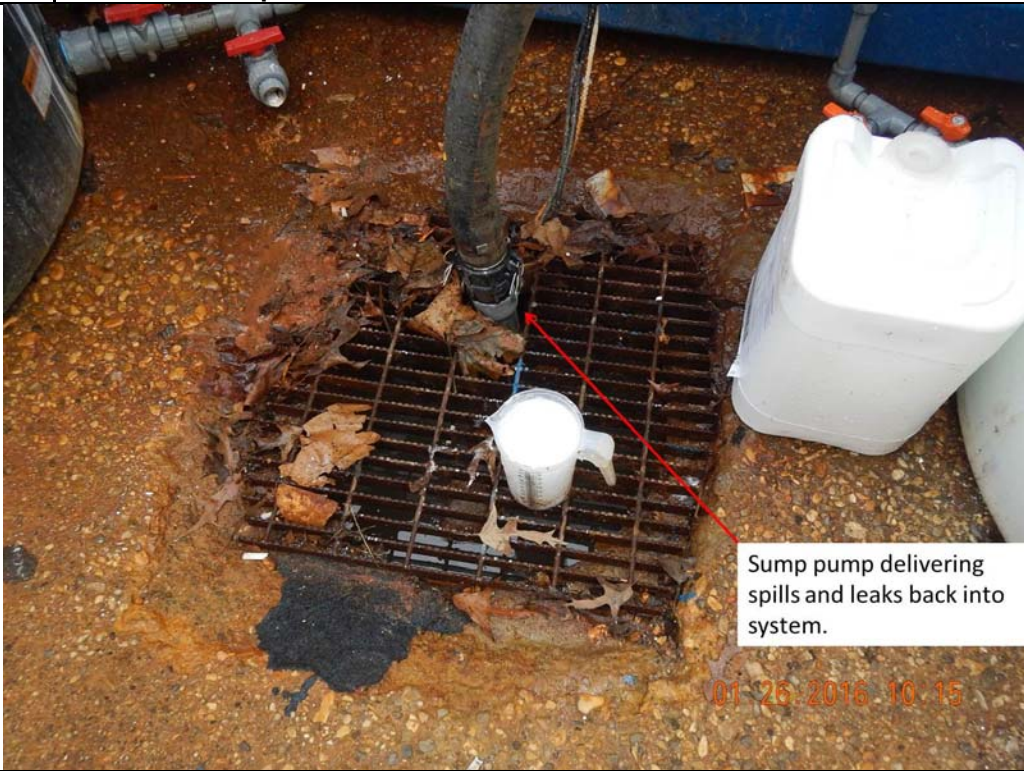
Location:	PJ'S Tank Wash		
Photographer:	Michael Young	Date:	01/26/2016
Time:	10:15	Witness:	Brian Hudson; Clark Reed; Cody Brickley
Photo #:	11	Description:	Close-up view of sump pump for releases and spills in treatment area. Cup of Ferric Chloride pictured.

Sump pump delivering spills and leaks back into system.

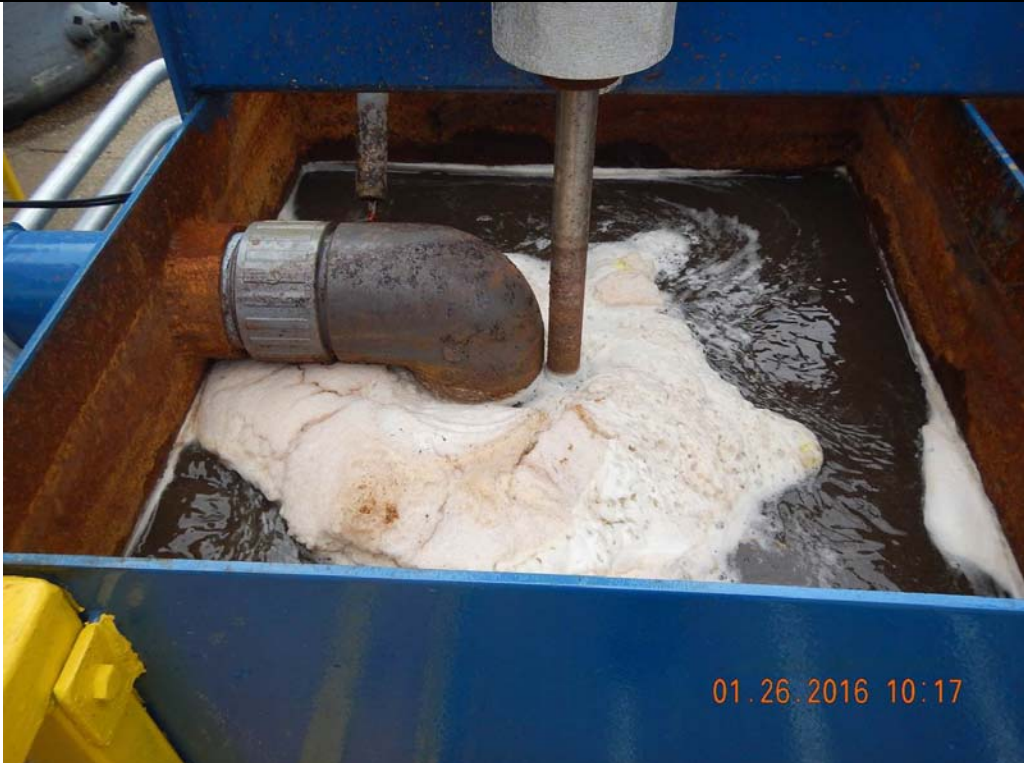
Photographer:	Michael Young	Date:	01/26/2016
Time:	10:17	Witness:	Brian Hudson; Clark Reed; Cody Brickley
Photo #:	12	Description:	Water entering dosing area after pH adjustment.

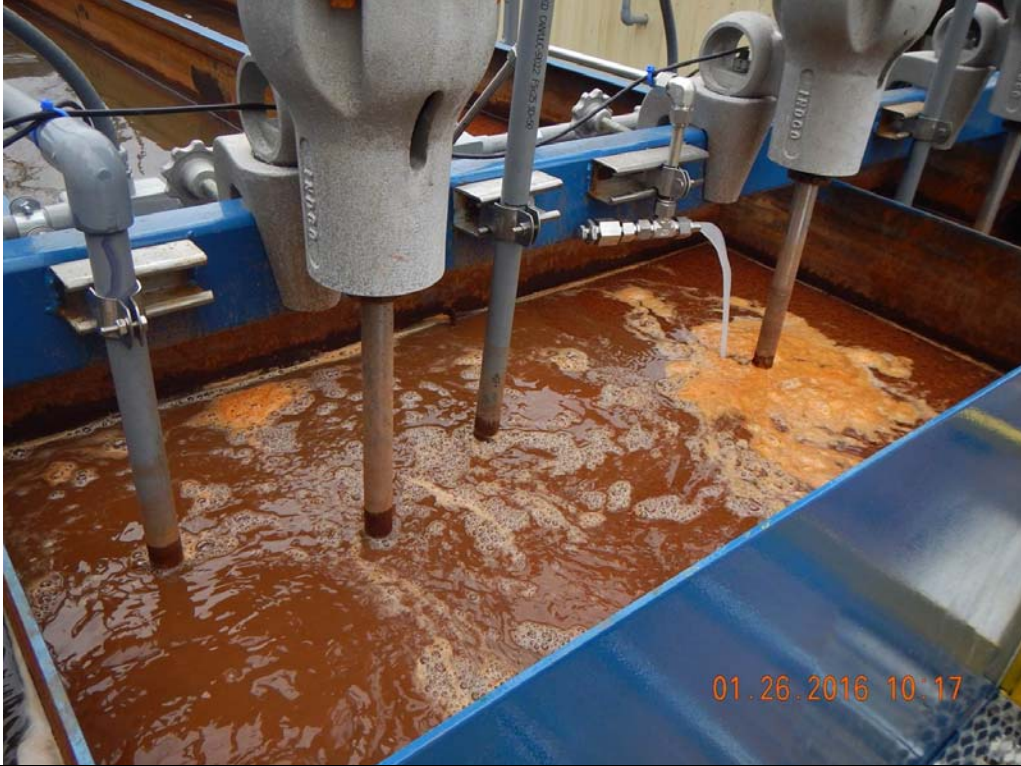
Location:	PJ'S Tank Wash				
Photographer:	Michael Young	Date:	01/26/2016	Time:	10:17
Witness:	Brian Hudson; Clark Reed; Cody Brickley			Photo #:	13
Description:	Ferric Chloride dosing area.

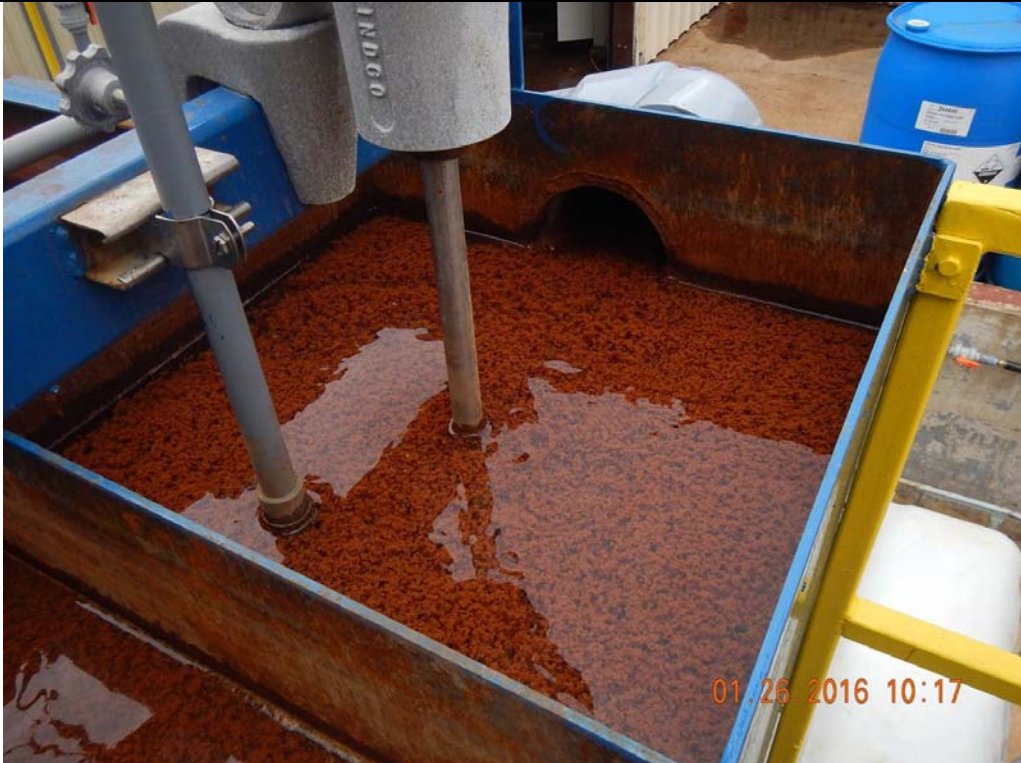
Photographer:	Michael Young	Date:	01/26/2016	Time:	10:17
Witness:	Brian Hudson; Clark Reed; Cody Brickley			Photo #:	14
Description:	Mixing zone for coagulant.

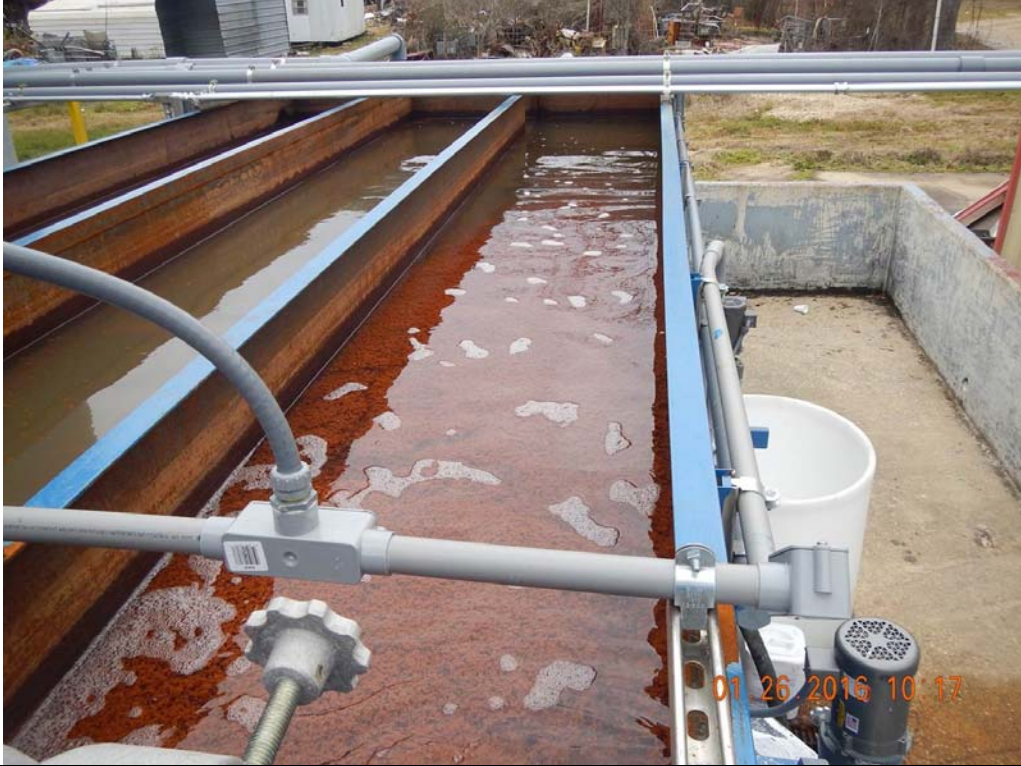
Location:	PJ'S Tank Wash				
Photographer:	Michael Young	Date:	01/26/2016	Time:	10:17
Witness:	Brian Hudson; Clark Reed; Cody Brickley			Photo #:	15
Description:	Initial clarifier run after Ferric Chloride treatment.

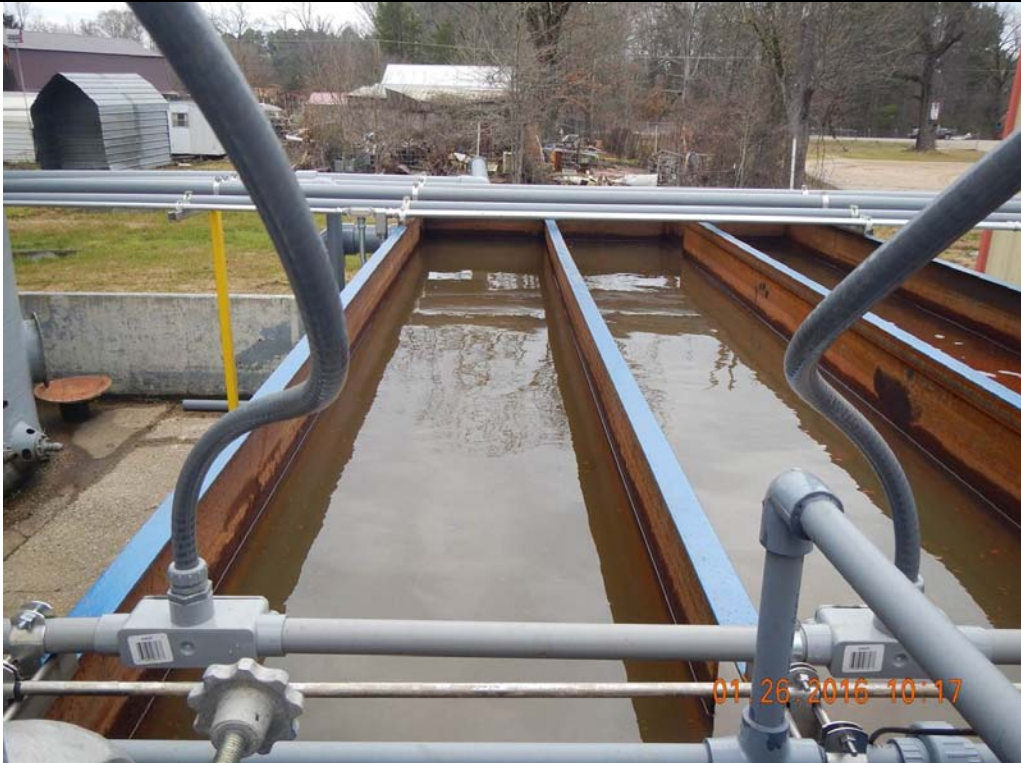
Photographer:	Michael Young	Date:	01/26/2016	Time:	10:17
Witness:	Brian Hudson; Clark Reed; Cody Brickley			Photo #:	16
Description:	Water in clarifier after treatment.

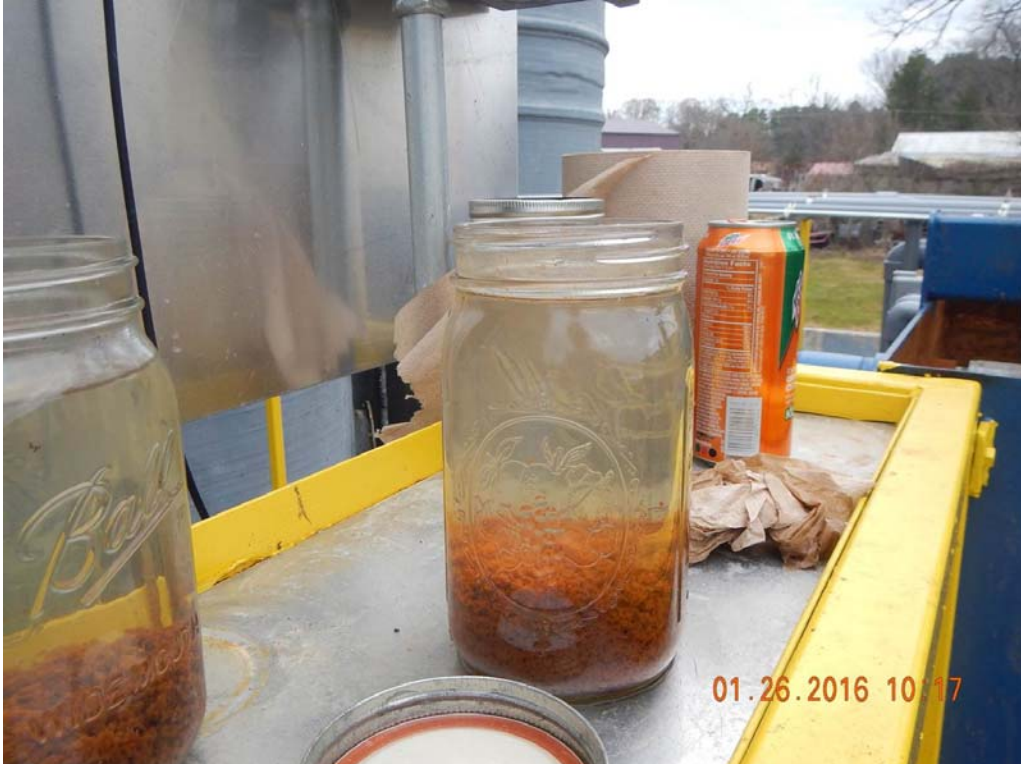
Location:	PJ'S Tank Wash		
Photographer:	Michael Young	Date:	01/26/2016
Time:	10:17	Witness:	Brian Hudson; Clark Reed; Cody Brickley
Photo #:	17	Description:	Sample of water in mixing zone.

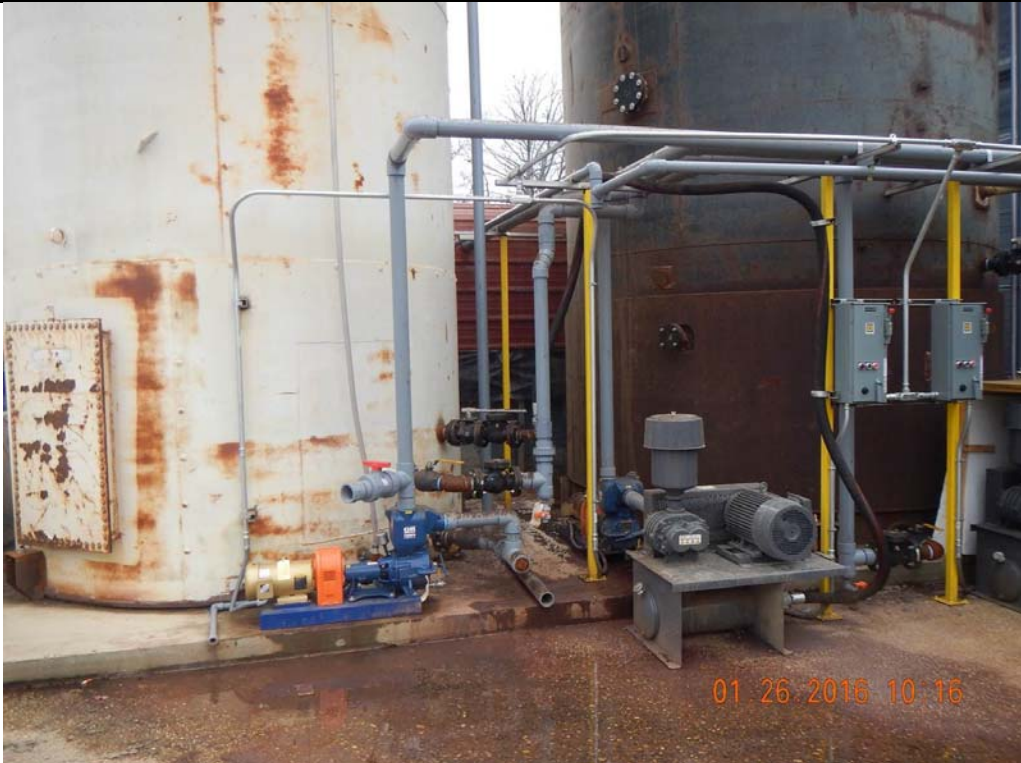
Photographer:	Michael Young	Date:	01/26/2016
Time:	10:16	Witness:	Brian Hudson; Clark Reed; Cody Brickley
Photo #:	18	Description:	Storage tanks for treated wash water. Currently hauling to ground injection well.

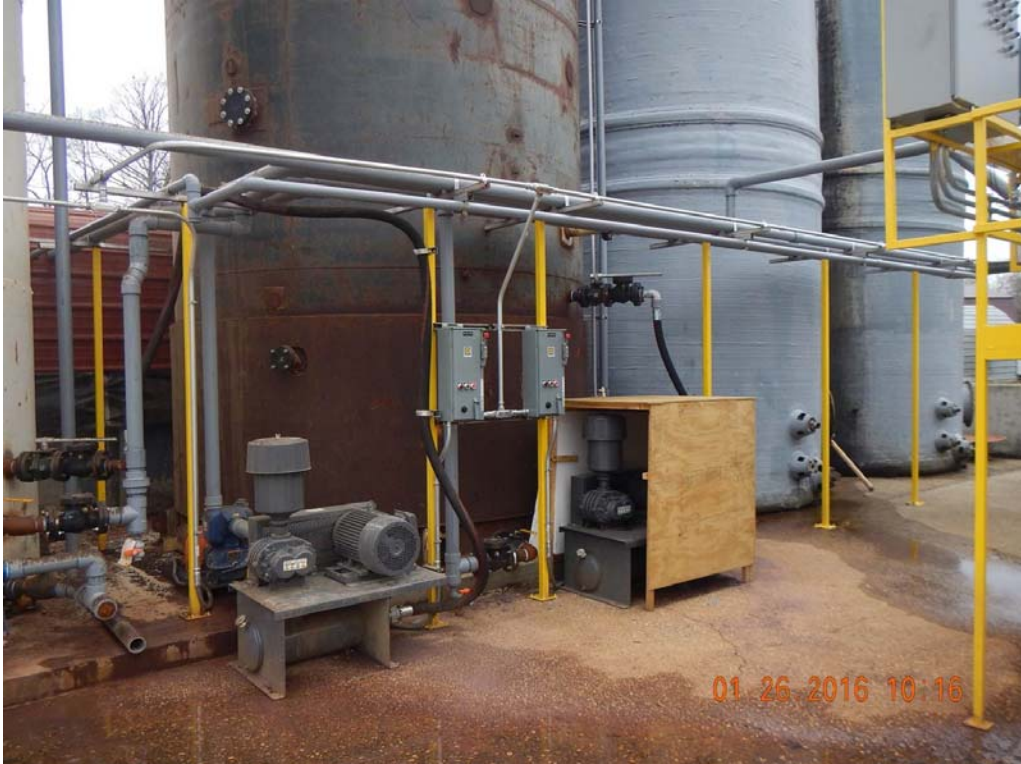
Location:	PJ'S Tank Wash		
Photographer:	Michael Young	Date:	01/26/2016
Time:	10:16	Witness:	Brian Hudson; Clark Reed; Cody Brickley
Photo #:	19	Description:	Additional storage tanks for treated wastewater. In secondary containment.

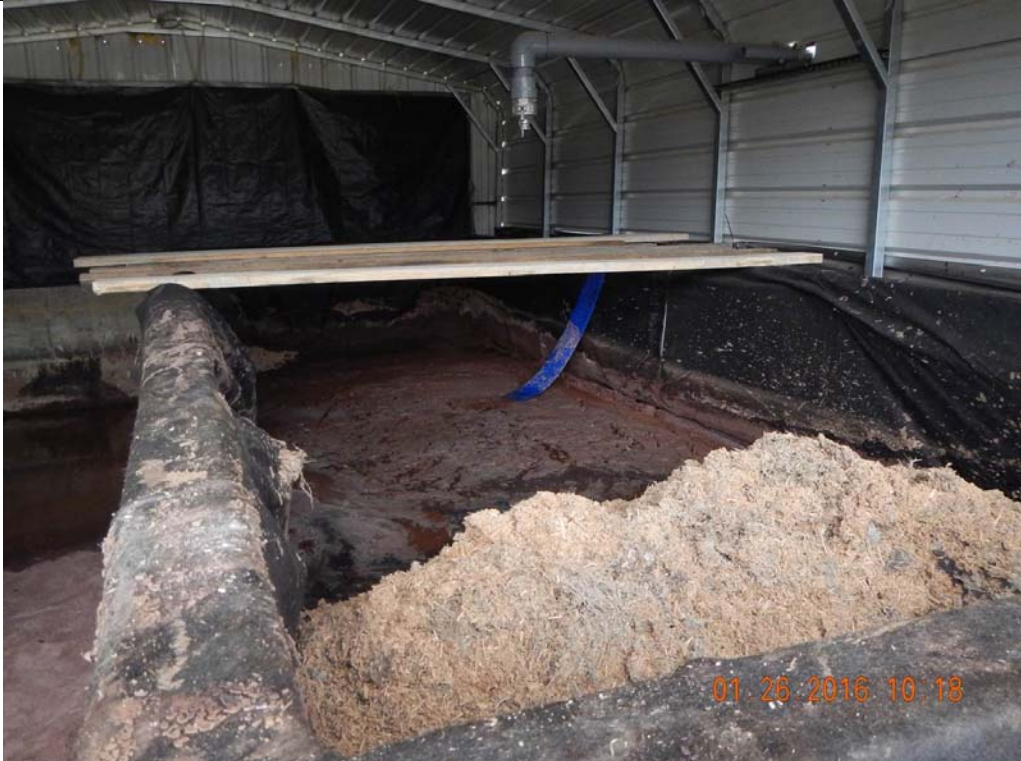
Photographer:	Michael Young	Date:	01/26/2016
Time:	10:18	Witness:	Brian Hudson; Clark Reed; Cody Brickley
Photo #:	20	Description:	Sludge storage area is covered and has secondary containment with sump pump.

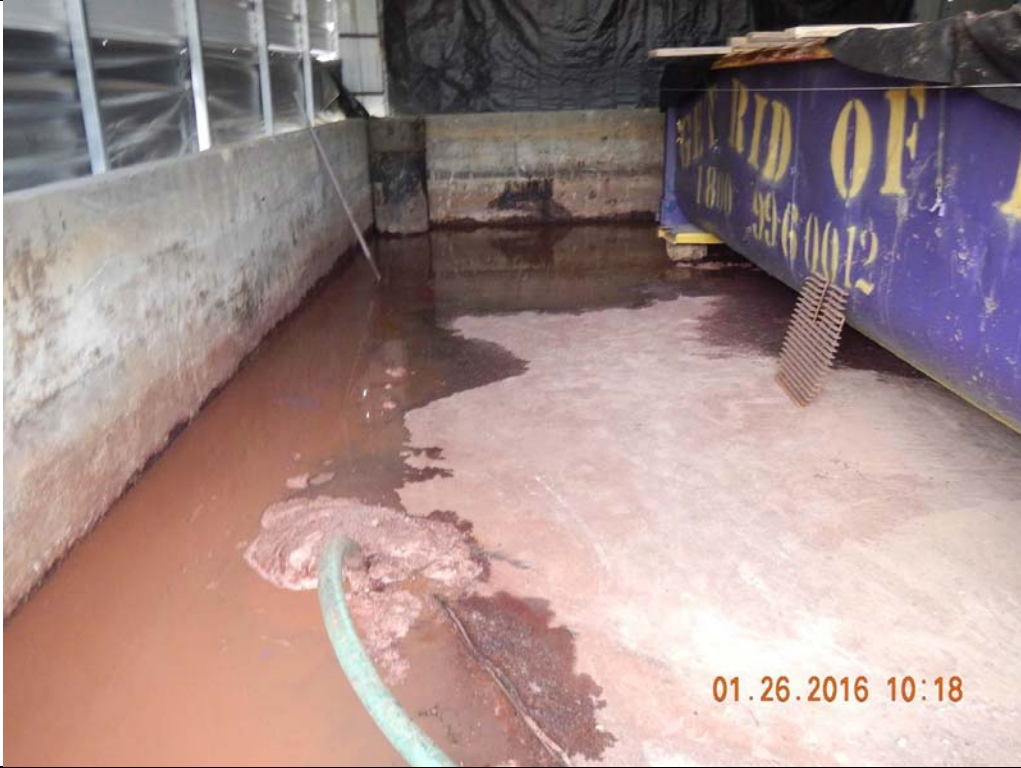
Location:	PJ'S Tank Wash		
Photographer:	Michael Young	Date:	01/26/2016
Time:	10:18	Witness:	Brian Hudson; Clark Reed; Cody Brickley
Photo #:	21	Description:	Area of concern with sludge storage, but staff assured that the area is pumped daily.

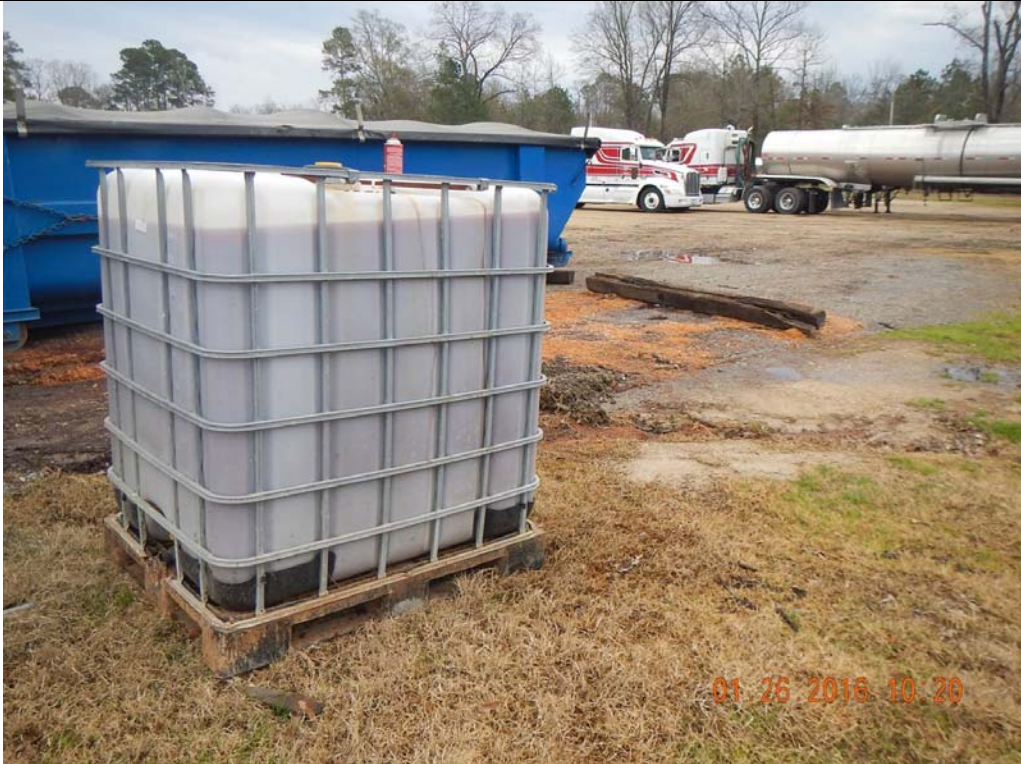
Photographer:	Michael Young	Date:	01/26/2016
Time:	10:20	Witness:	Brian Hudson; Clark Reed; Cody Brickley
Photo #:	22	Description:	Sludge storage container is hauled to landfill and remains covered until disposal.

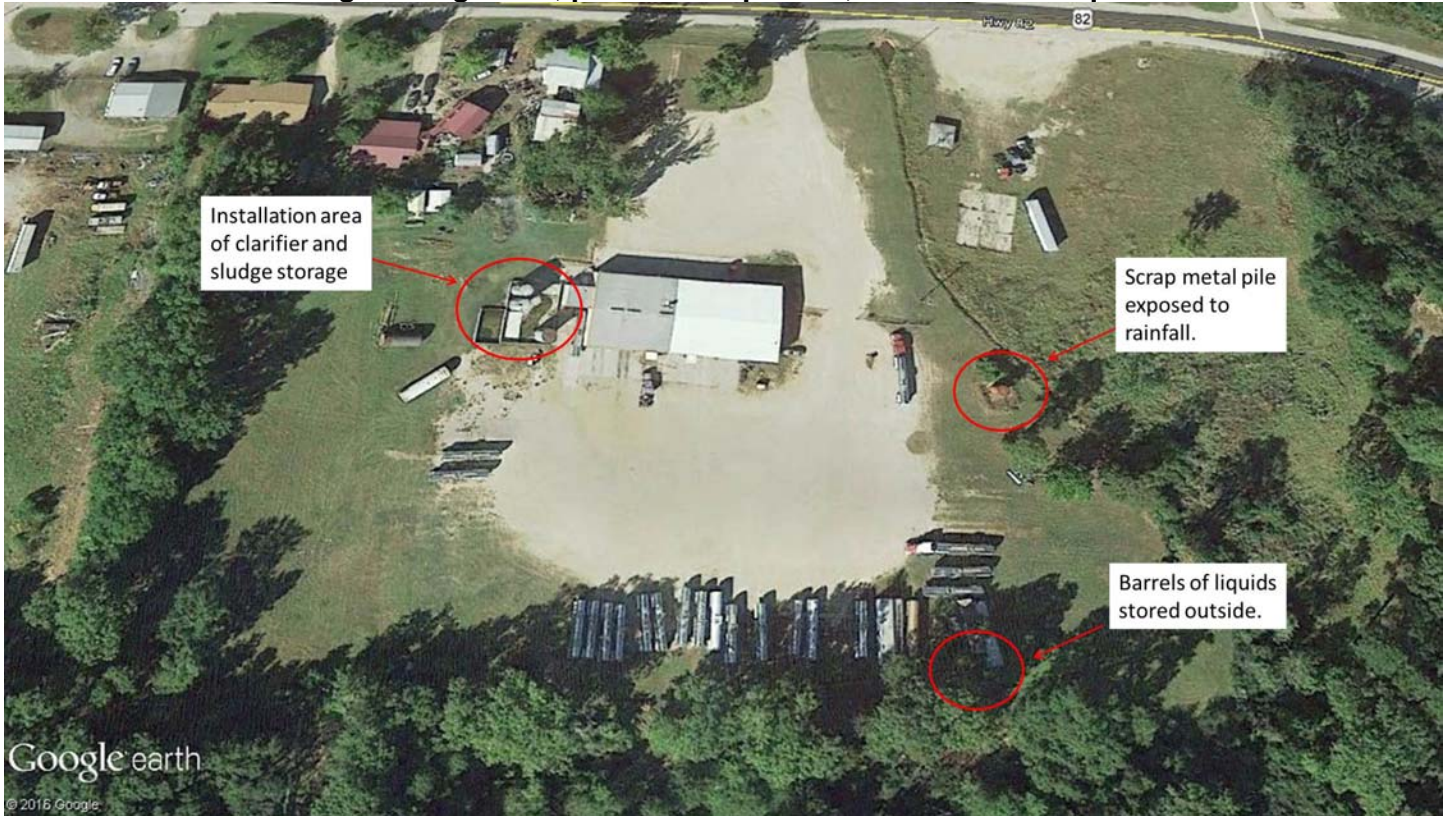
Figure 1. Overview of PJ'S Tank Wash in Crossett, AR. Locations identified are the installation area for the clarifier and sludge storage area, piles of scrap metal, and barrels of liquid stored outside.
