RE: Flint Creek Power Plant Class 3N Landfill
ADEQ Transmittal of Preliminary Site Investigation Report
AFIN: 04-00107 Permit No: 0273-S3N-R2
Document ID: 70741 Cross Reference: 70740

SUBJECT: Preliminary Site Investigation for the Proposed Lateral Expansion at the Flint Creek Power Plant Class 3N Landfill

Permit Number: 0273-S3N-R2 AFIN: 04-00107
Document ID: 70740 Cross Reference: 70529

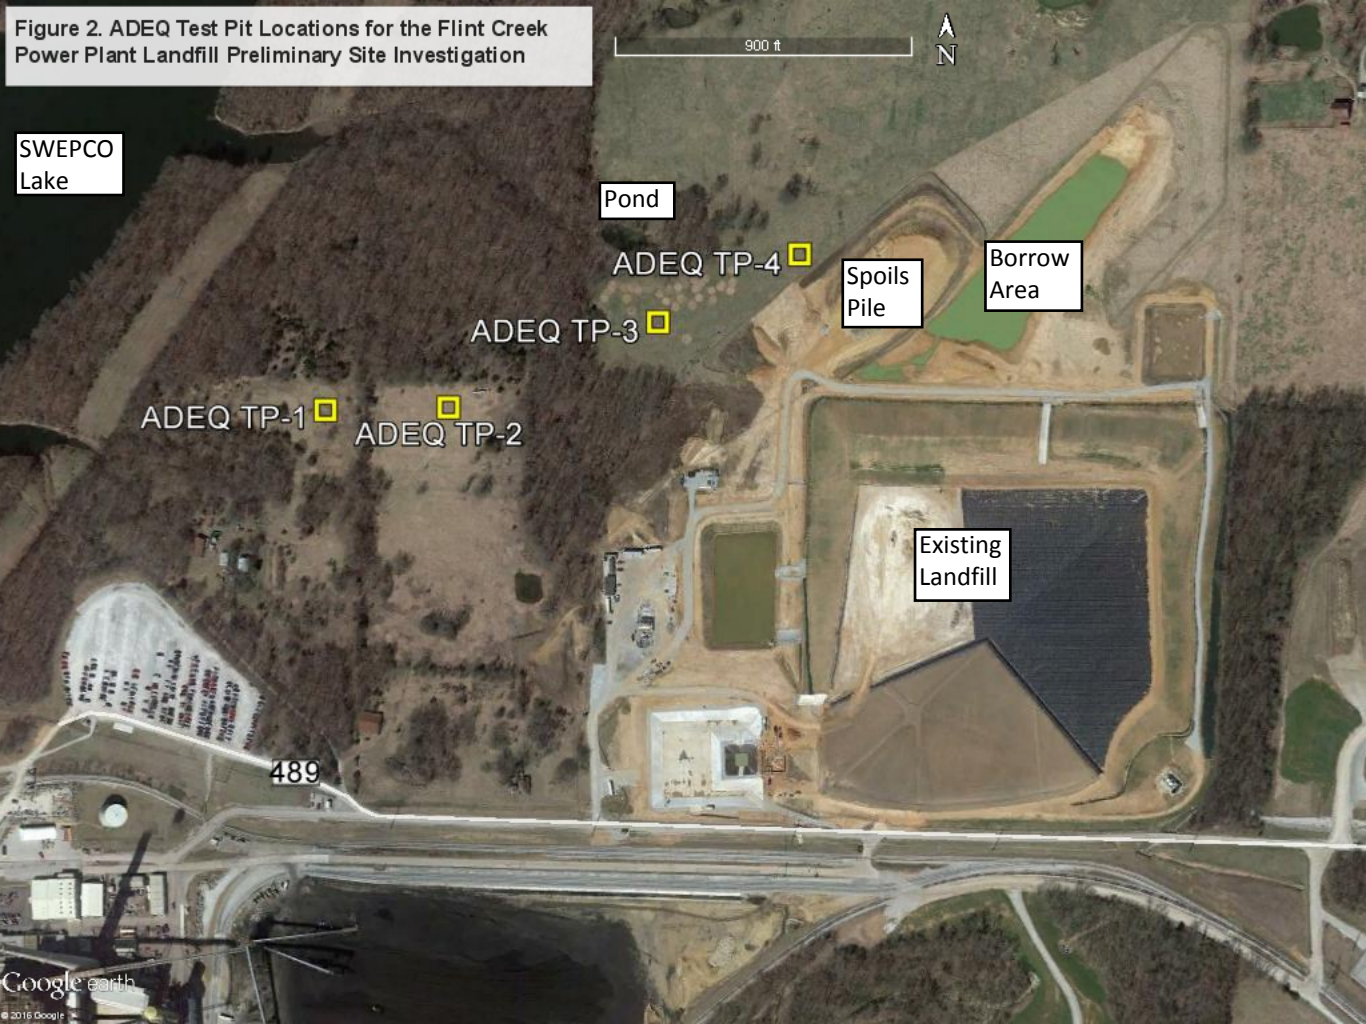
Figure 2. ADEQ Test Pit Locations for the Flint Creek Power Plant Landfill Preliminary Site Investigation

Four test pits were excavated during this investigation (ADEQ TP-1, ADEQ TP-2, ADEQ TP-3, and ADEQ TP-4). The locations are shown in Figure 2. Test pit photographs are attached.

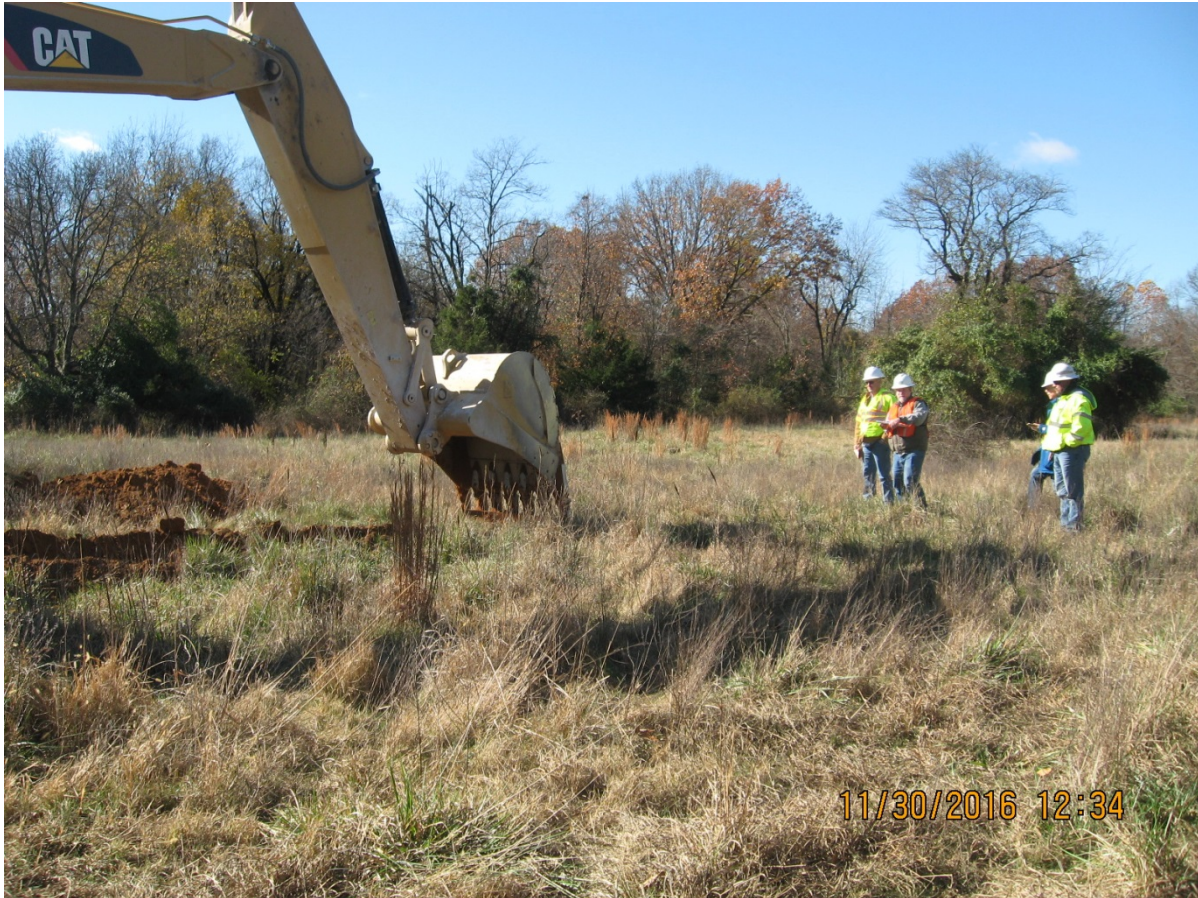
SITE NAME: Flint Creek Power Plant Landfill	PHOTO #: 1
SITE LOCATION: Gentry, Arkansas	
AFIN#: 04-00107	PERMIT # 0273-S3N-R2
PHOTOGRAPHER: Jenny Pearson <i>J.P.</i>	WITNESS: Bill Sadler <i>BS</i>
DATE: November 30, 2016	CAMERA: Canon PowerShot A560
DIRECTION: West	
SUBJECT: Excavating Test Pit ADEQ TP-1

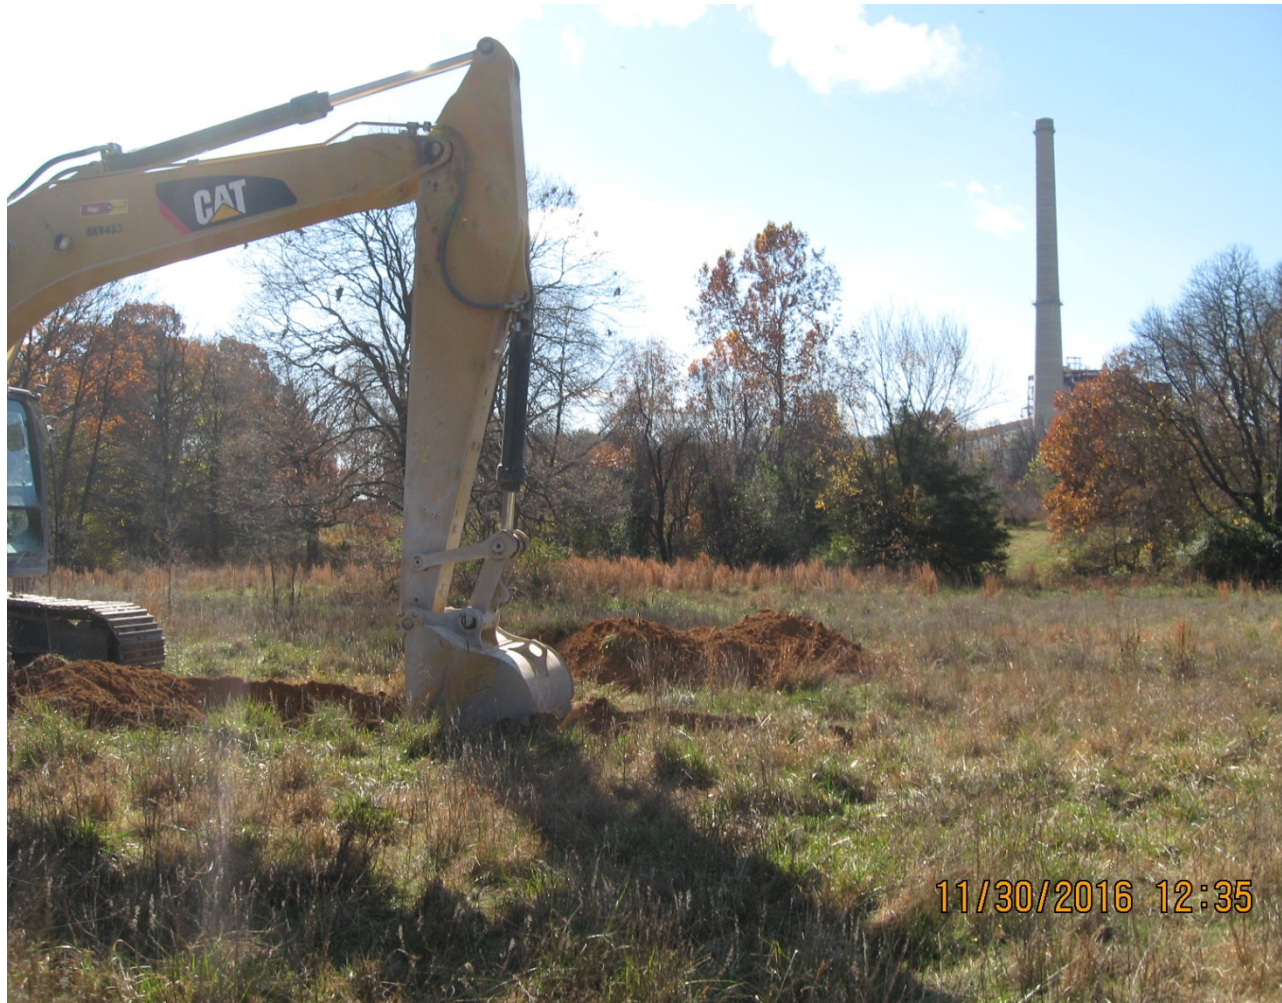
SITE NAME: Flint Creek Power Plant Landfill	PHOTO #: 2
SITE LOCATION: Gentry, Arkansas	
AFIN#: 04-00107	PERMIT # 0273-S3N-R2
PHOTOGRAPHER: Jenny Pearson <i>JP</i>	WITNESS: Bill Sadler <i>BS</i>
DATE: November 30, 2016	CAMERA: Canon PowerShot A560
DIRECTION: South - Southwest	
SUBJECT: Excavating Test Pit ADEQ TP-1; Power Plant in Background

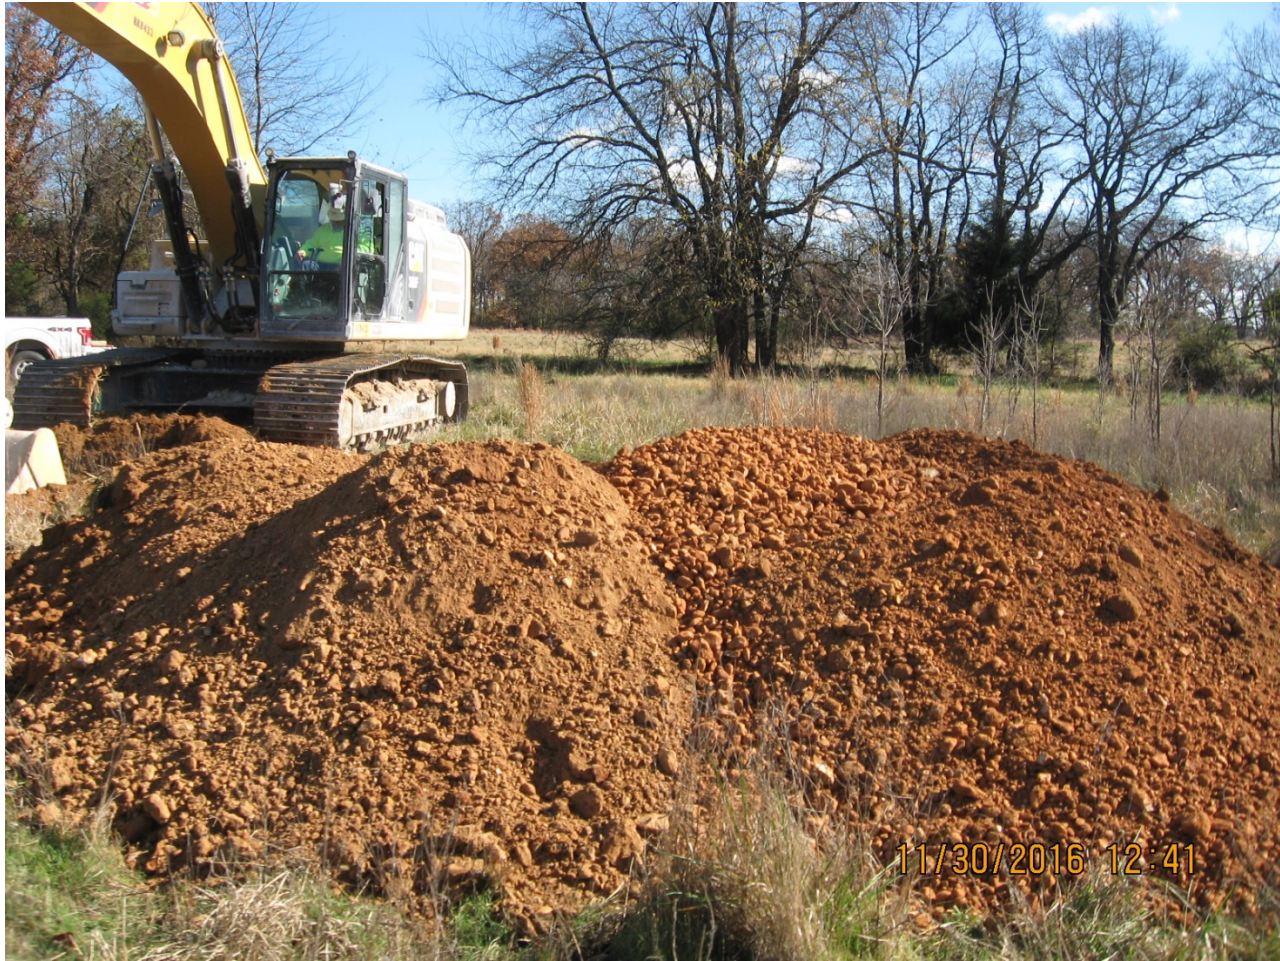
SITE NAME: Flint Creek Power Plant Landfill	PHOTO #: 3
SITE LOCATION: Gentry, Arkansas	
AFIN#: 04-00107	PERMIT # 0273-S3N-R2
PHOTOGRAPHER: Jenny Pearson <i>J.P.</i>	WITNESS: Bill Sadler <i>BS</i>
DATE: November 30, 2016	CAMERA: Canon PowerShot A560
DIRECTION: East	
SUBJECT: Excavated Materials at ADEQ TP-1; Note Gravel on top of pile

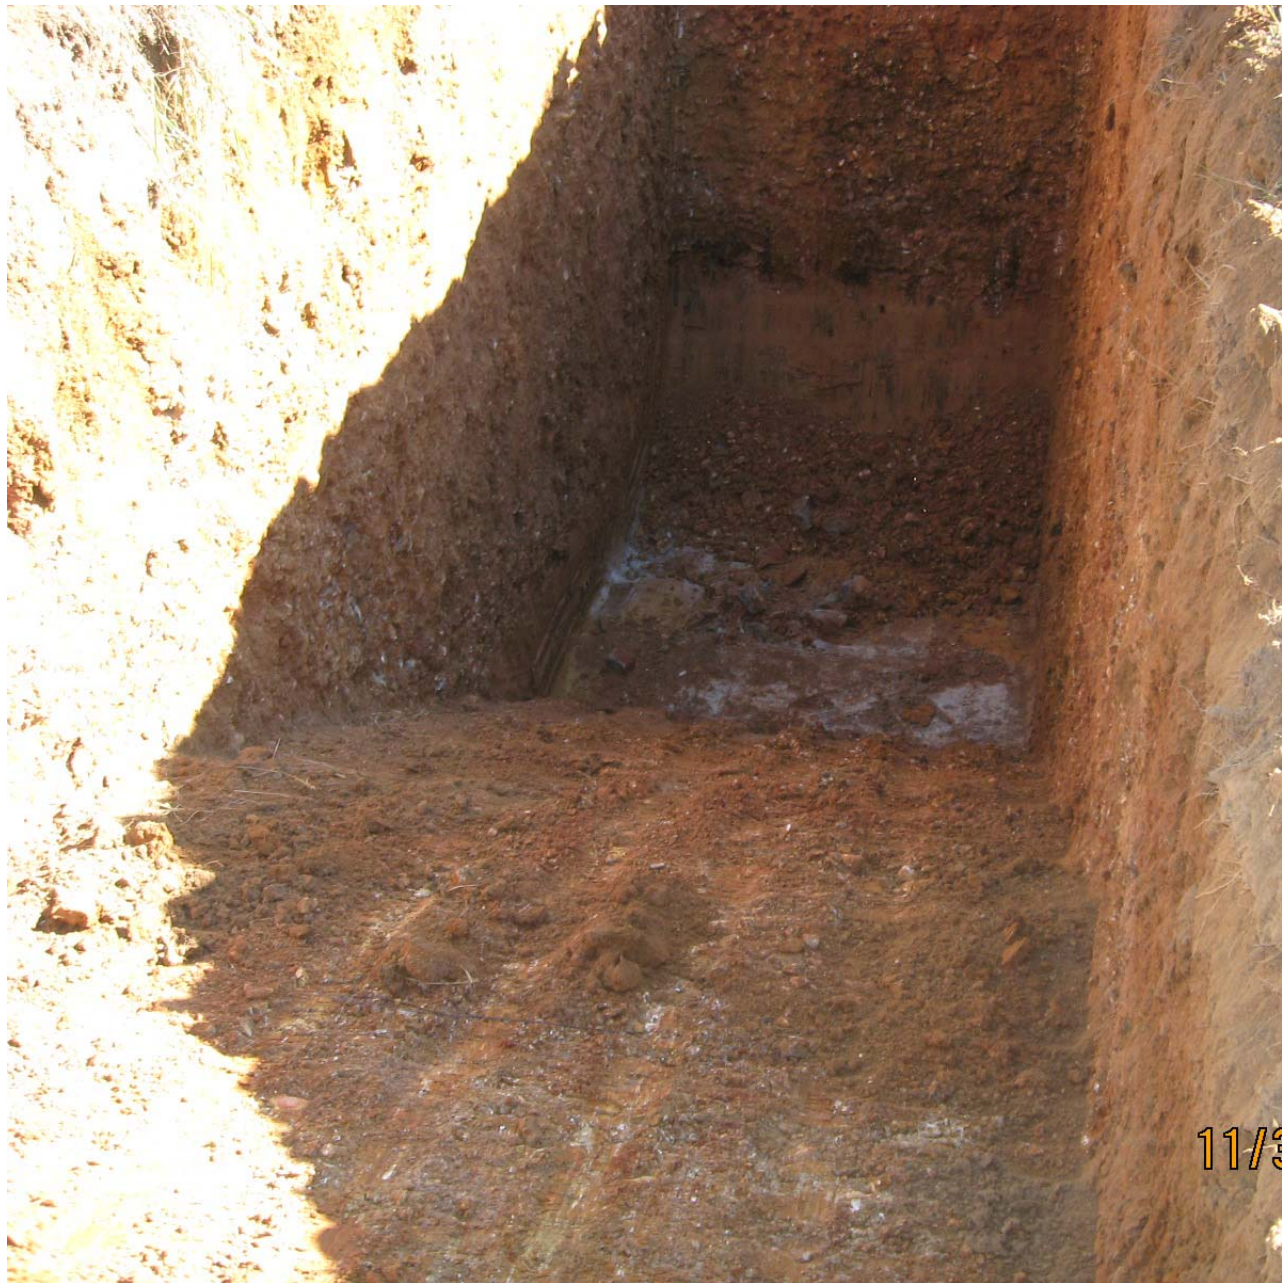
Trackhoe refusal on competent chert layer, recovered pieces of the chert

SITE NAME: Flint Creek Power Plant Landfill	PHOTO #: 4
SITE LOCATION: Gentry, Arkansas	
AFIN#: 04-00107	PERMIT # 0273-S3N-R2
PHOTOGRAPHER: Bill Sadler <i>BS</i>	WITNESS: Jenny Pearson <i>JP</i>
DATE: November 30, 2016	CAMERA: Canon PowerShot A560
DIRECTION: East	
SUBJECT: Test Pit ADEQ TP-1 at Final Depth; Note Gray Chert at bottom of Test Pit

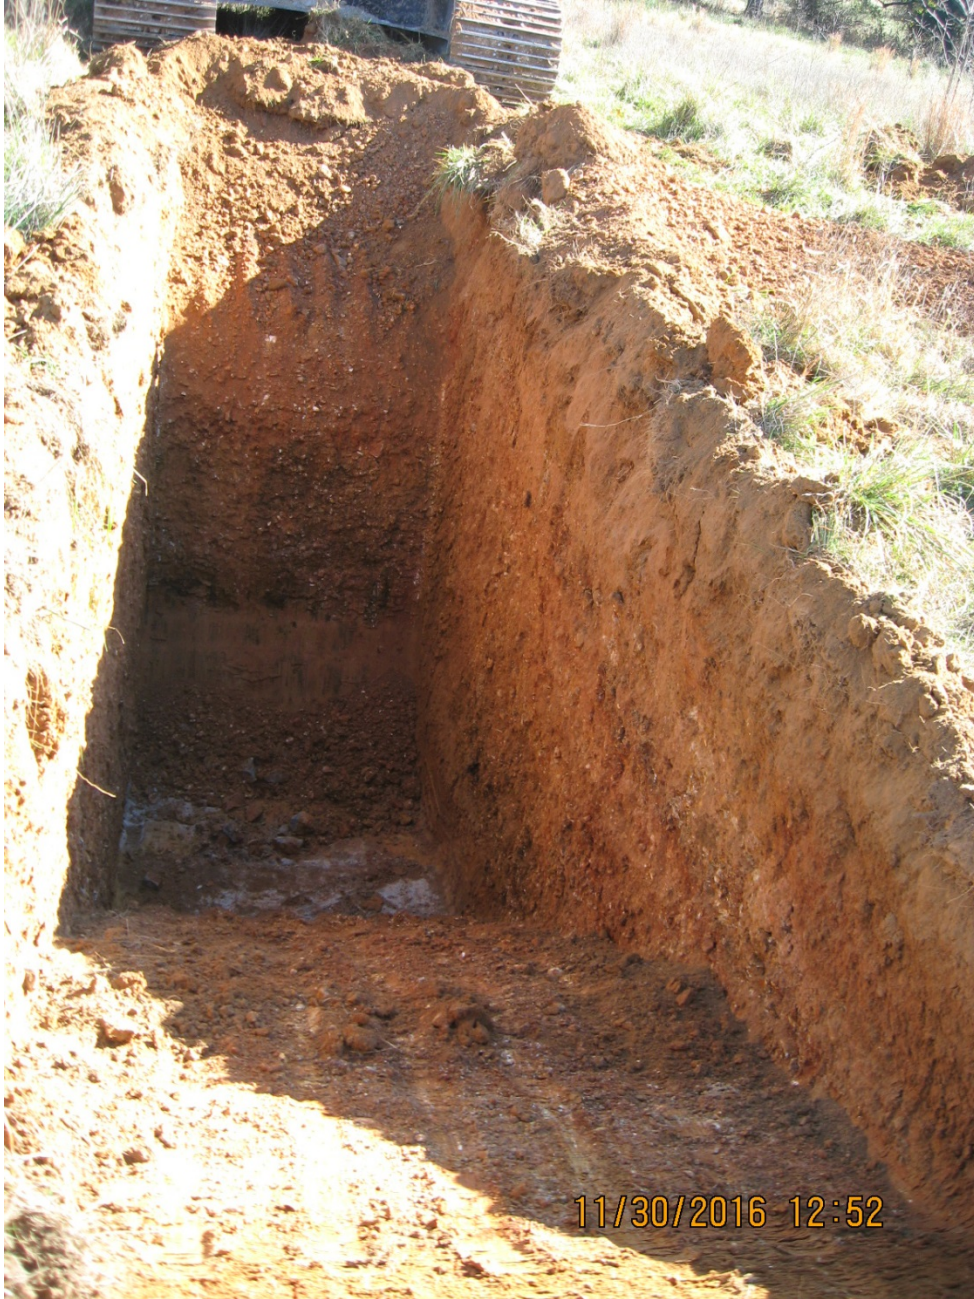
SITE NAME: Flint Creek Power Plant Landfill	PHOTO #: 5
SITE LOCATION: Gentry, Arkansas	
AFIN#: 04-00107	PERMIT # 0273-S3N-R2
PHOTOGRAPHER: Bill Sadler <i>BS</i>	WITNESS: Jenny Pearson <i>JP</i>
DATE: November 30, 2016	CAMERA: Canon PowerShot A560
DIRECTION: East	
SUBJECT: Test Pit ADEQ TP-1 at Final Depth; Note Gravel Zone on Side of Test Pit

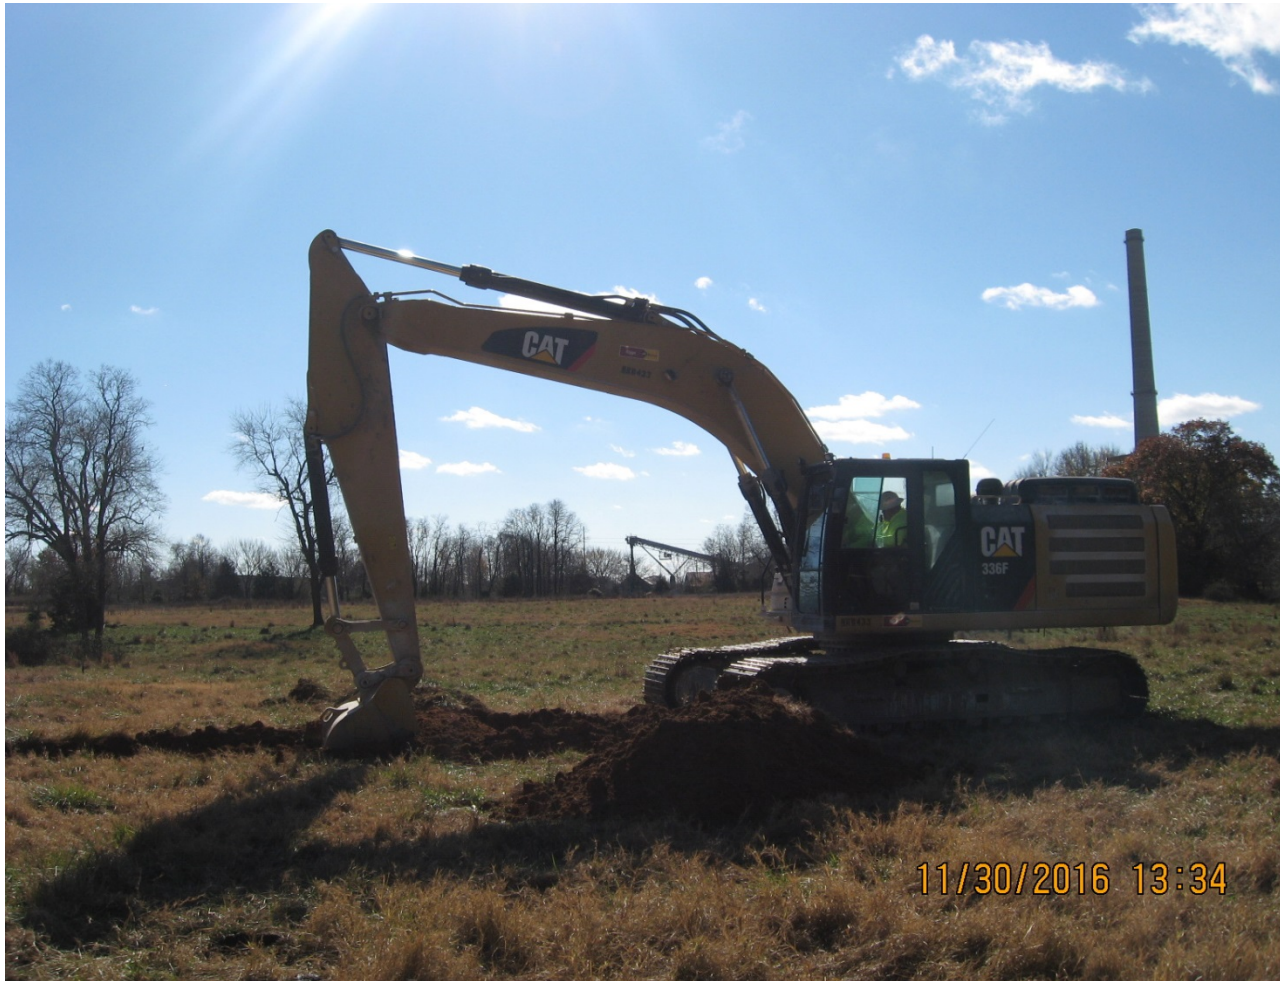
<u>Feet Depth</u>	<u>Lithology</u>
0 to 2.5	Silty Clay - soil with some gravel, reddish brown, slightly moist
2.5 to 9	Clayey Gravel – chert gravel up to several inches in diameter, white, competent, subrounded to subangular; clay brownish red, firm, moist
9 to 11	Silty Clay – small amount of gravel, brownish red, firm, moist
11	Chert – competent layer, gray

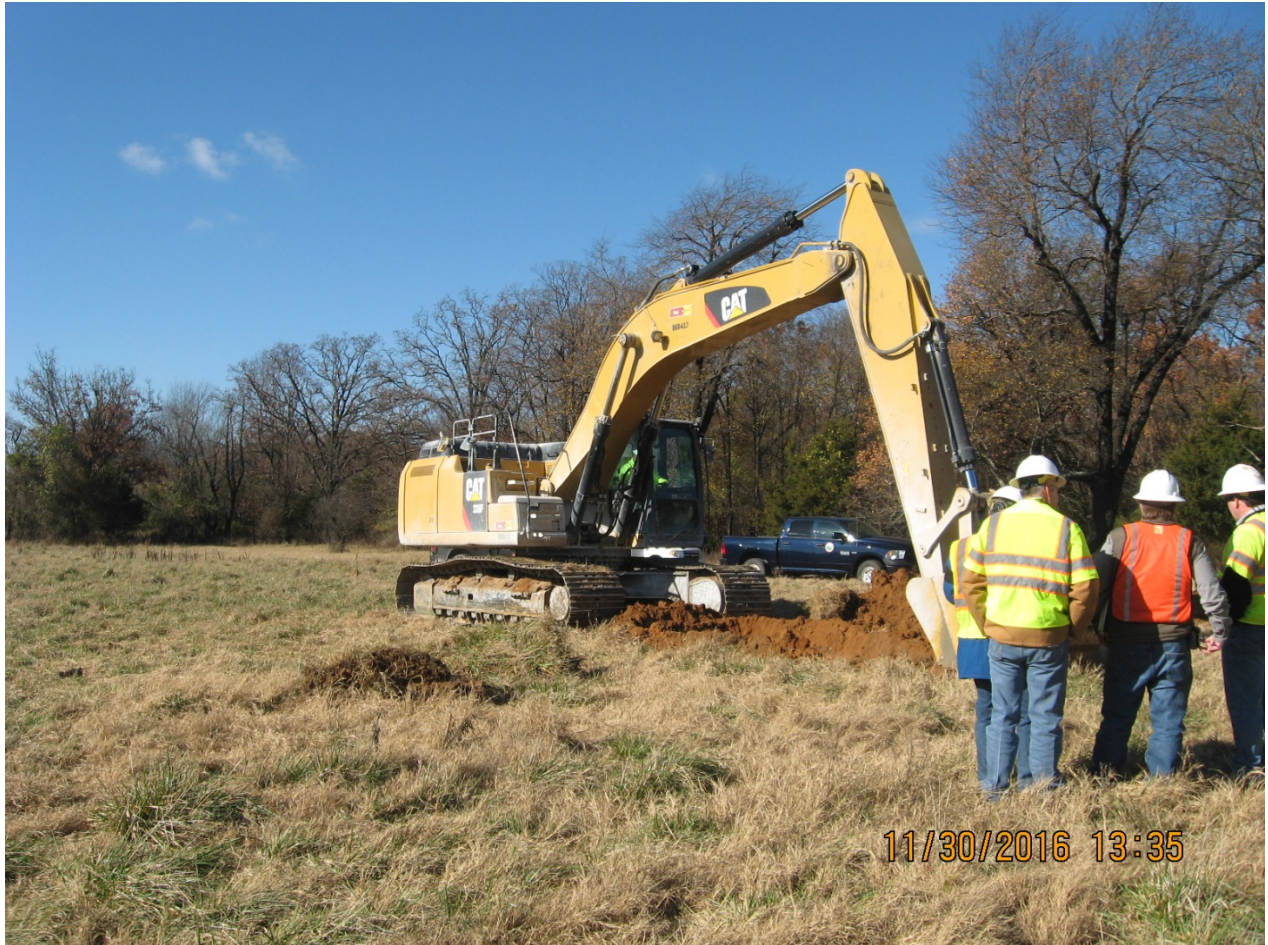
SITE NAME: Flint Creek Power Plant Landfill	PHOTO #: 6
SITE LOCATION: Gentry, Arkansas	
AFIN#: 04-00107	PERMIT # 0273-S3N-R2
PHOTOGRAPHER: Jenny Pearson <i>J.P.</i>	WITNESS: Bill Sadler <i>BS</i>
DATE: November 30, 2016	CAMERA: Canon PowerShot A560
DIRECTION: South	
SUBJECT: Excavating at Test Pit ADEQ TP-2; Note Power Plant in Background

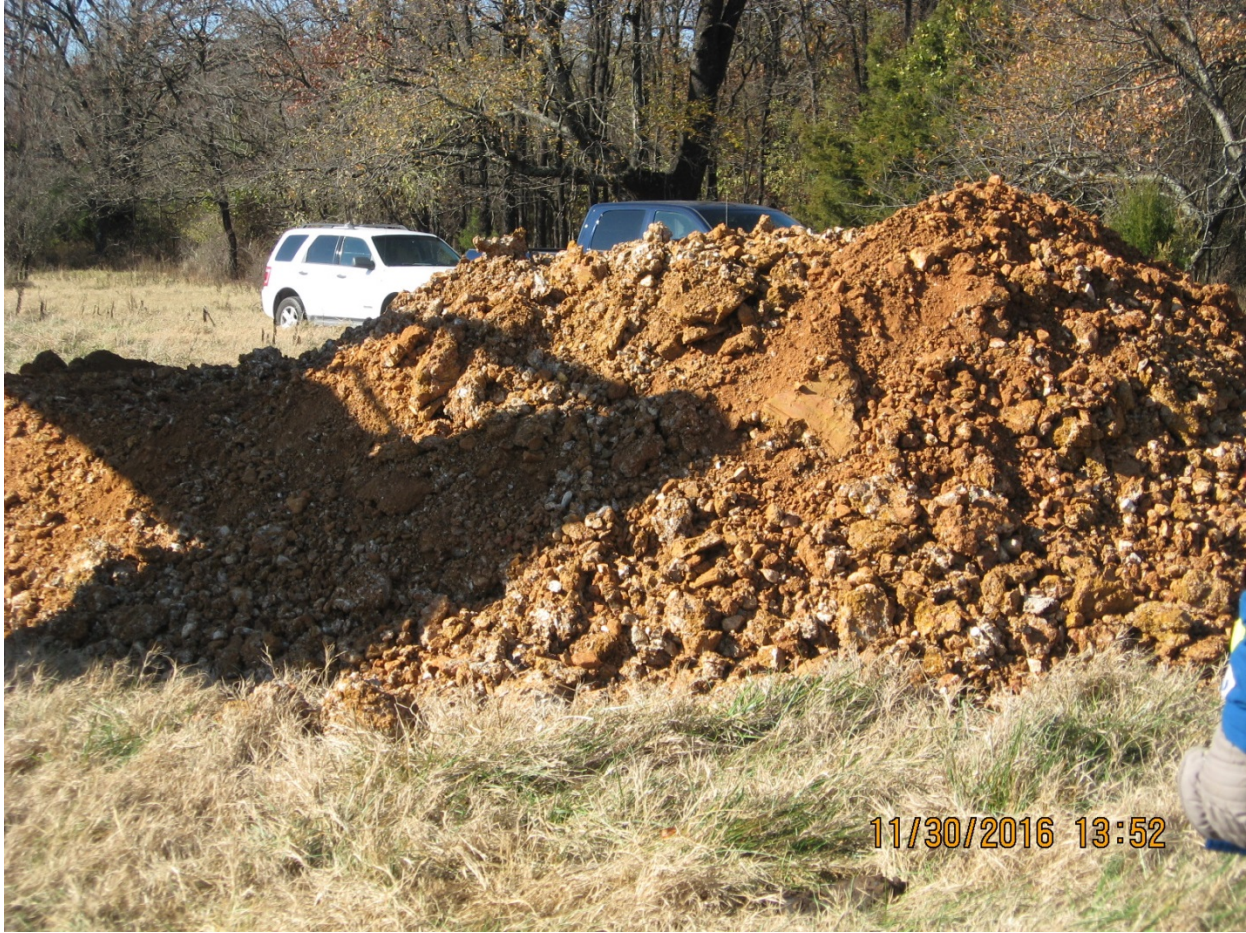
SITE NAME: Flint Creek Power Plant Landfill	PHOTO #: 8
SITE LOCATION: Gentry, Arkansas	
AFIN#: 04-00107	PERMIT # 0273-S3N-R2
PHOTOGRAPHER: Bill Sadler <i>BS</i>	WITNESS: Jenny Pearson <i>JP</i>
DATE: November 30, 2016	CAMERA: Canon PowerShot A560
DIRECTION: Northwest	
SUBJECT: Excavated Materials at ADEQ TP-2

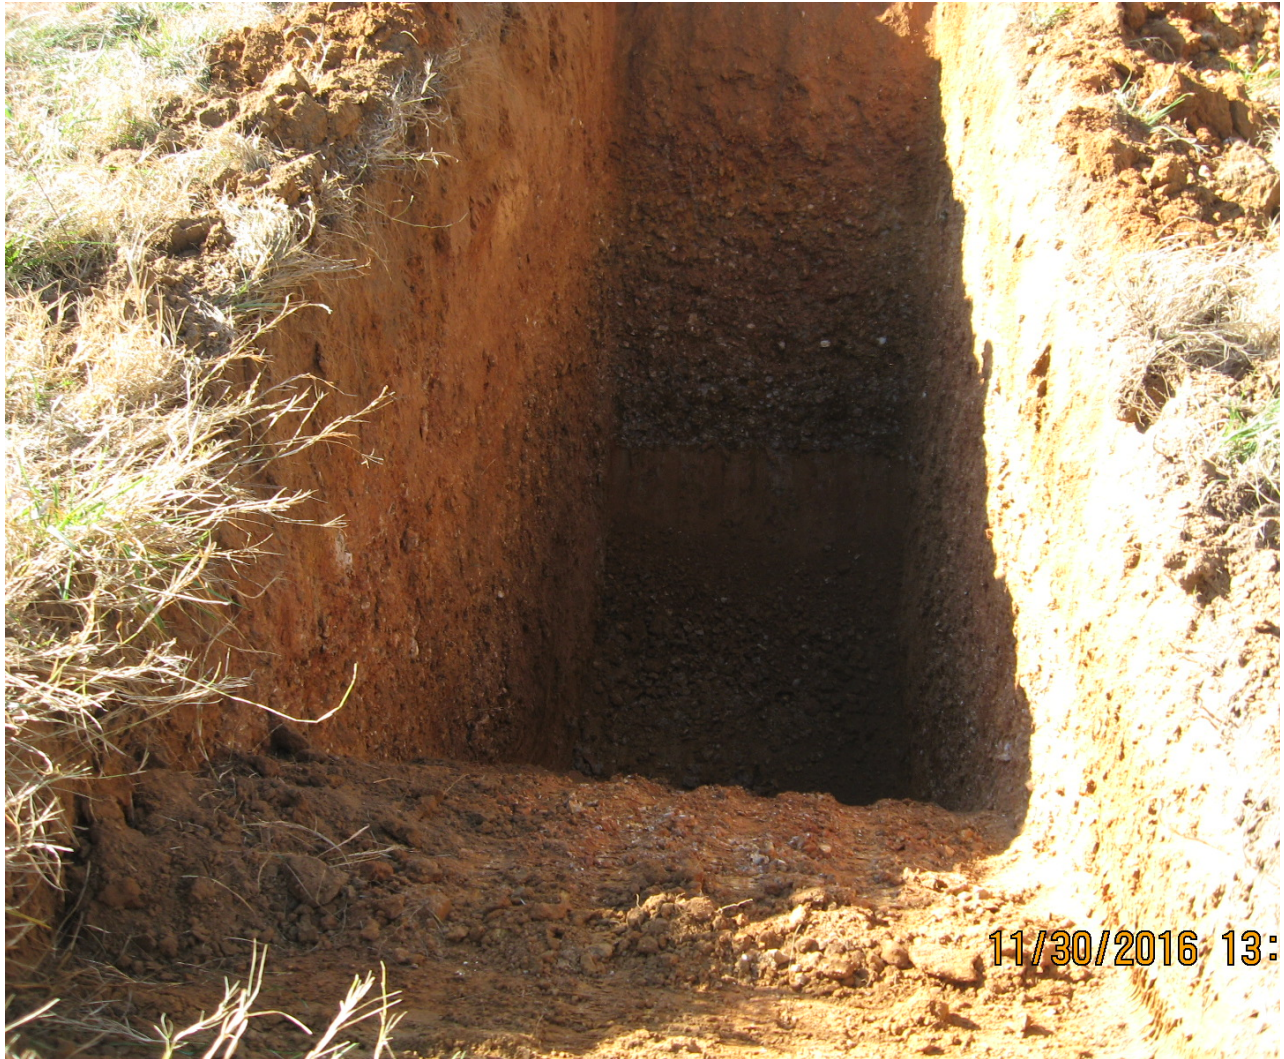
SITE NAME: Flint Creek Power Plant Landfill	PHOTO #: 9
SITE LOCATION: Gentry, Arkansas	
AFIN#: 04-00107	PERMIT # 0273-S3N-R2
PHOTOGRAPHER: Bill Sadler <i>BS</i>	WITNESS: Jenny Pearson <i>JP</i>
DATE: November 30, 2016	CAMERA: Canon PowerShot A560
DIRECTION: West	
SUBJECT: Test Pit ADEQ TP-2

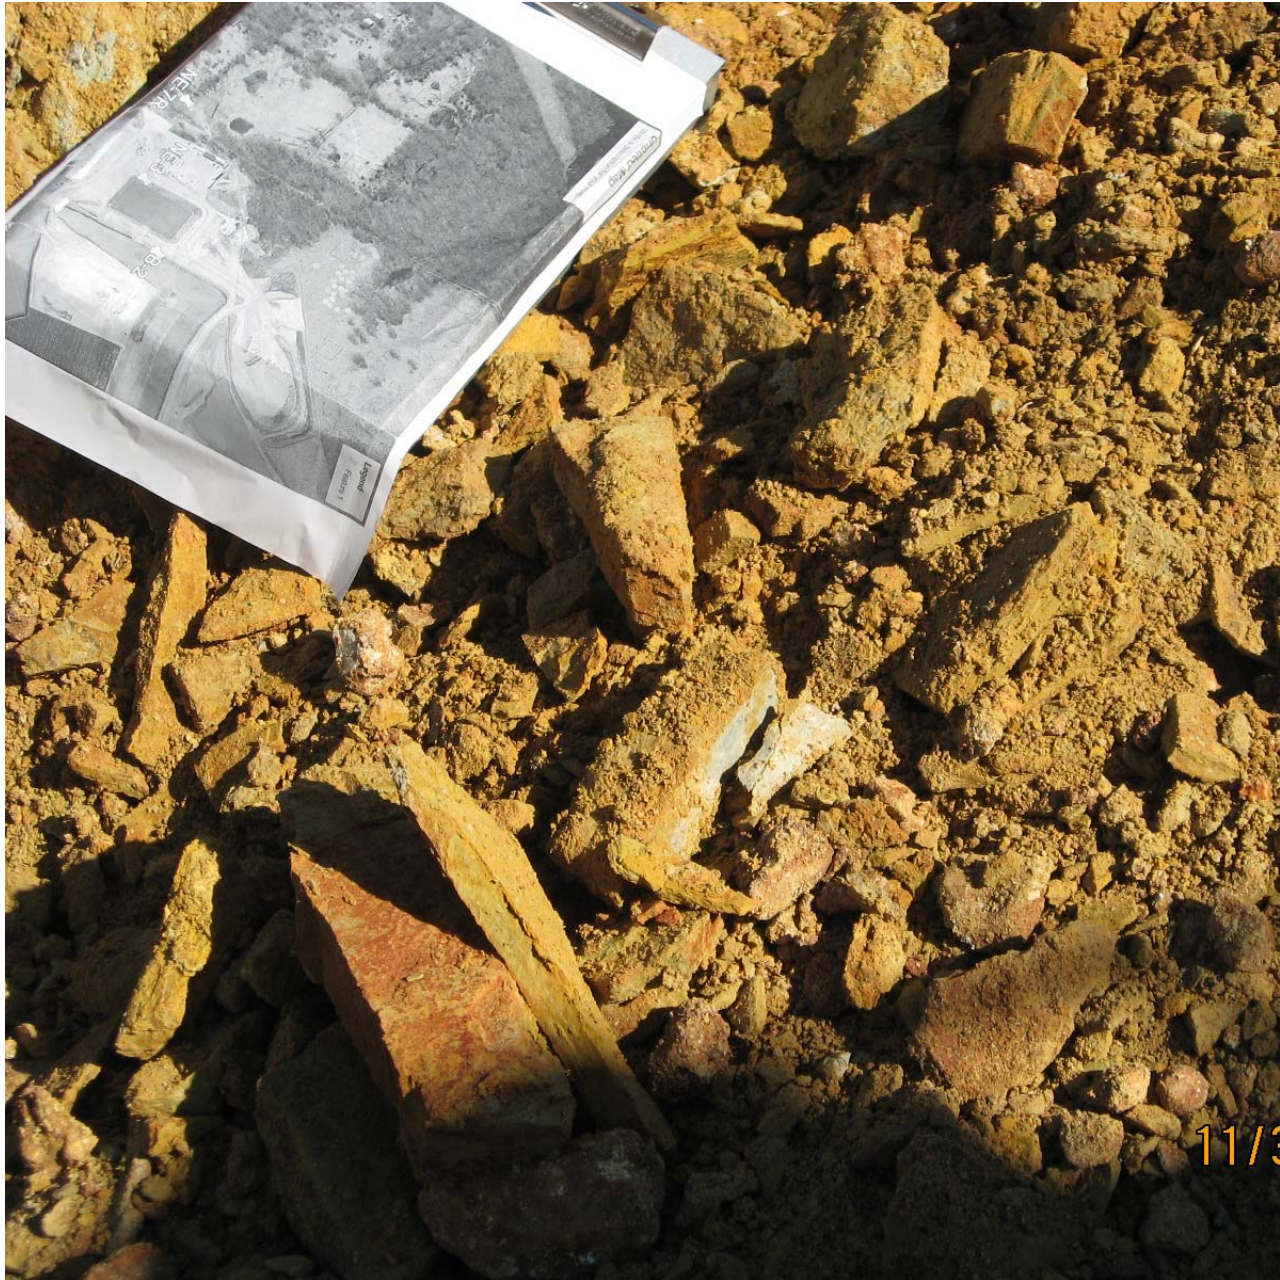
- a. the competent subrounded to subangular chert gravel which has been rounded by moving water and was found in all four of the test pits; and
- b. the silty sandstone found in test pit ADEQ TP-2.

SITE NAME: Flint Creek Power Plant Landfill	PHOTO #: 10
SITE LOCATION: Gentry, Arkansas	
AFIN#: 04-00107	PERMIT # 0273-S3N-R2
PHOTOGRAPHER: Jenny Pearson <i>J.P.</i>	WITNESS: Bill Sadler <i>BS</i>
DATE: November 30, 2016	CAMERA: Canon PowerShot A560
DIRECTION: East	
SUBJECT: Excavated Materials from ADEQ TP-2; Note Silty Sandstone Blocks on Top

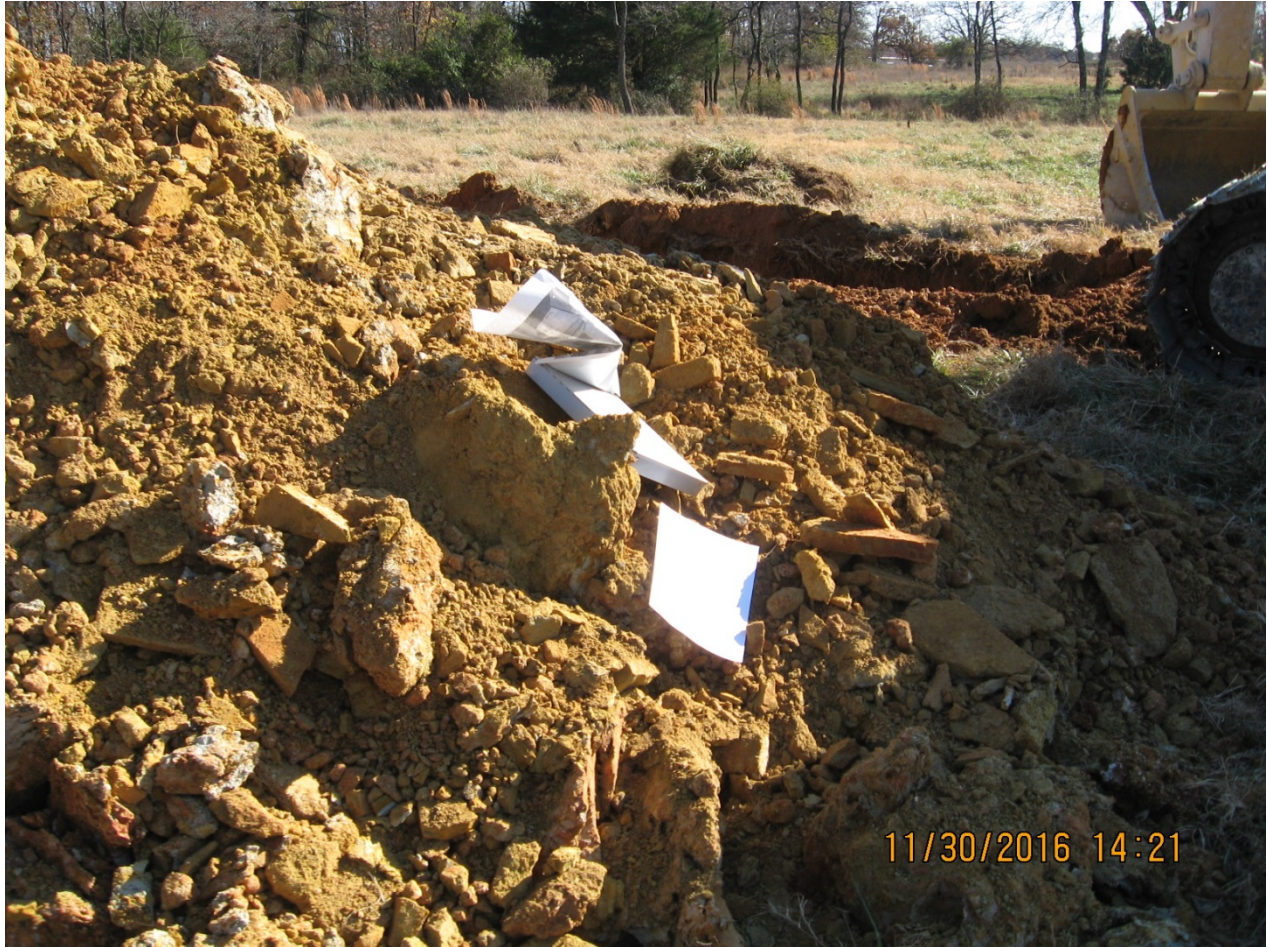
DATE: November 30, 2016	CAMERA: Canon PowerShot A560
DIRECTION: East	
SUBJECT: Excavated Materials from ADEQ TP-2;

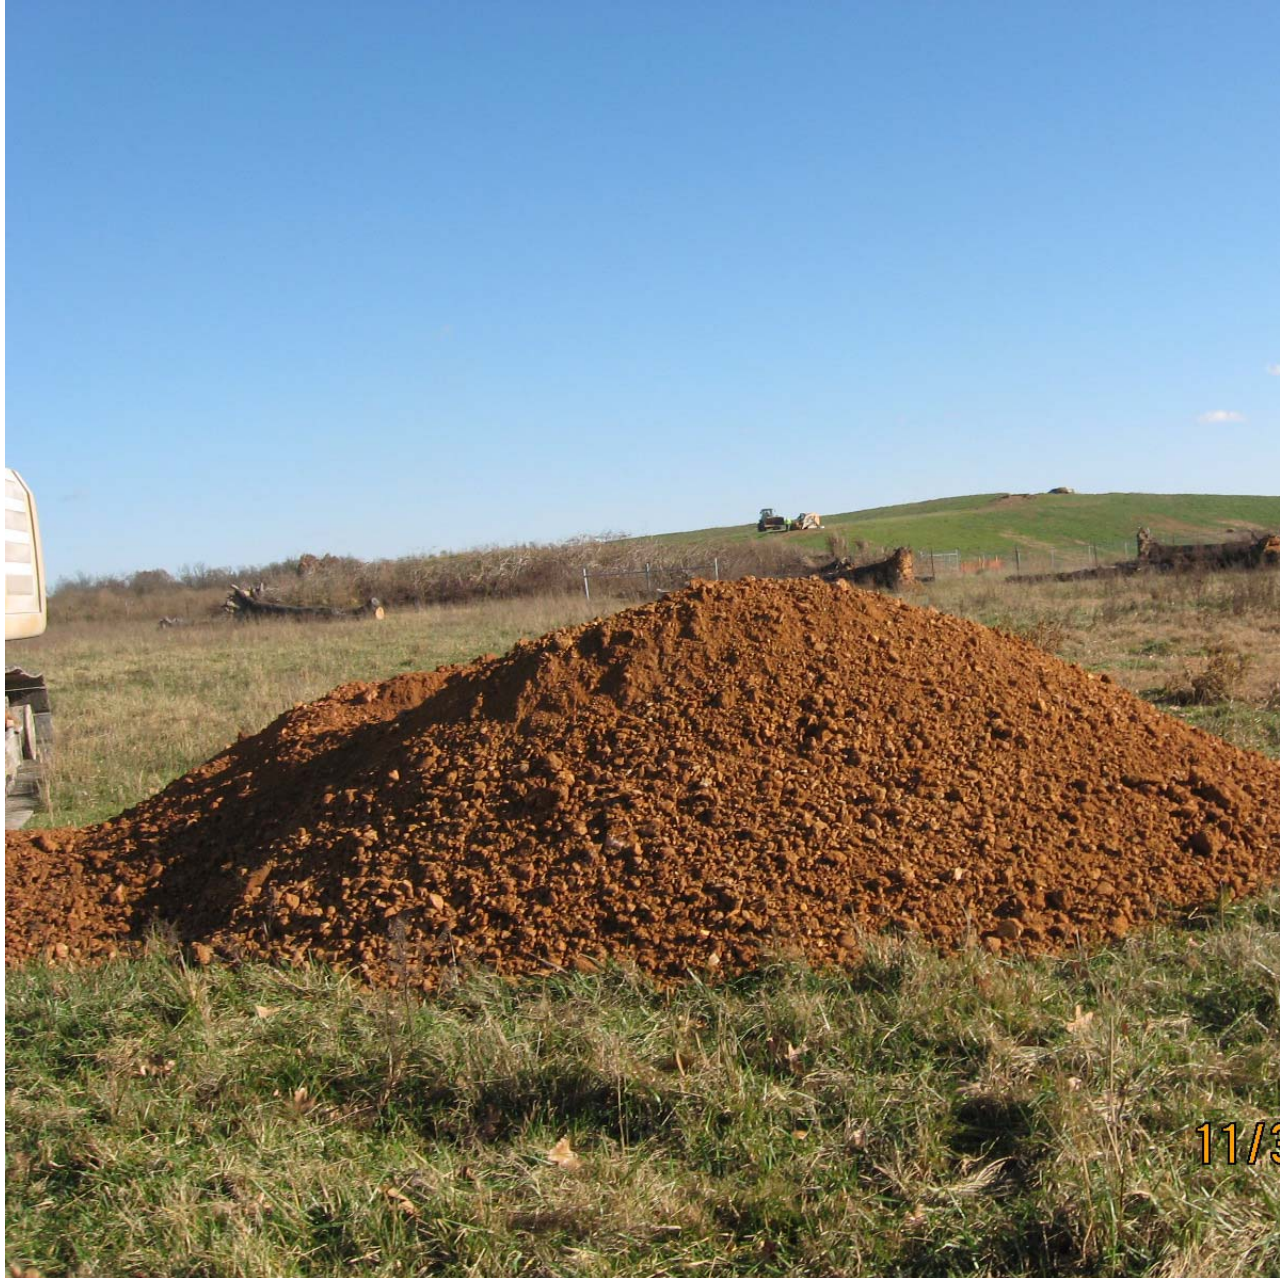
DATE: November 30, 2016	CAMERA: Canon PowerShot A560
DIRECTION: Southwest	
SUBJECT: About to Begin Excavating Test Pit ADEQ TP-3

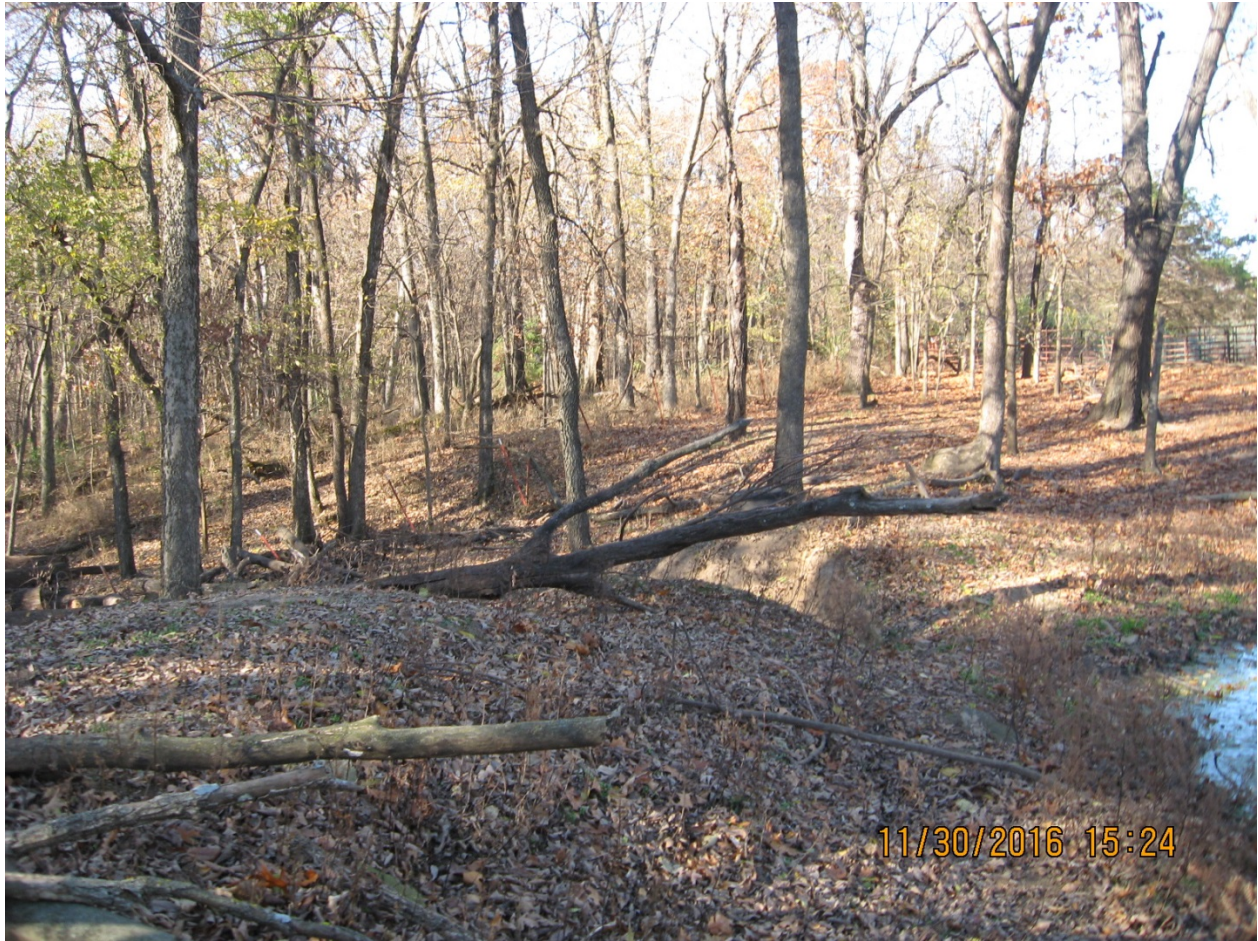
SITE NAME: Flint Creek Power Plant Landfill	PHOTO #: 18
SITE LOCATION: Gentry, Arkansas	
AFIN#: 04-00107	PERMIT # 0273-S3N-R2
PHOTOGRAPHER: Jenny Pearson <i>J.P.</i>	WITNESS: Bill Sadler <i>BS</i>
DATE: November 30, 2016	CAMERA: Canon PowerShot A560
DIRECTION: Northwest	
SUBJECT: Pond Levee for Pond on Northern Boundary of Proposed Expansion Area; Facility personnel said that pond levee was breached during a high rainfall event.

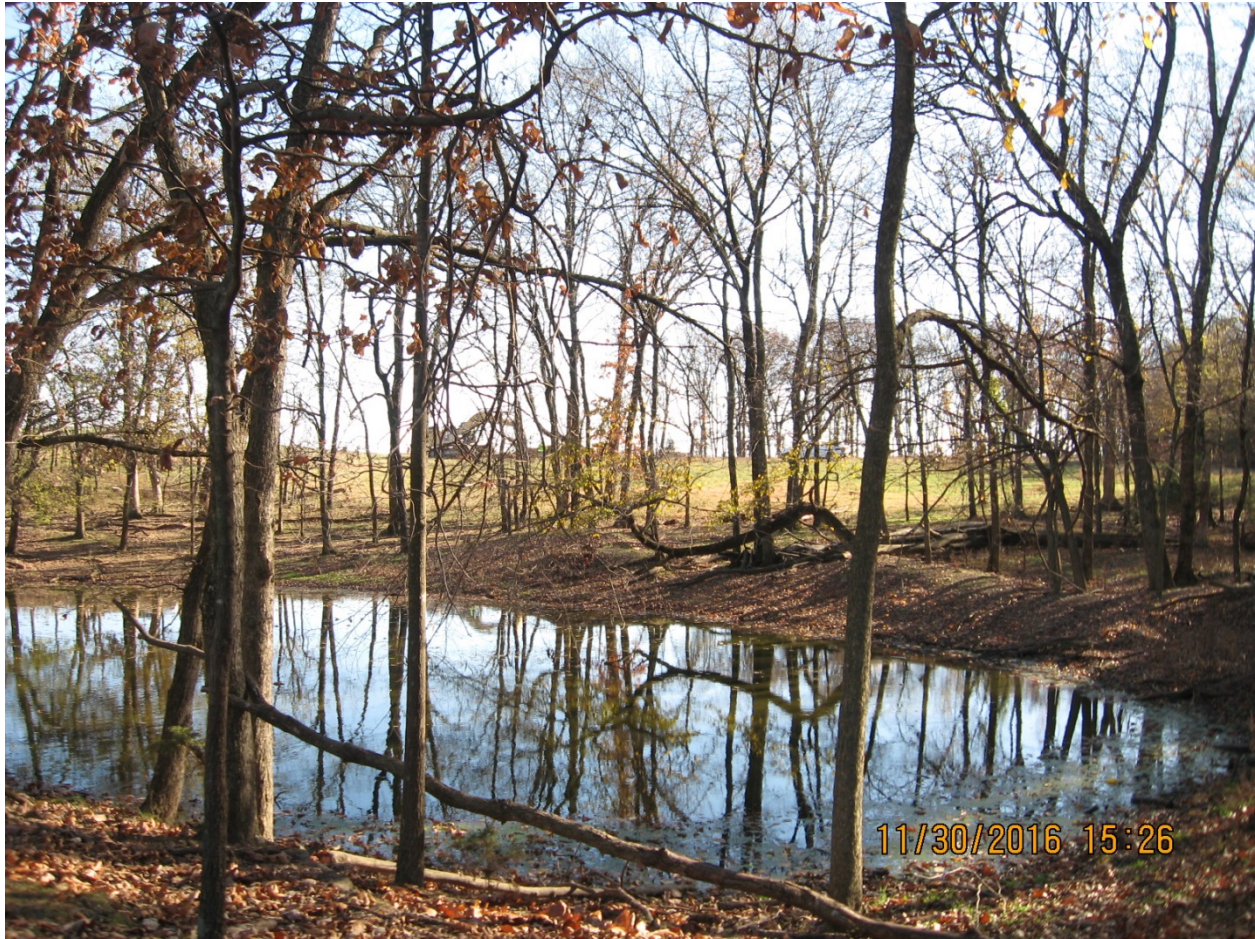
SITE NAME: Flint Creek Power Plant Landfill	PHOTO #: 19
SITE LOCATION: Gentry, Arkansas	
AFIN#: 04-00107	PERMIT # 0273-S3N-R2
PHOTOGRAPHER: Jenny Pearson <i>J.P.</i>	WITNESS: Bill Sadler <i>BS</i>
DATE: November 30, 2016	CAMERA: Canon PowerShot A560
DIRECTION: West	
SUBJECT: Drainage West of Pond along Northern Border of Expansion

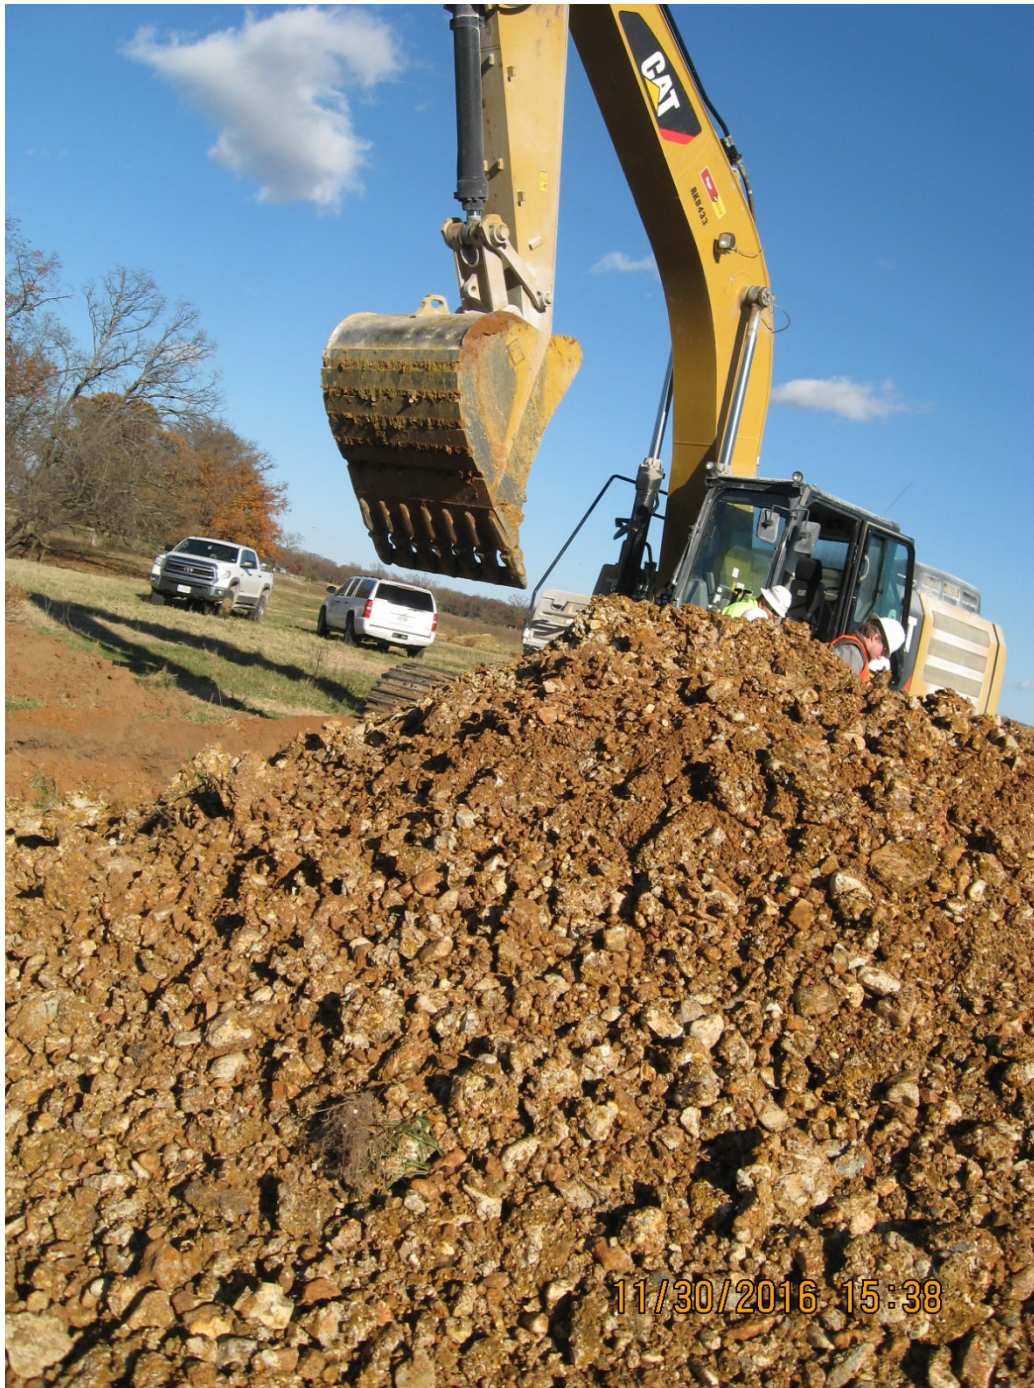
DATE: November 30, 2016	CAMERA: Canon PowerShot A560
DIRECTION: Northeast	
SUBJECT: Excavated Materials at Test Pit ADEQ TP-3; Note Clayey Gravel
