RE: Flint Creek Power Plant Class 3N Landfill
ADEQ Transmittal of Preliminary Site Investigation Report
AFIN: 04-00107 Permit No: 0273-S3N-R2
Document ID: 70741 Cross Reference: 70740

SUBJECT: Preliminary Site Investigation for the Proposed Lateral Expansion at the Flint Creek Power Plant Class 3N Landfill

Permit Number: 0273-S3N-R2 AFIN: 04-00107
Document ID: 70740 Cross Reference: 70529

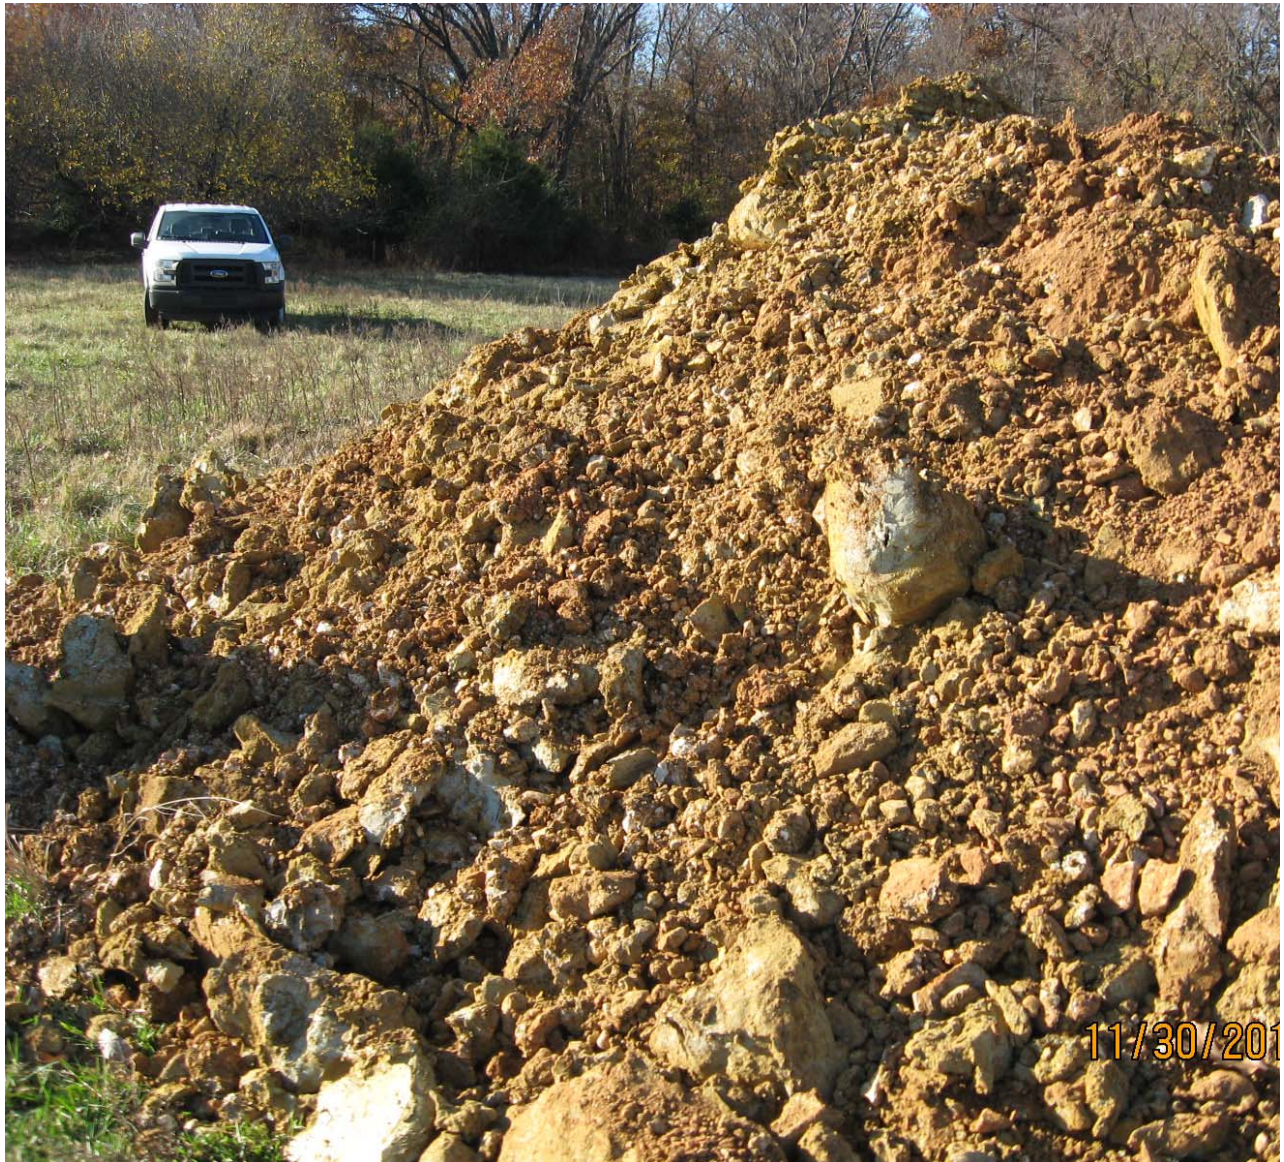
DATE: November 30, 2016	CAMERA: Canon PowerShot A560
DIRECTION: West	
SUBJECT: Excavated Materials at Test Pit ADEQ TP-3

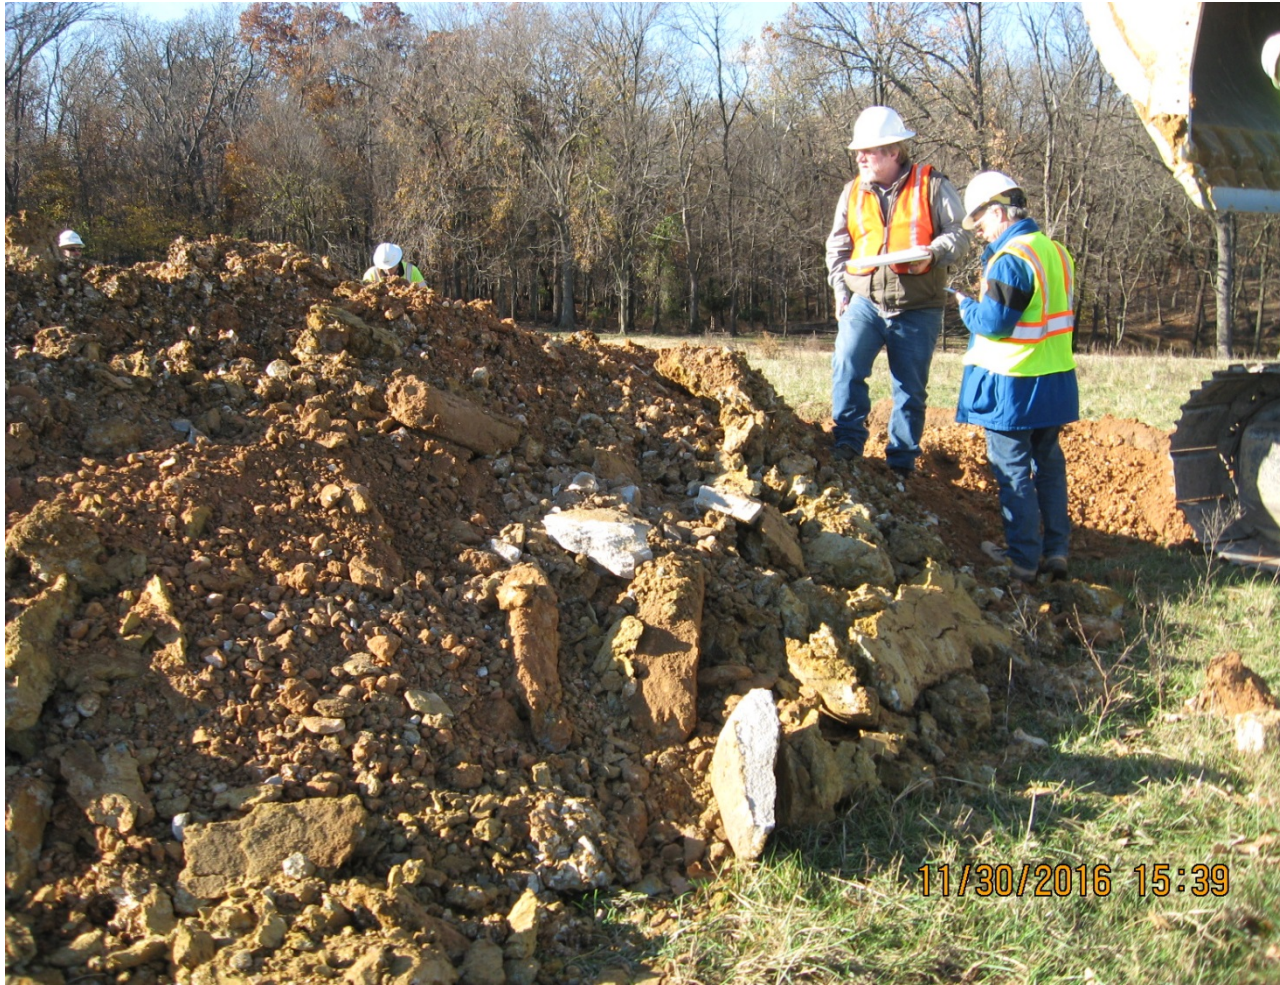
Trackhoe refusal on limestone, recovered pieces of limestone;

SITE NAME: Flint Creek Power Plant Landfill	PHOTO #: 23
SITE LOCATION: Gentry, Arkansas	
AFIN#: 04-00107	PERMIT # 0273-S3N-R2
PHOTOGRAPHER: Jenny Pearson <i>J.P.</i>	WITNESS: Bill Sadler <i>BS</i>
DATE: November 30, 2016	CAMERA: Canon PowerShot A560
DIRECTION: Northwest	
SUBJECT: Excavated Materials at Test Pit ADEQ TP-3; Note Gray Limestone in Foreground

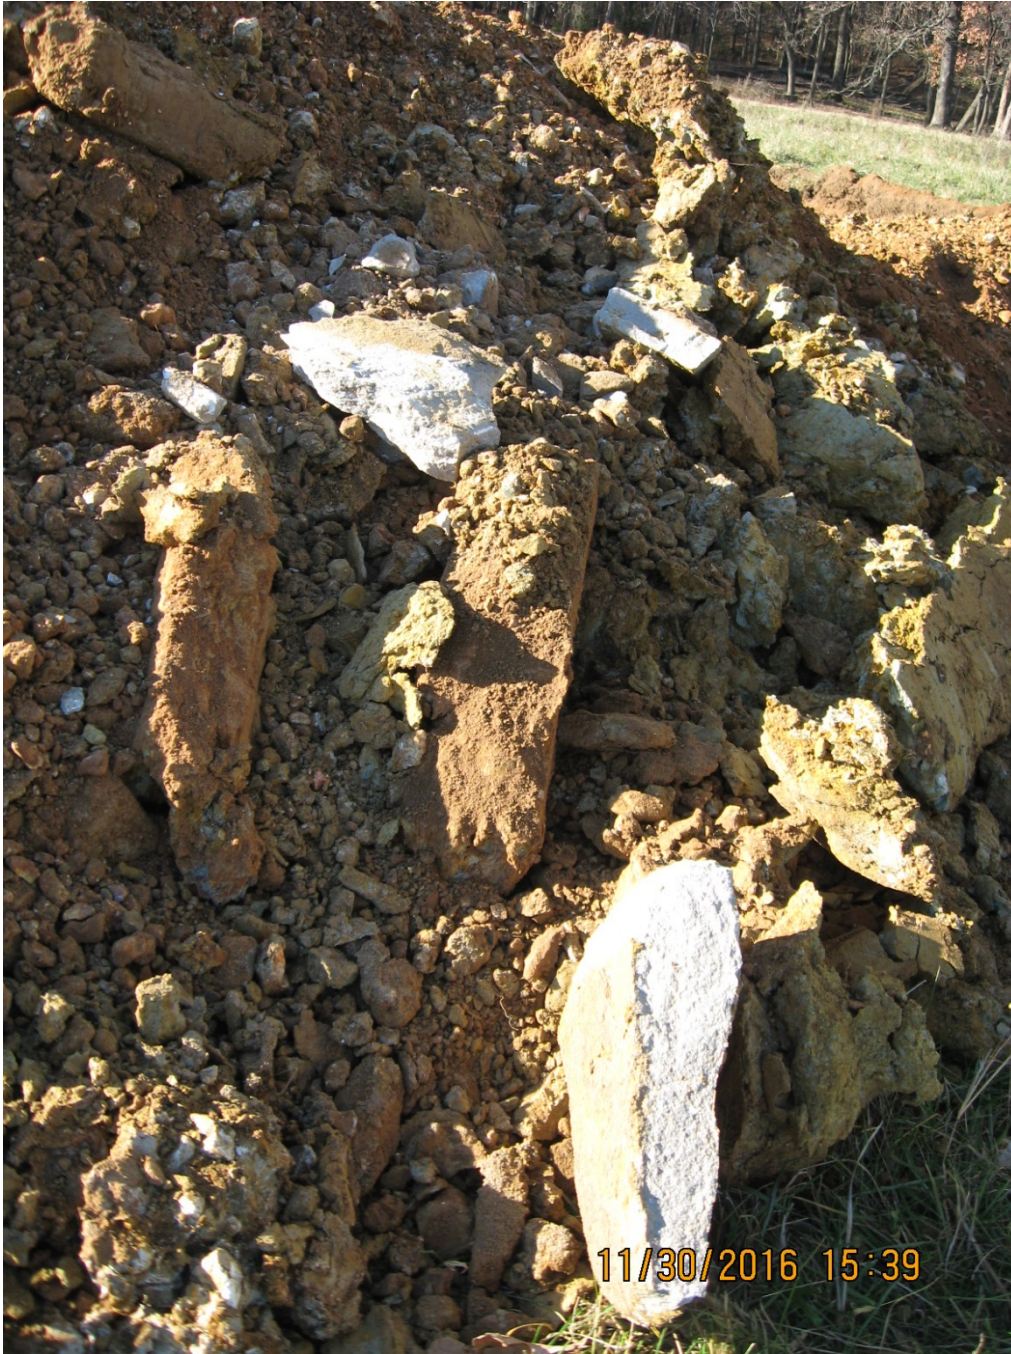
DATE: November 30, 2016	CAMERA: Canon PowerShot A560
DIRECTION: East	
SUBJECT: Excavated Materials at Test Pit ADEQ TP-3; Close-up of Gray Limestone

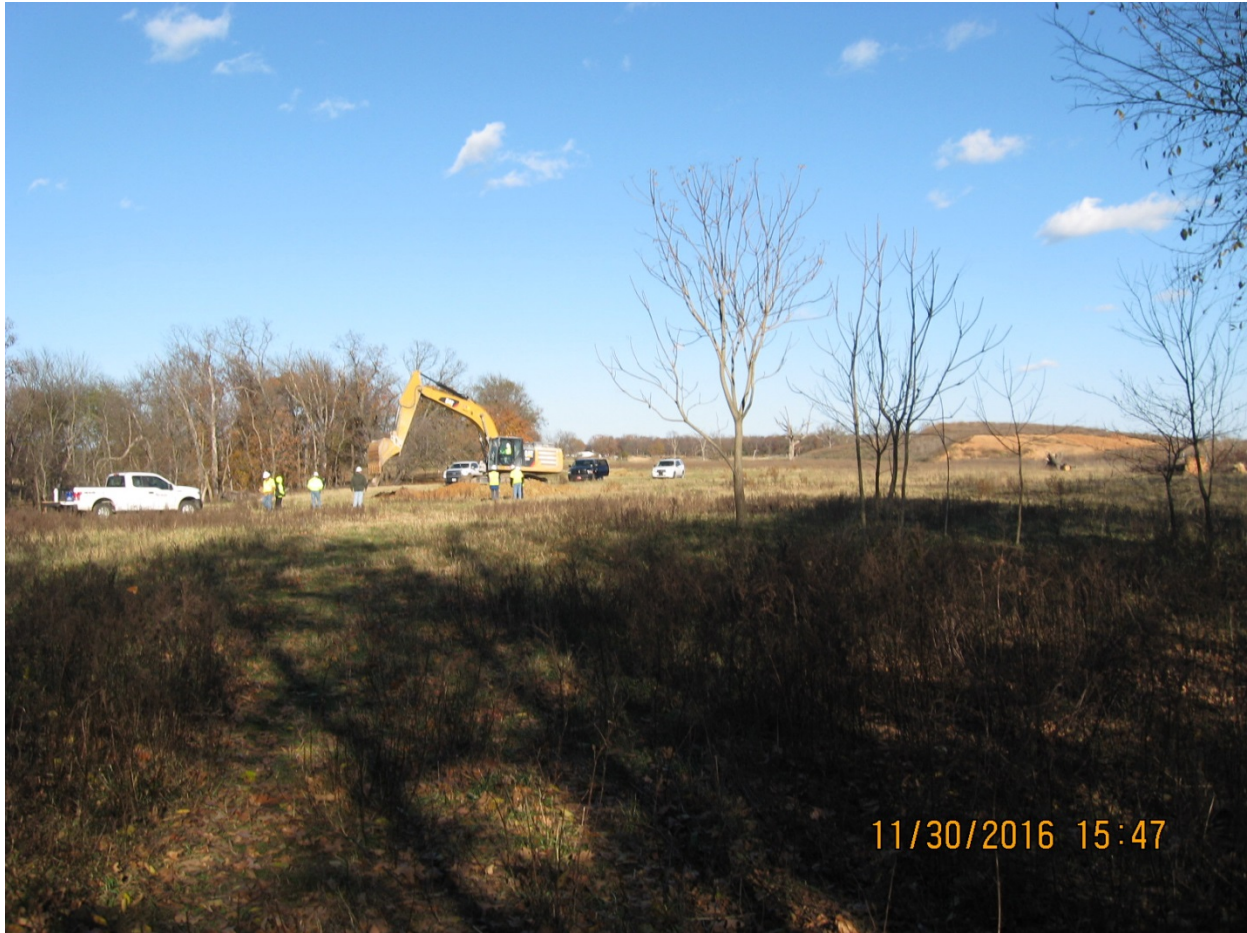
<u>Feet Depth</u>	<u>Lithology</u>
0 to 2.5	Silty Clay - soil with some gravel, reddish brown, slightly moist
2.5 to 6	Clayey Gravel with sand – chert gravel up to several inches in diameter, white, competent, subrounded to subangular; clay brownish red, firm, moist
6 to 11	Same as above except clay is light gray
11 to 15	Silty Clay – contains some sand, mottled gray and tan, firm, moist
15	Limestone – competent, gray, coarsely crystalline

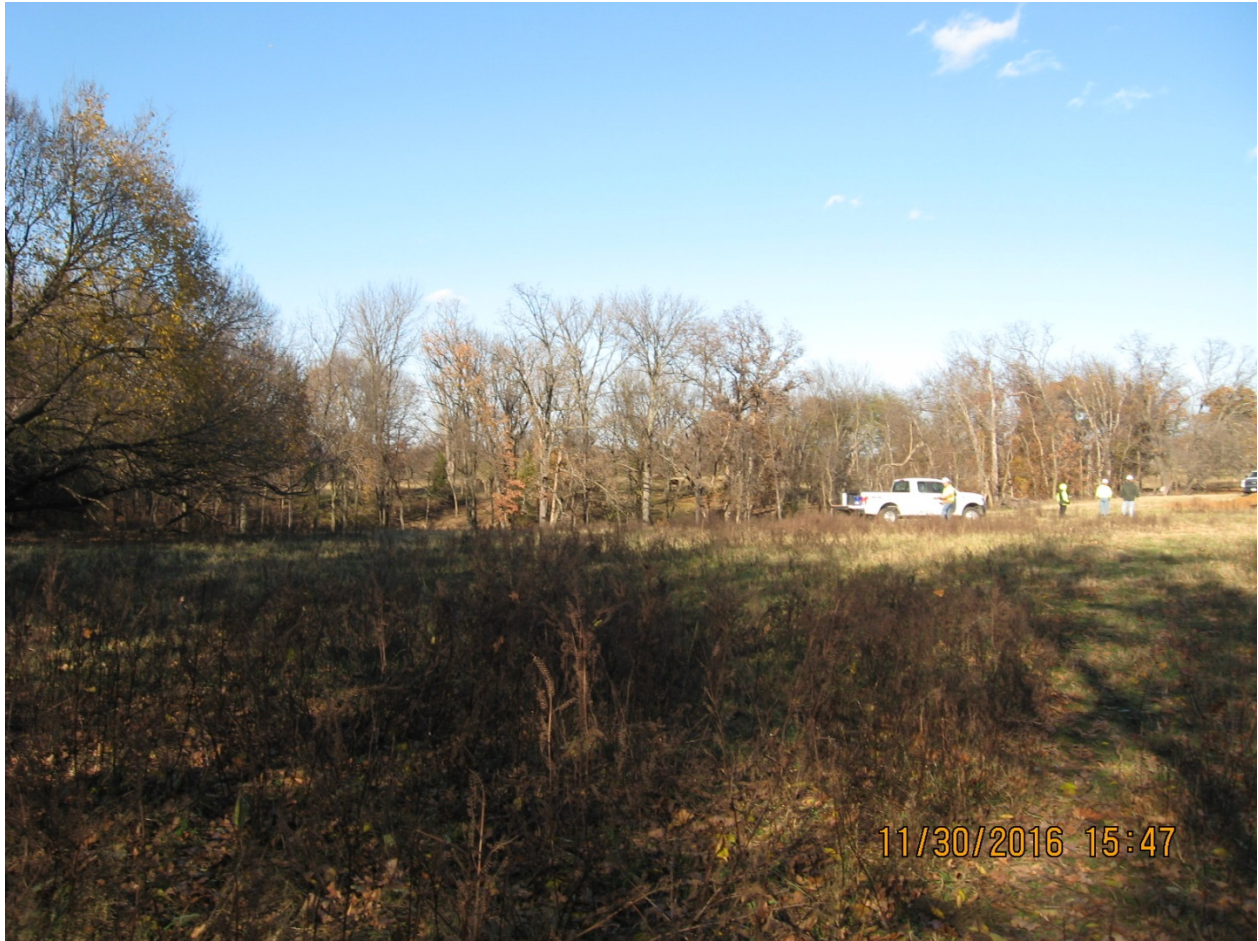
SITE NAME: Flint Creek Power Plant Landfill	PHOTO #: 25
SITE LOCATION: Gentry, Arkansas	
AFIN#: 04-00107	PERMIT # 0273-S3N-R2
PHOTOGRAPHER: Jenny Pearson <i>J.P.</i>	WITNESS: Bill Sadler <i>BS</i>
DATE: November 30, 2016	CAMERA: Canon PowerShot A560
DIRECTION: Northeast	
SUBJECT: Trackhoe at Test Pit ADEQ TP-3; Spoils Pile in Background

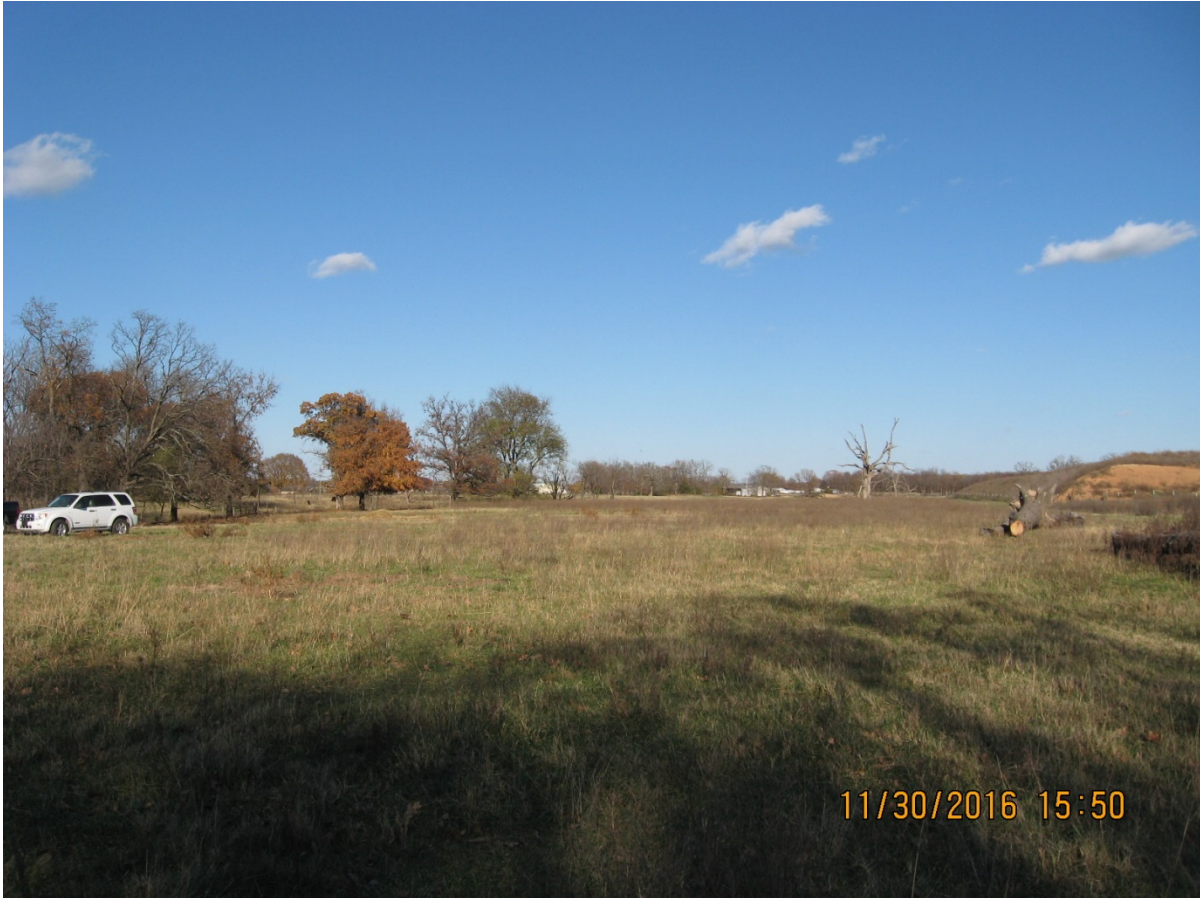
SITE NAME: Flint Creek Power Plant Landfill	PHOTO #: 26
SITE LOCATION: Gentry, Arkansas	
AFIN#: 04-00107	PERMIT # 0273-S3N-R2
PHOTOGRAPHER: Jenny Pearson <i>J.P.</i>	WITNESS: Bill Sadler <i>BS</i>
DATE: November 30, 2016	CAMERA: Canon PowerShot A560
DIRECTION: North	
SUBJECT: Test Pit ADEQ TP-3 is to the Right; Pond on Northern Border of Expansion Area is in Woods in Central Portion of Photo

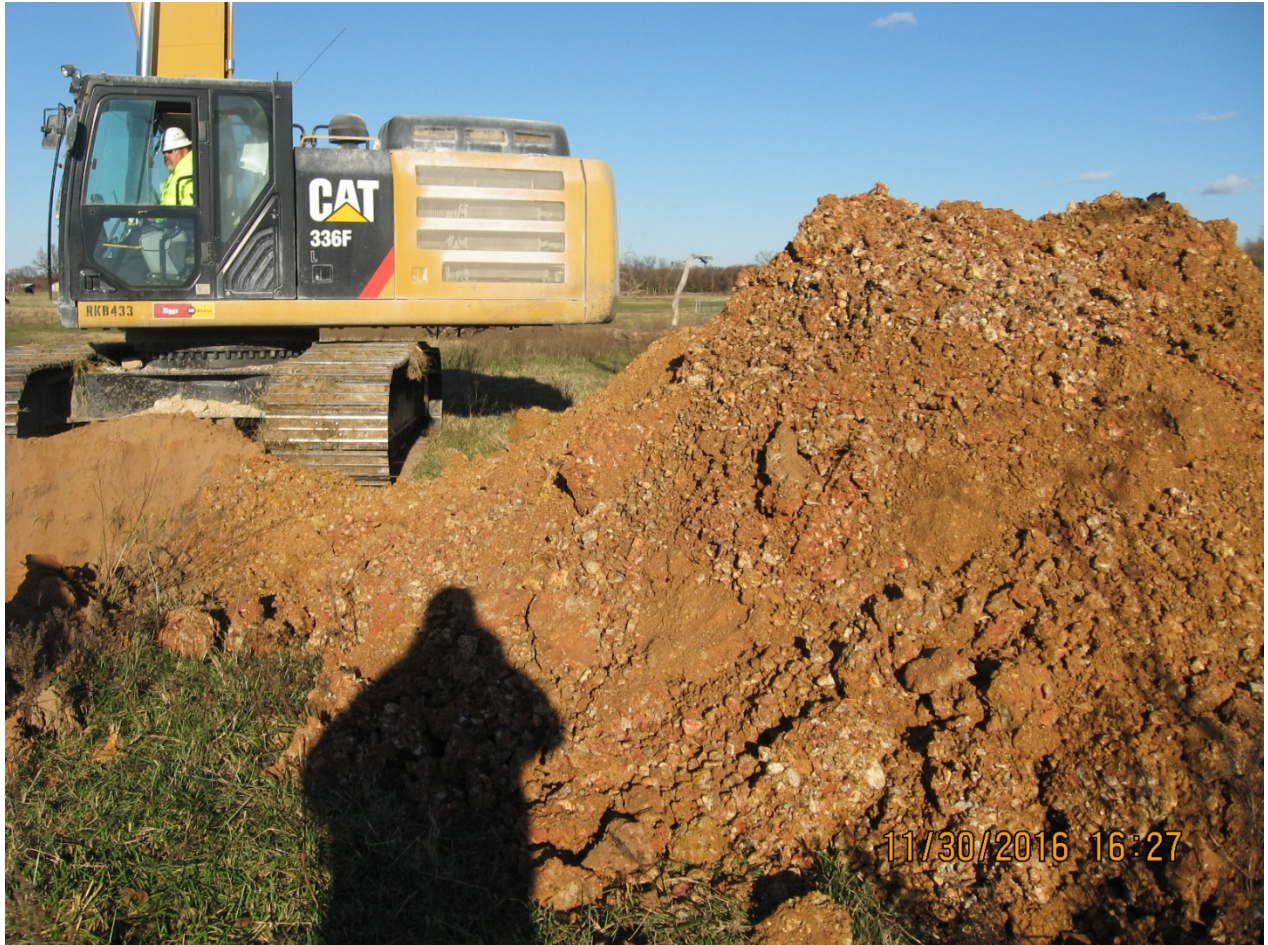
WITNESS:
DATE: November 30, 2016	CAMERA: Canon PowerShot A560
DIRECTION: Northeast	
SUBJECT: Excavated Materials at Test Pit ADEQ TP-4

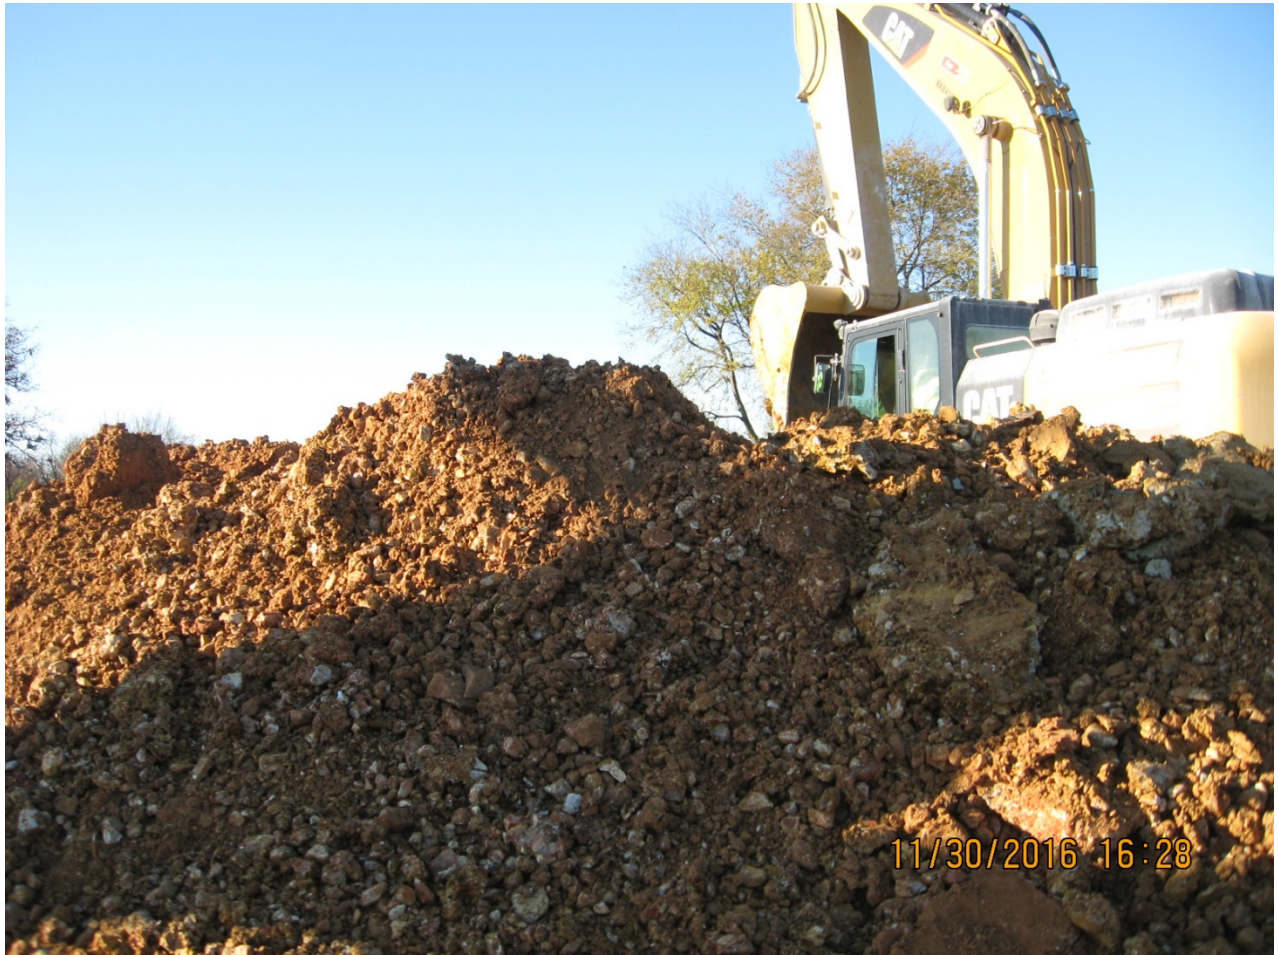
WITNESS:
DATE: November 30, 2016	CAMERA: Canon PowerShot A560
DIRECTION: Northwest	
SUBJECT: Excavated Materials at Test Pit ADEQ TP-4

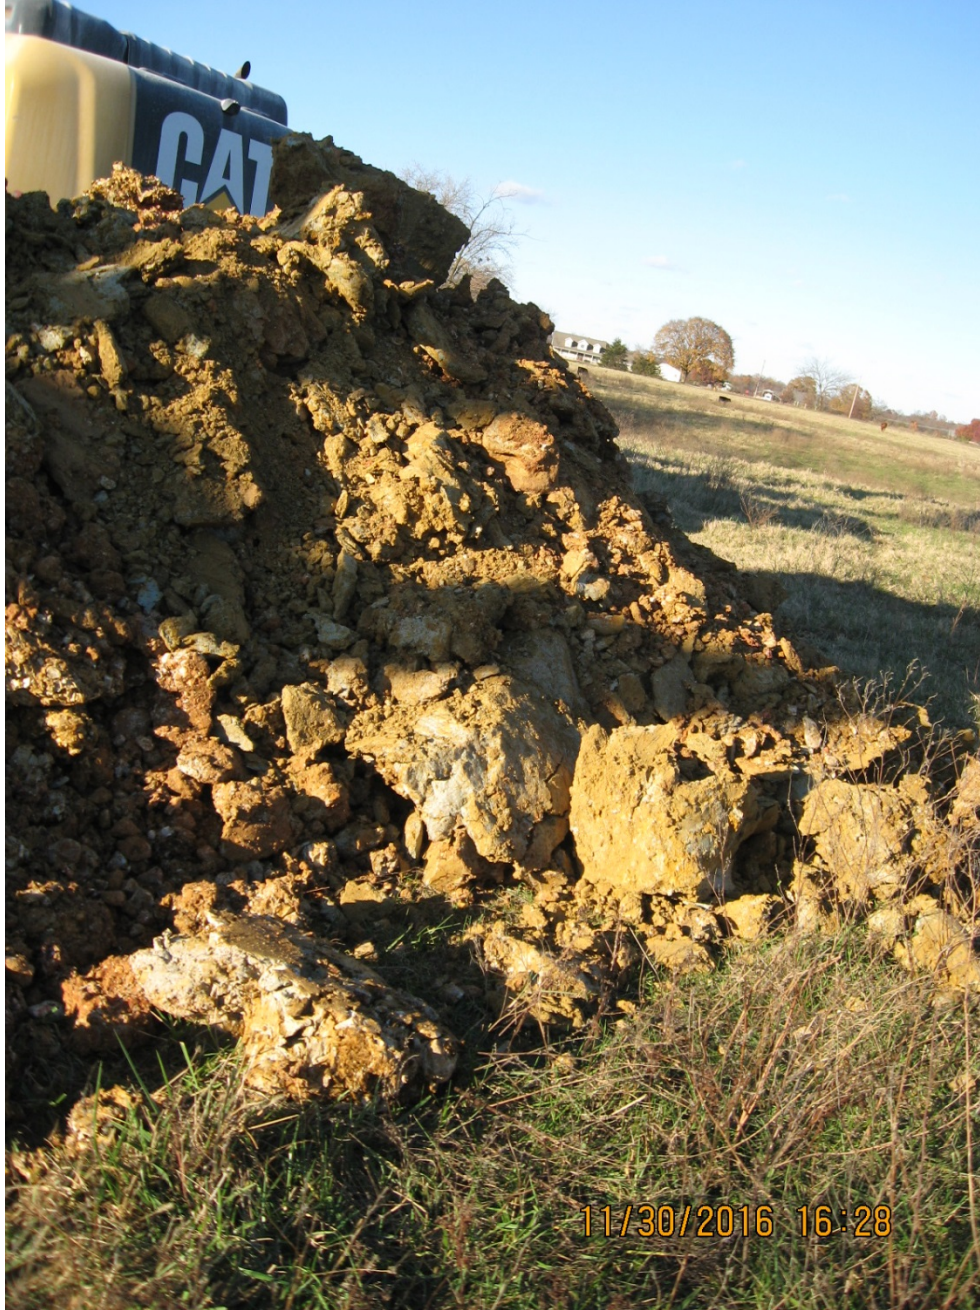
WITNESS:
DATE: November 30, 2016	CAMERA: Canon PowerShot A560
DIRECTION: North	
SUBJECT: Excavated Materials at Test Pit ADEQ TP-4

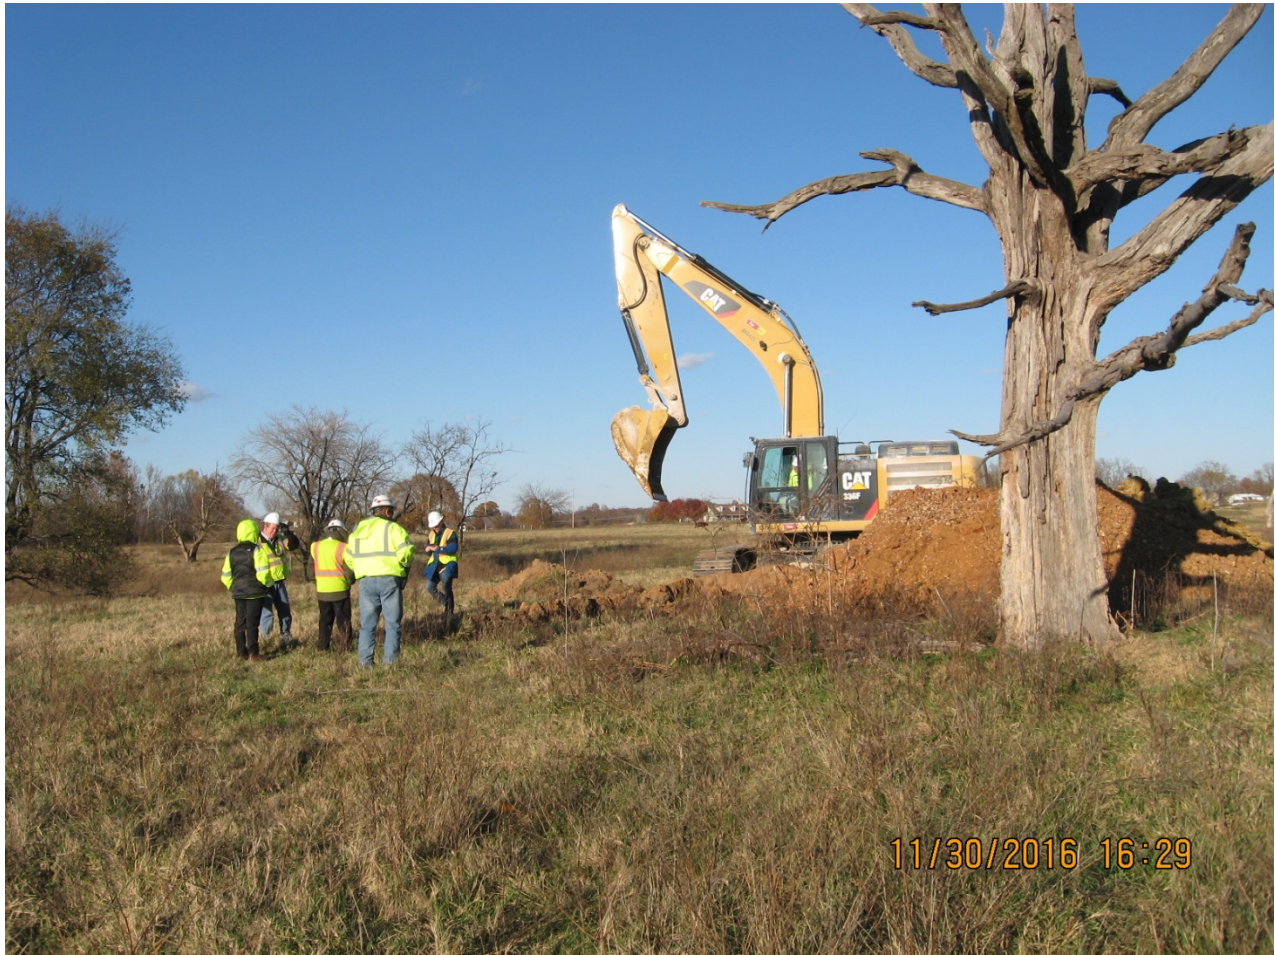
WITNESS:
DATE: November 30, 2016	CAMERA: Canon PowerShot A560
DIRECTION: North	
SUBJECT: Test Pit ADEQ TP-4

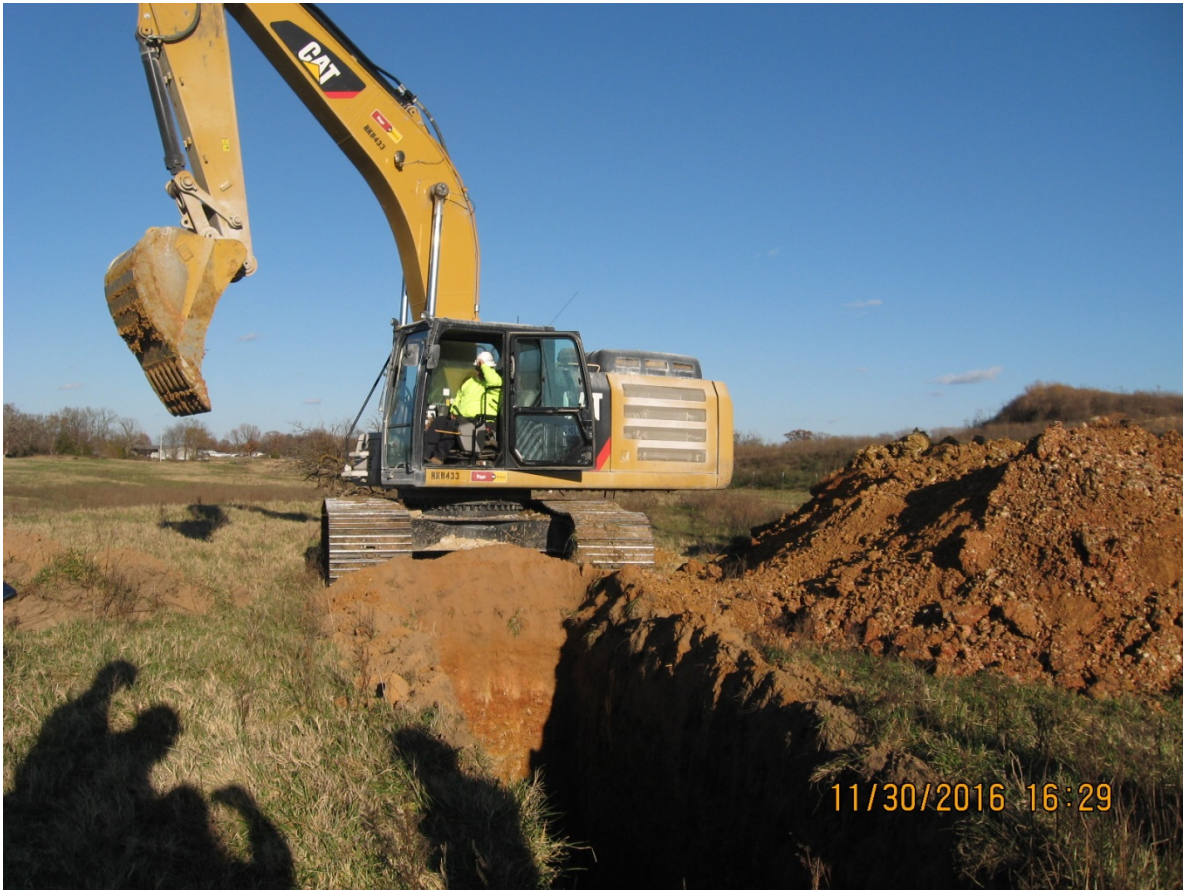
WITNESS:
DATE: November 30, 2016	CAMERA: Canon PowerShot A560
DIRECTION: Northeast	
SUBJECT: Test Pit ADEQ TP-4

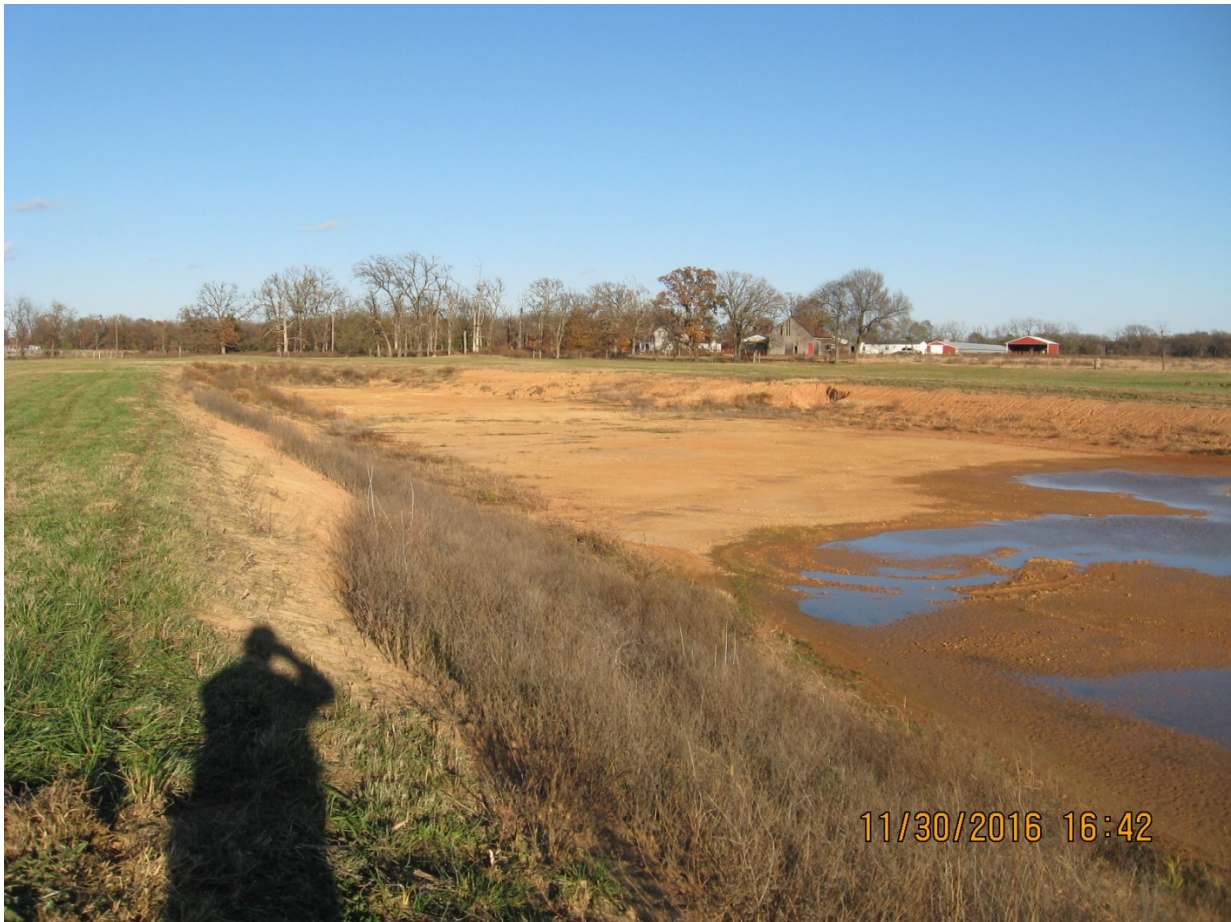
SITE NAME: Flint Creek Power Plant Landfill	PHOTO #: 33
SITE LOCATION: Gentry, Arkansas	
AFIN#: 04-00107	PERMIT # 0273-S3N-R2
PHOTOGRAPHER: Bill Sadler <i>BS</i>	WITNESS: Jenny Pearson <i>JP</i>
DATE: November 30, 2016	CAMERA: Canon PowerShot A560
DIRECTION: Northeast	
SUBJECT: Northeastern end of Borrow Area at Eastern End of Proposed Expansion Area

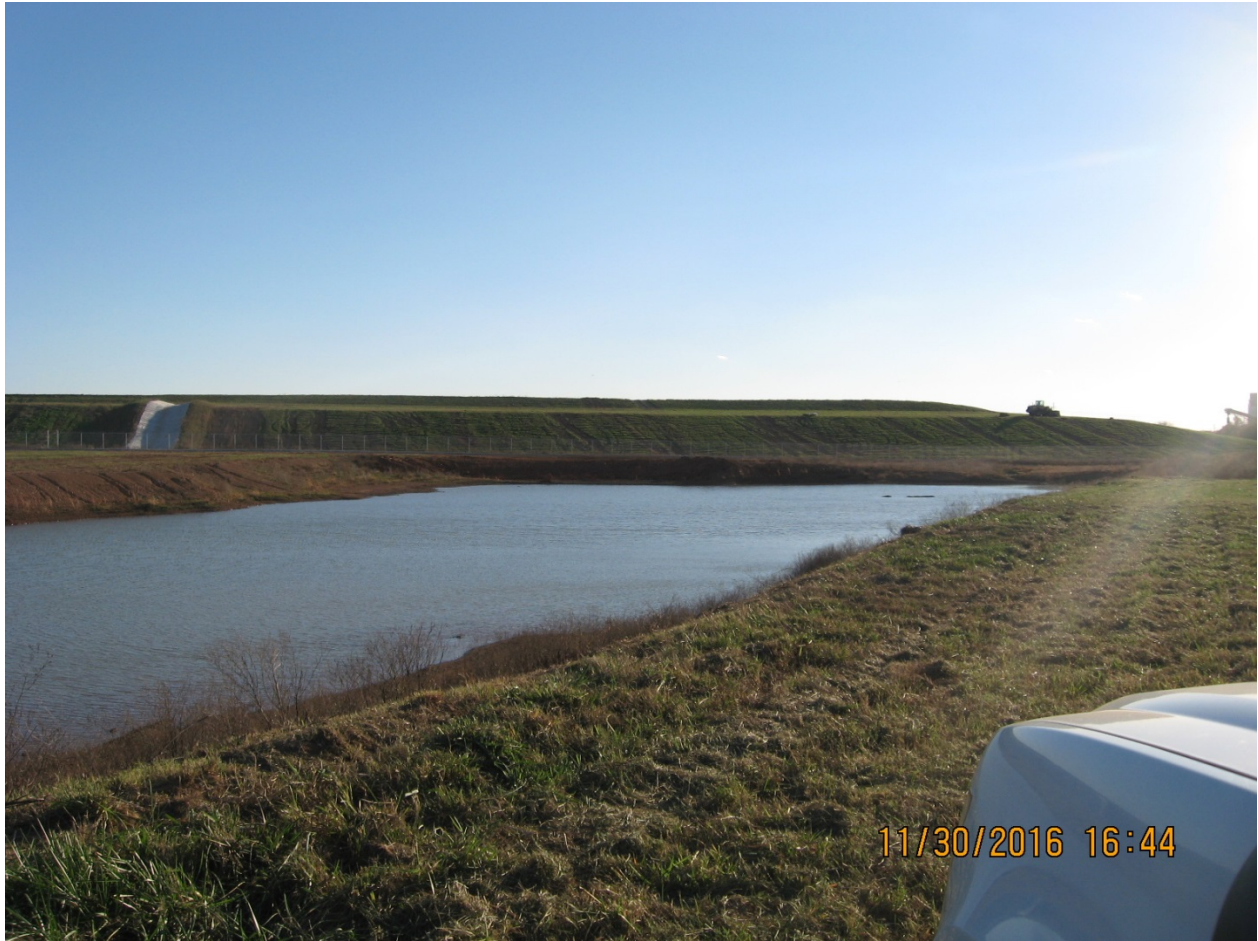
SITE NAME: Flint Creek Power Plant Landfill	PHOTO #: 34
SITE LOCATION: Gentry, Arkansas	
AFIN#: 04-00107	PERMIT # 0273-S3N-R2
PHOTOGRAPHER: Bill Sadler <i>BS</i>	WITNESS: Jenny Pearson <i>JP</i>
DATE: November 30, 2016	CAMERA: Canon PowerShot A560
DIRECTION: South	
SUBJECT: Southwestern end of Borrow Area at Eastern End of Proposed Expansion Area (Filled with Water); Existing Landfill in Background
