Re: Georgia-Pacific, Crossett Mill - Biweekly Air Monitoring Report for Hydrogen Sulfide

Please find the following biweekly report for the Georgia-Pacific (GP) Crossett Mill hydrogen sulfide (H₂S) and meteorological monitoring program covering the calendar period of September 19, 2018 through October 2, 2018. Elevated concentrations of H₂S were recorded during the evening of September 29th. The maximum rolling 30-minute average H₂S concentration recorded during this reporting period was 35.1 ppb.

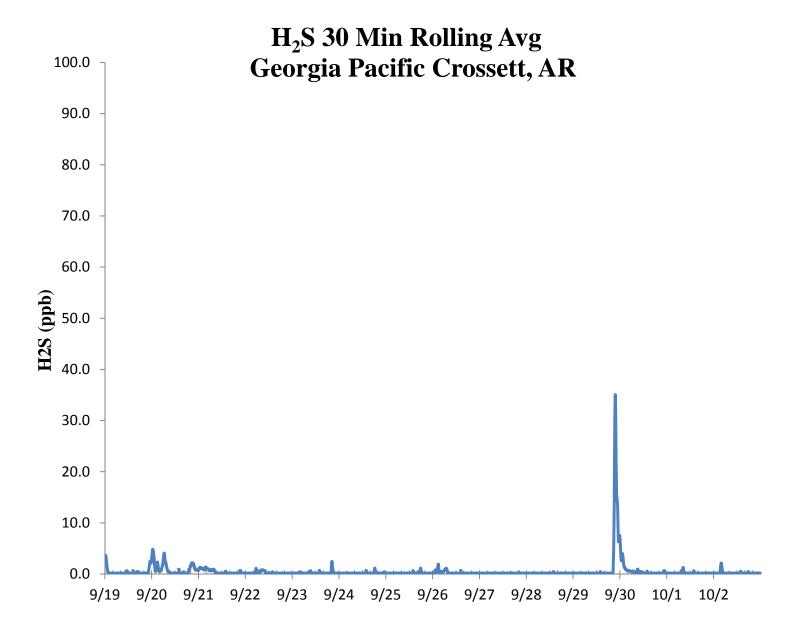
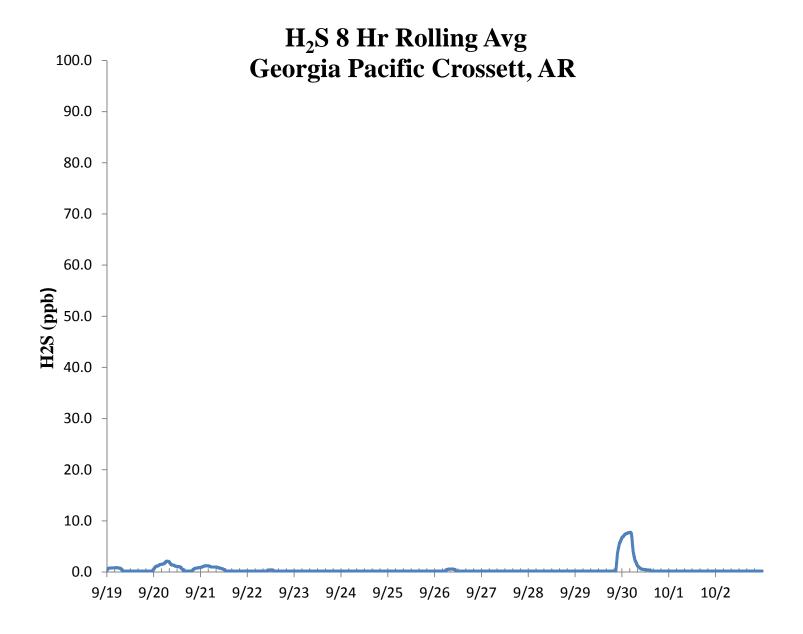
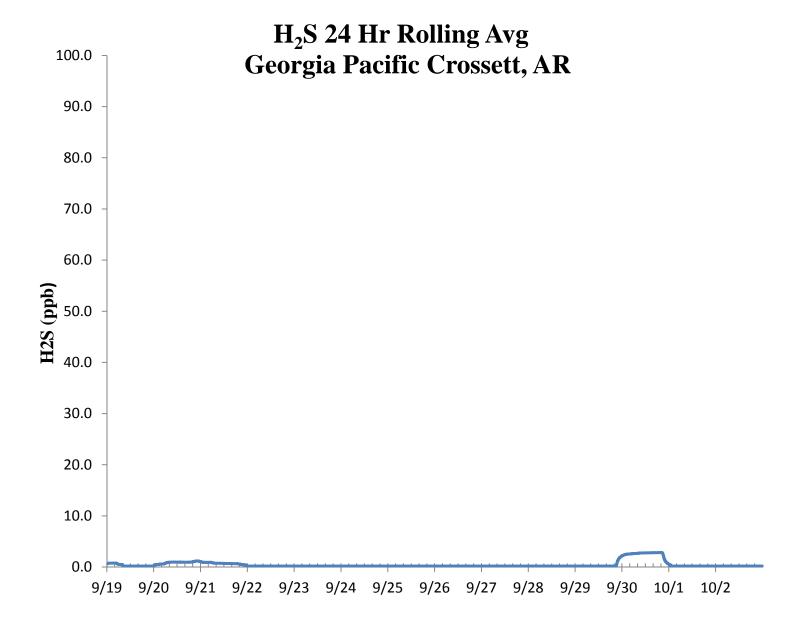
Included in this report are three plots presenting H₂S concentrations across different rolling average periods (30-minute, 8-hour, and 24-hour), daily 1-point quality control (QC) checks with precision and bias estimates and time series plots for all recorded meteorological (met) parameters for the two week period.

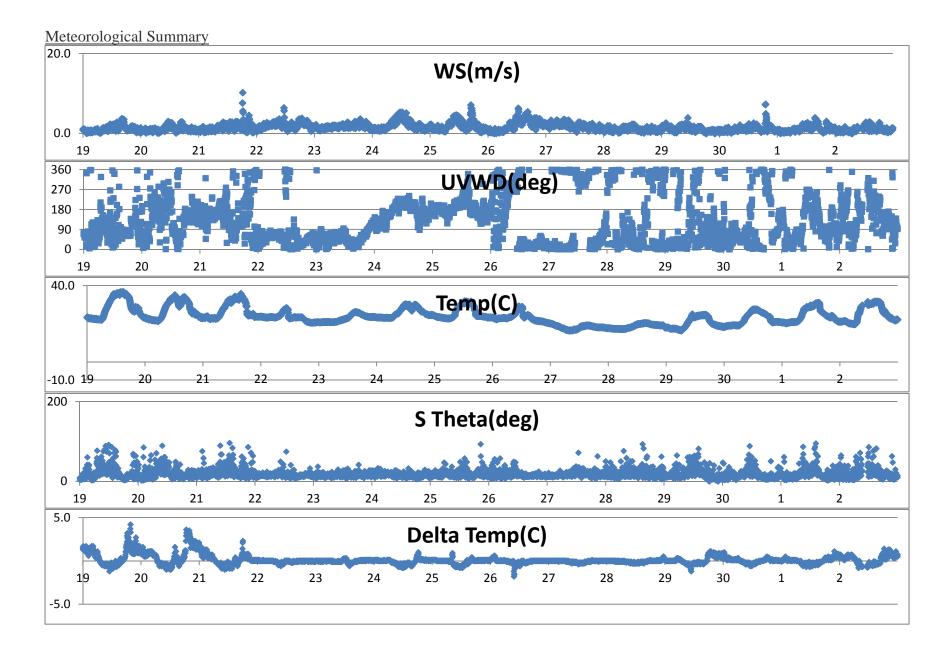
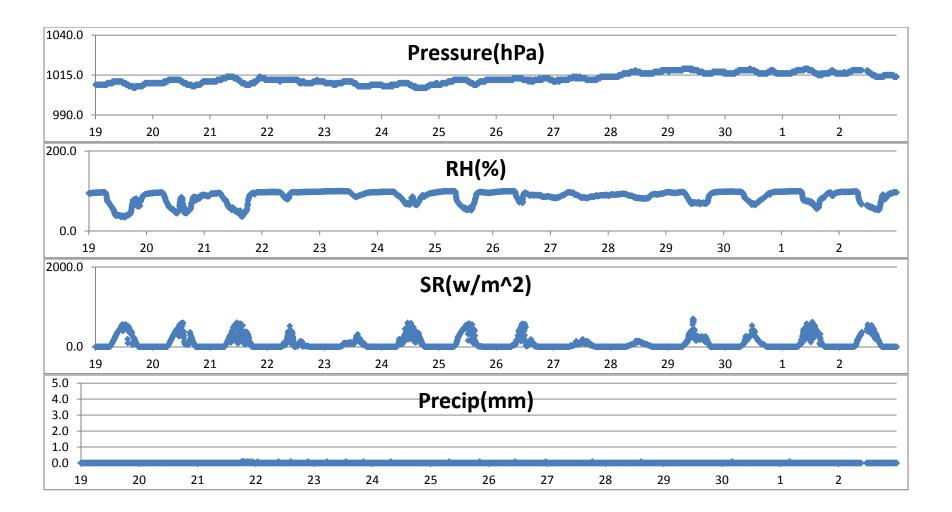
Fourteen-day time series plots for all recorded meteorological (met) parameters are presented in the final charts. A brief power interruption was responsible for loss of all met parameters for approximately two hours on October 2^{nd} .
