# ARKANSAS WASTE-TO-ENERGY WAREHOUSE SITE

## STATE PRIORITY LIST SITE OSCEOLA, ARKANSAS

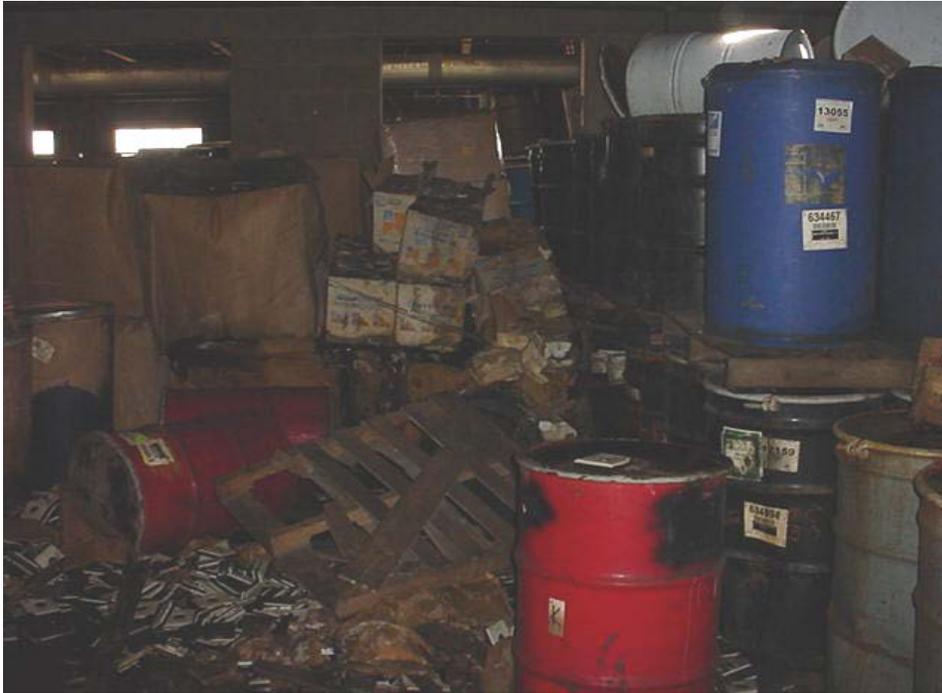
Site Photo: Parsons Warehouse – Site Discovery in March 2003

ADEQ began an investigation of the AMWE facilities in 2003 in response to local citizen complaints. During its investigation, ADEQ discovered an estimated 20,000 drums improperly stored at the warehouse. Some drums were leaking and in extremely poor condition and numerous spills were observed on the warehouse floor. Hazard categorization tests on a portion of the drums indicated that several displayed hazardous characteristics such as flammability, ignitability, and corrosivity. Large quantities of medical waste were also stored at the warehouse, which was in degraded condition.

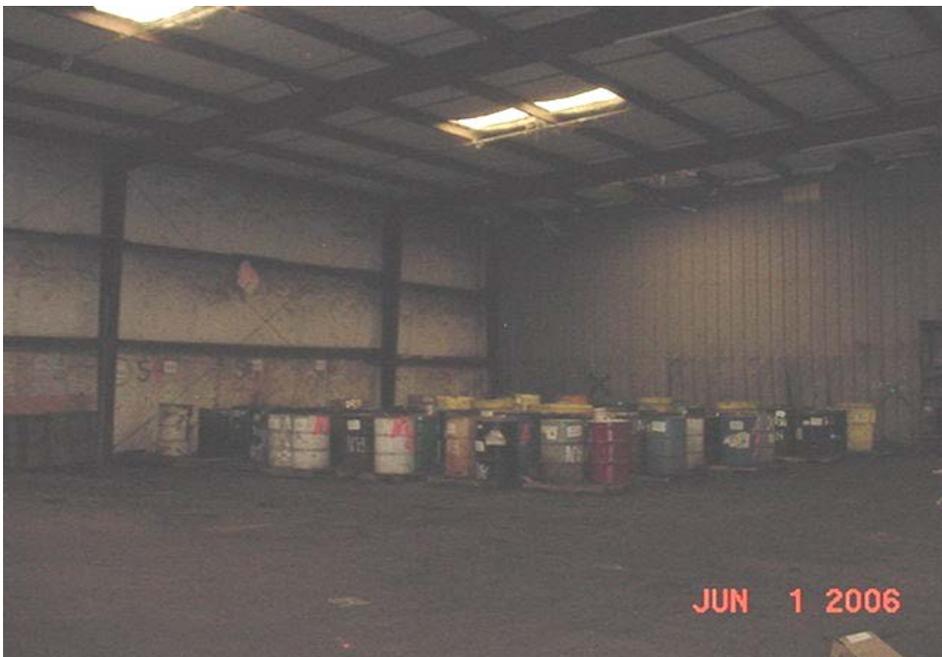
Site Photo: Parsons Warehouse – Drums Labeled and Ready for Disposal in June 2006

An estimated 1,000 containers were staged within the warehouse starting in June 2006 while the EPA negotiated with other PRPs to arrange for disposal. Of the approximately 40 PRPs, four or five had between 20 to 200 drums of waste to address; the other PRPs had less than 20 drums. Starting in March 2010, the EPA worked with the Department of Justice to enforce the removal of all remaining containers. The final removal was completed in June 2012.
