STATE PRIORITY LIST SITE SUMMARY

Facility Name:	Fulton Class 3C Landfill
Facility Location:	Rogers, Arkansas
EPA RCRA ID No:	N/A
EPA CERCLA ID No:	N/A
AFIN:	04-00165
County:	Benton
Arkansas Senate District:	8
Arkansas House District:	96
US Congressional District:	3

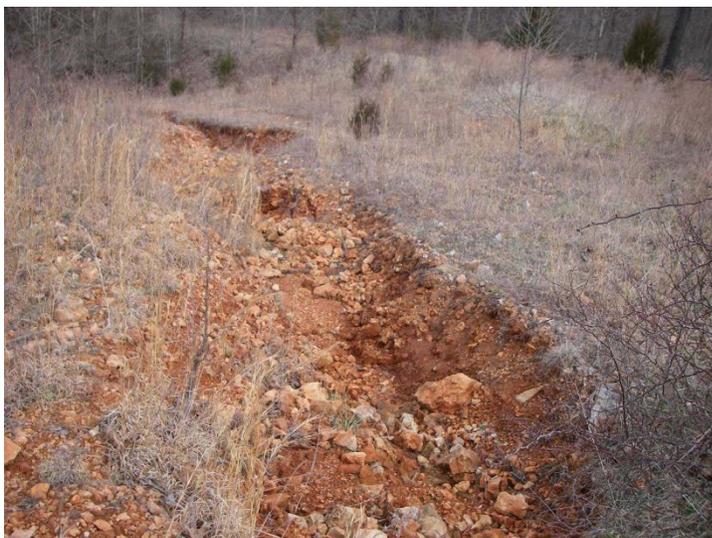
Site Photos: Pictured below: Erosion along the east side of the landfill

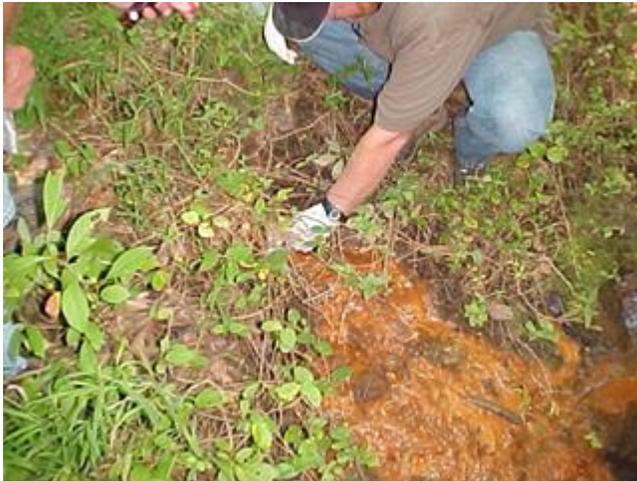
Pictured above: ES Spring 2 approximately 825' South of LF

Historical water quality test data from springs around the site have shown elevated levels of organic and inorganic contaminants relative to EPA Regional Screening Levels (RSLs) for tap water. During the most recent sampling event in 2005, most of the springs had obvious visual indications of impact due to iron oxide precipitate. The sample concentrations were high in both iron and manganese which is potentially caused by landfill impact. In addition, several volatile organic compounds were present. The parameters that exceeded the EPA RSLs for tap water during the 2005 sampling event included: iron; manganese; 1,1-dichloroethane; 1,4-dichlorobenzene; vinyl chloride; and trichloroethene.
