ARKANSAS  
Department of Environmental Quality

COMPLAINT INFORMATION			
GPS LOCATION: <b>N34° 41' 44.5" W 92° 37' 8.1"</b>	AFIN: <b>88-00847</b> PERMIT#: <b>ARR040003</b>		
DATE RECEIVED: <b>2-26-8</b>	COUNTY: <b>Saline</b>		
COMPLAINANT NAME: <b>April Burchfield</b>	COMPLAINT AGAINST: <b>Saline County (Lanny Fite County Judge)</b>		
ADDRESS: <b>15221 Laura Way, Alexander</b>	ADDRESS: <b>200 N. Main St., Benton, AR, STE. 117</b>		
PHONE: <b>223-1254</b>	PHONE: <b>501-860-6738</b>		
TRACKING & REFERRAL INFORMATION			
PERSON RECEIVING REPORT: <b>EMF</b>	DATE: <b>2-26-8</b>	SUPERVISOR REFERRAL:	DATE:
INSPECTOR REFERRAL:	DATE:	MEDIA SUPERVISOR REFERRAL:	DATE:
PHONE REFERRAL CONTACT:	DATE:	RECEIVING INSPECTOR:	DATE:
DETAILED DESCRIPTION			
<b>Complainant states that the county is building a bridge across Caney Creek, with no erosion or sediment controls.</b>			
LOCATION			
<b>½ mile north of the Lake Norrell Road, and West Lawson Road intersection, north of Avilla.</b>

COMPLAINT INVESTIGATION	
COMPLAINT#:	AFIN: 88-00847 PERMIT#: ARR040003
INSPECTOR: EMF	DATE: 2-29-8
ACTION TAKEN:	PHOTOS TAKEN: <input type="checkbox"/> YES <input type="checkbox"/> NO
<p>At 1350 on 2-29-8, Bob singleton

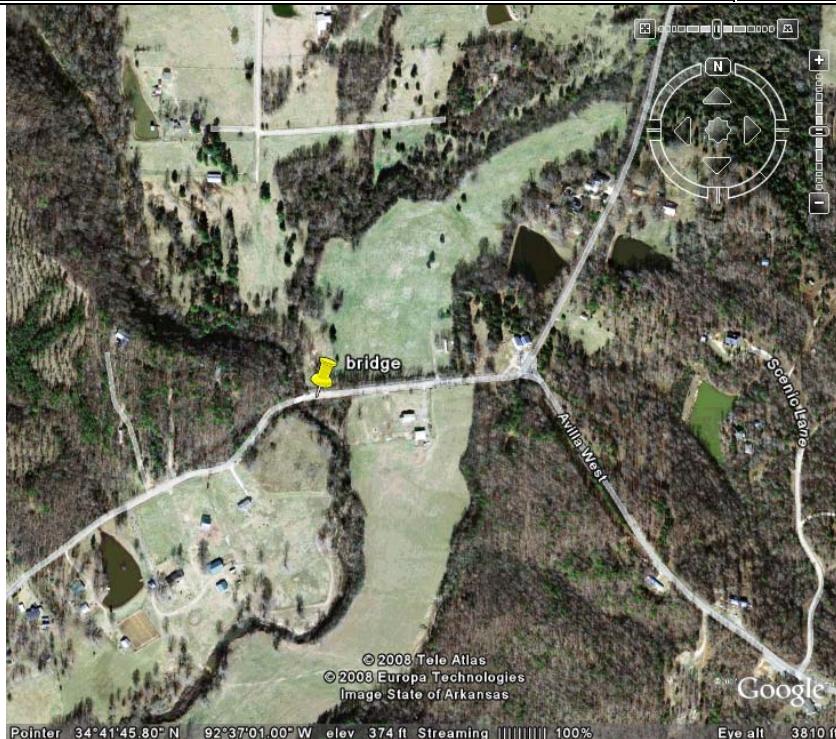
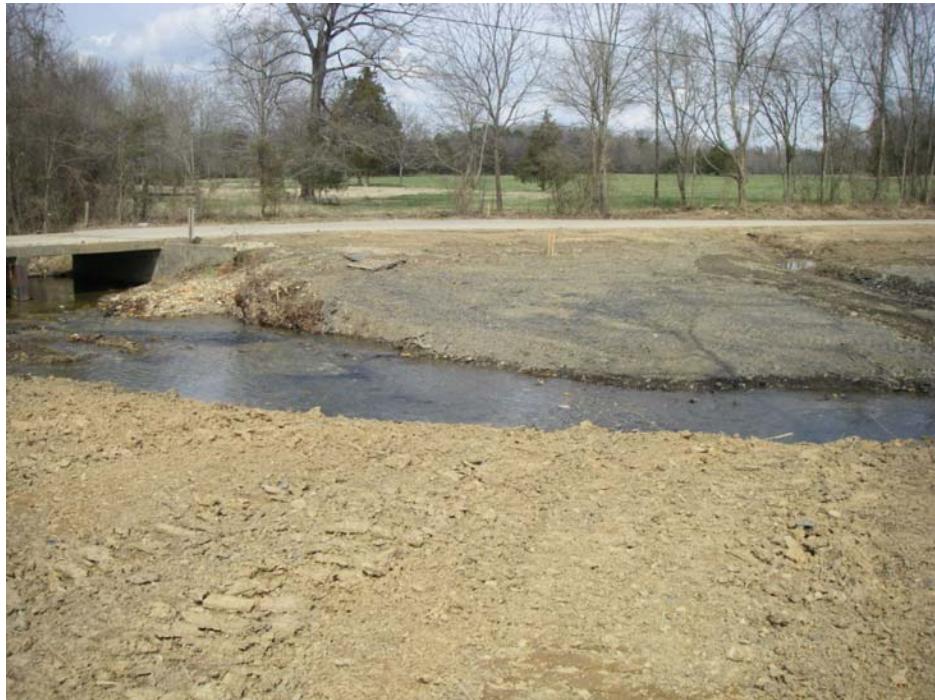
These photos show the downstream side of the current bridge. All the vegetation was removed from the banks. In the photo below you can see the orange marking paint on the ground and across the creek.

<b>FURTHER ACTION:</b> <p>A NC letter was sent to Judge Lanny Fite and the county for failing to obtain the required approval for the project.</p>	
INSPECTOR SIGNATURE:  Eric M. Fleming /

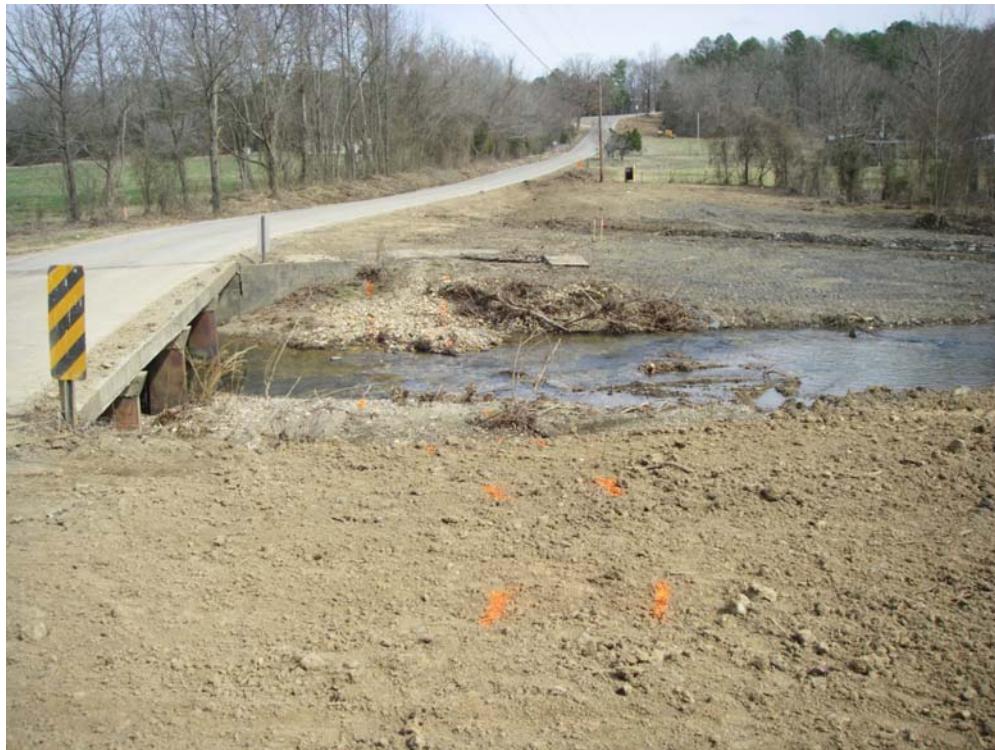
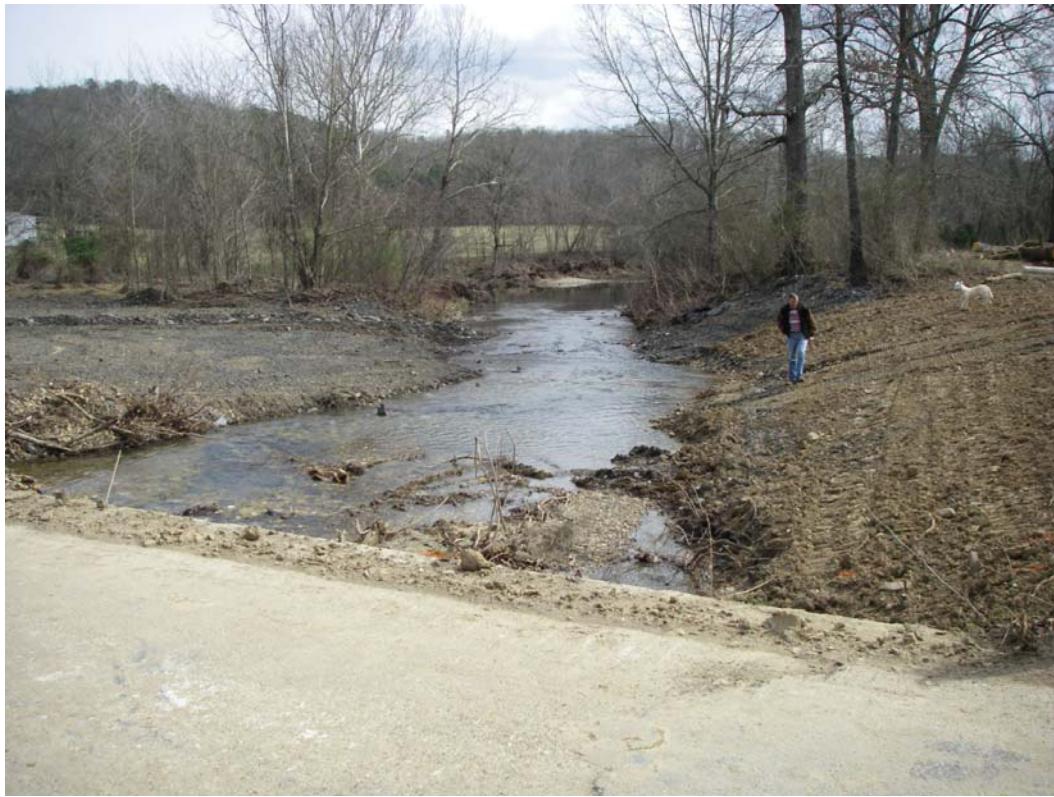
Two more photos of the downstream side of the current bridge, with the unstabilized areas right down to the water line. There were no erosion controls at this site.
