<h1>ADEQ</h1> <p>A R K A N S A S Department of Environmental Quality</p>		WATER DIVISION COMPLAINT REPORT	
		AFIN: 63-00088	PERMIT #: AR0041424
		COUNTY: 63 Saline	PDS #: 015800
		GPS LOCATION: LAT: 34.615932 LONG: -92.393194 <input type="checkbox"/> Discharge Site / <input checked="" type="checkbox"/> General Area / <input type="checkbox"/> Entrance	
COMPLAINANT NAME: Jimmy Andrews		COMPLAINT AGAINST: Pleasant Oaks Sewer Improv.dis

Water Division Photographic Evidence Sheet			
Location:	Pleasant Oaks Sewer Improv.dis;		
Photographer:	Clark Baker	Date:	6/18/2013
Time:	1559		
Witness:	None		Photo #:
1			
Description:	SSO with heavy flow and solids present

Re: Pleasant Oaks Sewer Improvement District #31
Unpermitted Discharge

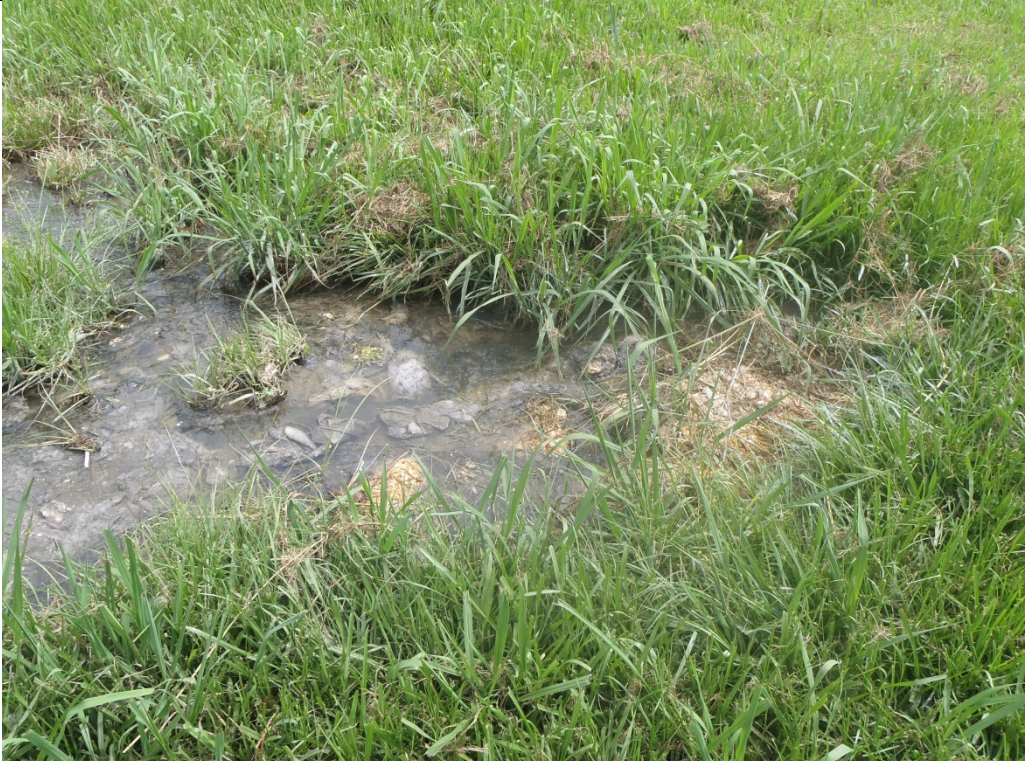
Photographer:	Clark Baker	Date:	6/18/2013
Time:	1559		
Witness:	None		Photo #:
2			
Description:	Solids in SSO

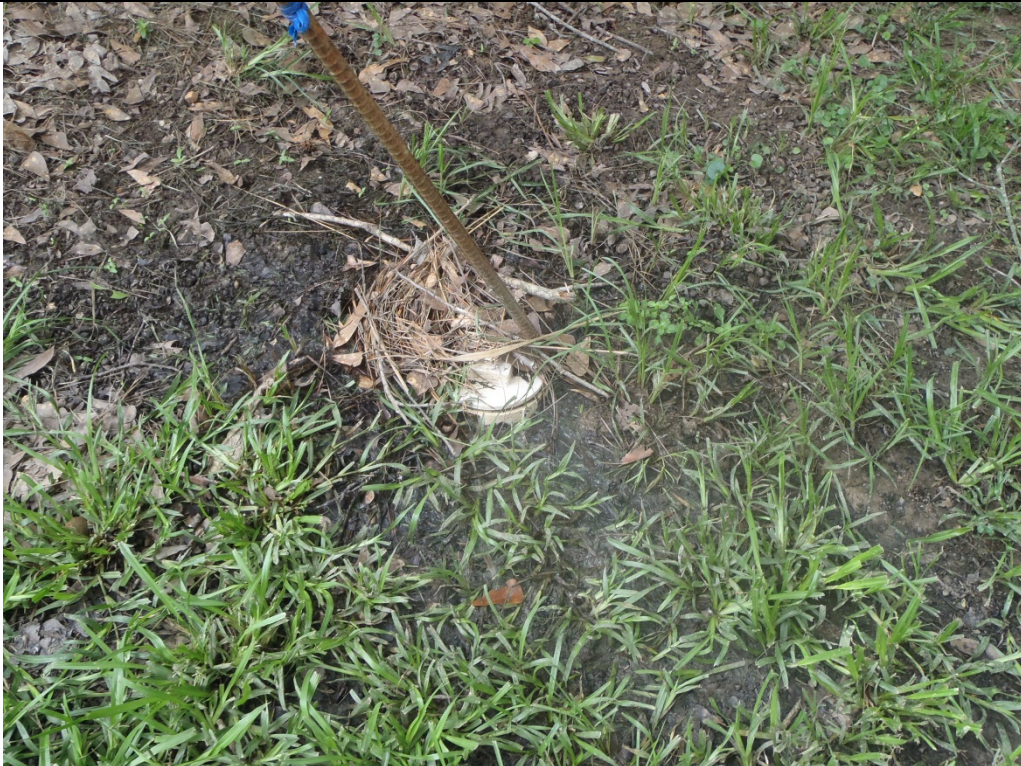
Location:	Pleasant Oaks Sewer Improv.dis;		
Photographer:	Clark Baker	Date:	6/18/2013
Witness:	None	Time:	1600
		Photo #:	3
Description:	Leaking flush out valve

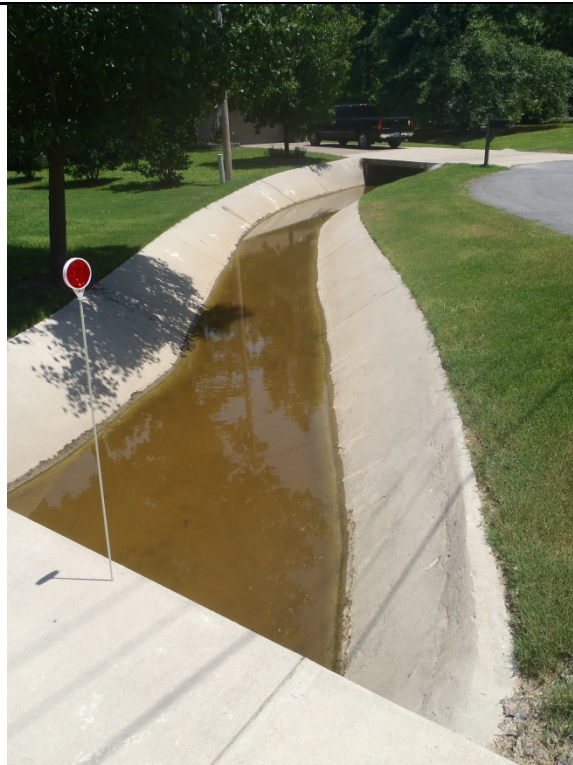
Photographer:	Clark Baker	Date:	6/19/2013
Witness:	None	Time:	1357
		Photo #:	4
Description:	Sample site #1

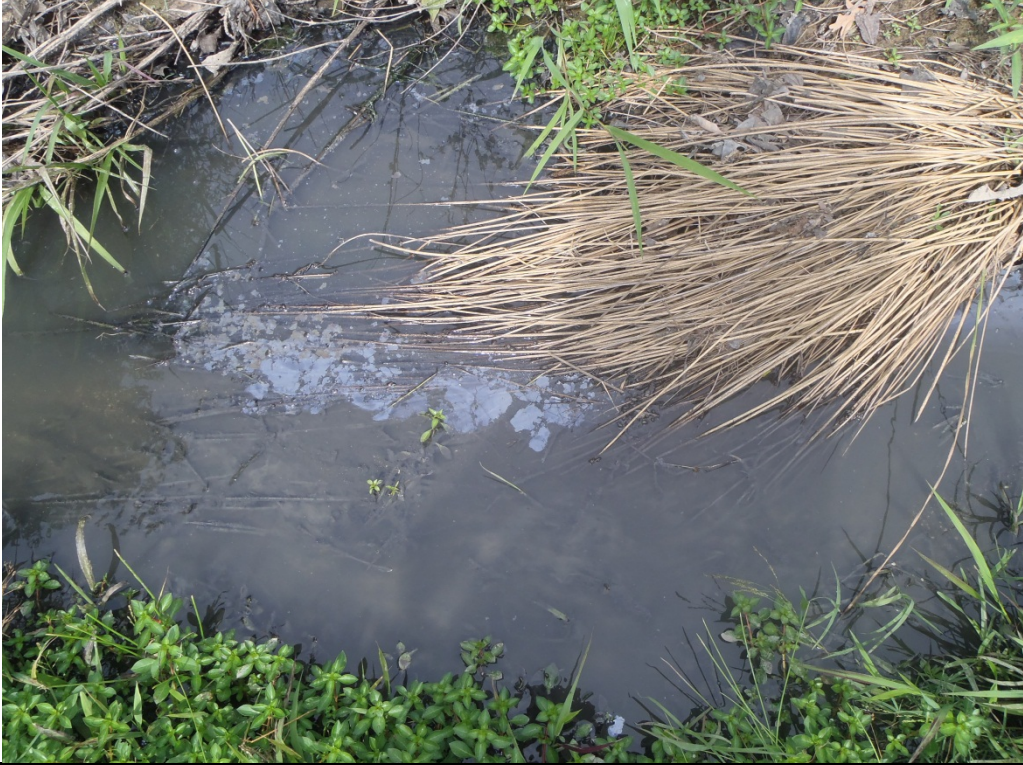
Water Division Photographic Evidence Sheet			
Location:	Pleasant Oaks Sewer Improv.dis;		
Photographer:	Clark Baker	Date:	6/18/2013
Witness:	None	Time:	1559
		Photo #:	5
Description:	Sample site #2

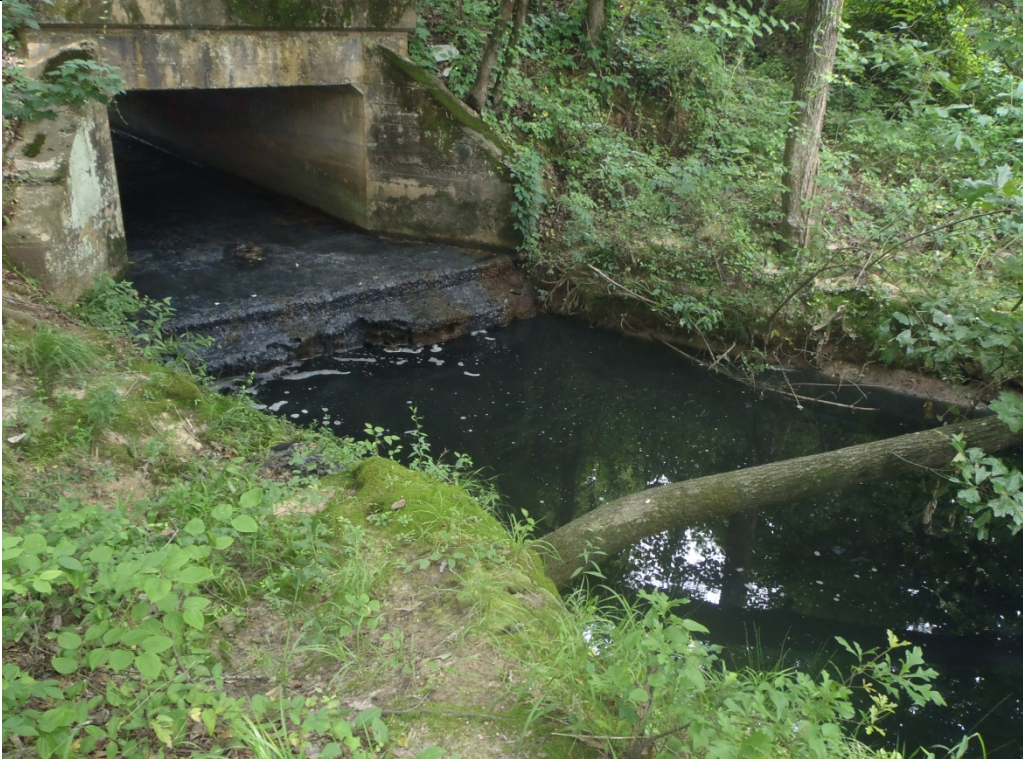
Photographer:	Clark Baker	Date:	6/18/2013
Witness:	Jimmy Andrews	Time:	1633
		Photo #:	6
Description:	Sample site #3

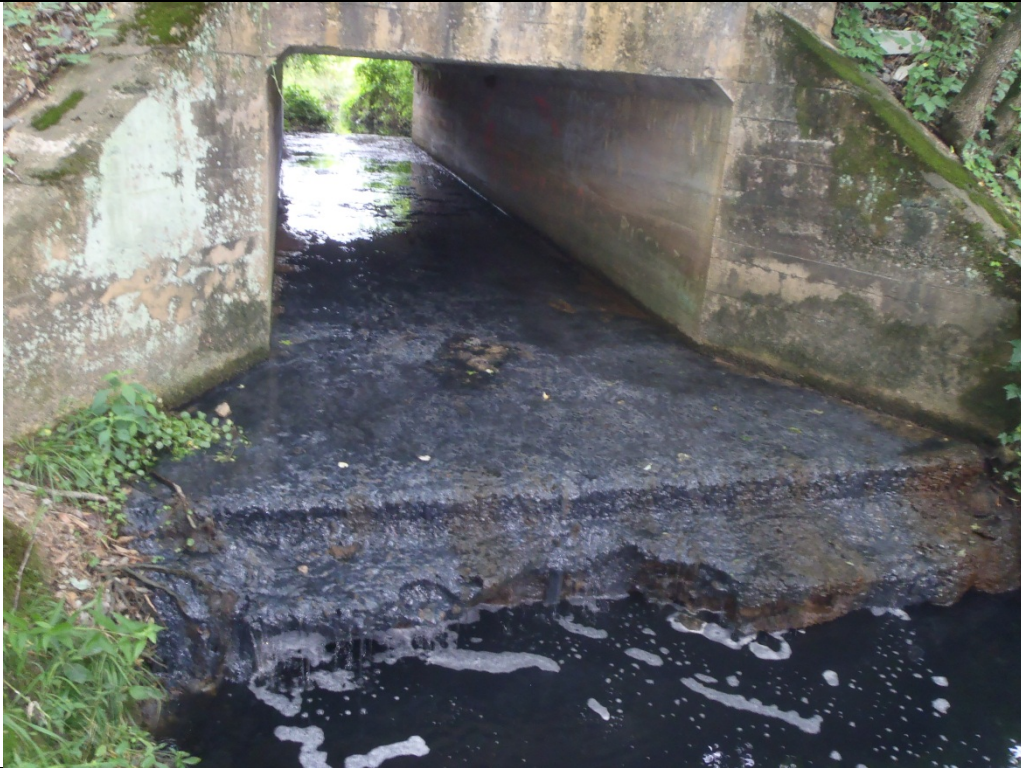
Location:	Pleasant Oaks Sewer Improv.dis;		
Photographer:	Clark Baker	Date:	6/18/2013
Witness:	None	Time:	1634
		Photo #:	7
Description:	Culvert flowing into plunge pool at sample site #3

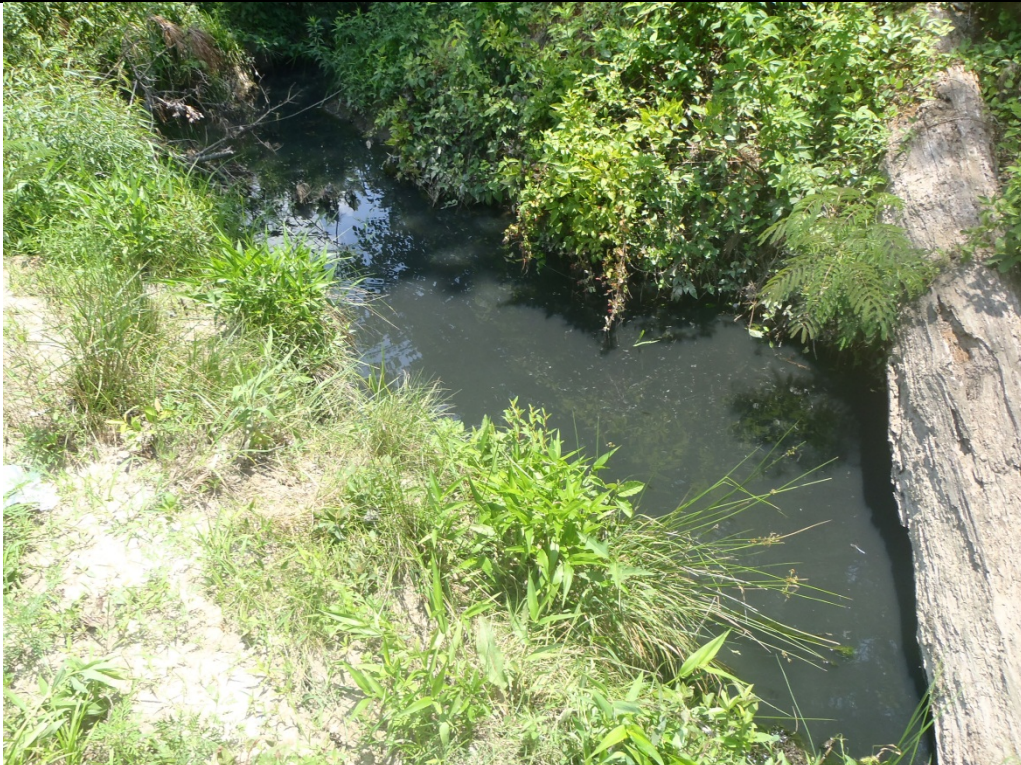
Photographer:	Clark Baker	Date:	6/18/2013
Witness:	Jimmy Andrews	Time:	1647
		Photo #:	8
Description:	Sample site #4

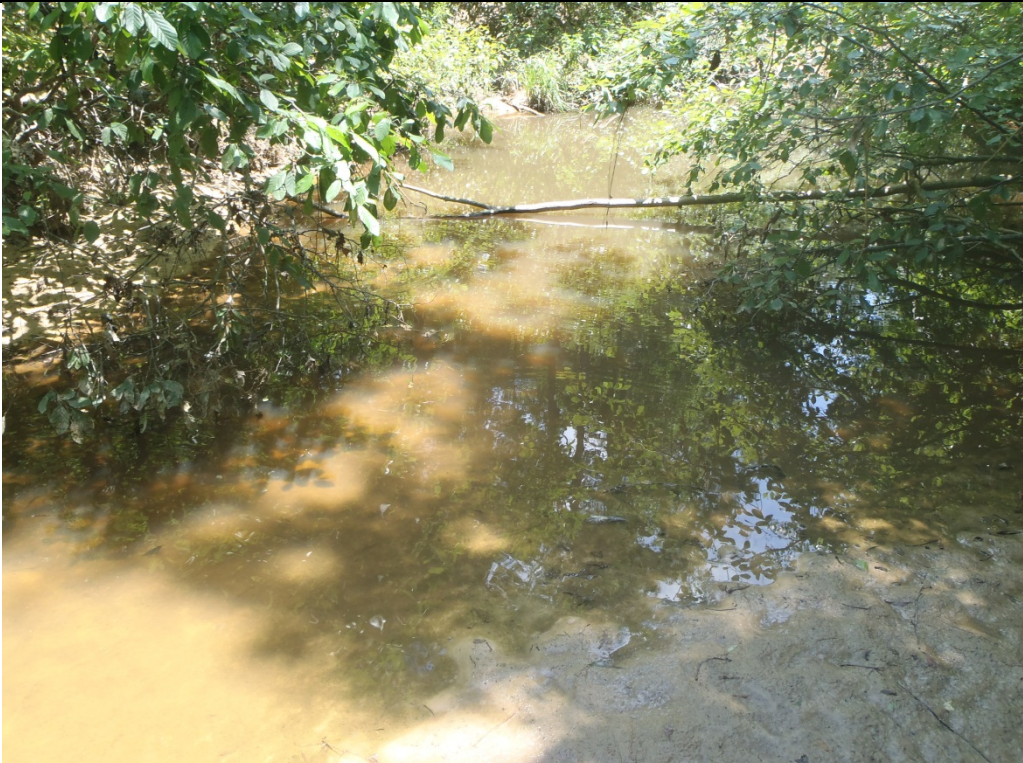
Photographer:	Clark Baker	Date:	6/19/2013
Witness:	None	Time:	1341
		Photo #:	10
Description:	Sample site #5

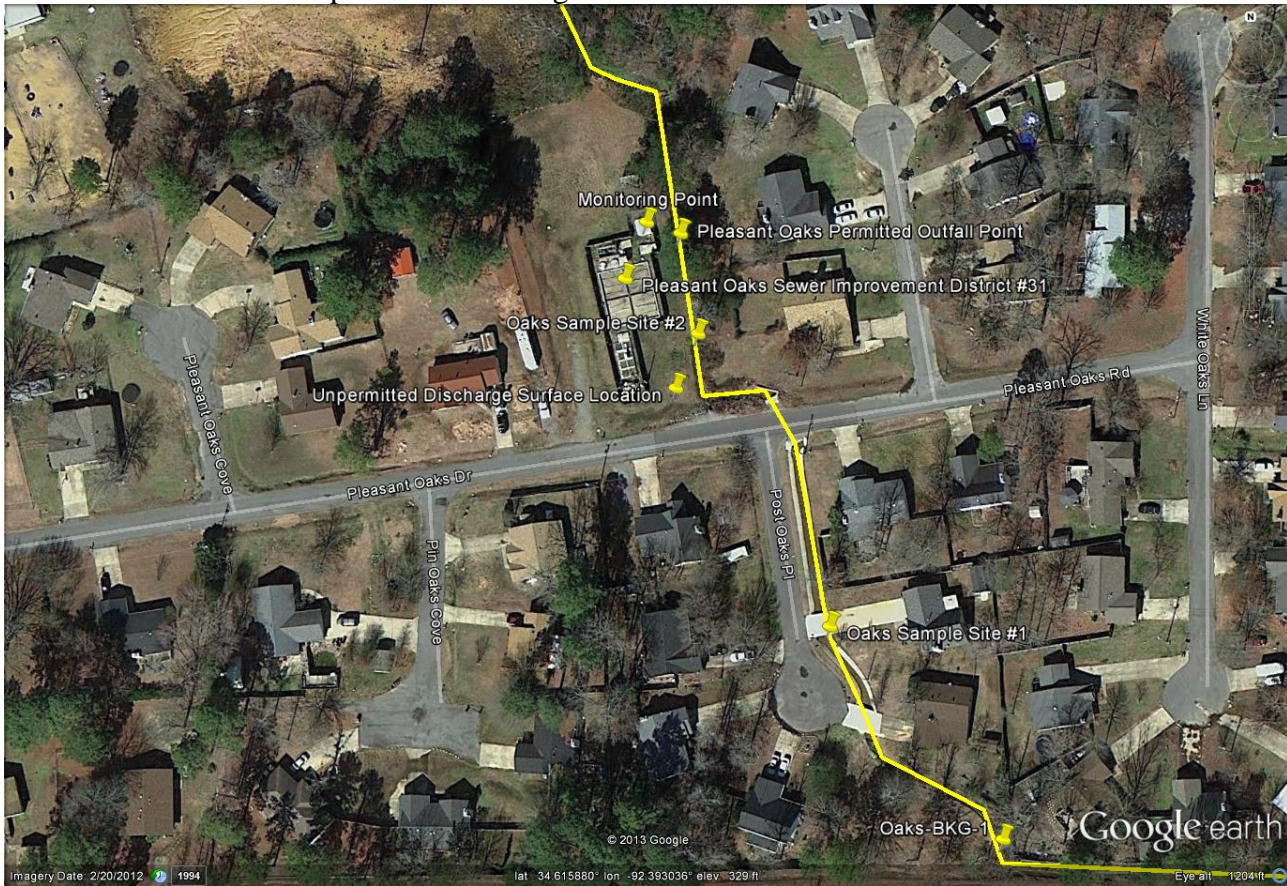
Google Earth Image 2 shows sample sites from Oaks-BKG-1 to Oaks Sample Site #2; as well as, the facility and the location of the unpermitted discharge.

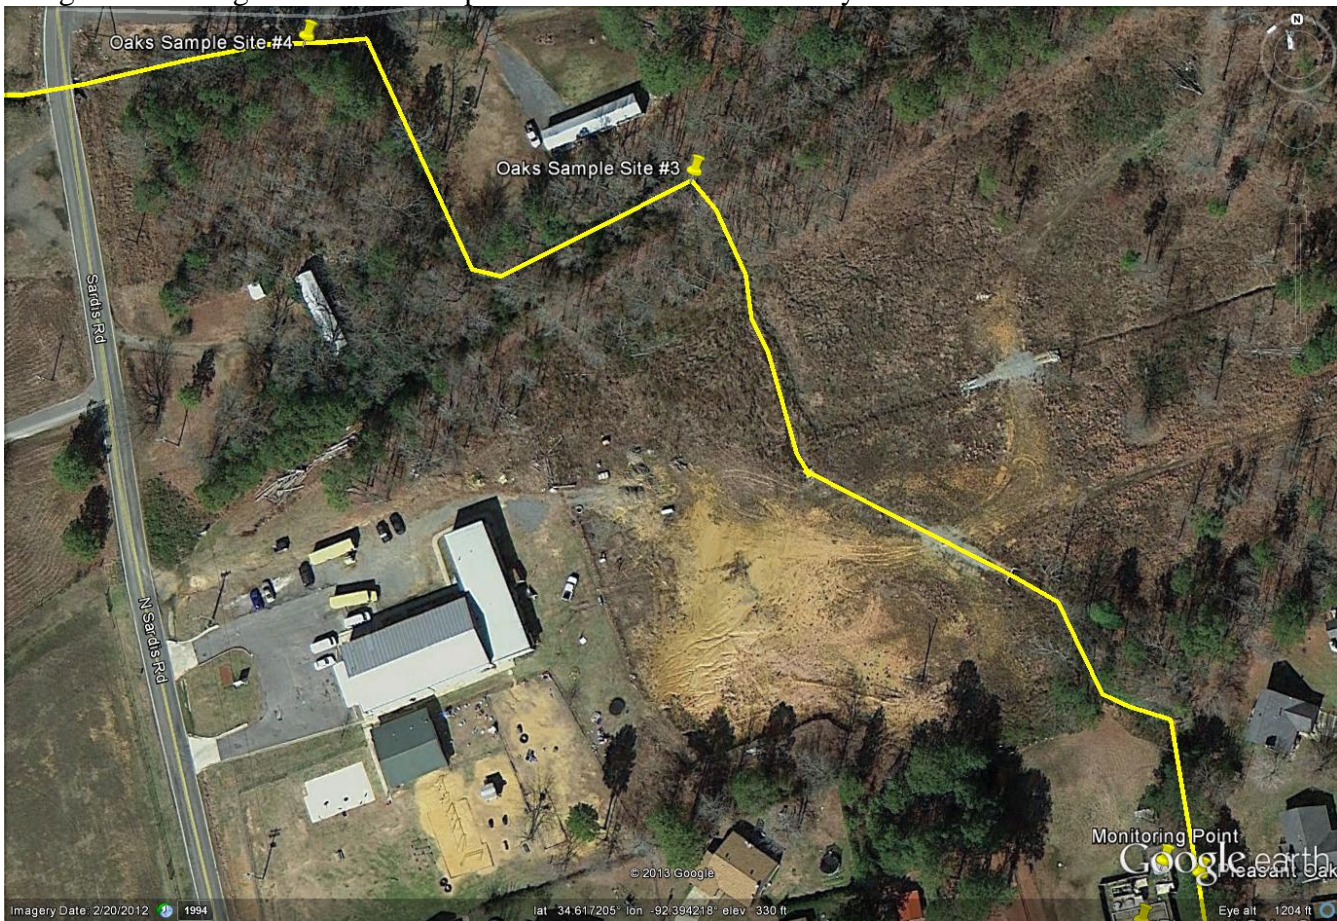
Google Earth Image 3 shows the impacted stream from the facility to Oaks Sardis Rd.

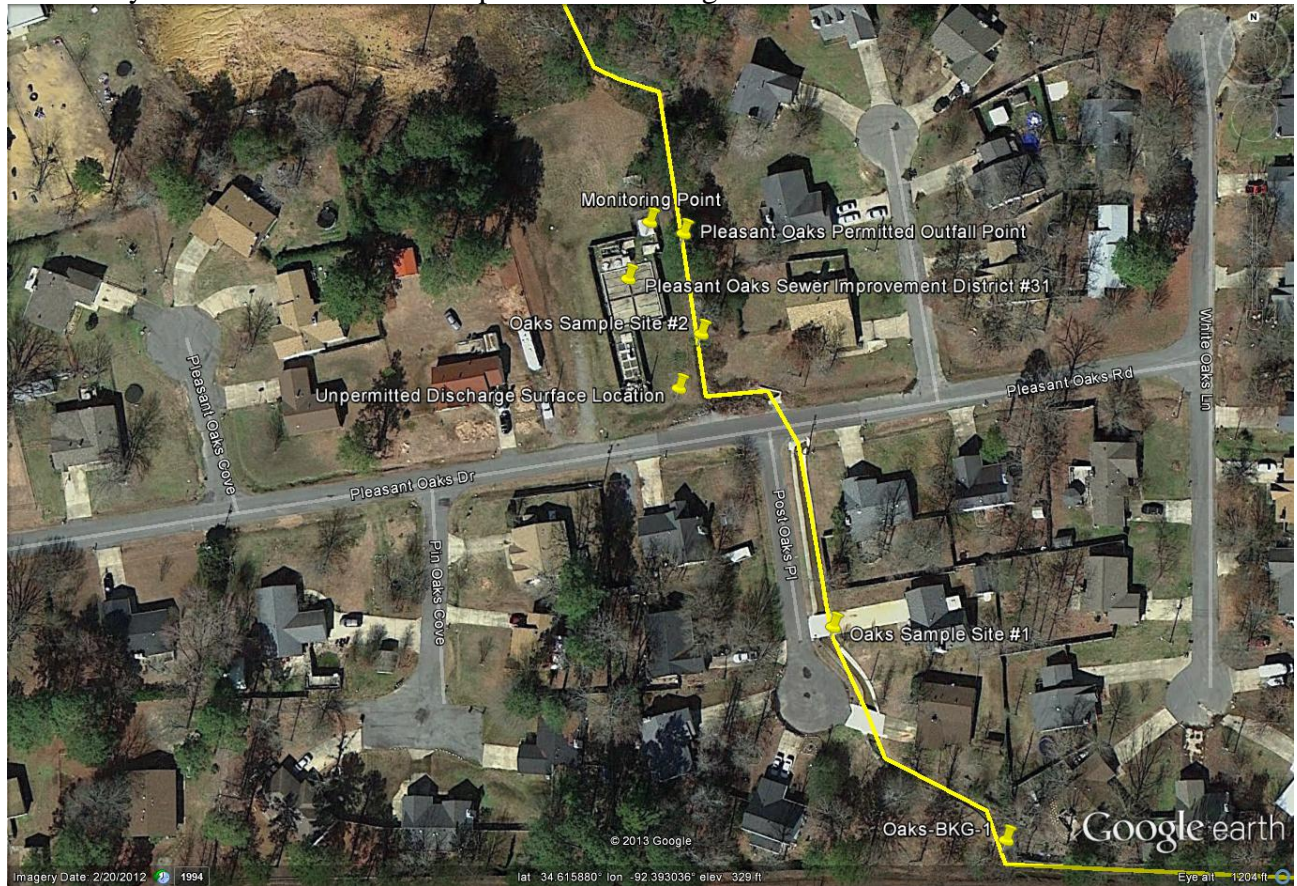
Google Earth Image 2 shows sample sites from Oaks-BKG-1 to Oaks Sample Site #2; as well as, the facility and the location of the unpermitted discharge.

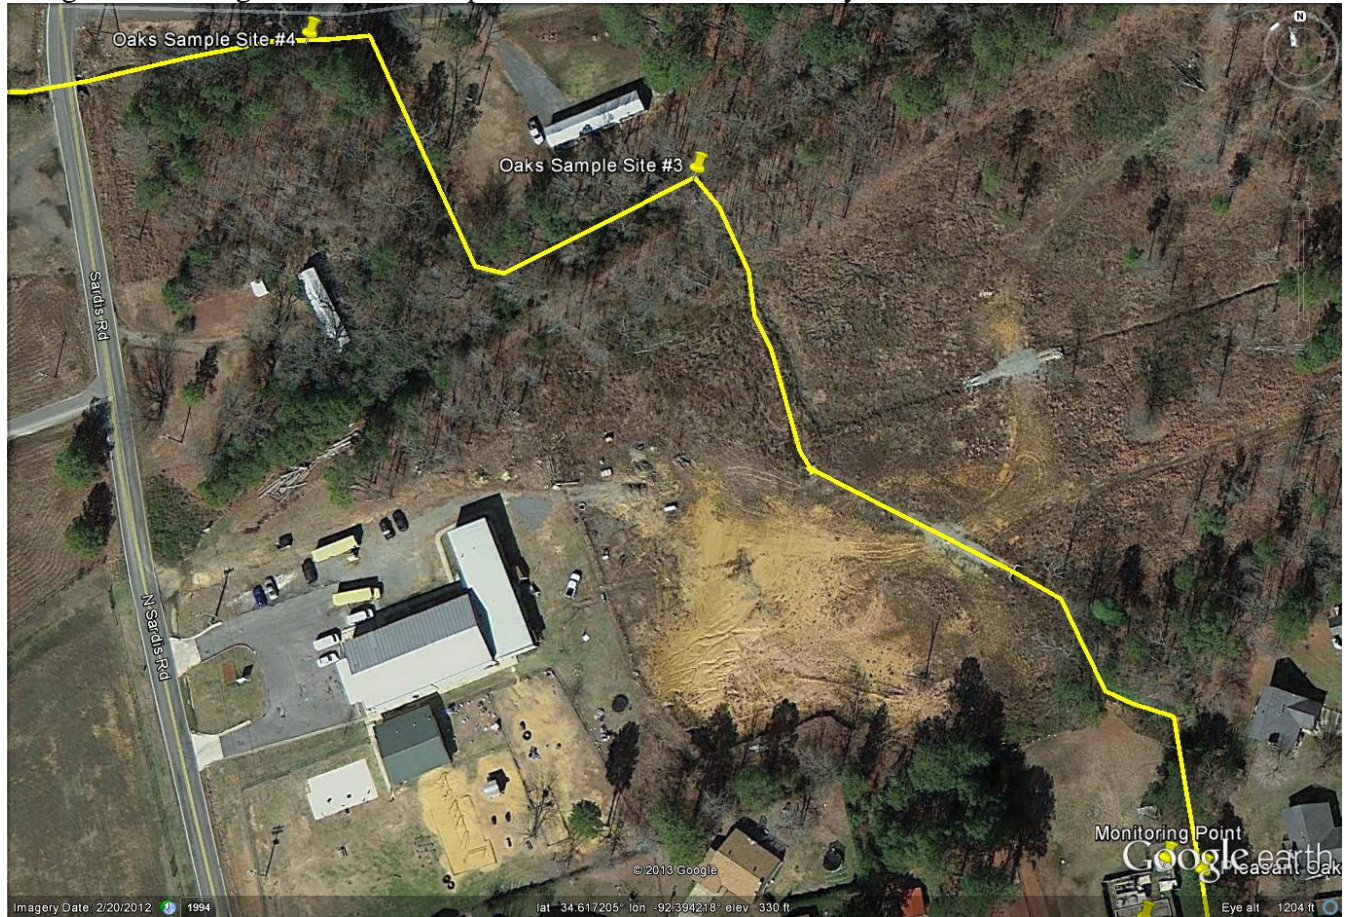
Google Earth Image 3 shows the impacted stream from the facility to Oaks Sardis Rd.

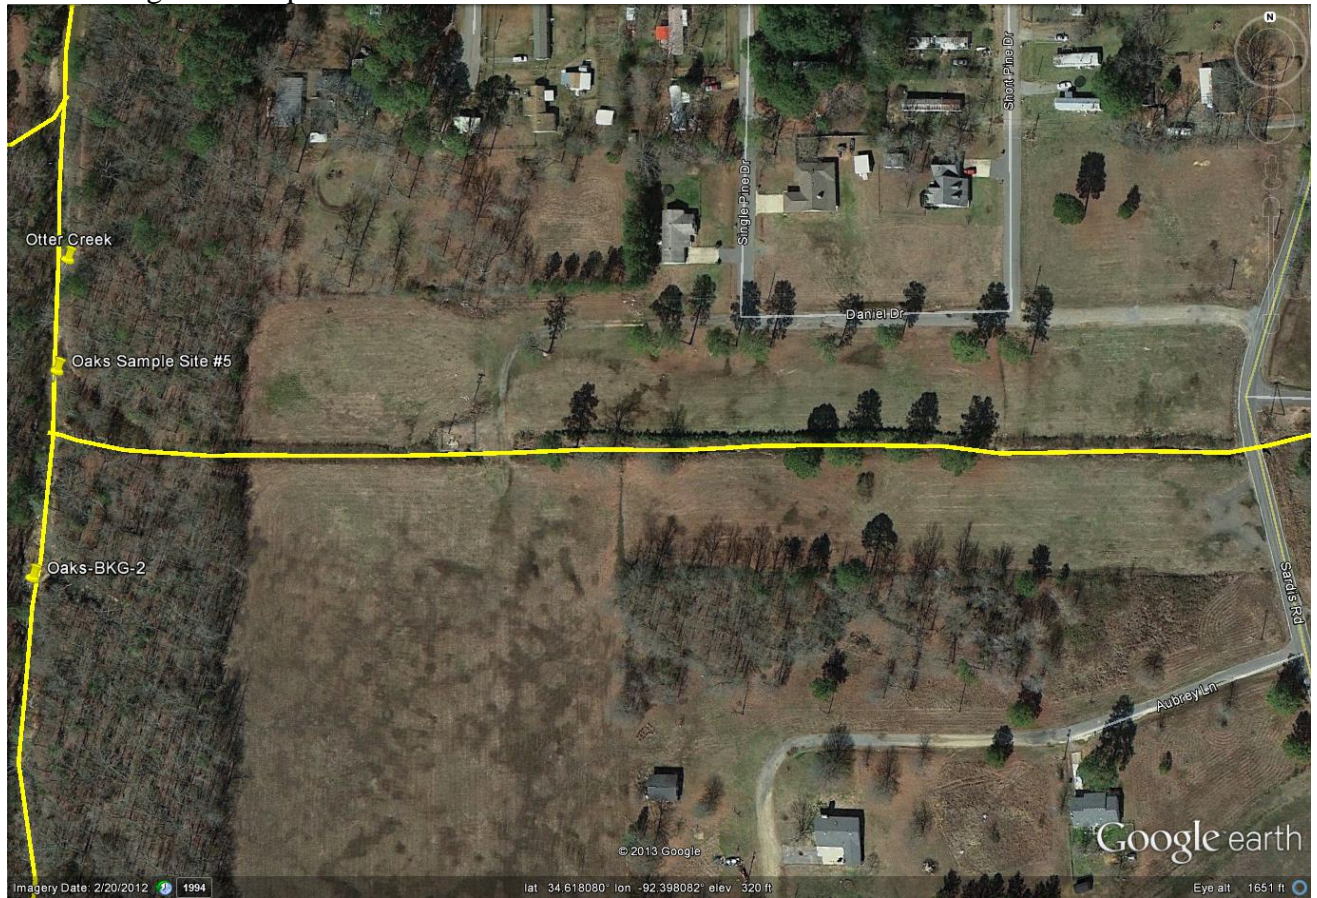
Google Earth Image 4 shows the impacted stream from Sardis Rd. to its entry point in Otter Creek along with sample locations in Otter Creek.

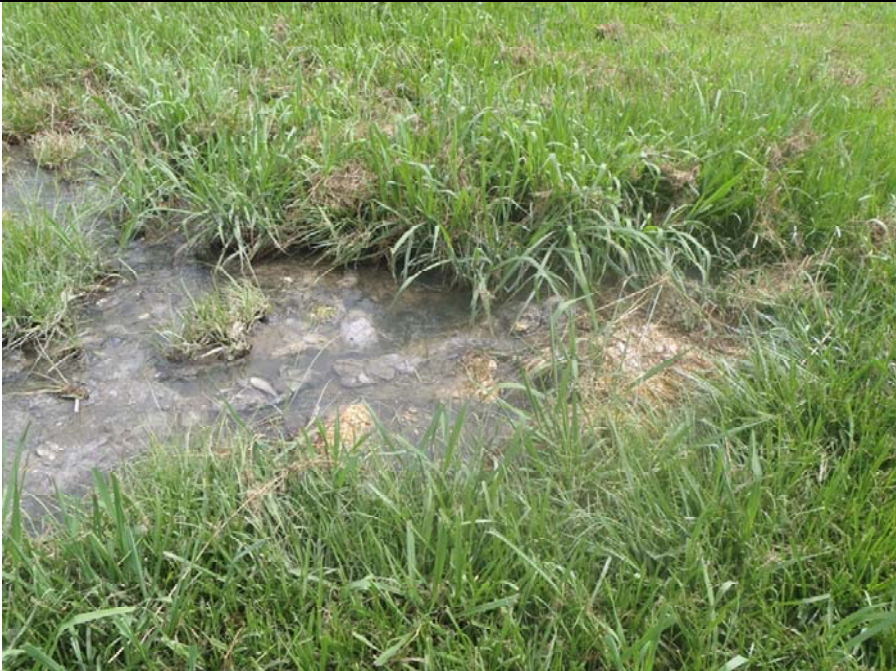
On 6/18/2013, I responded to a complaint of sewage discharging into a creek. The complainant claimed the discharge had been occurring for the past few weeks. The complaint was confirmed during the site visit where I observed sewage flowing out of the ground near the Pleasant Oaks Sewer Improvement District #31 facility. Dissolved Oxygen (DO), pH, and Temperature readings were taken and recorded. I also collected fecal and E. coli samples (see Table 1). Unfortunately, due to a late return, the samples were not able to be processed within the six hour holding period.

Water Division NPDES Photographic Evidence Sheet									
Location:		Pleasant Oaks Waste Water Improvement District #13							
Photographer:		Clark Baker				Witness:		None	
Photo #	1	Of	2		Date:	6/18/2013	Time:	3:59	
Description:		Unpermitted discharge
