NPDES Compliance Inspection Report

Name and Location of Facility Inspected (For industrial users discharging to POTW, also include POTW name and NPDES permit number)	Entry Time /Date 0800 on 3-12-08	Permit Effective Date 3-1-04
<u>Truck-O-Mat Truckwash – located at the Galloway exit, off of I-40, in North Little Rock, AR</u>	Exit Time/Date 0915 on 3-12-08	Permit Expiration Date 12-31-07

POTW Pretreatment Program

Industrial Site Visit

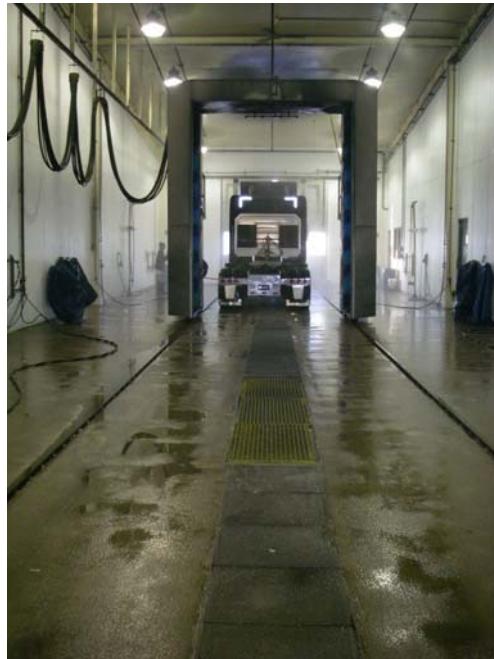
This photo shows the large wash bay, located inside the facility.

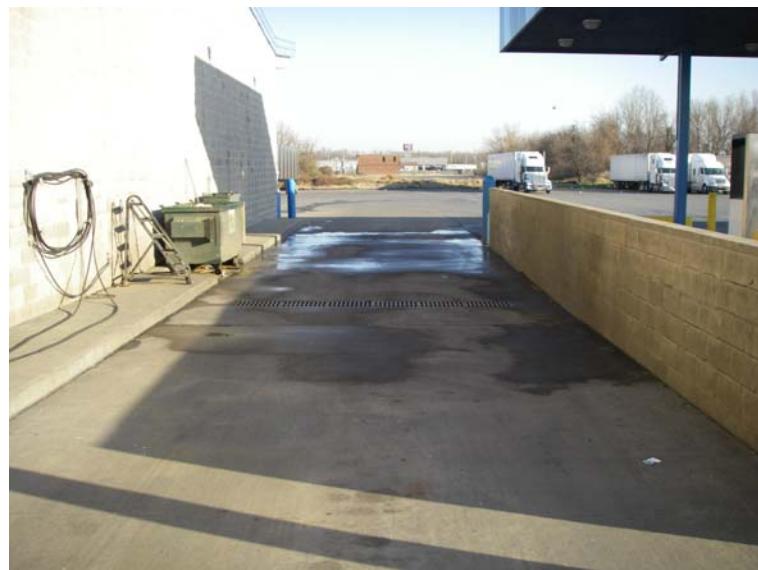
During this site visit I found that an outside grated floor drain, located east of the wash bay, drains into the pretreatment system. This inflow water dilutes the facility process wastestream and causes an inflow into the POTW.

This photo shows the outdoor washing station. The grated drain seen in this photo is allowing rain water to enter the pretreatment system, thereby diluting the process wastestream.

During this site visit I found that an outside grated floor drain, located east of the wash bay, drains into the pretreatment system. This inflow water dilutes the facility process wastestream and causes an inflow into the POTW. This should be corrected.
