RE: City of Bryant MS4 inspection
AFIN: 88-00831 Permit No.: ARR040008

On November 4, 2013, I performed a compliance and complaint inspection of the Forest Cove HMGP Project in response to a complaint. The inspection was conducted in accordance with the provisions of the Federal Clean Water Act, the Arkansas Water and Air Pollution Control Act, and the regulations promulgated thereunder. A copy of the inspection report is enclosed for your records.

Inspection Report: **Forest Cove HMGP Project**, AFIN: **88-00831**, Permit #: **ARR040008**

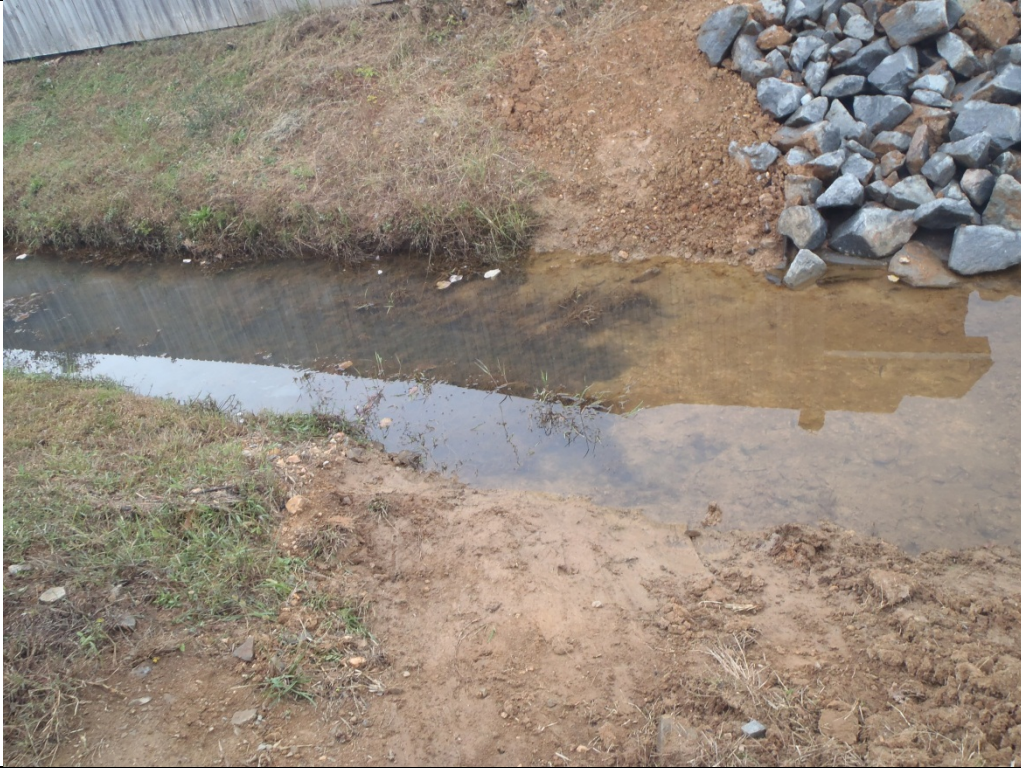
Location:	Forest Cove		
Photographer:	Clark Baker	Date:	11/4/2013
Witness:	None	Time:	1506
		Photo #:	1
Description:	The stream as it enters the project site

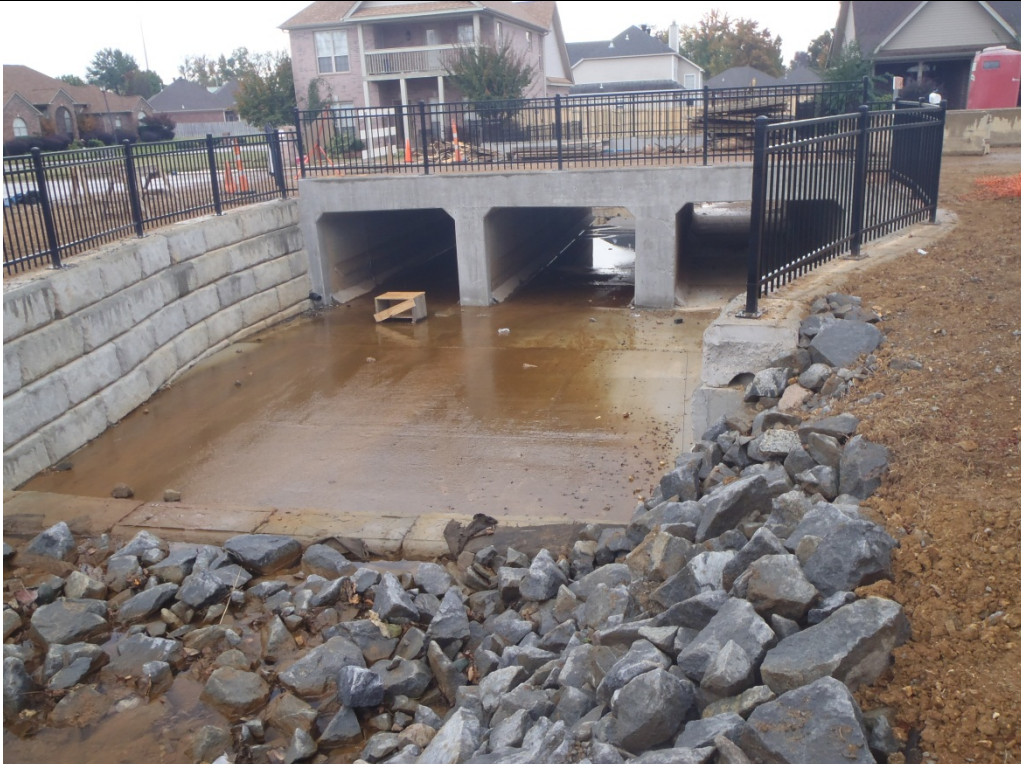
Photographer:	Clark Baker	Date:	11/4/2013
Witness:	None	Time:	1507
		Photo #:	2
Description:	The beginning of the project

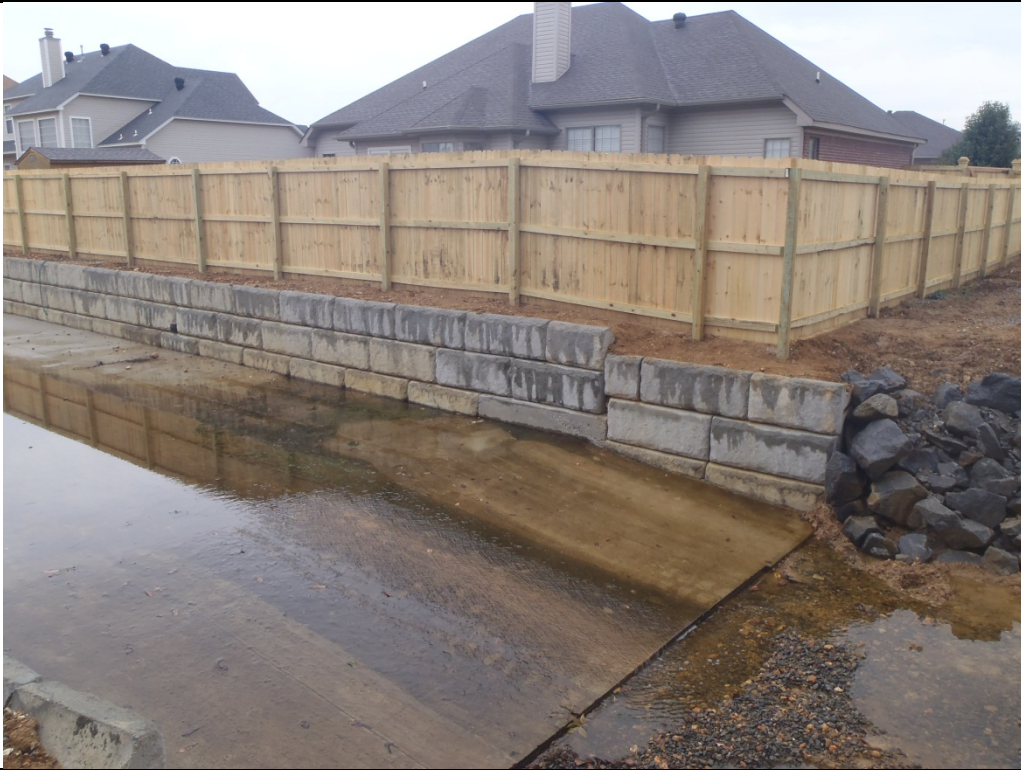
Location:	Forest Cove		
Photographer:	Clark Baker	Date:	11/4/2013
Witness:	None	Time:	1502
		Photo #:	3
Description:	The extent of the current

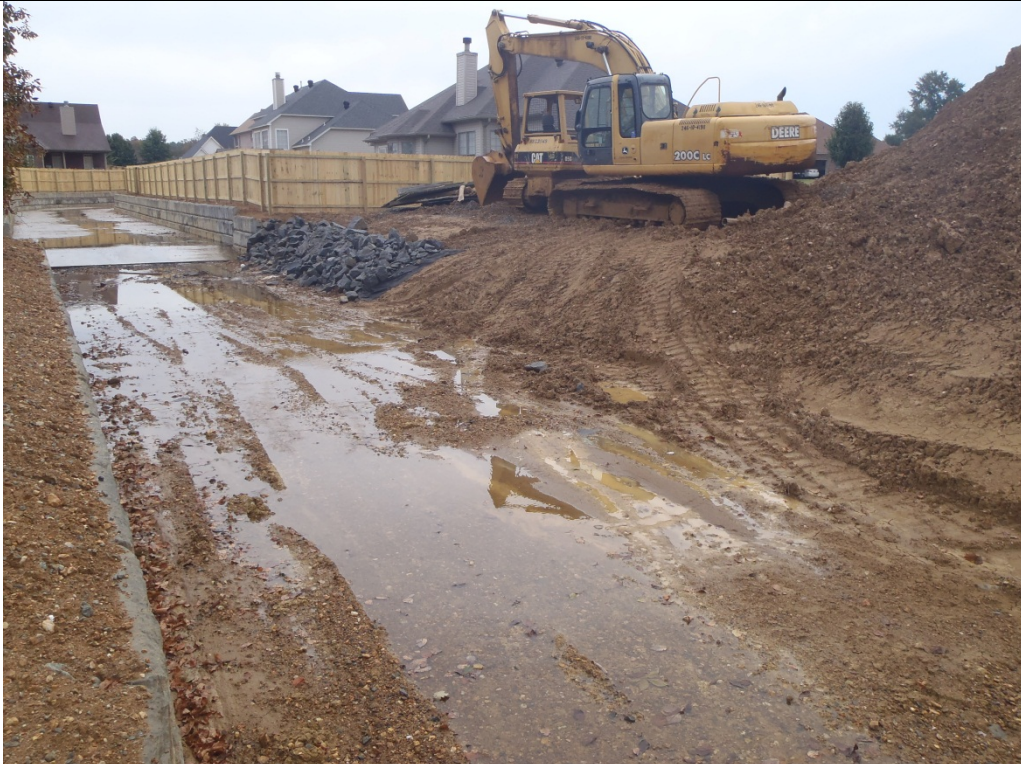
Photographer:	Clark Baker	Date:	11/4/2013
Witness:	None	Time:	1501
		Photo #:	4
Description:	The continuation of the project and evidence of in stream work and disturbance

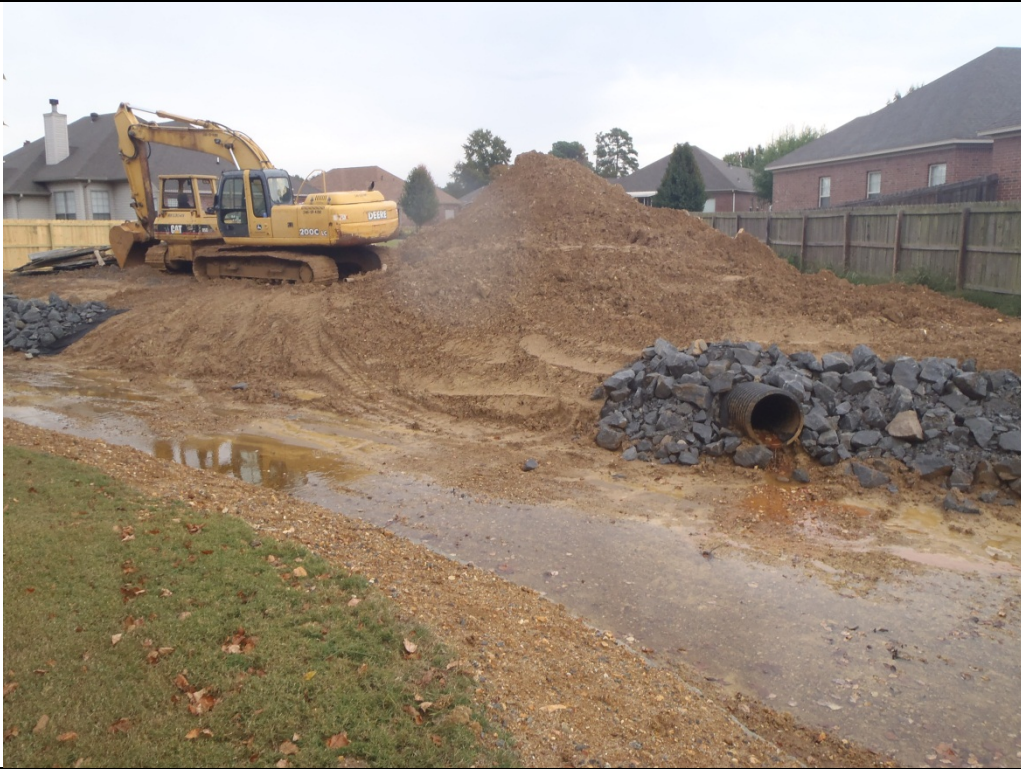
**	OTHER:				
SUMMARY OF FINDINGS					
1. Failure to require construction site operators to implement appropriate erosion and sediment control BMPs as required by Part 3.2.4.1.2 of the permit.

Location:	Forest Cove		
Photographer:	Clark Baker	Date:	11/4/2013
Witness:	None	Time:	1521
		Photo #:	5
Description:	Stock piled material exposed to the weather with no stormwater controls to prevent the polluting of the stream from sediment run off

1. We are requiring the contractor to install silt fencing in various areas until vegetation can be reestablished. Some of the areas will be sodded this week and others have been seeded and straw placed since your inspection.
2. The contractor periodically collects waste such as discarded litter, construction debris, etc. We are requiring the contractor to collect waste more frequently and thoroughly.
3. We are requiring the contractor to update the site plan included with the SWPPP with all BMP's used at the site.

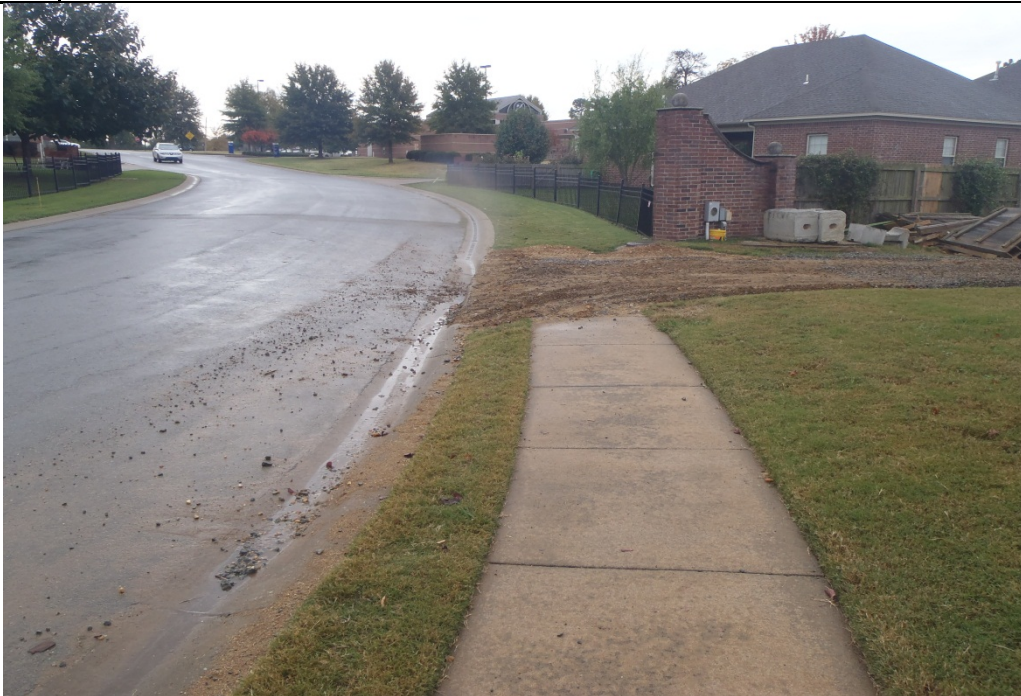
Photographer:	Clark Baker	Date:	11/4/2013
Witness:	None	Time:	1519
		Photo #:	6
Description:	Unstabilized site entrance with offsite tracking of sediment that is flowing into storm drain

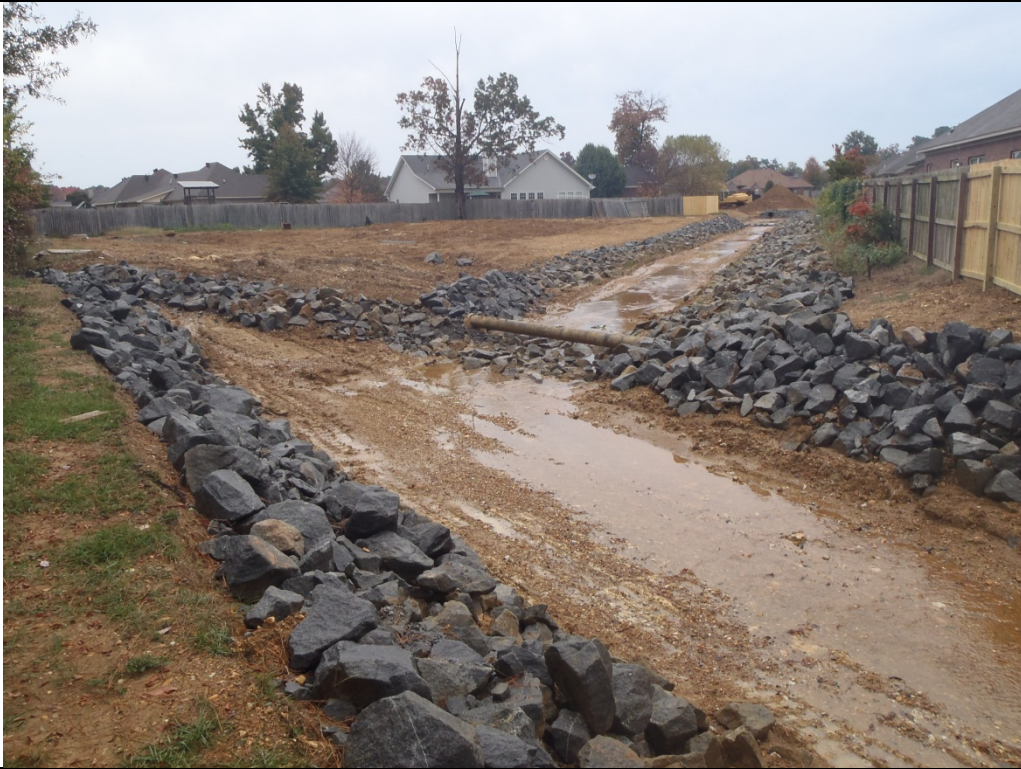
Location:	Forest Cove		
Photographer:	Clark Baker	Date:	11/4/2013
Witness:	None	Time:	1456
		Photo #:	7
Description:	Rip rap placed on stream banks and in channel, Unstable ground with no stormwater controls to prevent the polluting of the stream by sediment run off

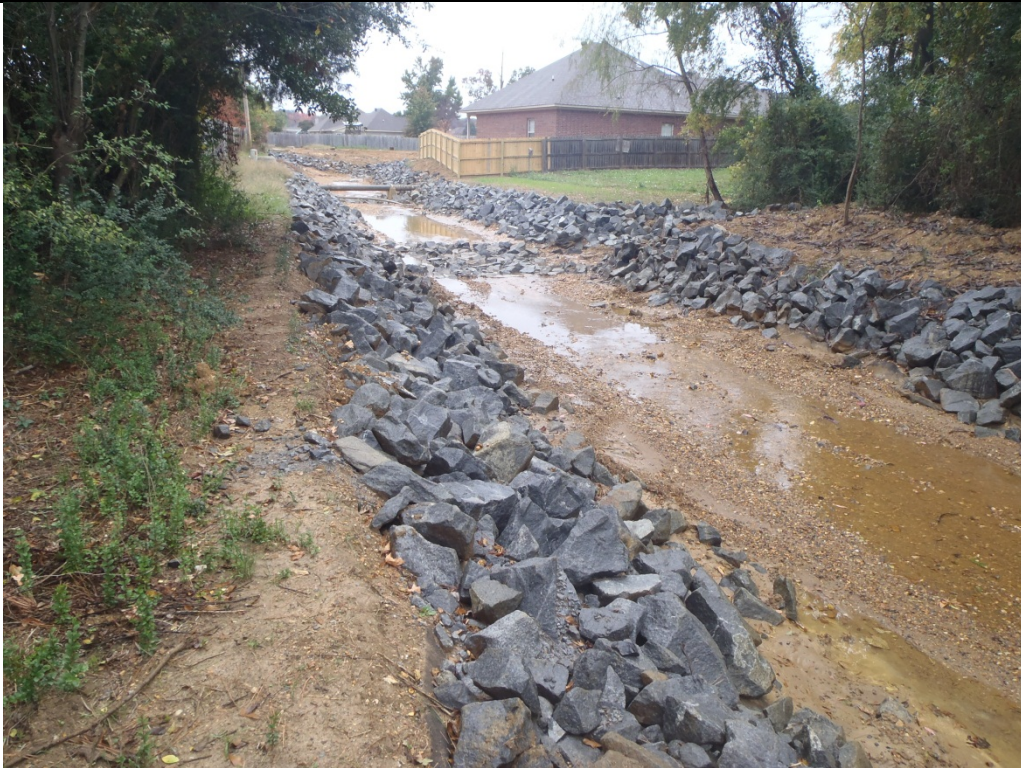
Photographer:	Clark Baker	Date:	11/4/2013
Witness:	None	Time:	1454
		Photo #:	8
Description:	Stream banks stabilized with rip rap, rip rap placed in the stream channel

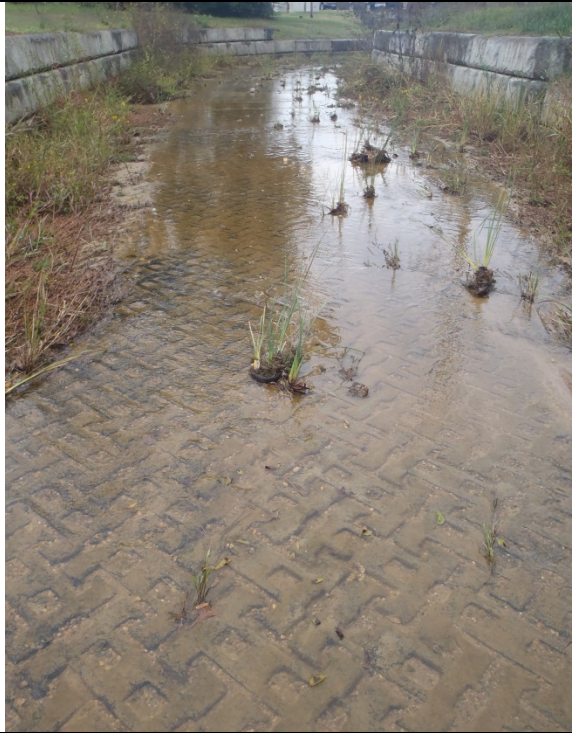
Location:	Forest Cove		
Photographer:	Clark Baker	Date:	11/4/2013
Witness:	None	Time:	1530
		Photo #:	9
Description:	Stream channelized in the past with cinder blocks serving as the stream bed

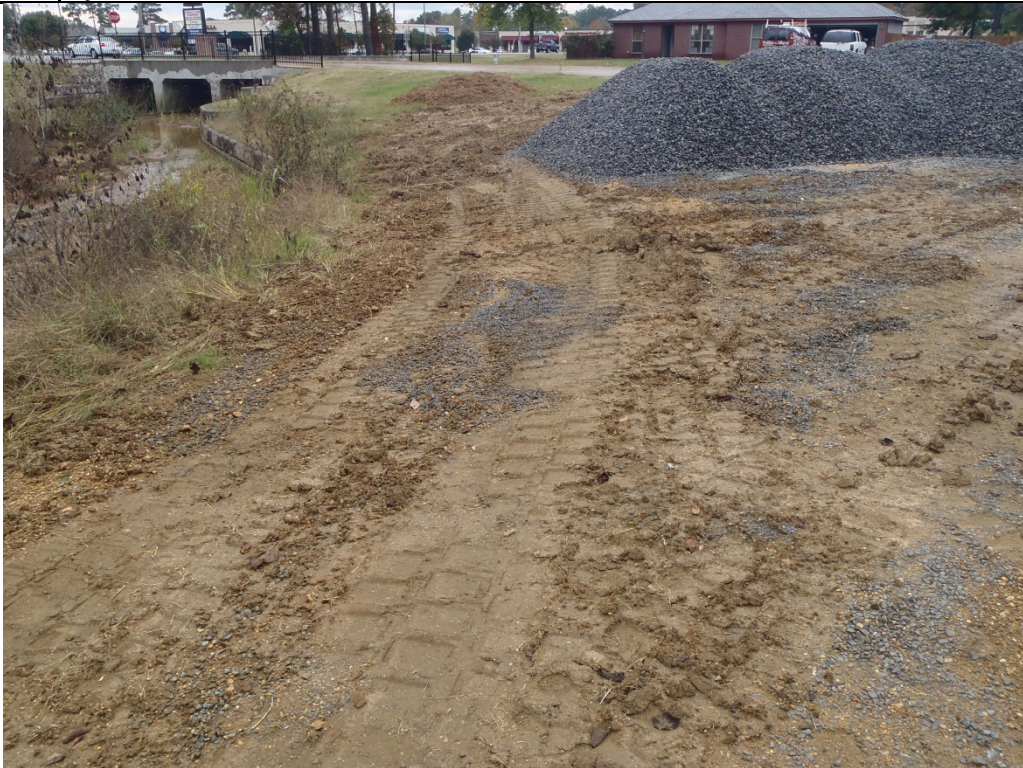
Photographer:	Clark Baker	Date:	11/4/2013
Witness:	None	Time:	1452
		Photo #:	10
Description:	Unstable ground with no stormwater controls to prevent the polluting of the stream by sediment run off

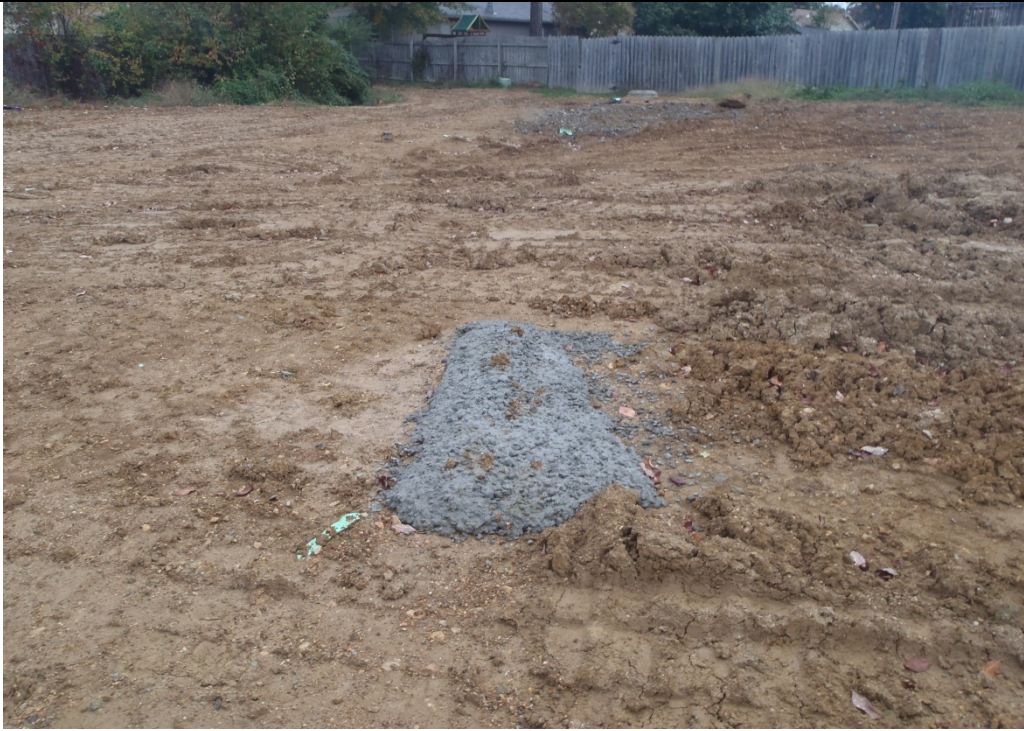
3. Failure to implement procedures for site plan review which incorporate consideration of potential water quality impacts as required by Part 3.2.4.1.4 of the permit.					
GENERAL COMMENTS					
The Department has no records of a Short Term Activity Authorization (STAA) having been applied for by the City of Bryant for this project.					
INSPECTOR'S SIGNATURE:

Location:	Forest Cove		
Photographer:	Clark Baker	Date:	11/4/2013
Witness:	None	Time:	1459
		Photo #:	11
Description:	Concrete washout is not properly identified on the SWPPP map

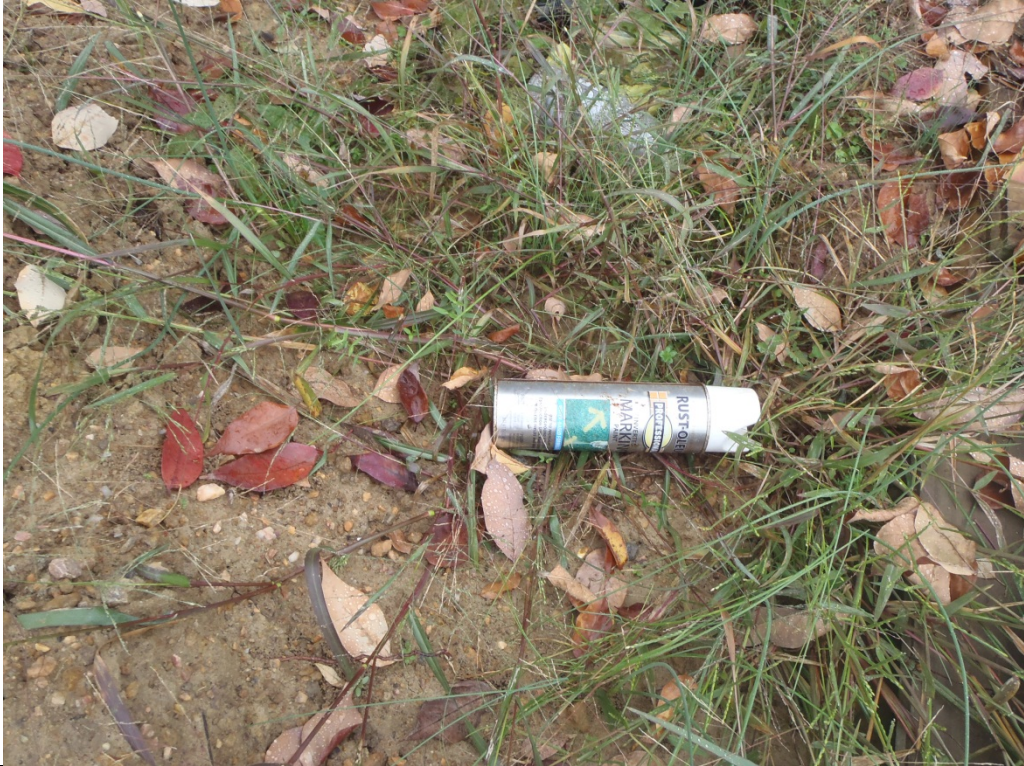
2. Failure to require construction site operators to control waste such as discarded litter at the construction site that may cause adverse impacts to water quality as required by Part 3.2.4.1.3 of the permit.

Photographer:	Clark Baker	Date:	11/4/2013
Witness:	None	Time:	1458
		Photo #:	12
Description:	Litter like this can of marking paint is throughout the site

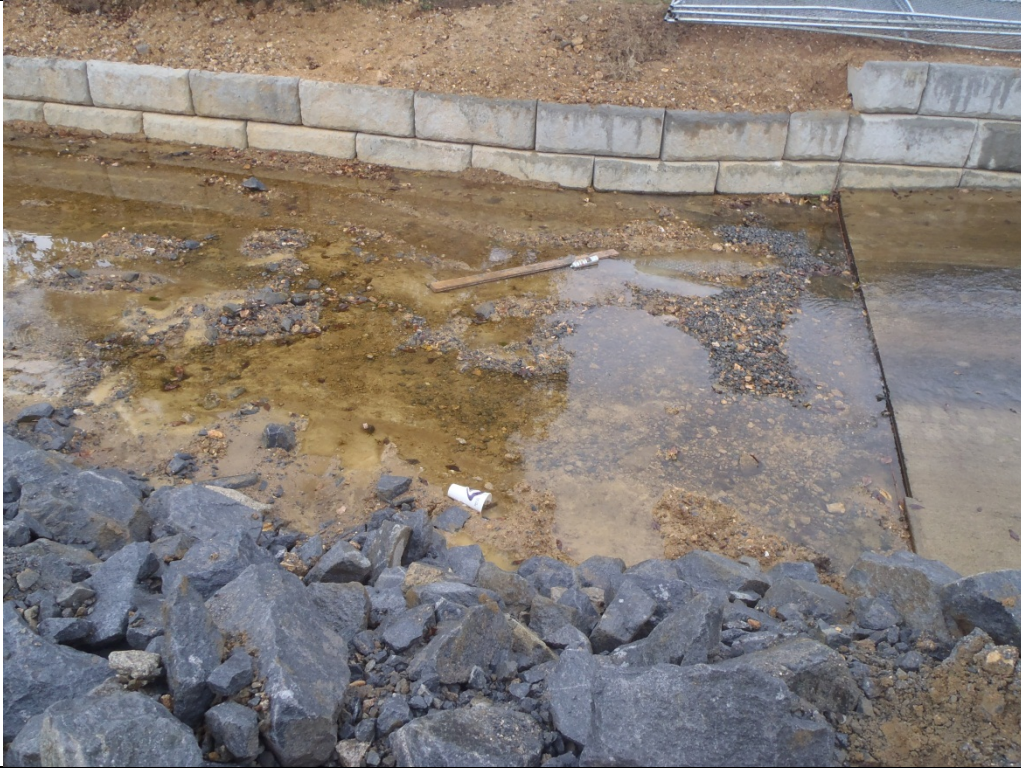
Location:	Forest Cove		
Photographer:	Clark Baker	Date:	11/4/2013
Witness:	None	Time:	1520
		Photo #:	13
Description:	Litter like this 2x4 lumber, can of marking paint, and fast food cup in the stream

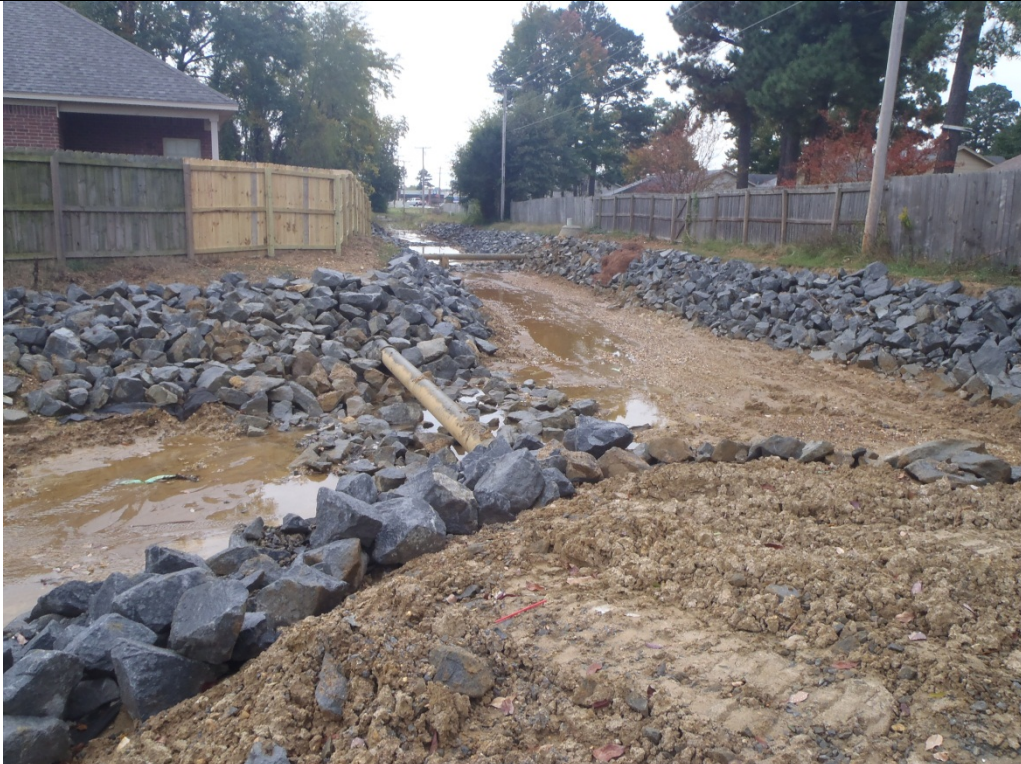
Photographer:	Clark Baker	Date:	11/4/2013
Witness:	None	Time:	1526
		Photo #:	14
Description:	Sediment built up in the stream channel

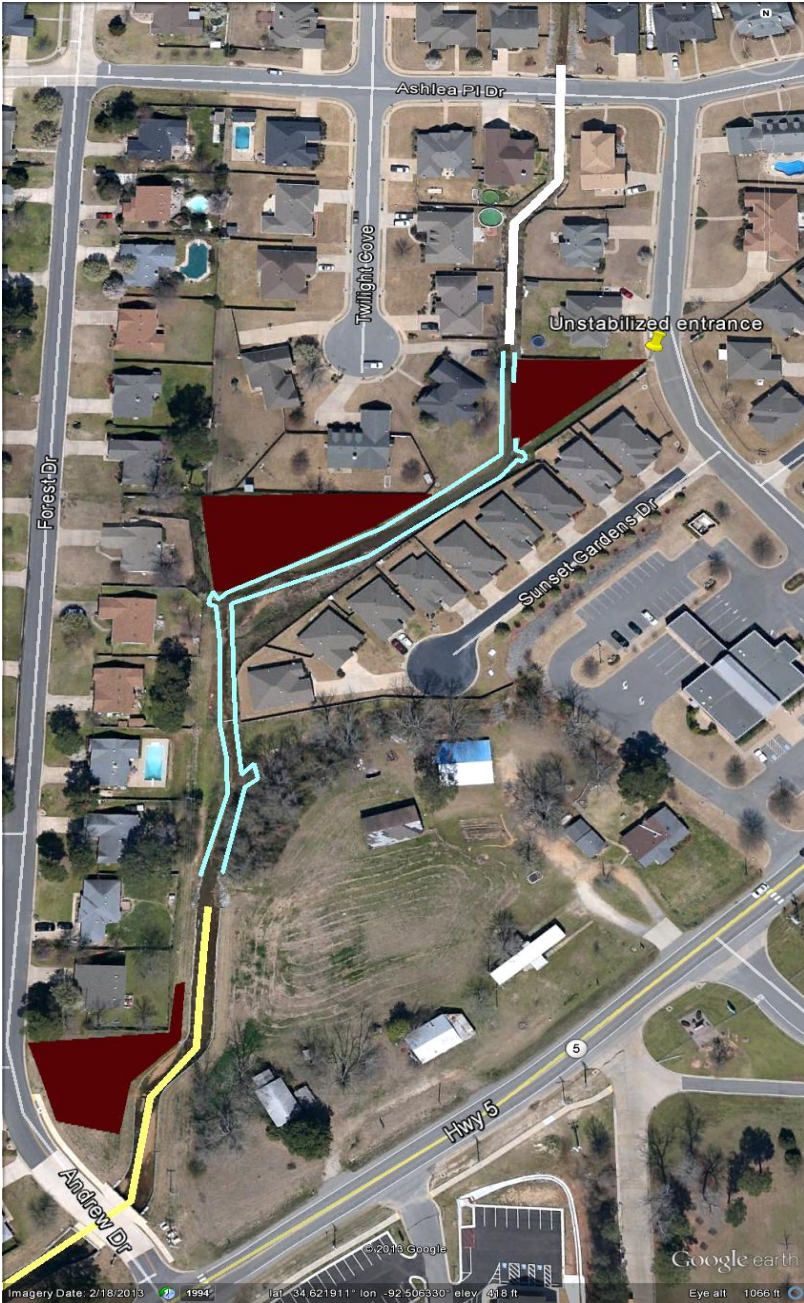
Google Earth Image of the project area. The area in white has already had its stream bed concreted and its banks replaced with storm walls. The area in light blue has had its banks disturbed to install rip rap, and the area in yellow has a stream bed of cinder blocks. The three brown areas are areas of disturbed earth with no stormwater controls installed to prevent the pollution of the stream:

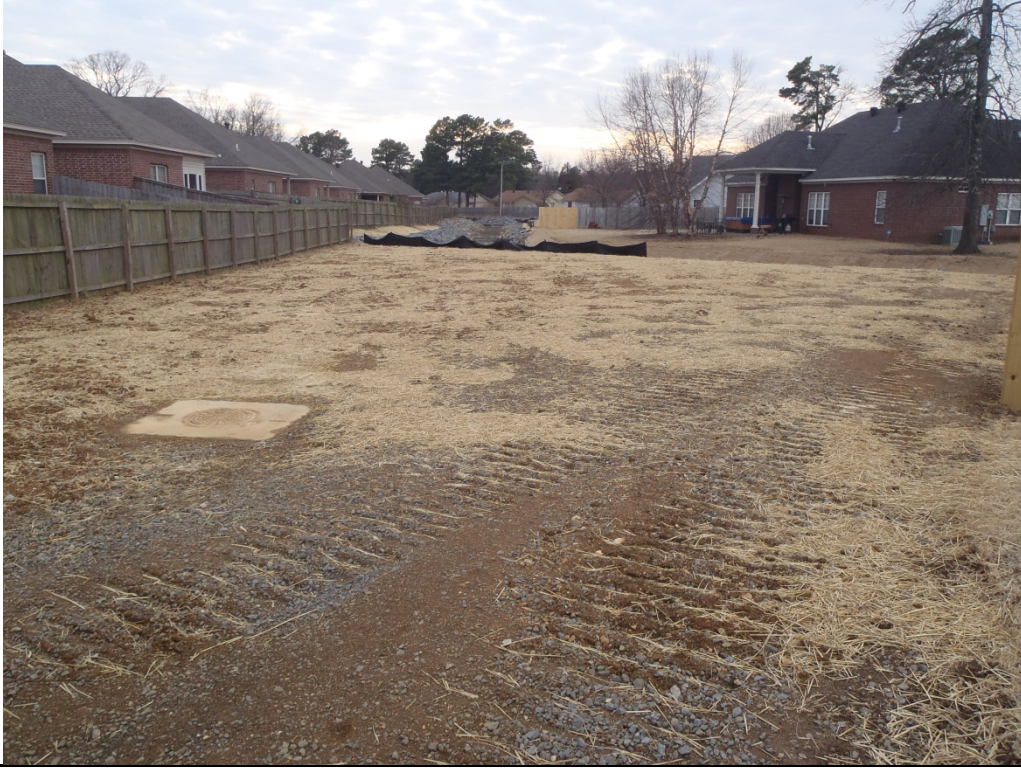
Location:	Forest Cove				
Photographer:	Clark Baker	Date:	2/10/2014	Time:	1546
Witness:	None			Photo #:	1
Description:	Stormwater controls have been installed and soil stabilized

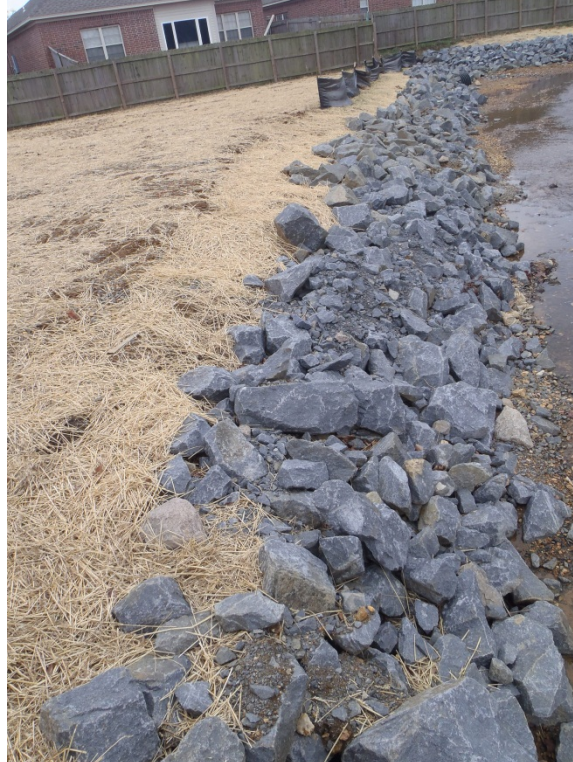
Photographer:	Clark Baker	Date:	2/10/2014	Time:	1547
Witness:	None			Photo #:	2
Description:	Stormwater controls have been installed and soil stabilized

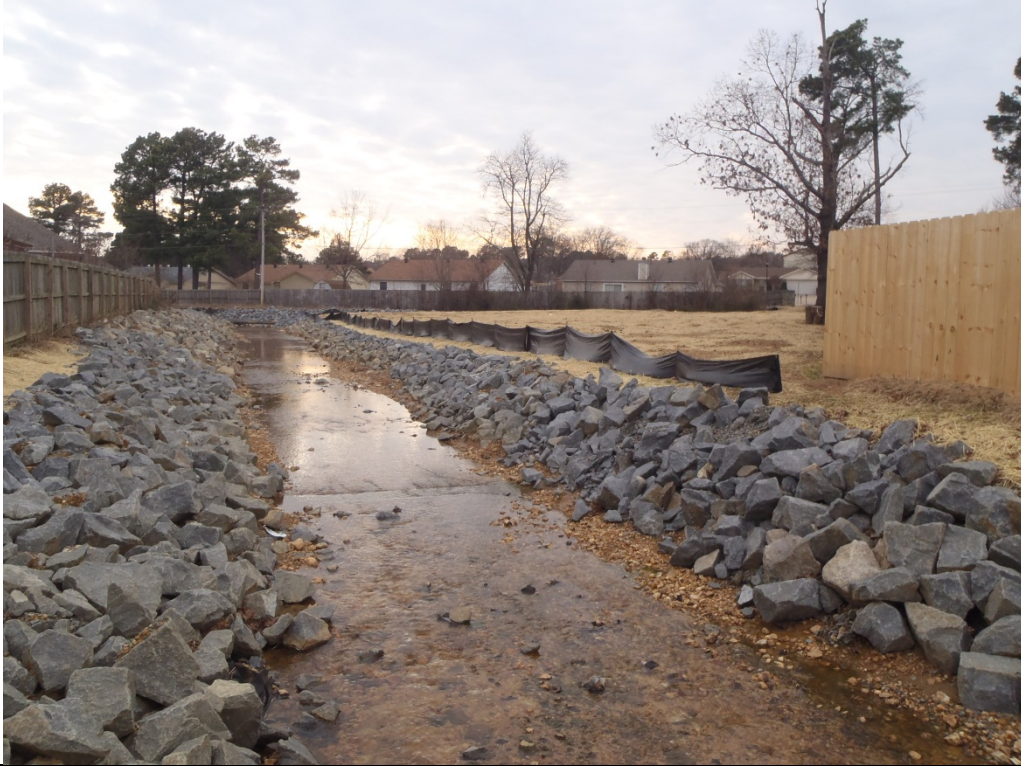
Location:	Forest Cove				
Photographer:	Clark Baker	Date:	2/10/2014	Time:	1548
Witness:	None			Photo #:	3
Description:	Stormwater controls have been installed and soil stabilized

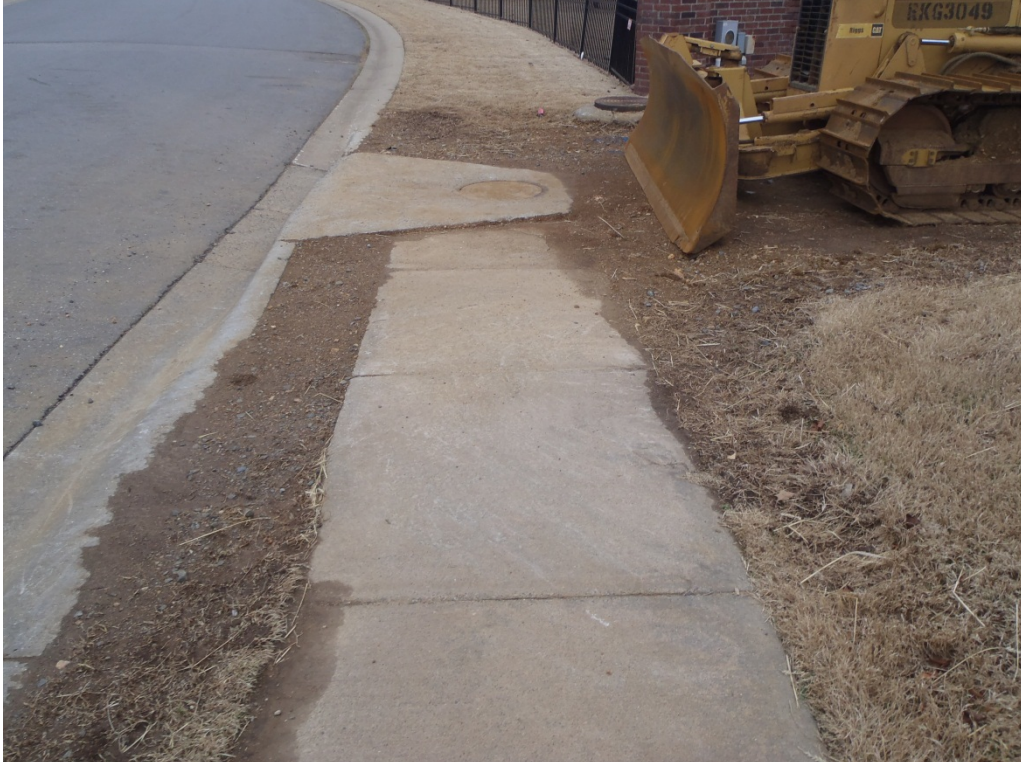
Photographer:	Clark Baker	Date:	2/10/2014	Time:	1546
Witness:	None			Photo #:	4
Description:	Off-site tracking has been cleaned up
