**MAYFLOWER PIPELINE INCIDENT RESPONSE  
 EXXONMOBIL ENVIRONMENTAL SERVICES COMPANY  
 DOWNSTREAM AREAS DATA ASSESSMENT REPORT**

**SITE LOCATION MAP**

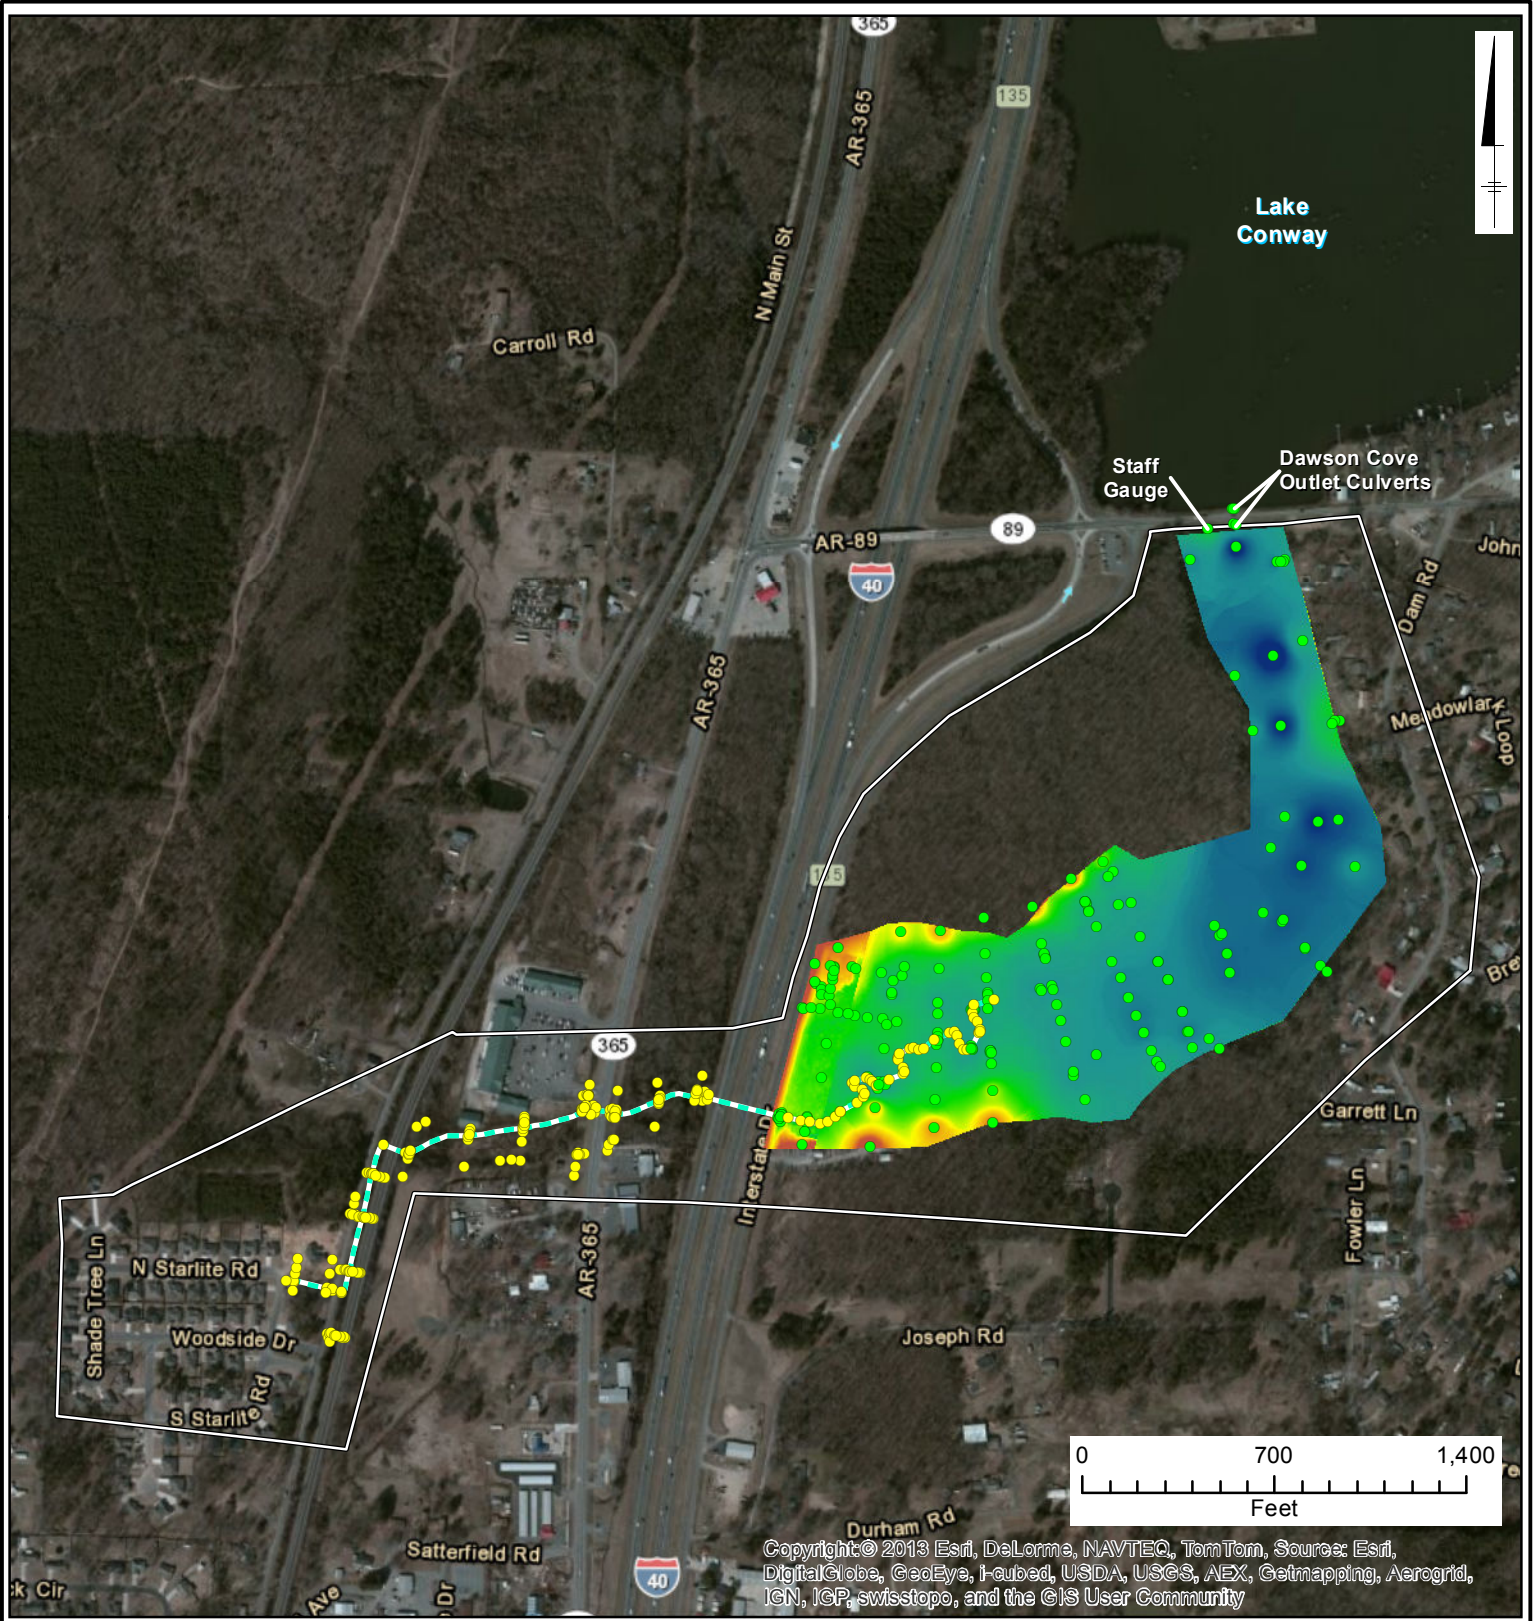
**FIGURE  
3-1**

**NOTE:**  
 1. Survey data collected during field activities interpolated by the Inverse Distance Weighting (IDW) method using an optimized power term to develop a digital elevation model (DEM) for the area shown.

**SITE LOCATION TOPOGRAPHIC SURVEY**

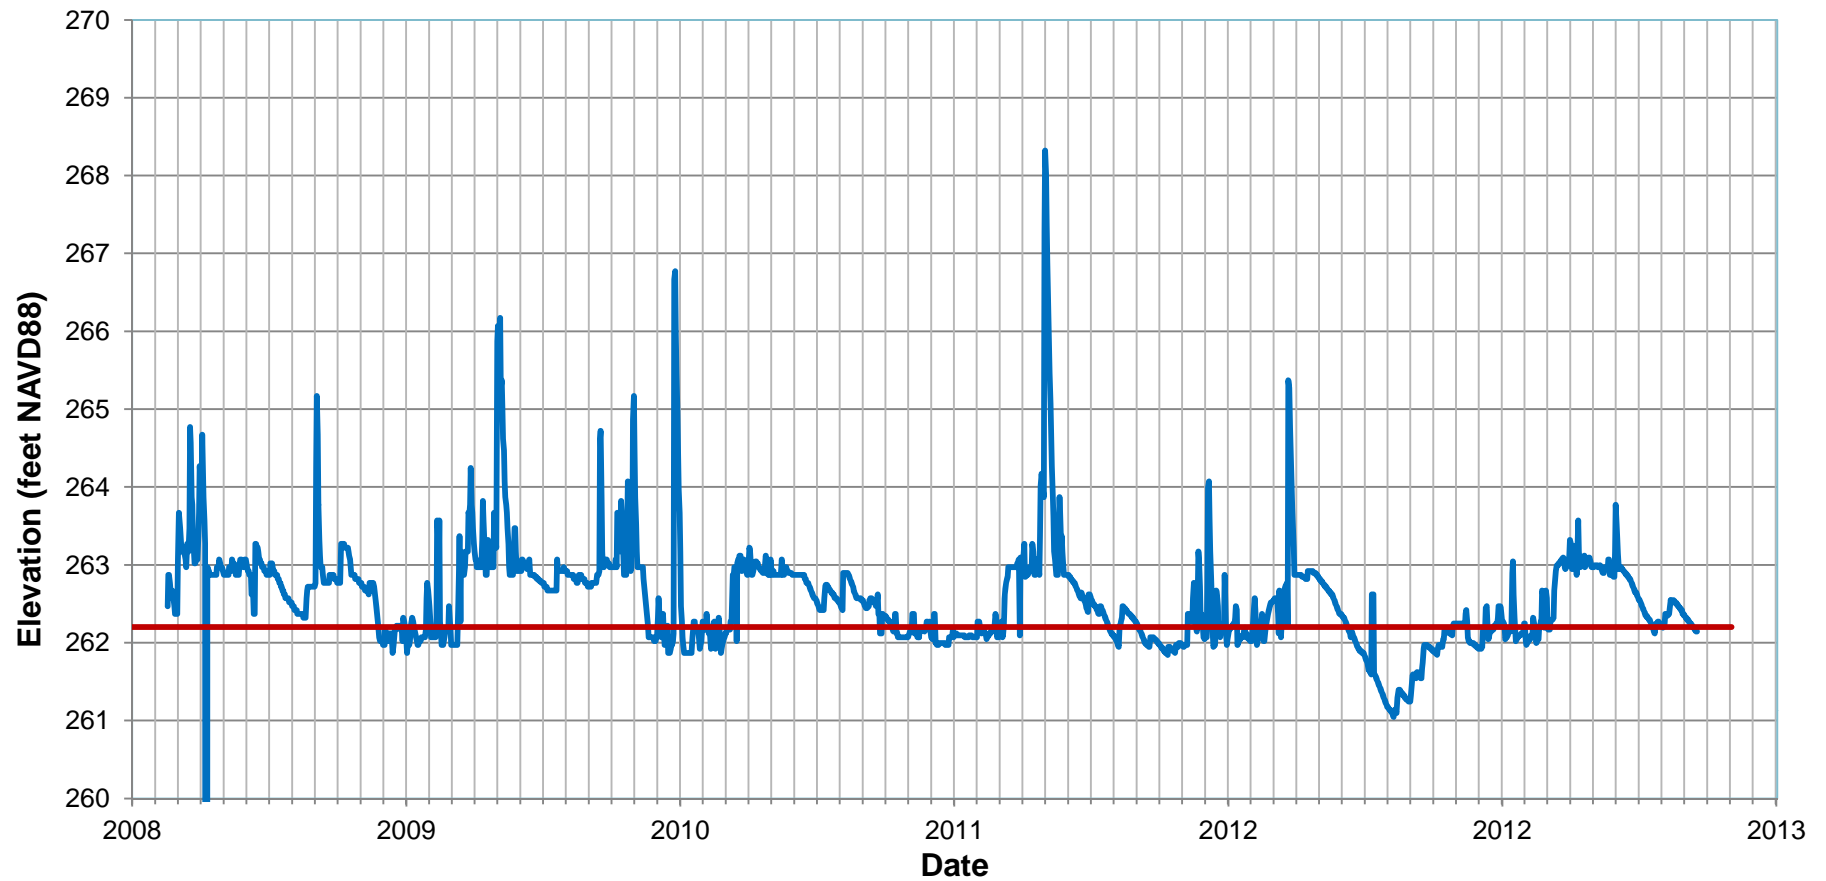
FIGURE <b>3-4</b>

1. Water elevation data are available from February 18, 2008 through September 16, 2013. The data are provided by Lake Manager, Mr. Matthew Horton (Arkansas Game and Fish Commission [AGFC], District 10 Lake Manager).
2. Water surface elevations are recorded at the gauge located near the AGFC Mayflower Enforcement Training Center.
3. Lake Conway levels on April 9 and 10, 2008 were reported as 236.12 feet and 236.02 feet (NAVD88). No additional information related to this data point is available at this time.

MAYFLOWER PIPELINE INCIDENT RESPONSE EXXONMOBIL ENVIRONMENTAL SERVICES COMPANY DOWNSTREAM AREAS DATA ASSESSMENT REPORT	
<b>Lake Conway Peak Daily Water                  Elevation Data</b>

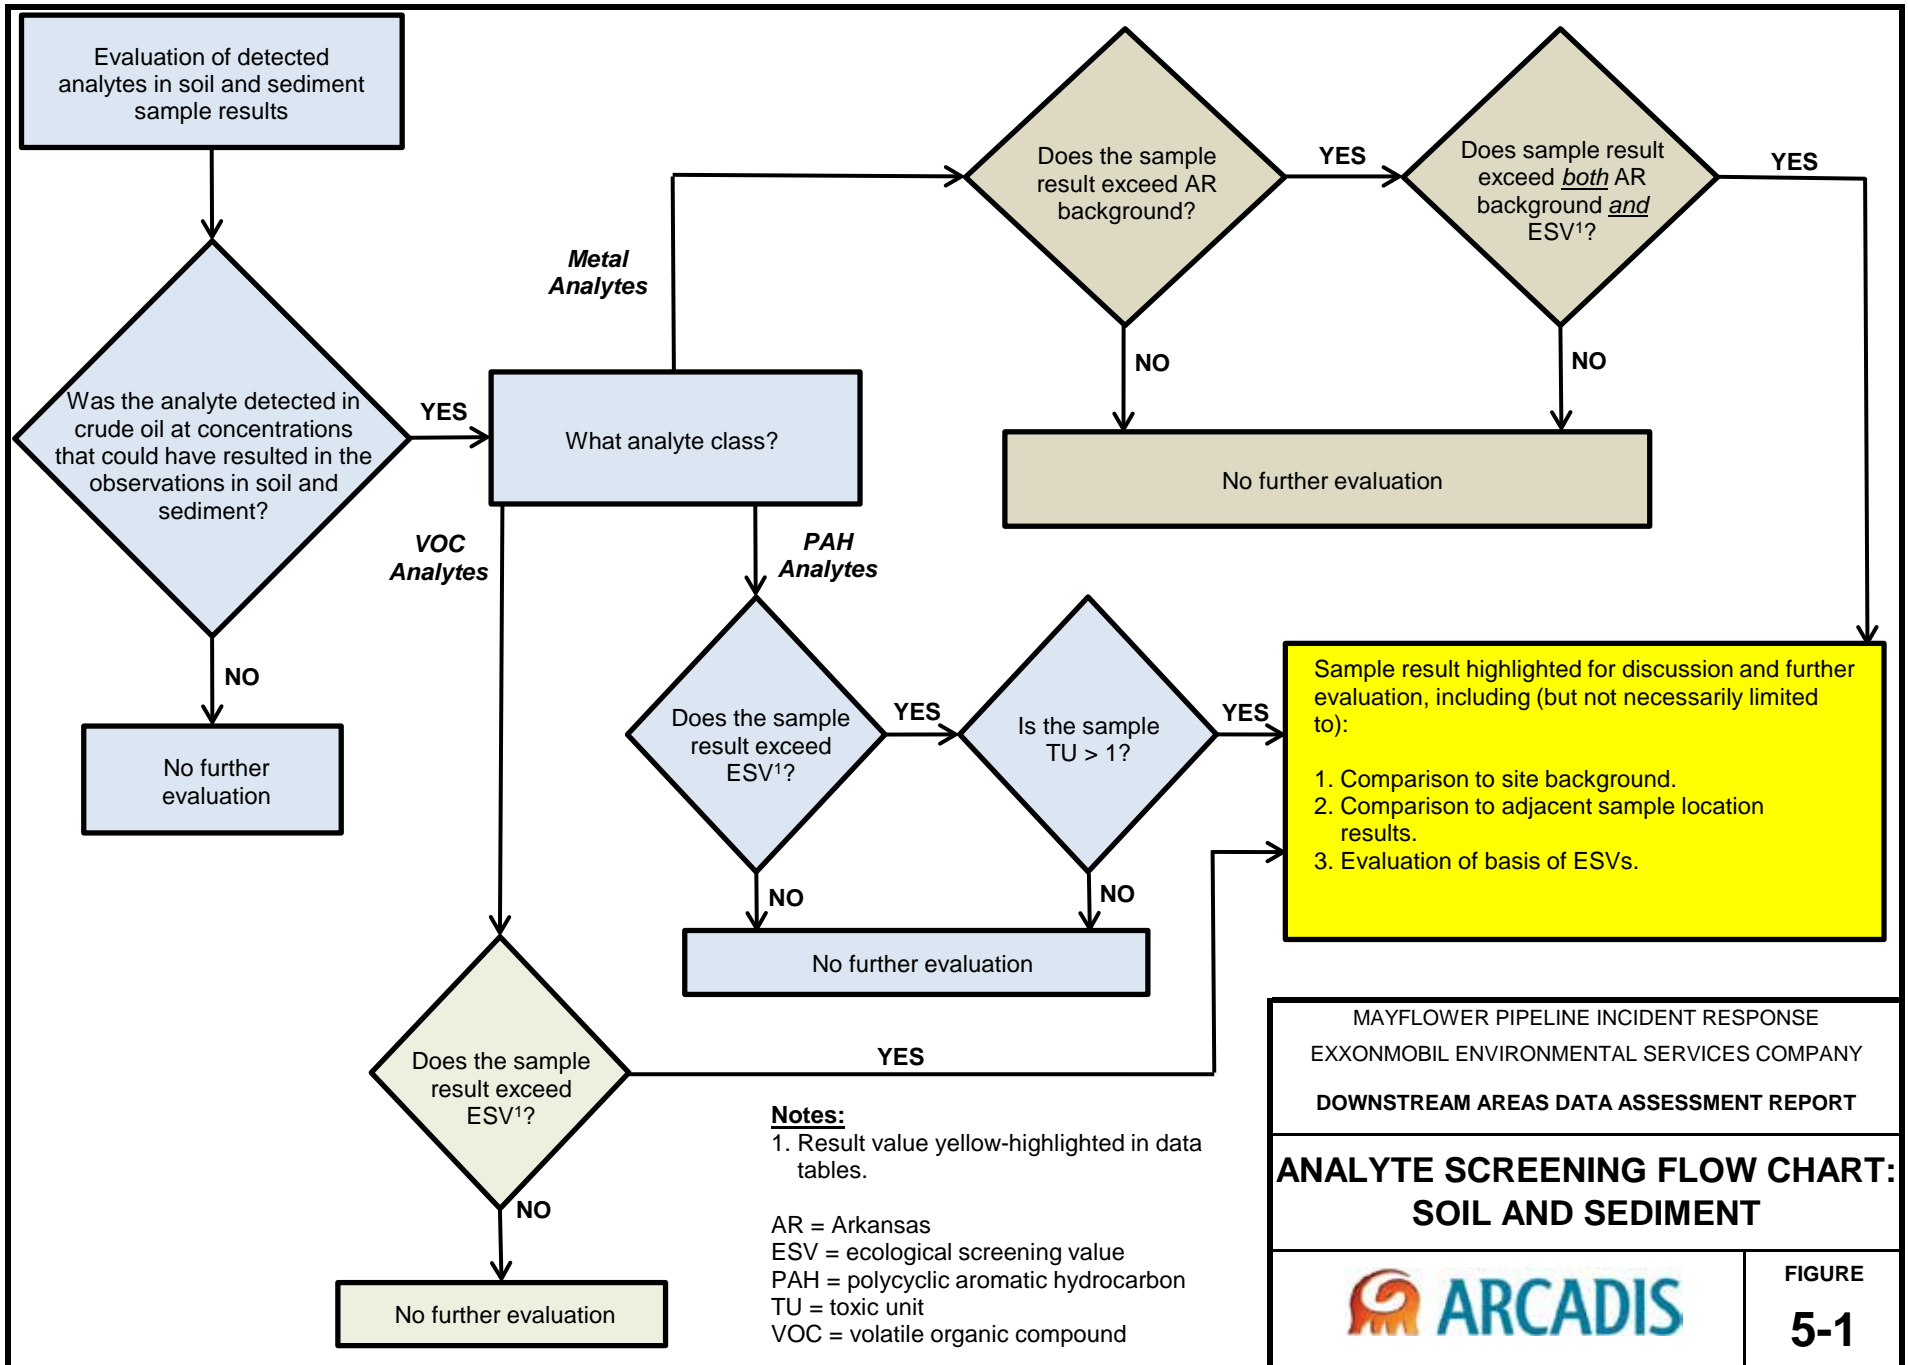
**ANALYTE SCREENING FLOW CHART:  
 SOIL AND SEDIMENT**

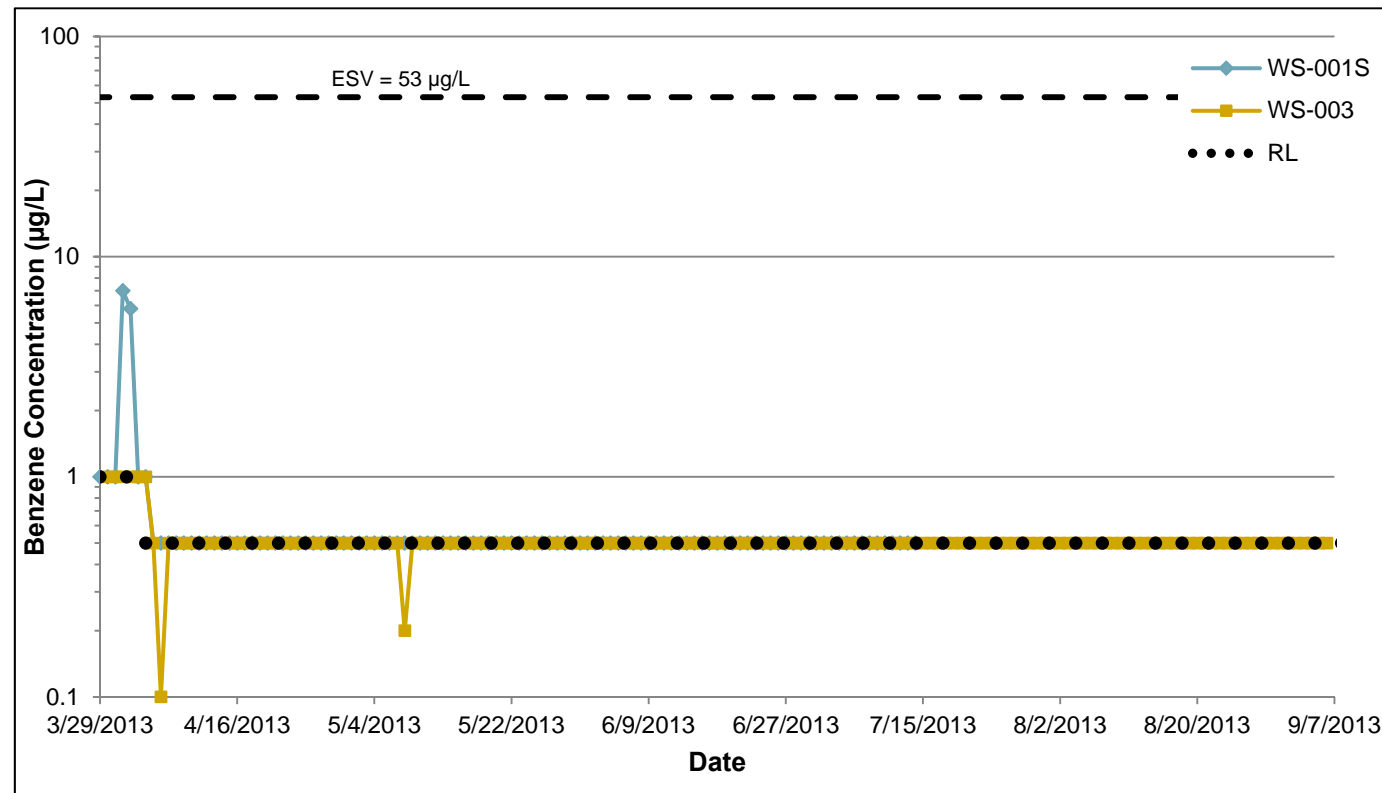
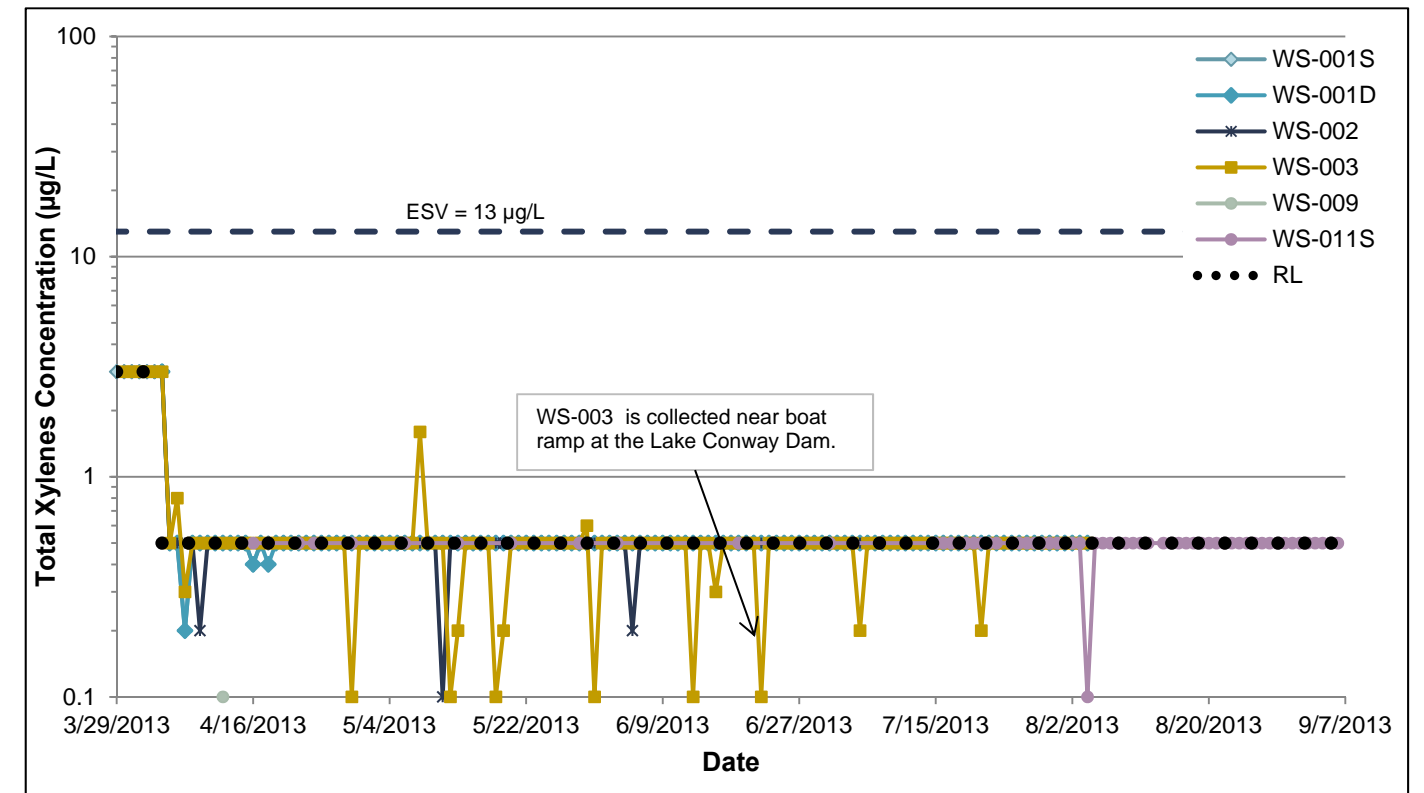
**No detected VOC concentrations above ESV at any location within Lake Conway.**  
The graphs below show benzene and total xylenes concentrations with time for the locations that had at least one detection.

1. Evaluation based on the following locations in Lake Conway: WS-001S, WS-001D, WS-002, WS-003, WS-006S, WS-006D, WS-009, WS-010S, WS-010D, WS-011S, WS-011D, WS-012S, WS-012D, WS-018S, WS-018D, and WS-021.

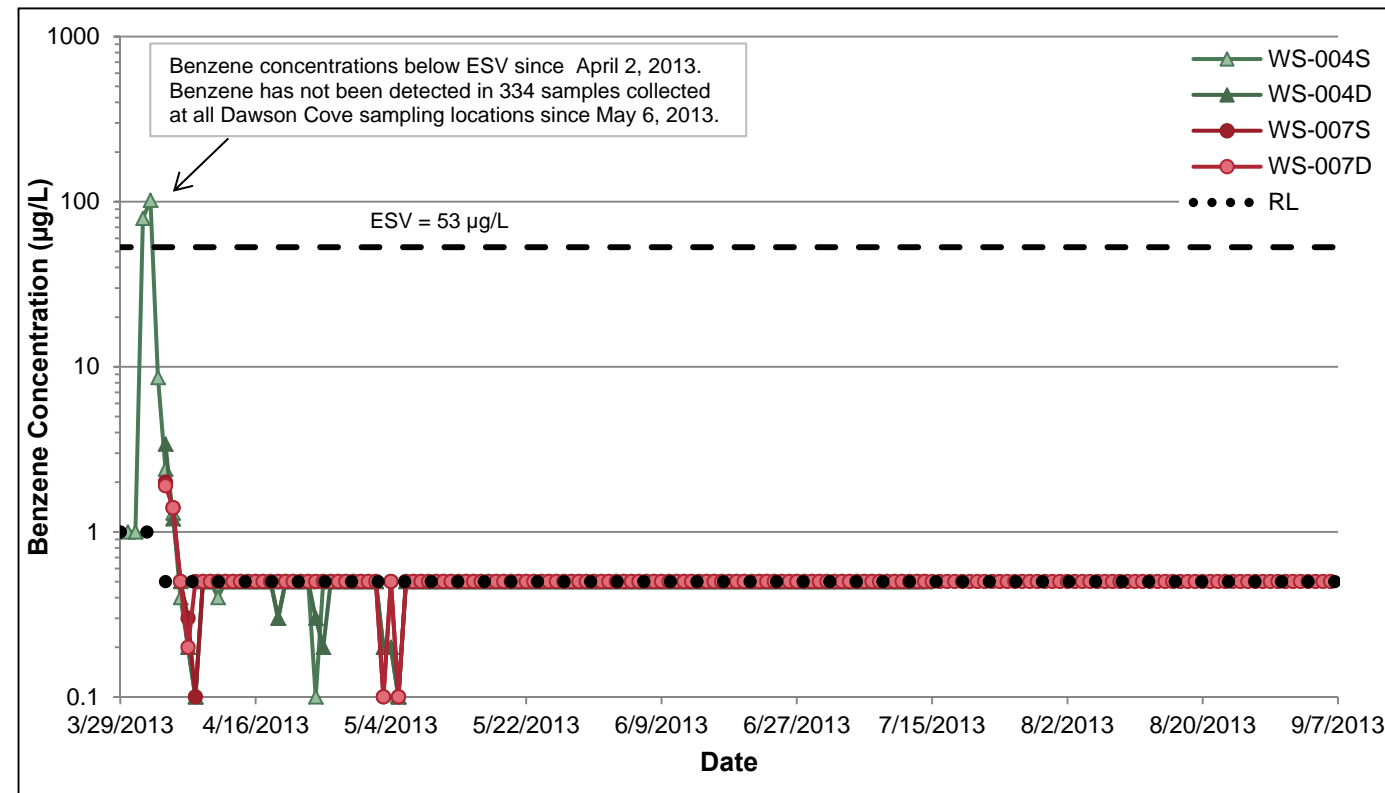
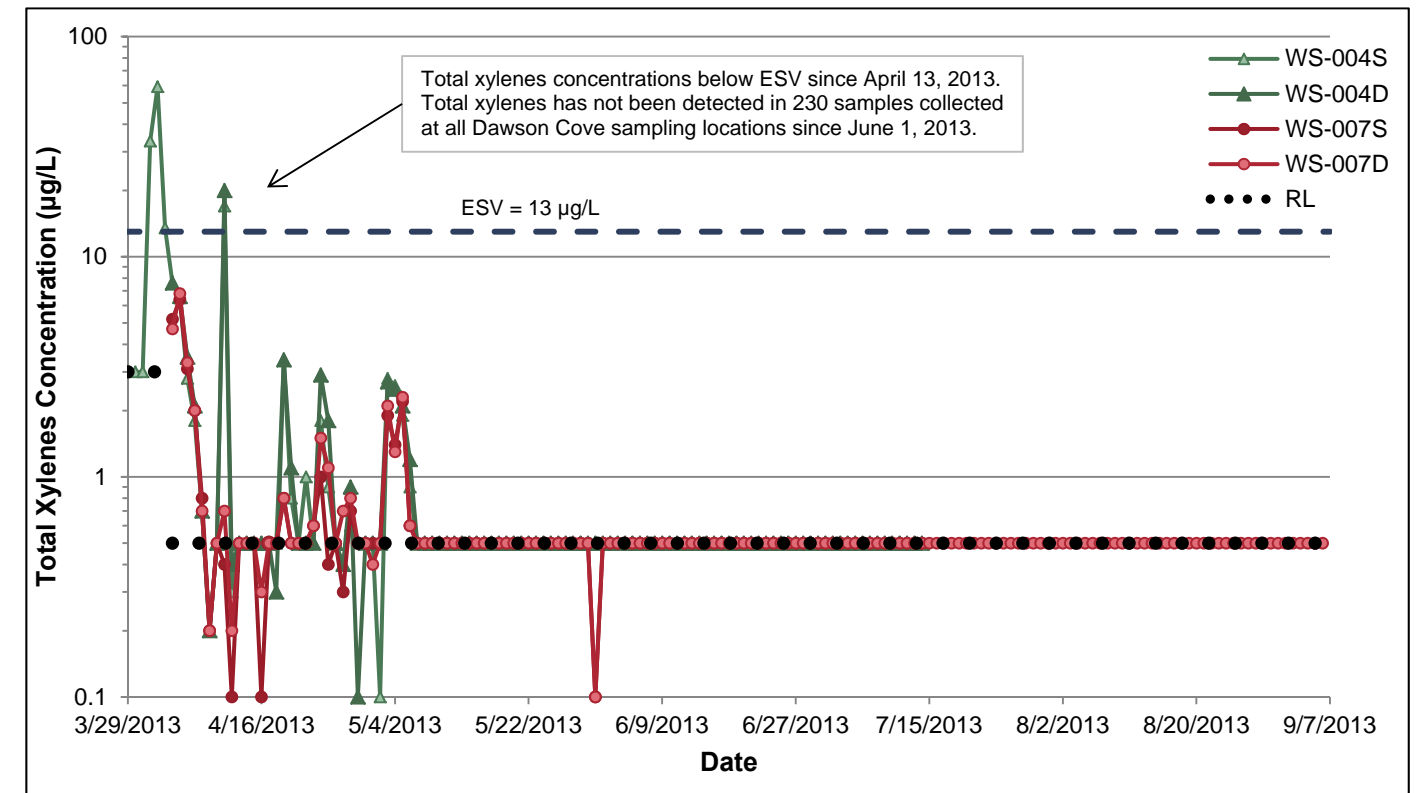
- Notes:**
- D = deep sample
  - µg/L = micrograms per liter
  - 1. Evaluation based on the following locations in Dawson Cove: WS-004S, WS-004D, WS-007S, WS-007D, and WS-020.

MAYFLOWER PIPELINE INCIDENT RESPONSE EXXONMOBIL ENVIRONMENTAL SERVICES COMPANY <b>DOWNSTREAM AREAS DATA ASSESSMENT REPORT</b>	
<b>EVALUATION OF VOCs IN DAWSON COVE</b> <b>SURFACE WATER (MARCH 29 - SEPTEMBER 6, 2013)</b>	
	FIGURE <b>8-3</b>

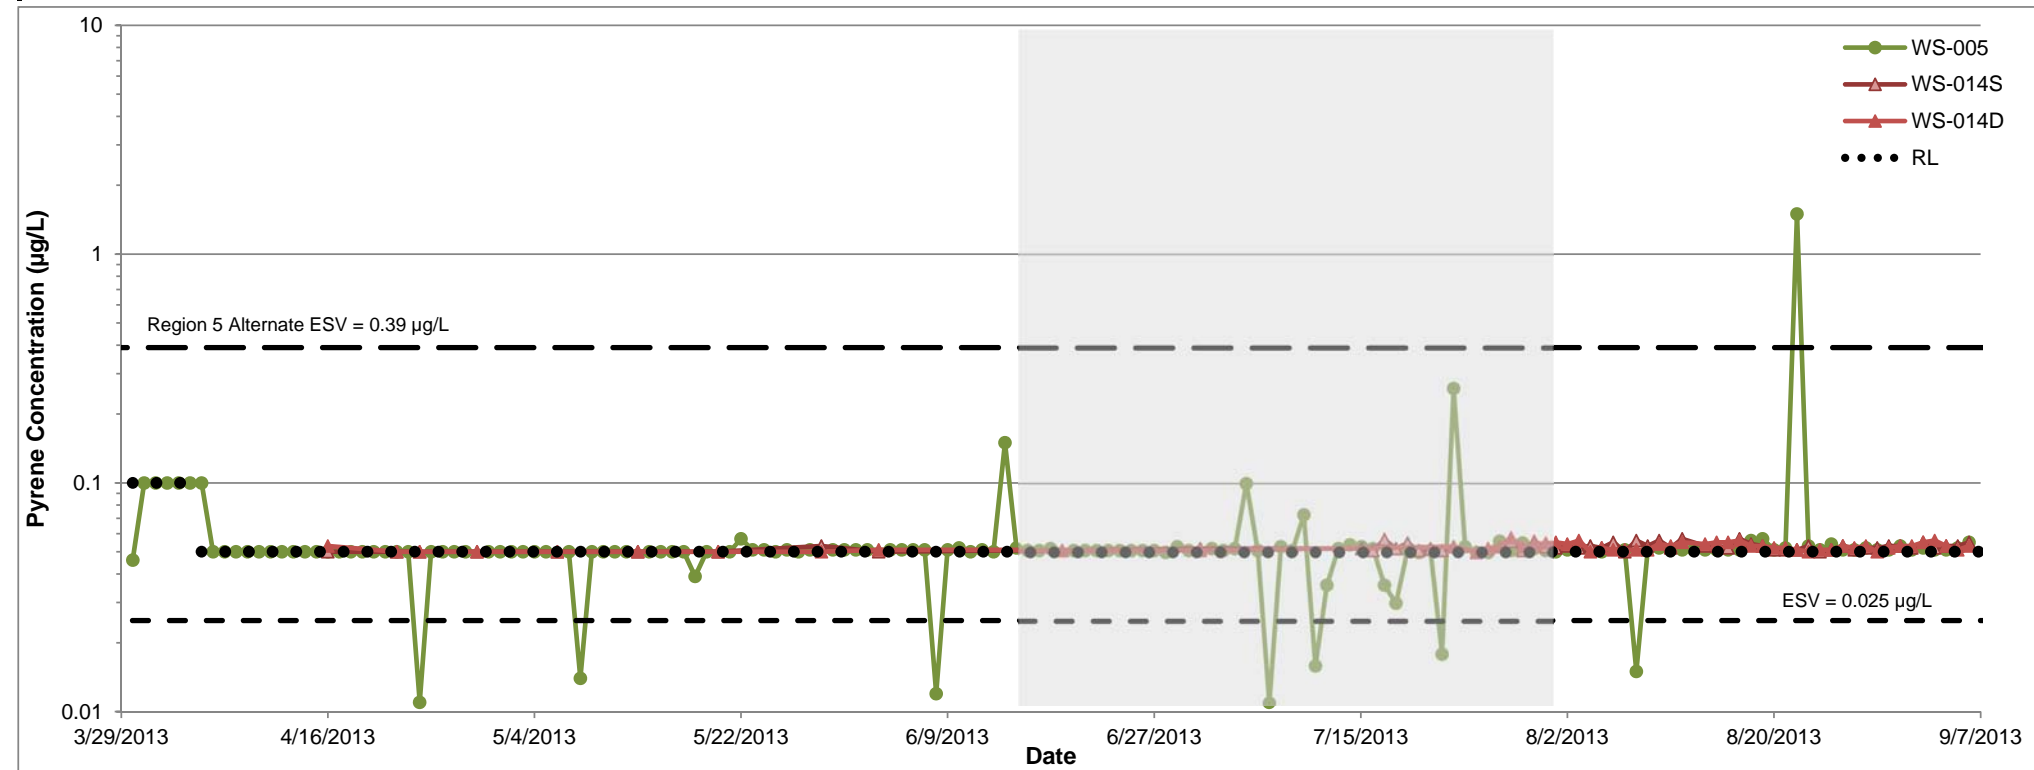
o **Pyrene:** There were ten detected concentrations above the ESV as shown in the pyrene concentration with time graph for background samples. The ESV of 0.025 µg/L is from Region 3 and is based on a value identified in 1999 by the Canadian Council of Ministers of the Environment (CCME). There was only one detected concentration of pyrene above the alternate ESV of 0.39 µg/L established by USEPA Region 5 as a RCRA Interim Criterion (USEPA 2003).

= Approximate timeframe with no flow through Dawson Cove culverts to Lake Conway

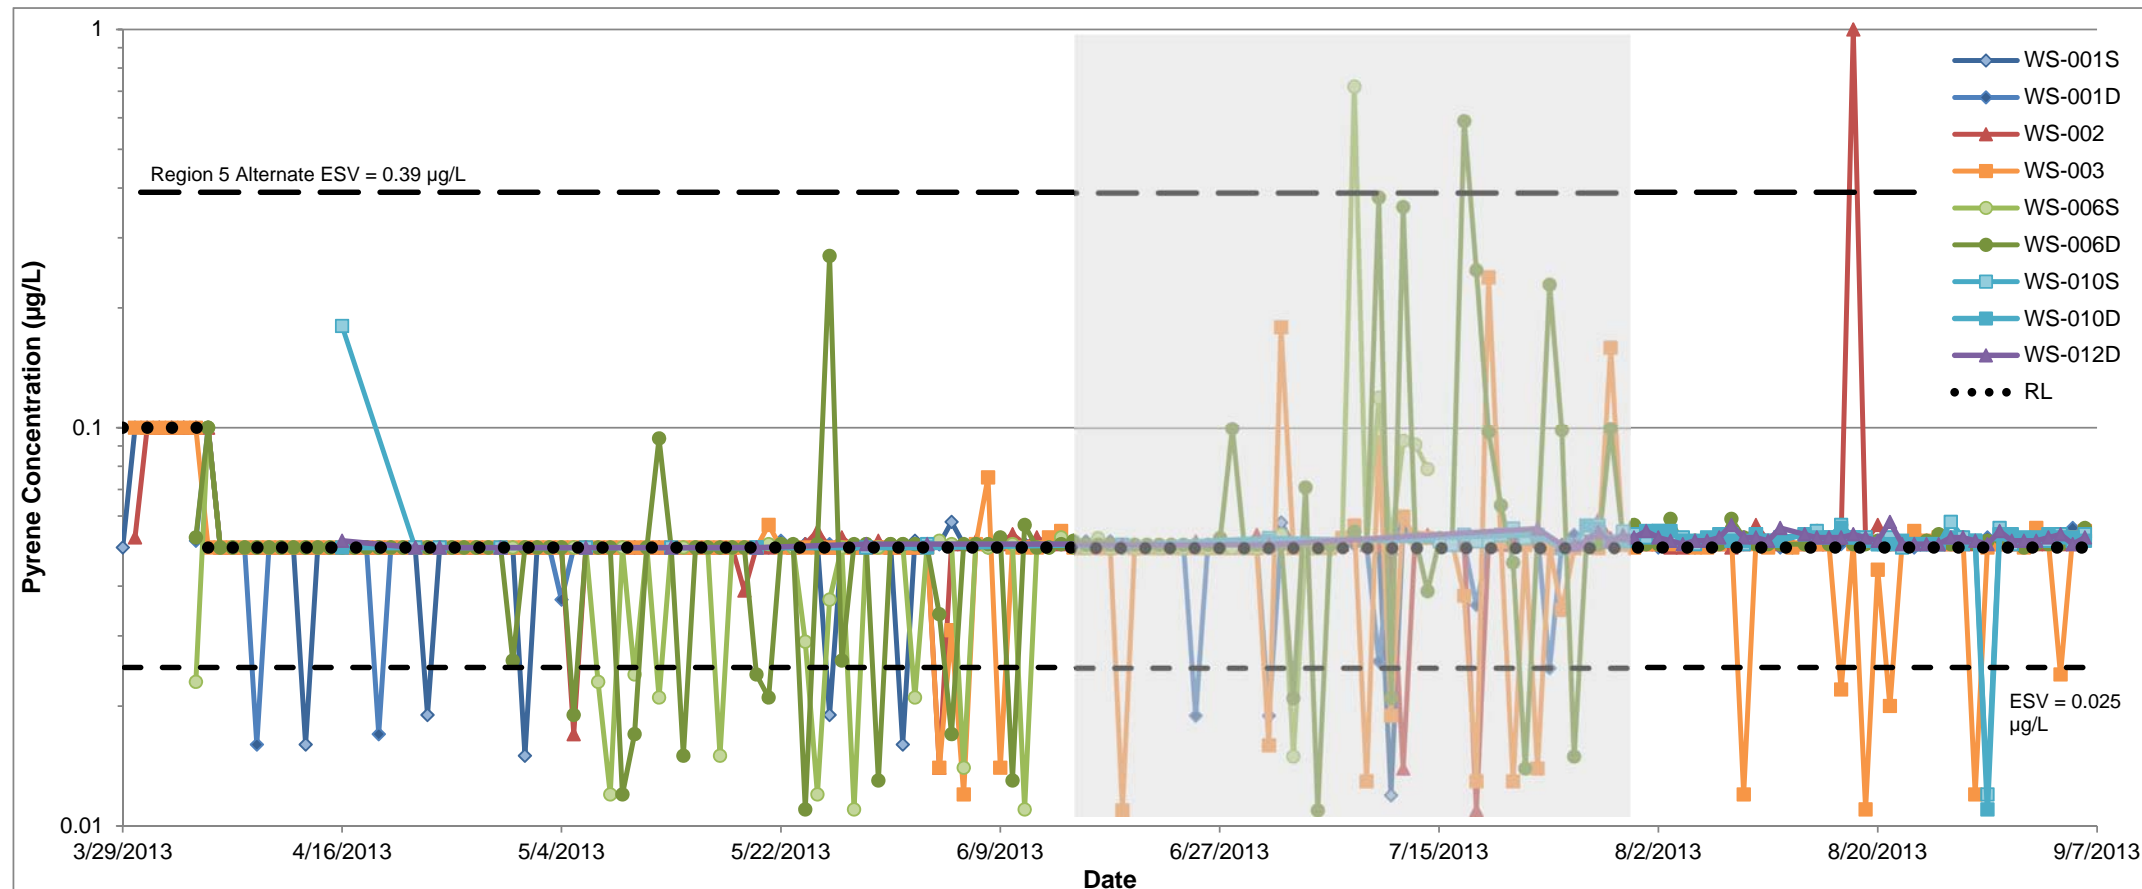
o **Pyrene:** There were 46 detected concentrations above the ESV as shown in the pyrene concentration with time graph for locations with recent detected pyrene concentrations above ESV. The maximum detected pyrene concentration of 1.0 µg/L in Lake Conway samples is less than the maximum of 1.5 µg/L detected pyrene concentration in a background sample. The ESV of 0.025 µg/L is from Region 3 and is based on a value identified in 1999 by the Canadian Council of Ministers of the Environment (CCME). There were only three detected concentrations of pyrene above the alternate ESV of 0.39 µg/L established by USEPA Region 5 as a RCRA Interim Criterion (USEPA 2003). Locations WS-002, WS-003, WS-010, and WS-012 are not located adjacent to the Dawson Cove outlet.

■ = Approximate timeframe with no flow through Dawson Cove culverts to Lake Conway

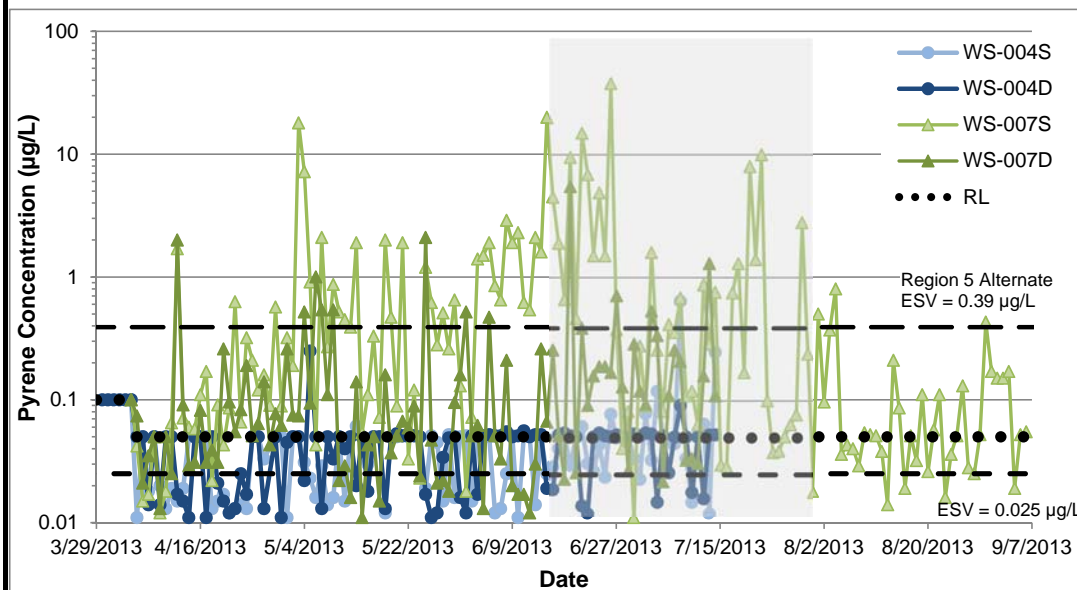
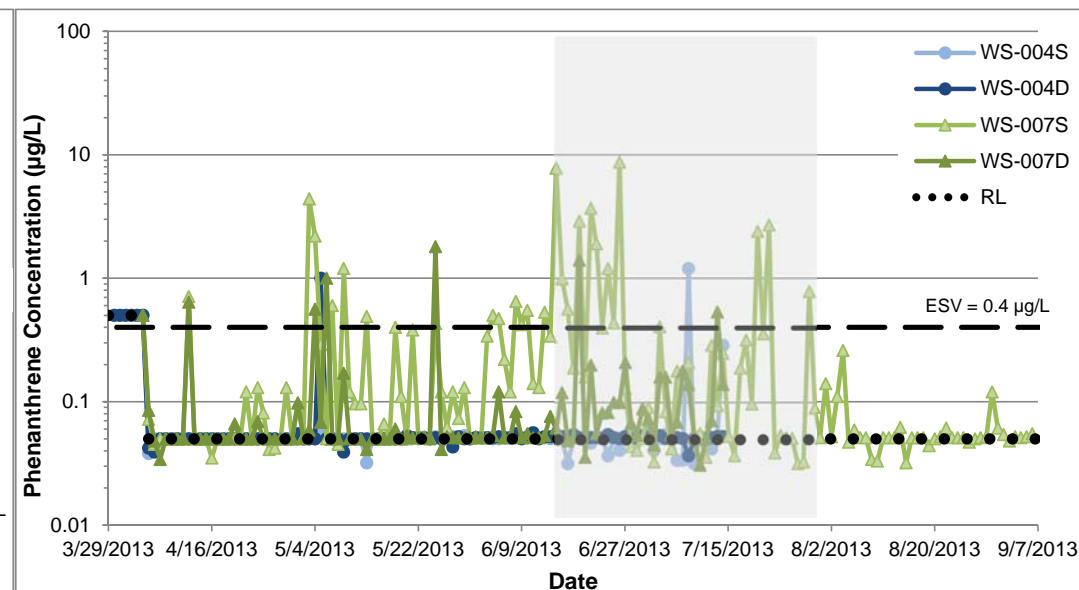
o **Pyrene:** There were 22 detected concentrations above the ESV of 0.025 µg/L. The ESV of 0.025 µg/L is from Region 3 and is based on a value identified in 1999 by the Canadian Council of Ministers of the Environment (CCME). Since August 5, 2013, there was only one detected concentration of pyrene above the alternate ESV of 0.39 µg/L established by USEPA Region 5 as a RCRA Interim Criterion (USEPA 2003). The recent maximum detected pyrene concentration of 0.43 µg/L is less than the recent maximum detected pyrene concentration of 1.5 µg/L in background surface water.

Pyrene and phenanthrene shown for illustration purposes. Similar trends observed for anthracene, benzo(a)anthracene, benzo(a)pyrene, benzo(b)fluoranthene, fluoranthene, and indeno(1,2,3-cd)pyrene.

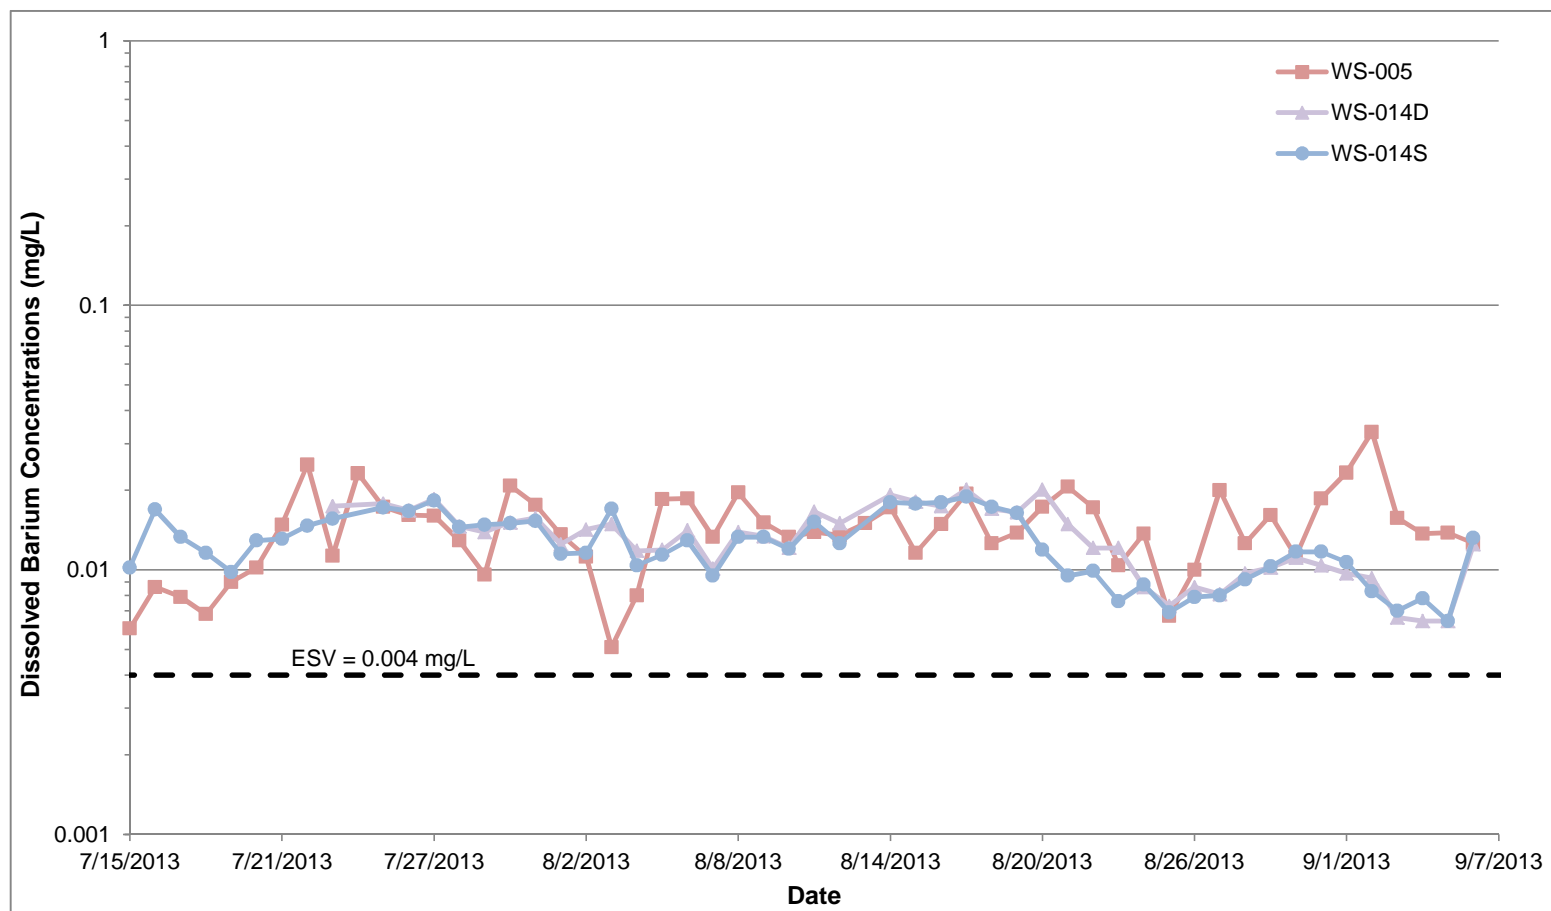
Between July 15 and September 6, 2013, dissolved barium concentrations in background surface water samples ranged from 0.0051 to 0.033 mg/L, above the ESV of 0.004 mg/L.

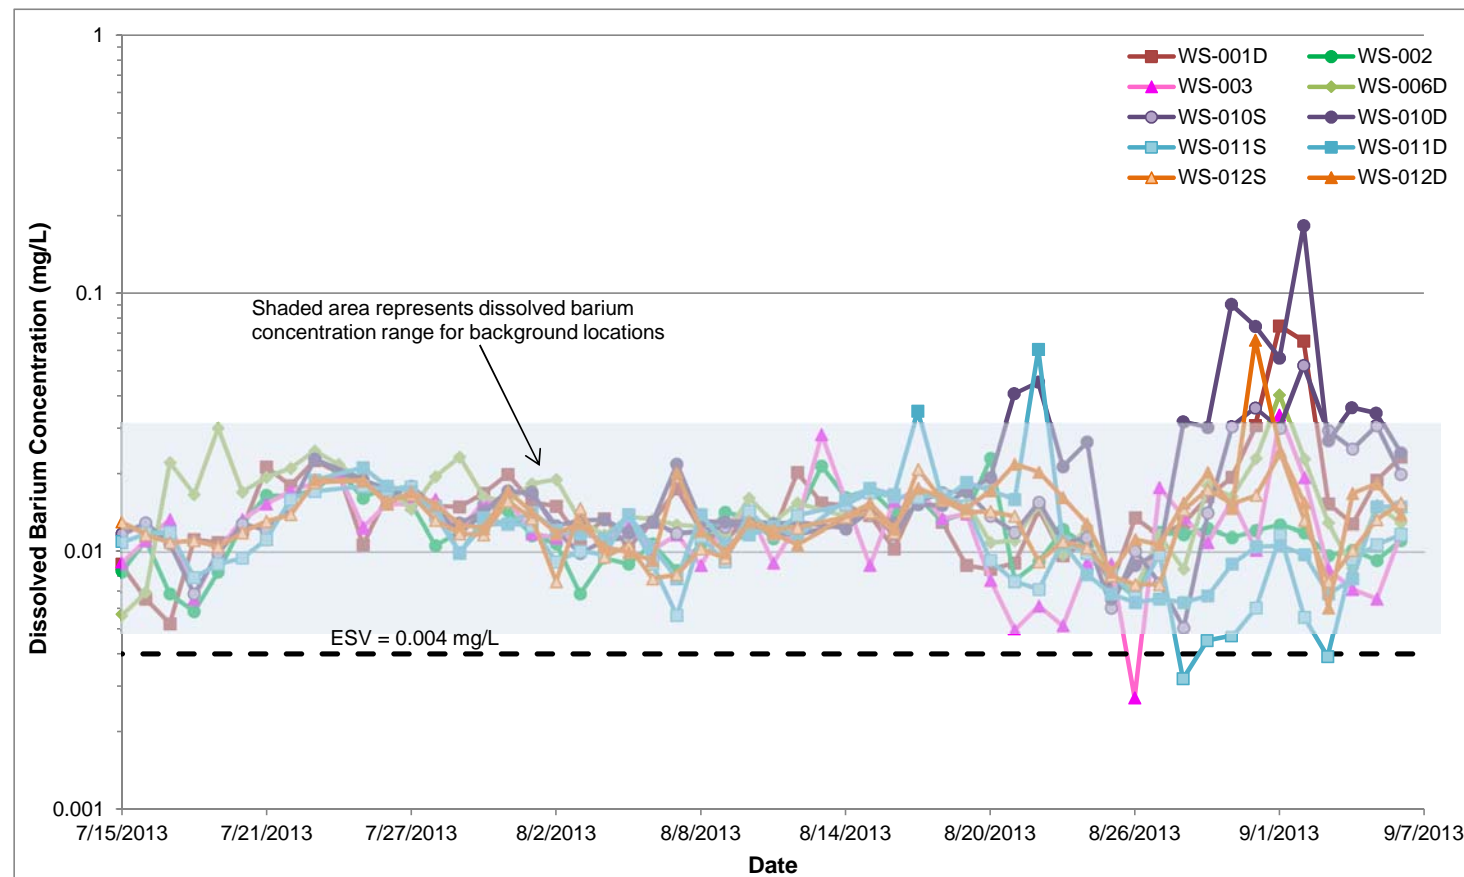
**Barium, Cadmium, Mercury, and Silver** are the only metals that have dissolved concentrations above the ESV in Lake Conway samples.

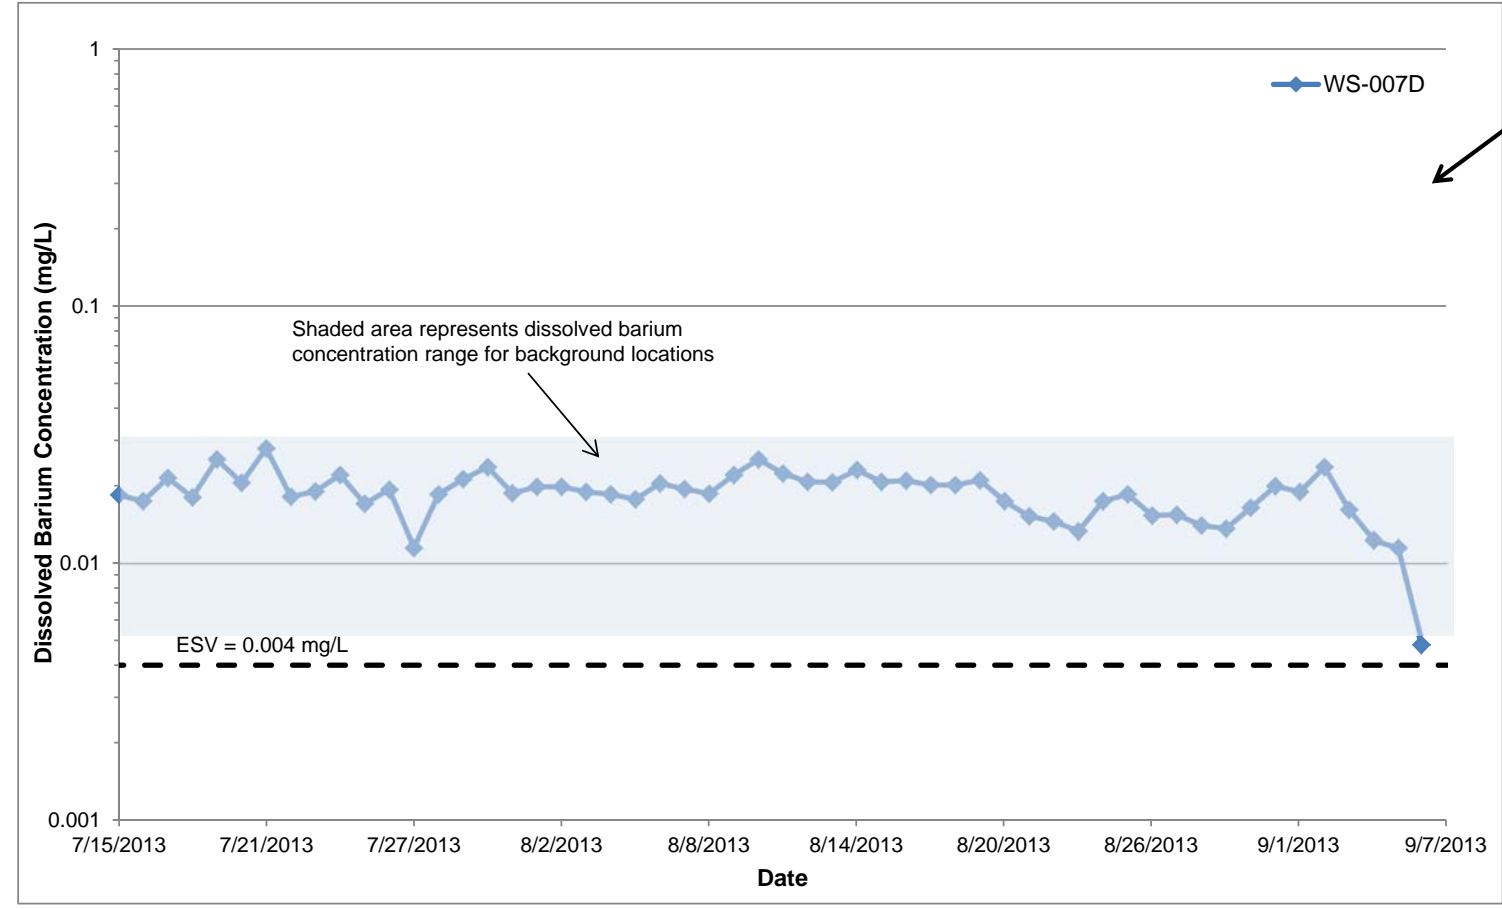
**Barium and Silver** are the only metals that have dissolved concentrations above the screening levels in Dawson Cove since July 15, 2013.
