**MAYFLOWER PIPELINE INCIDENT RESPONSE
 EXXONMOBIL ENVIRONMENTAL SERVICES COMPANY
 DOWNSTREAM AREAS DATA ASSESSMENT REPORT**

SITE LOCATION MAP

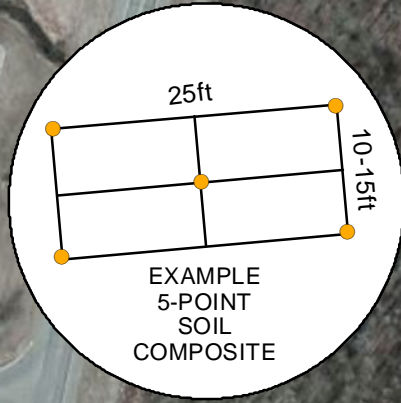
**FIGURE
 2-2**

NOTE:
 1. Surface soil samples were collected as five-point composite samples at locations shown. Example composite grid layout shown for illustrative purposes only; see Table 2-1 for actual sample grid dimensions at each location.

**SOIL AND SEDIMENT SAMPLE
 LOCATIONS IN A-365E & A-365W**

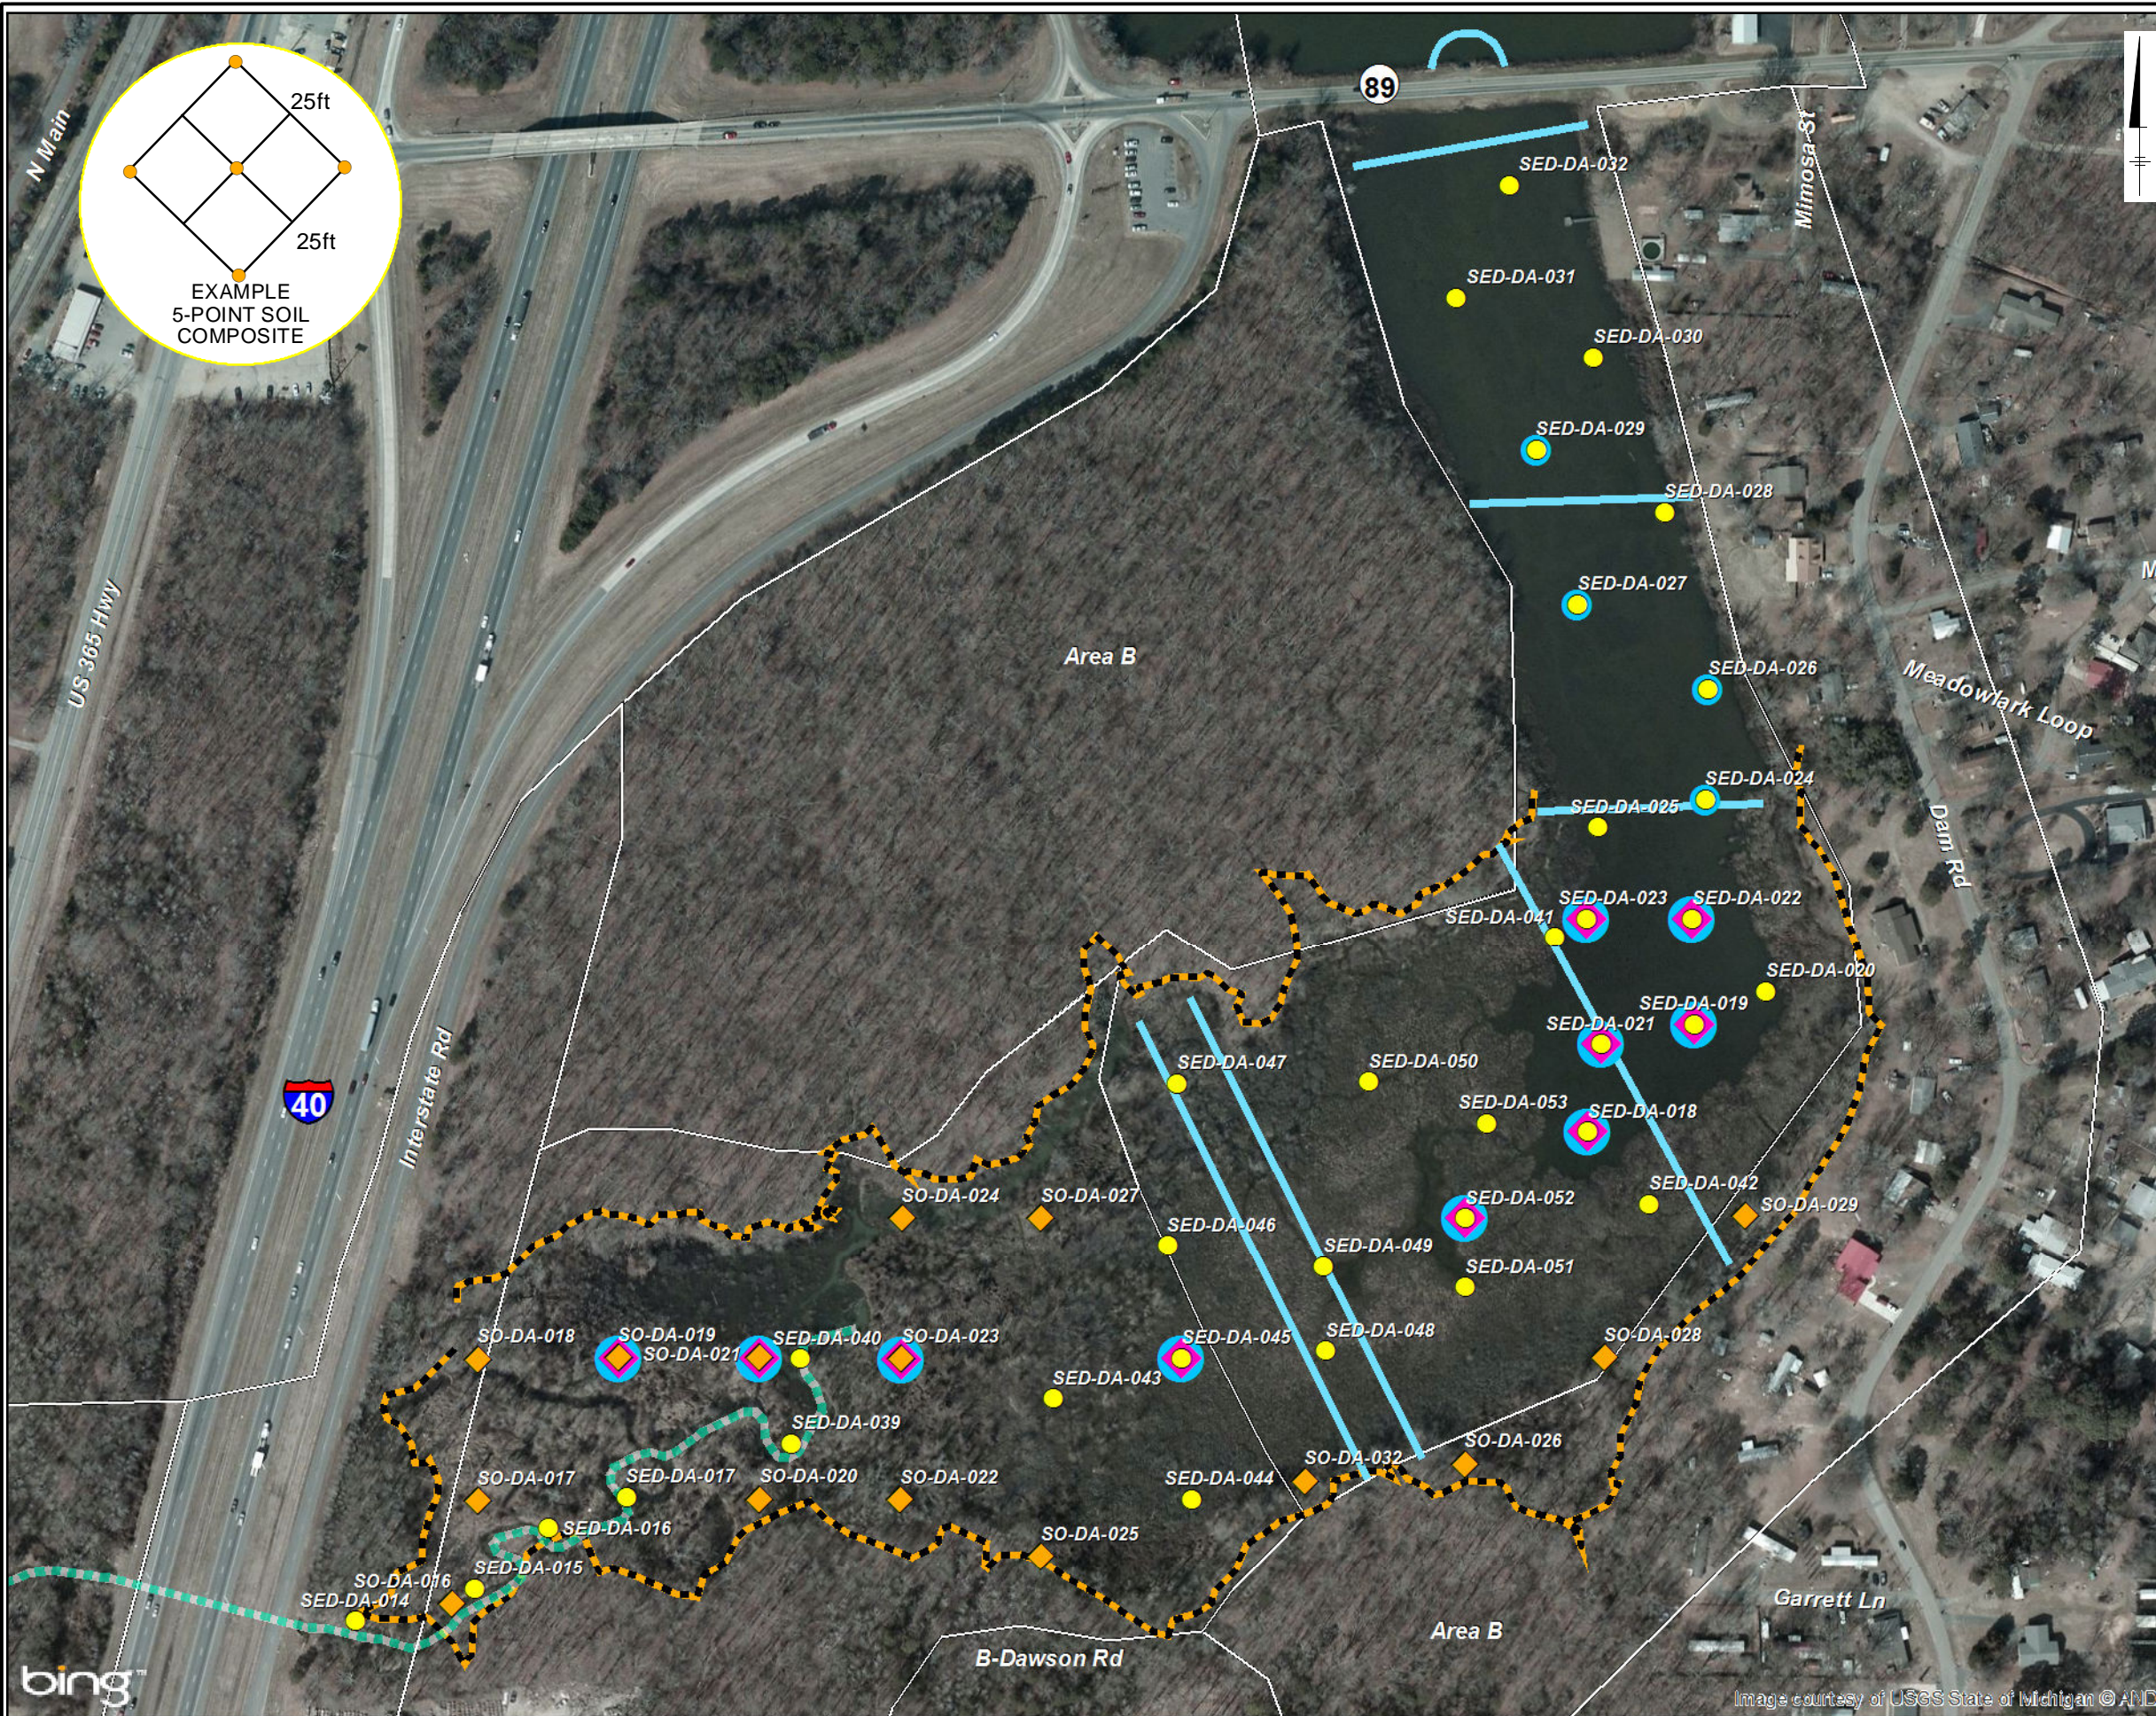
**FIGURE
 2-3**

1. Surface soil samples were collected as five-point composite samples at locations shown. Example composite grid layout shown for illustrative purposes only; see Table 2-1 for actual sample grid dimensions at each location.
2. Extent of oiling along shoreline delineating by ARCADIS and The Response Group during response efforts in Dawson Cove (April 2013).

**SOIL AND SEDIMENT SAMPLE
 LOCATIONS IN DAWSON COVE**

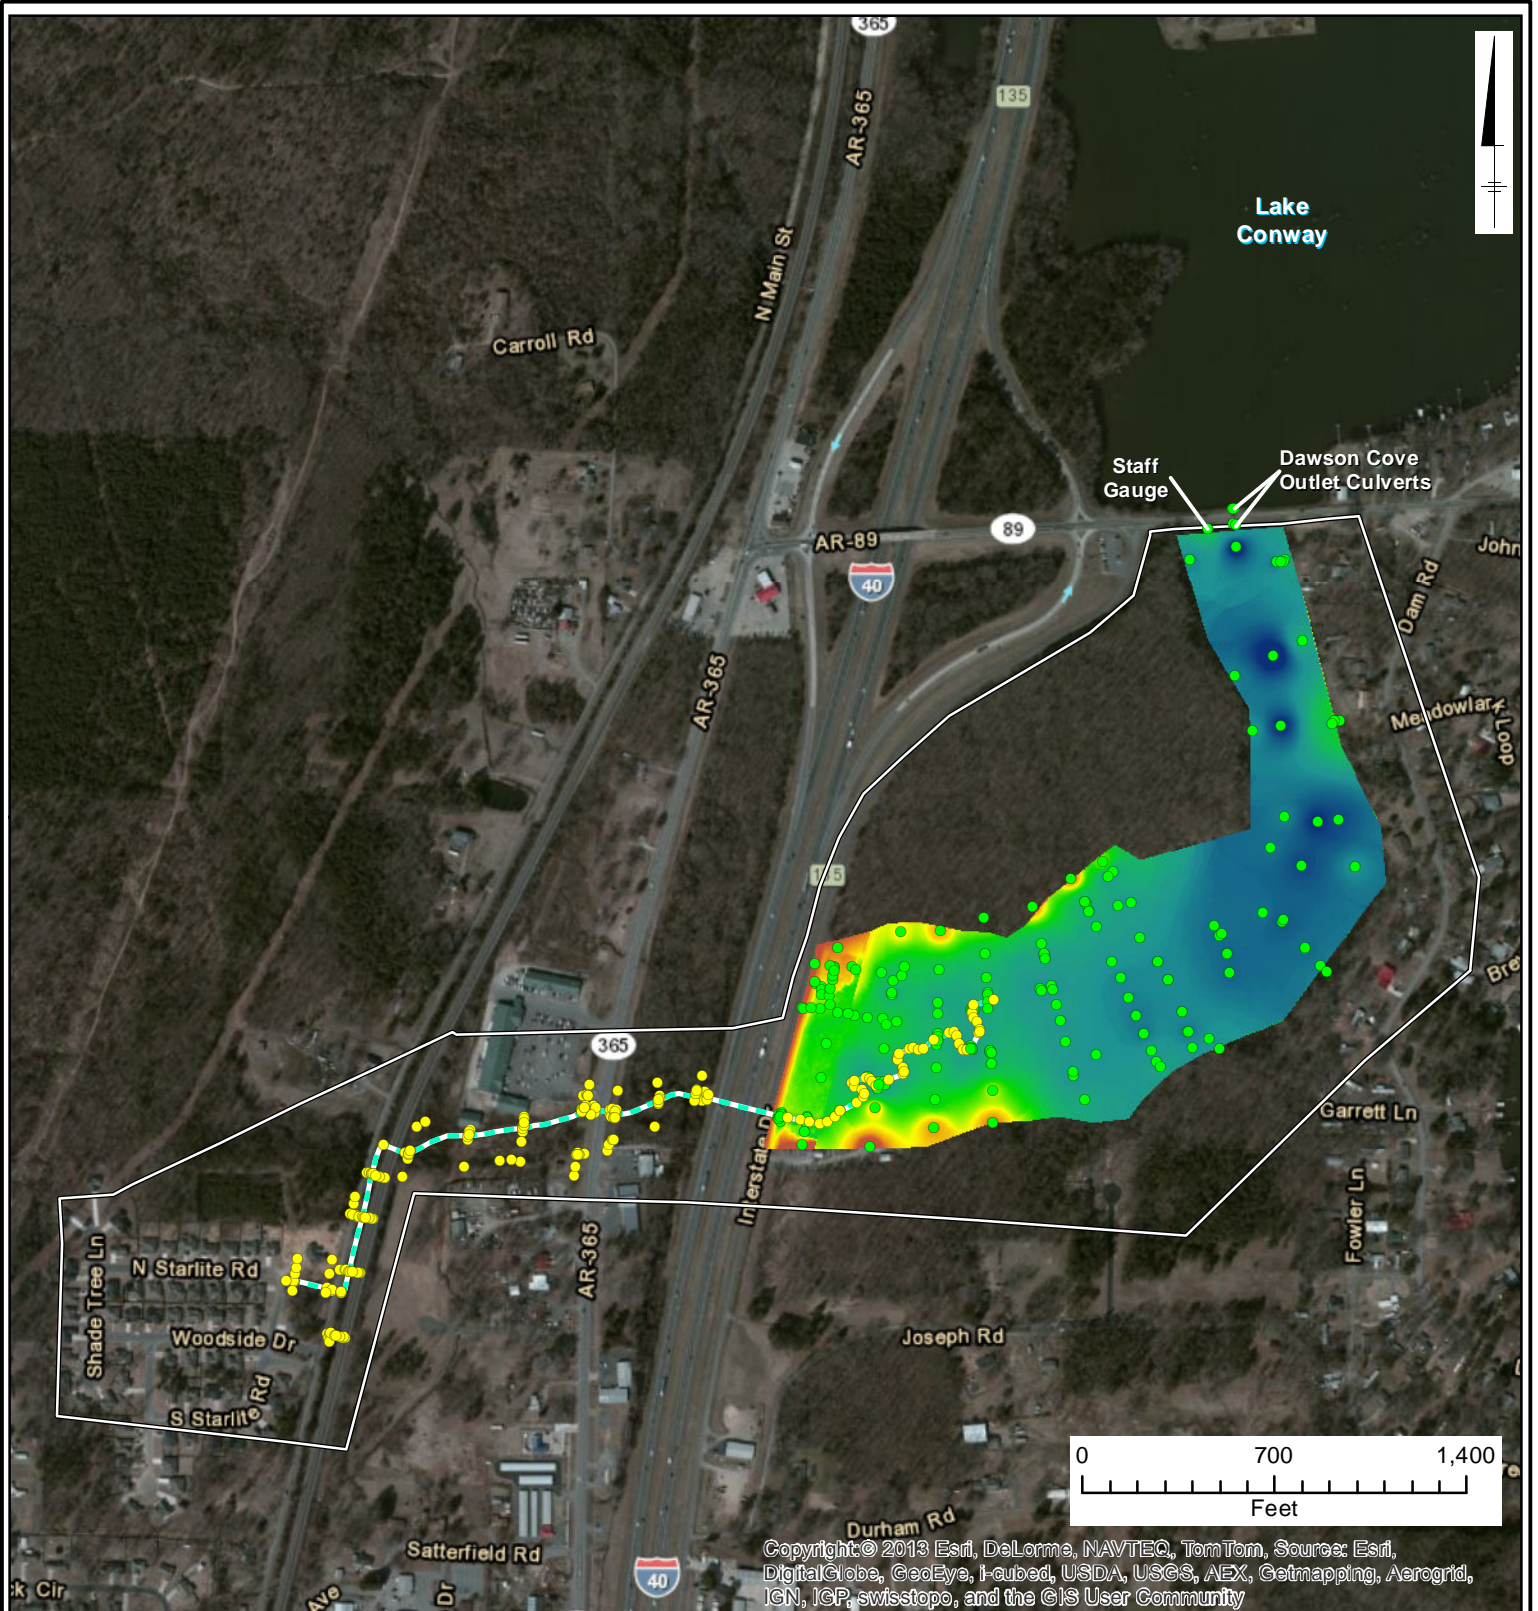
FIGURE 3-1

SITE LOCATION TOPOGRAPHIC SURVEY

NOTE:
 1. Survey data collected during field activities interpolated by the Inverse Distance Weighting (IDW) method using an optimized power term to develop a digital elevation model (DEM) for the area shown.
Map Date: 10/10/2013

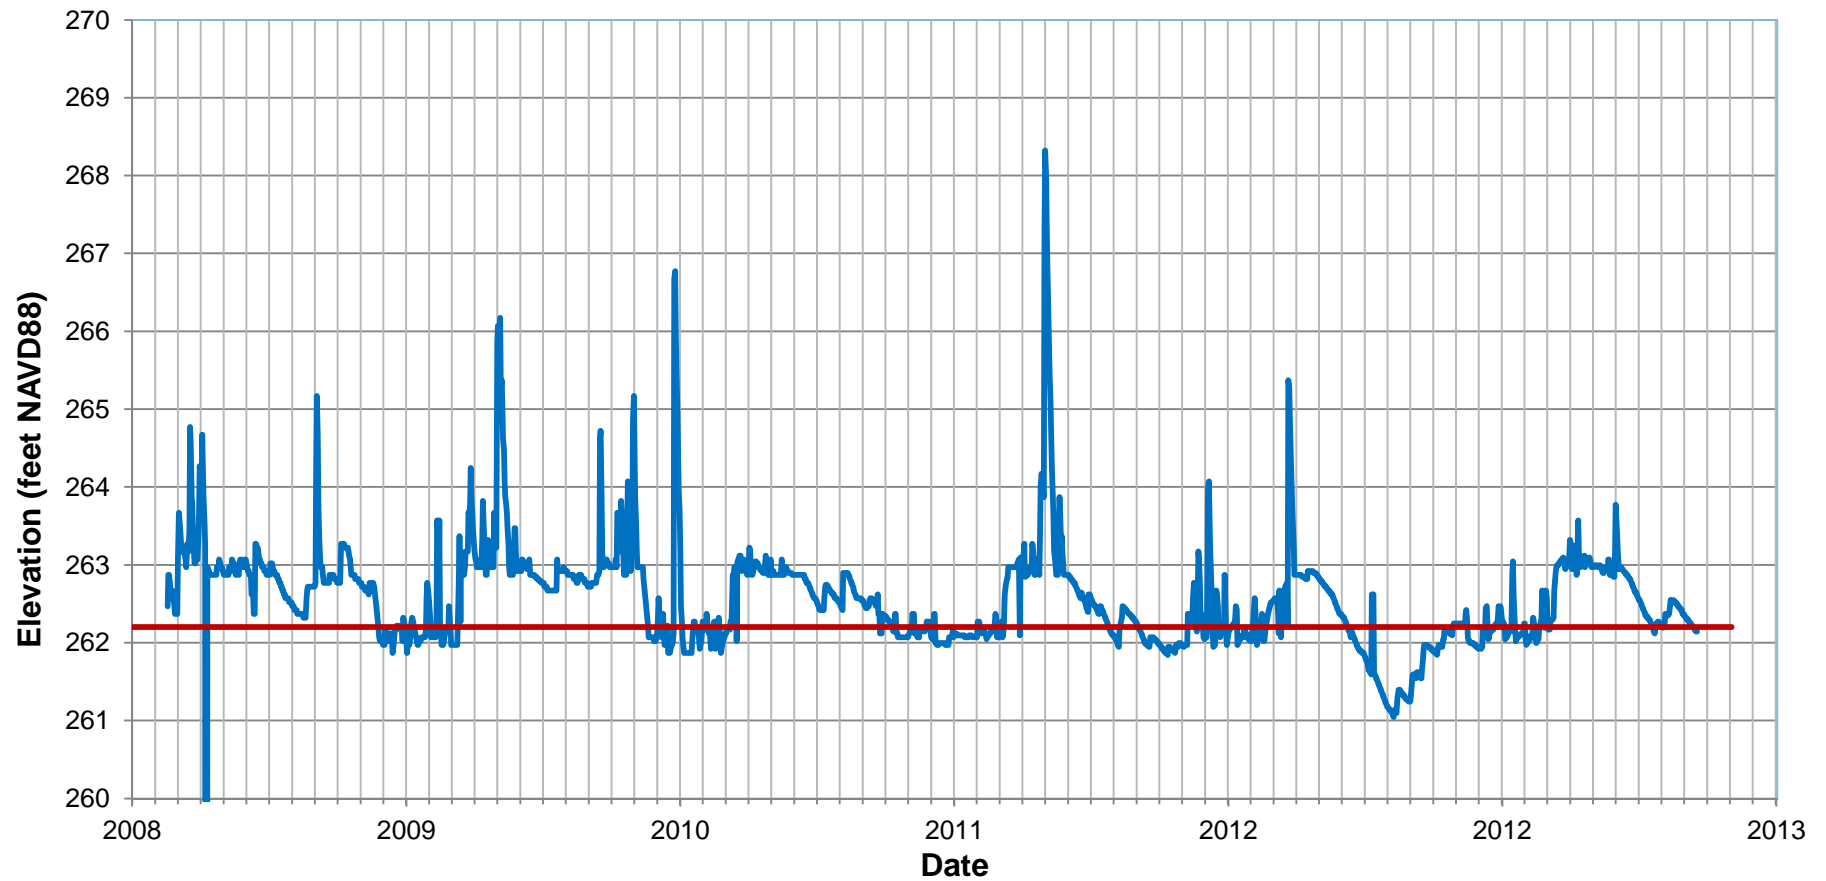
FIGURE 3-4

1. Water elevation data are available from February 18, 2008 through September 16, 2013. The data are provided by Lake Manager, Mr. Matthew Horton (Arkansas Game and Fish Commission [AGFC], District 10 Lake Manager).
2. Water surface elevations are recorded at the gauge located near the AGFC Mayflower Enforcement Training Center.
3. Lake Conway levels on April 9 and 10, 2008 were reported as 236.12 feet and 236.02 feet (NAVD88). No additional information related to this data point is available at this time.

MAYFLOWER PIPELINE INCIDENT RESPONSE EXXONMOBIL ENVIRONMENTAL SERVICES COMPANY DOWNSTREAM AREAS DATA ASSESSMENT REPORT	
Lake Conway Peak Daily Water Elevation Data

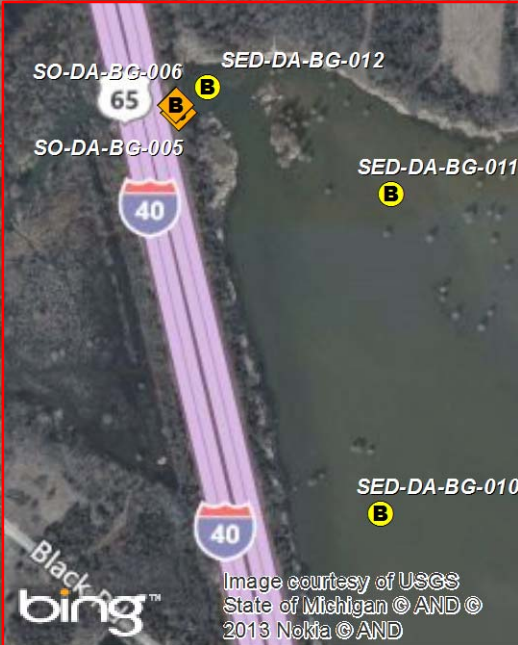
NOTES:
 1. All background data are from surface samples that were collected at depths of 0-0.5 foot below ground surface.
 2. Metals concentrations are presented in milligrams per kilogram.
 3. Yellow highlighted cells identify concentrations above the Arkansas Background and Ecological Screening Values.
 4. Only detected concentrations of nickel, selenium, and silver are shown.

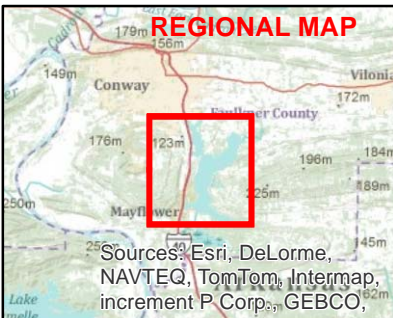
**SOIL BACKGROUND SAMPLING
 RESULTS: METALS**

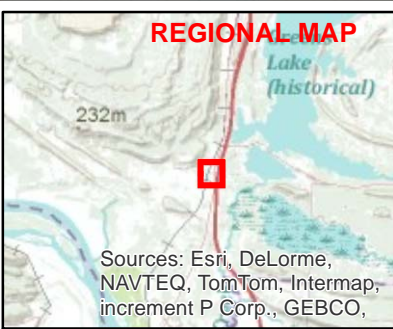
**DRAINAGE WAY SEDIMENT BACKGROUND
 SAMPLING RESULTS: METALS**

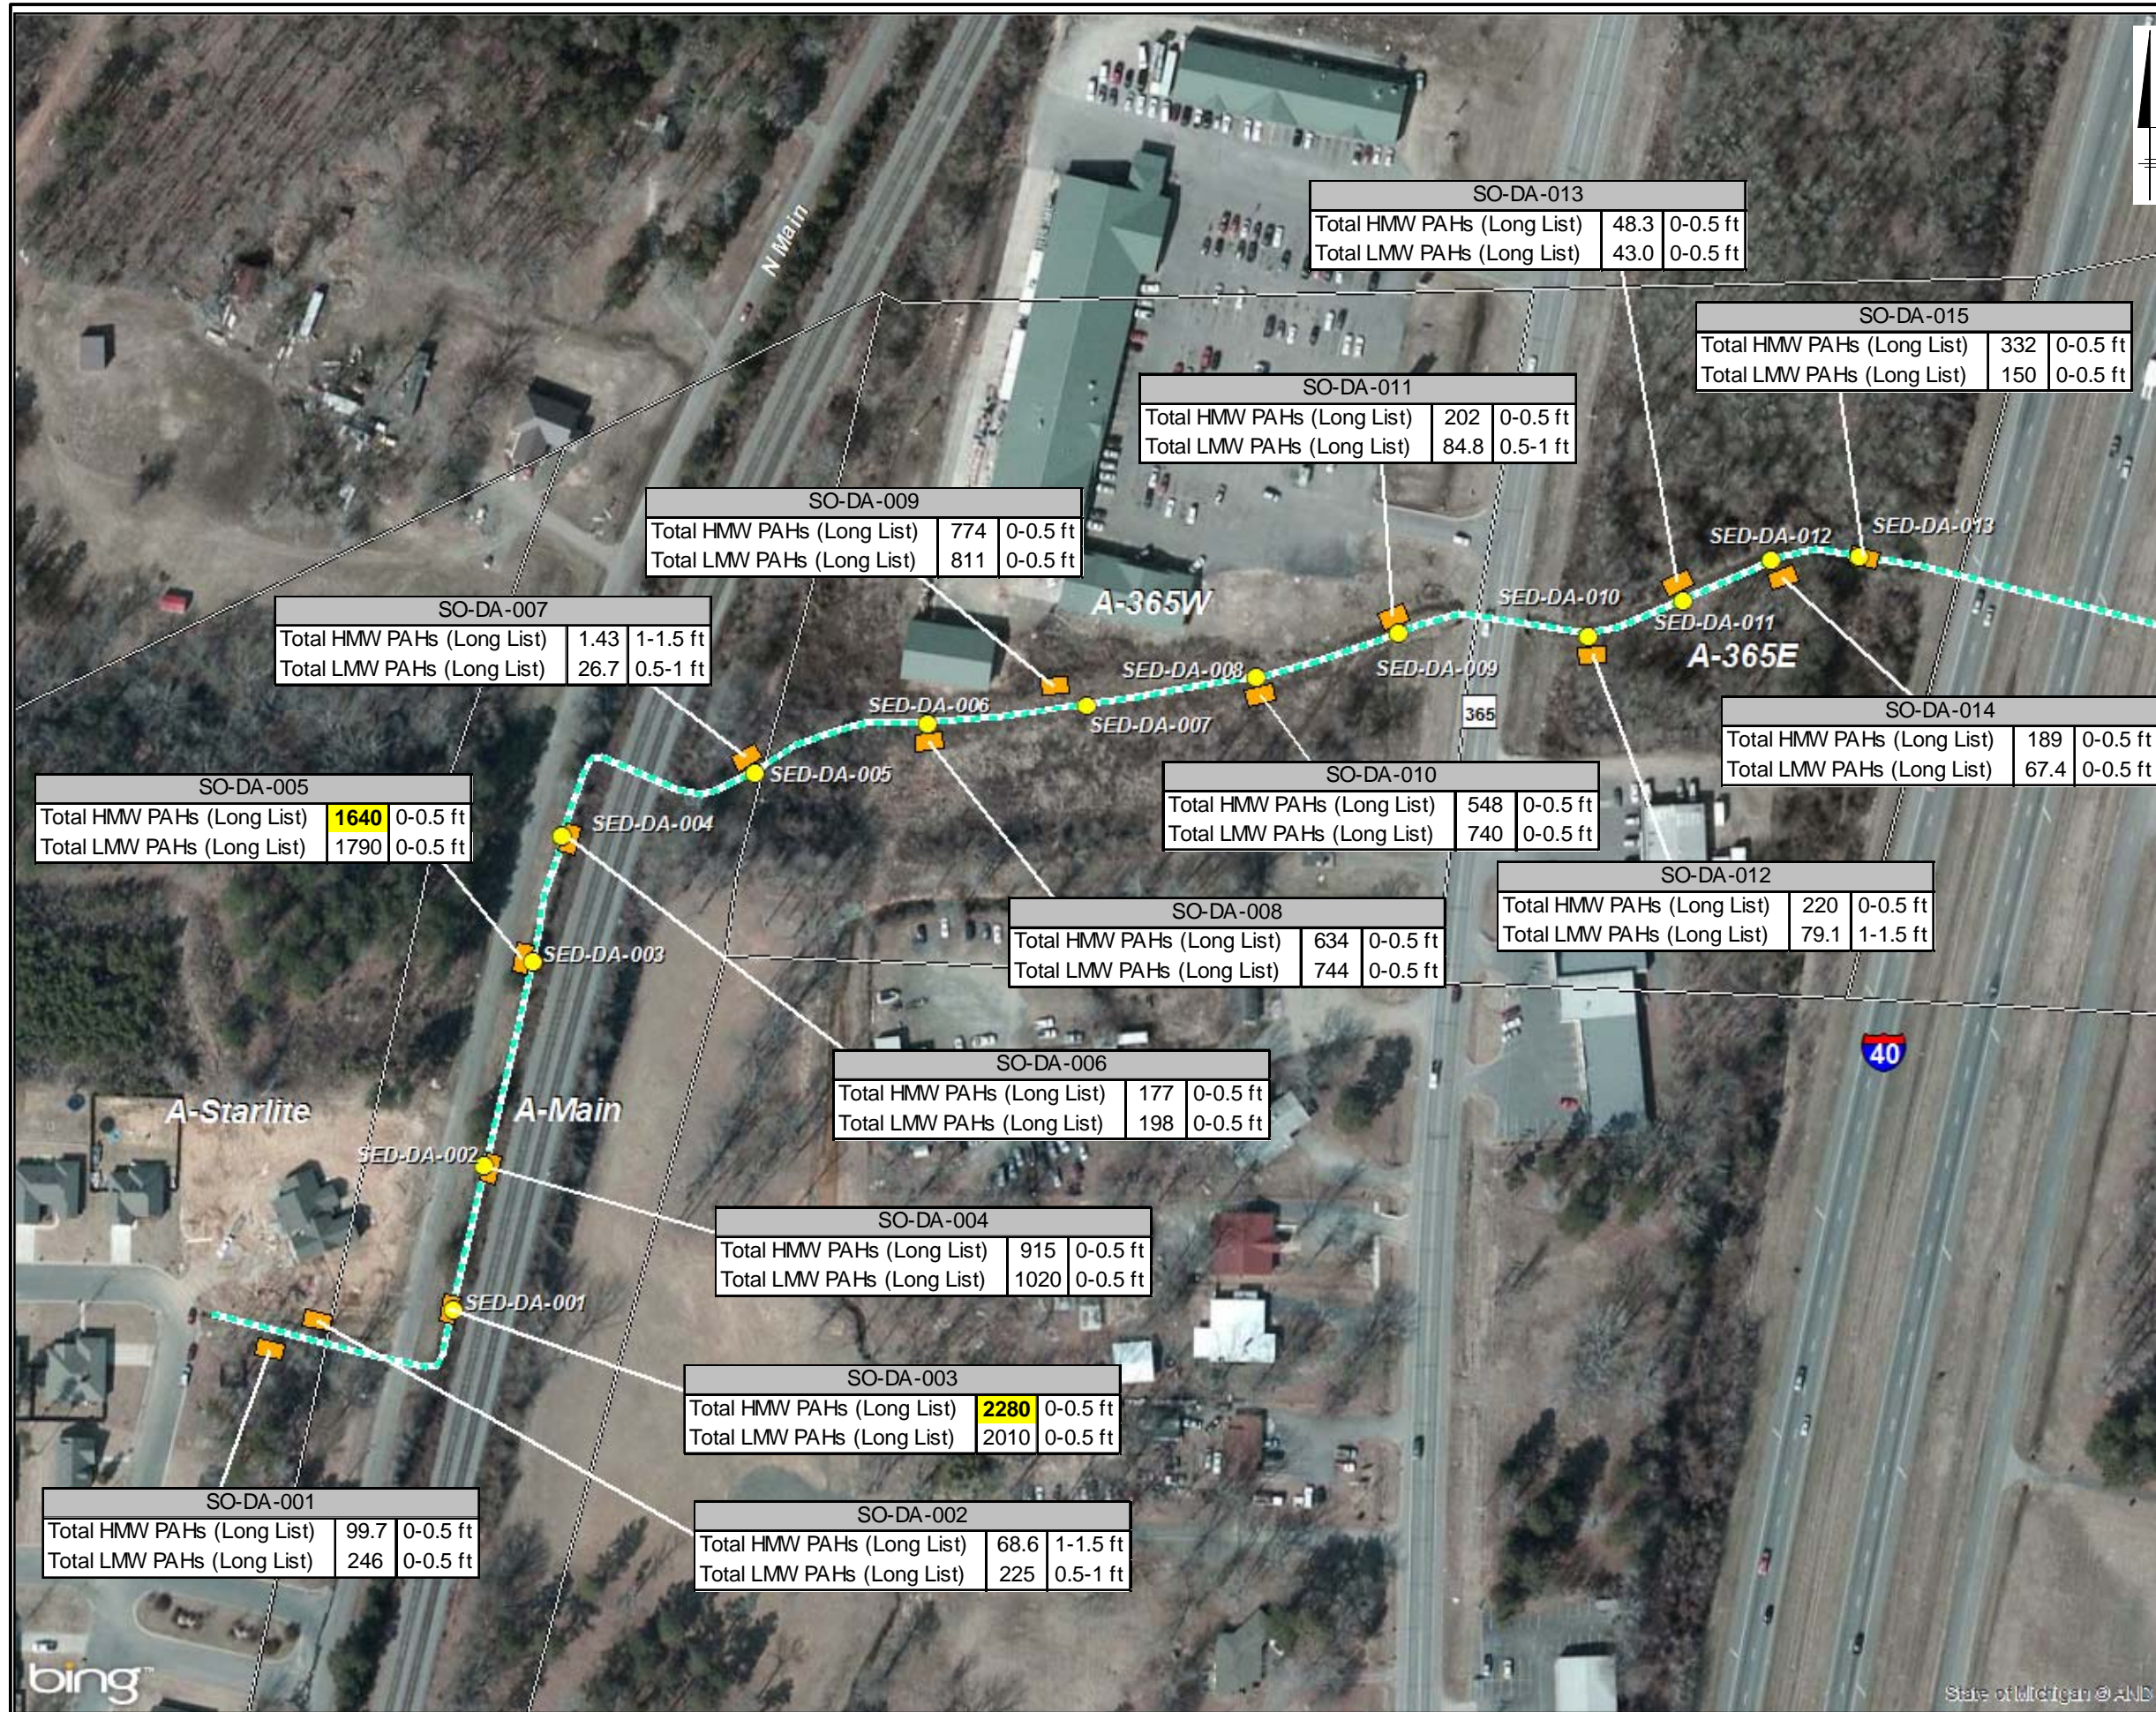
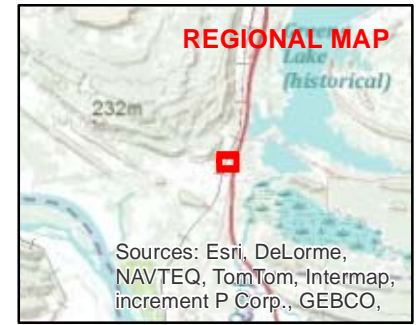
**FIGURE
 6-1.1**

1. Data boxes present maximum detections for each analyte at each location, and the associated sample depth interval at which the maximum detection was recorded (i.e., 0-0.5 foot, 0.5-1.0 foot, or 1.0-1.5 feet).
2. Polycyclic Aromatic Hydrocarbon concentrations are presented in micrograms per kilogram (µg/kg).
3. Yellow highlighted cells identify concentrations above the Ecological Screening Values.
4. PAH summations are based on the Long List of PAHs (Table 5-3).

**SOIL SAMPLING RESULTS IN DRAINAGE
 WAYS: PAHs**

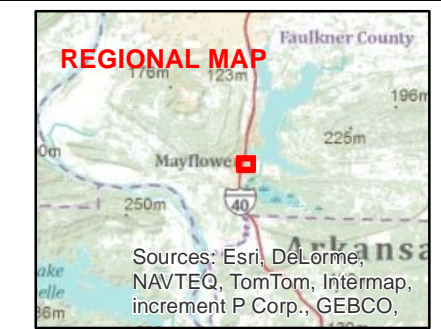
**SOIL SAMPLING RESULTS IN DAWSON COVE:
 PAHS**

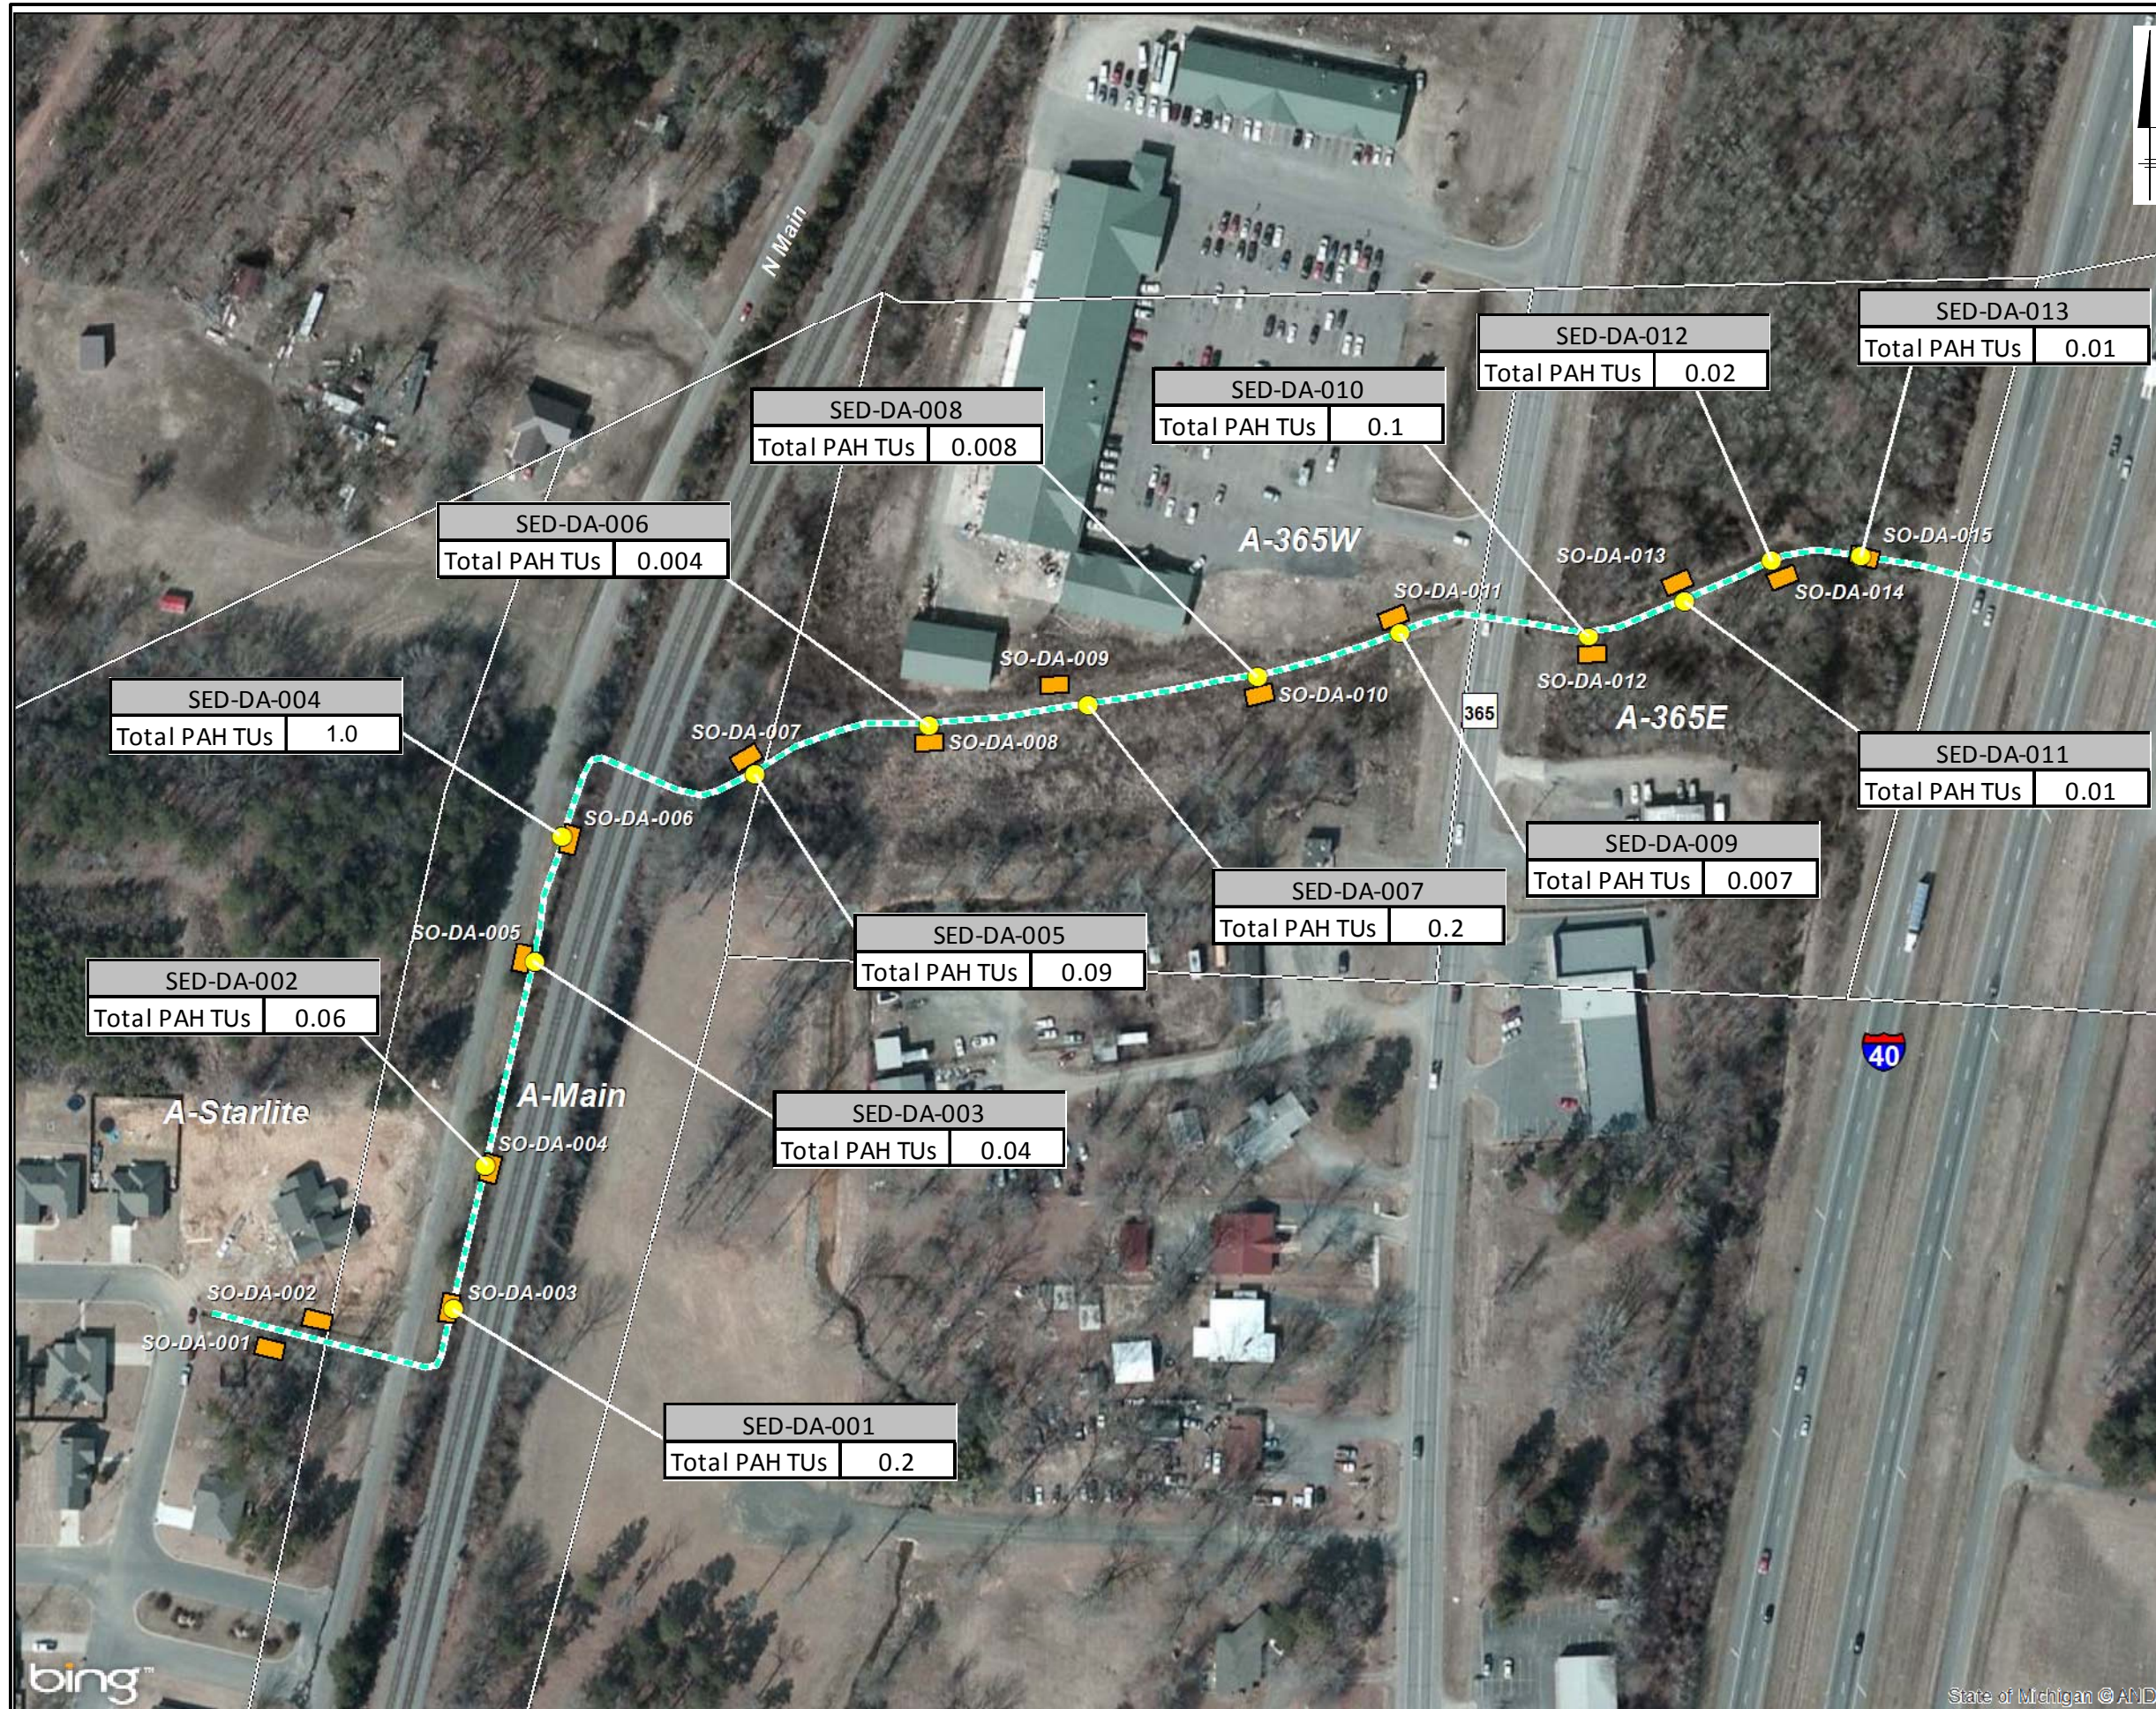
NOTES:
 1. Total Polycyclic Aromatic Hydrocarbon Toxic Unit values are unitless.
 2. All data are from surface samples that were collected at depths of 0-0.5 foot below sediment surface.

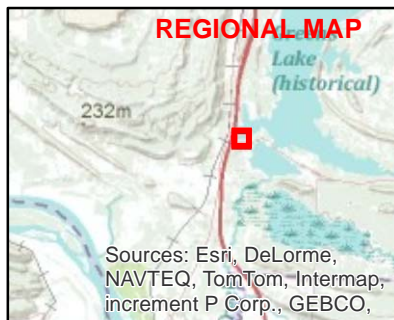
- NOTES:**
- Data boxes present maximum detections for each analyte at each location, and the associated sample depth interval at which the maximum detection was recorded (i.e., 0-0.5 foot, 0.5-1.0 foot, or 1.0-1.5 feet).
 - Polycyclic Aromatic Hydrocarbon concentrations are presented in micrograms per kilogram ($\mu\text{g}/\text{kg}$).
 - Yellow highlighted cells identify concentrations above the Ecological Screening Values.
 - PAH summations are based on the Priority+2 List and the Long List of PAHs (Table 5-3).
 - As requested by ADEQ, the six Lake Conway sediment locations were re-sampled on November 19 and 20, 2013 (SED-DA-033R through SED-DA-038R).

**SEDIMENT SAMPLING RESULTS IN
 LAKE CONWAY: PAHS**

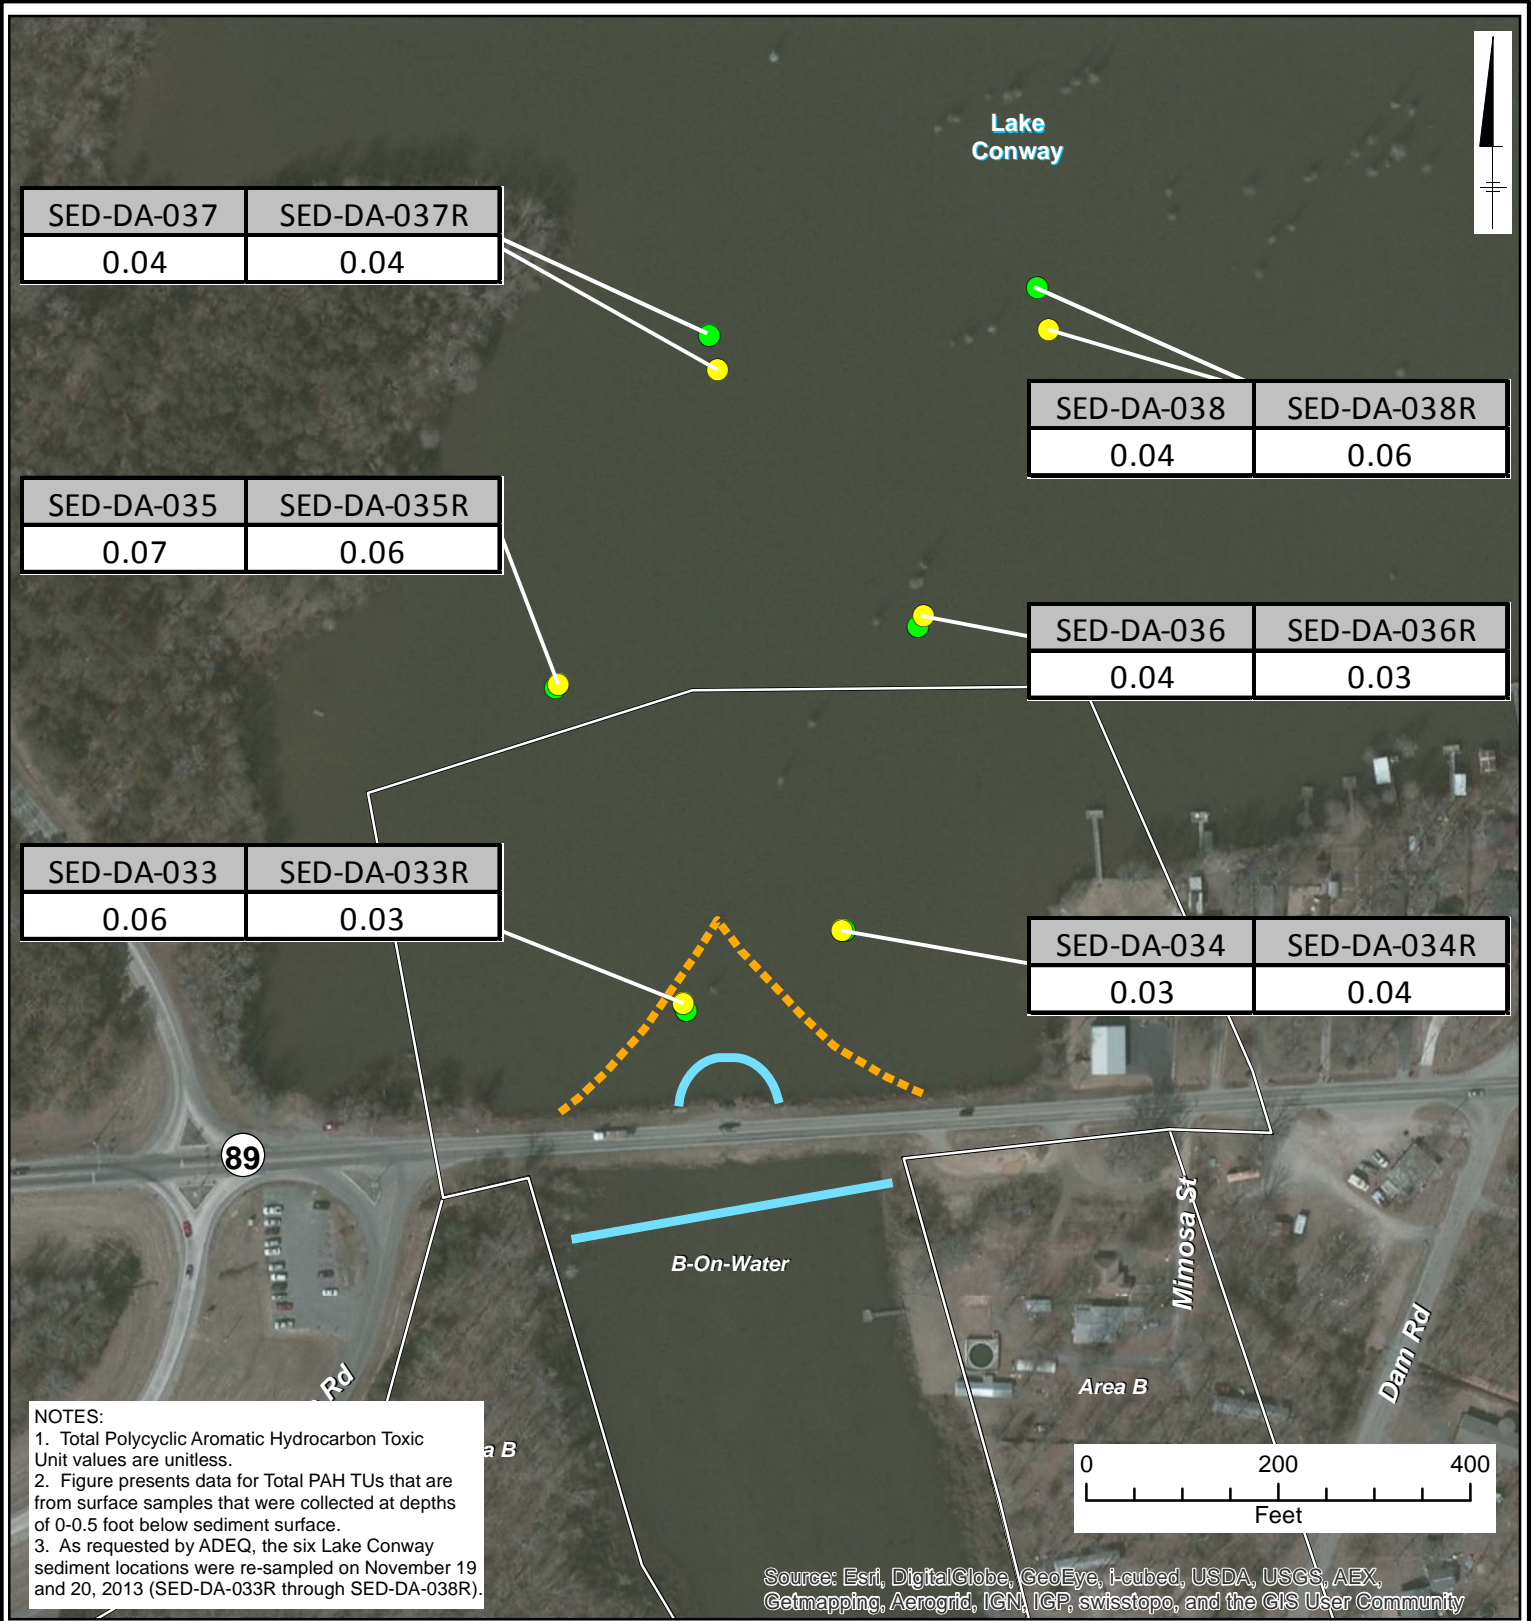
**FIGURE
 7-3.2**

NOTES:
 1. Total Polycyclic Aromatic Hydrocarbon Toxic Unit values are unitless.
 2. Figure presents data for Total PAH TUs that are from surface samples that were collected at depths of 0-0.5 foot below sediment surface.
 3. As requested by ADEQ, the six Lake Conway sediment locations were re-sampled on November 19 and 20, 2013 (SED-DA-033R through SED-DA-038R).

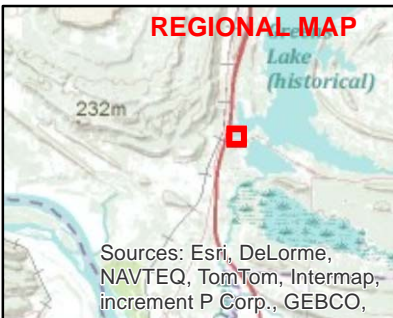
**SEDIMENT SAMPLING RESULTS IN
 LAKE CONWAY: TOXIC UNIT**

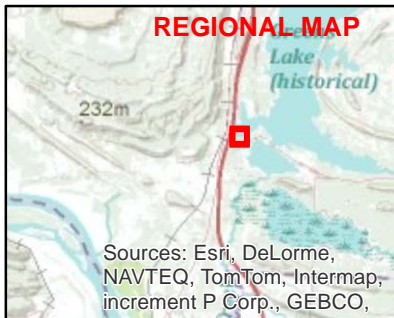
**SEDIMENT SAMPLING RESULTS IN
 LAKE CONWAY: METALS**

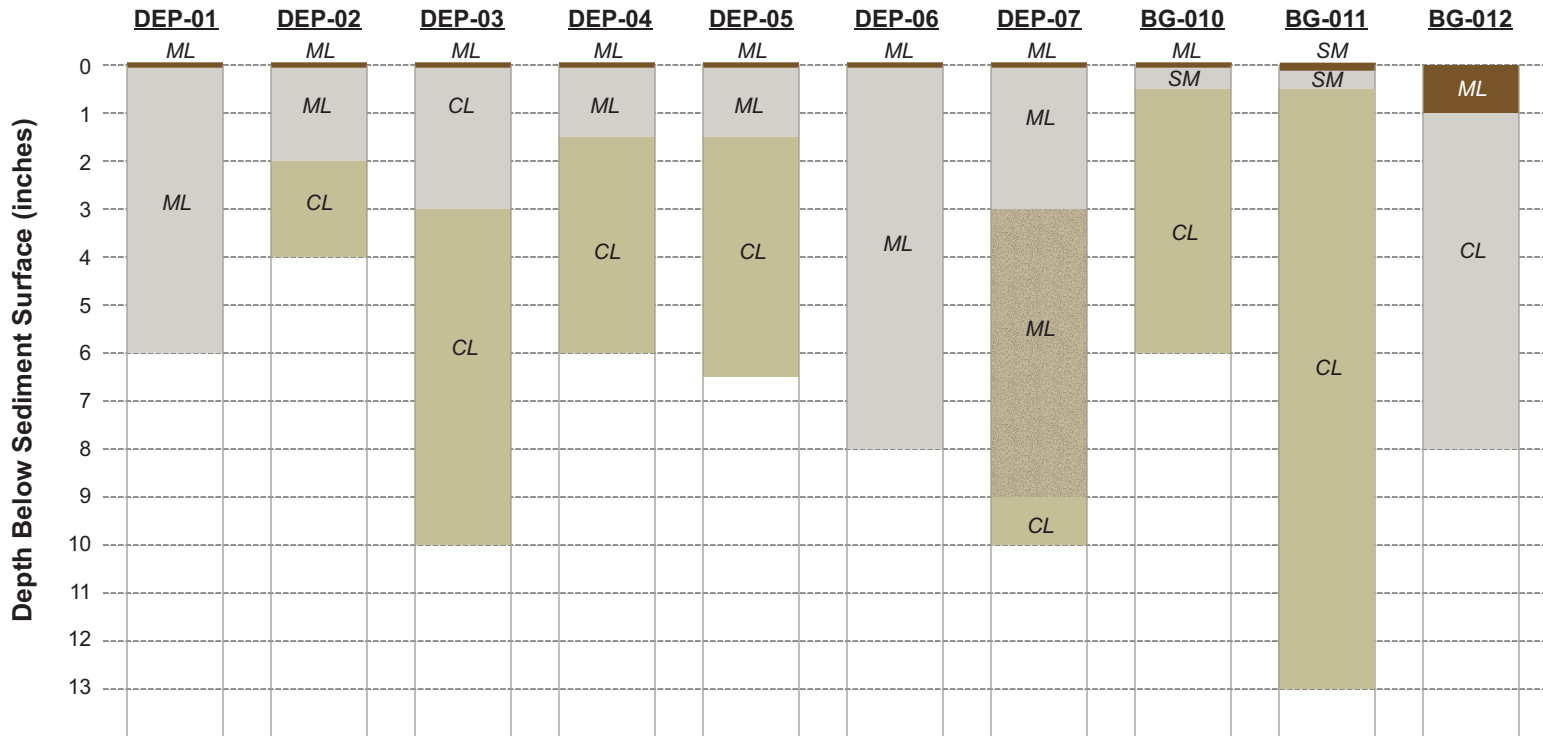
FIGURE
7-4.1

USCS Soil Group Symbol:

CL = Inorganic clay of low plasticity, lean clay

2. All sediment colors depicted are approximate representations of colors observed during field sampling.
