**MAYFLOWER PIPELINE INCIDENT RESPONSE
 EXXONMOBIL ENVIRONMENTAL SERVICES COMPANY
 DOWNSTREAM AREAS DATA ASSESSMENT REPORT**

SITE LOCATION MAP

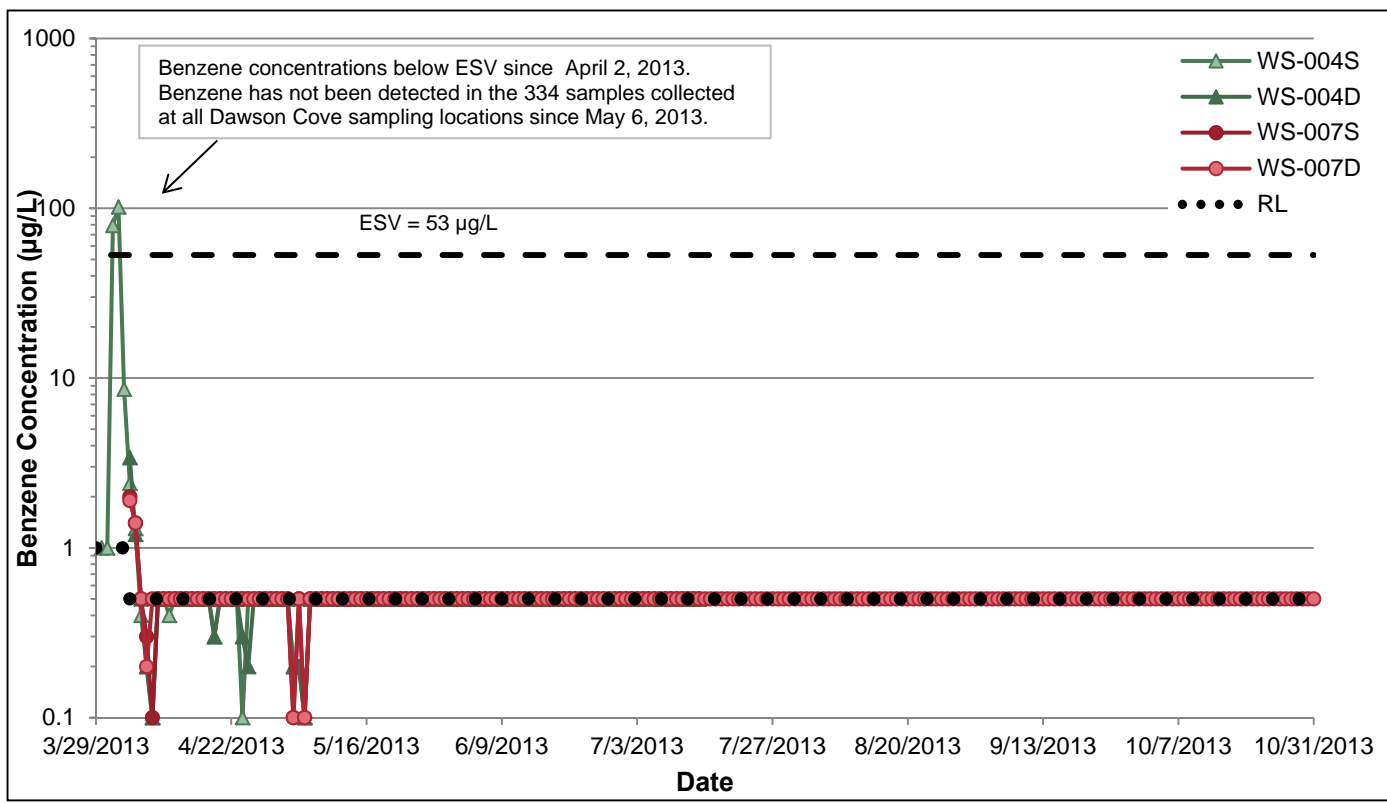
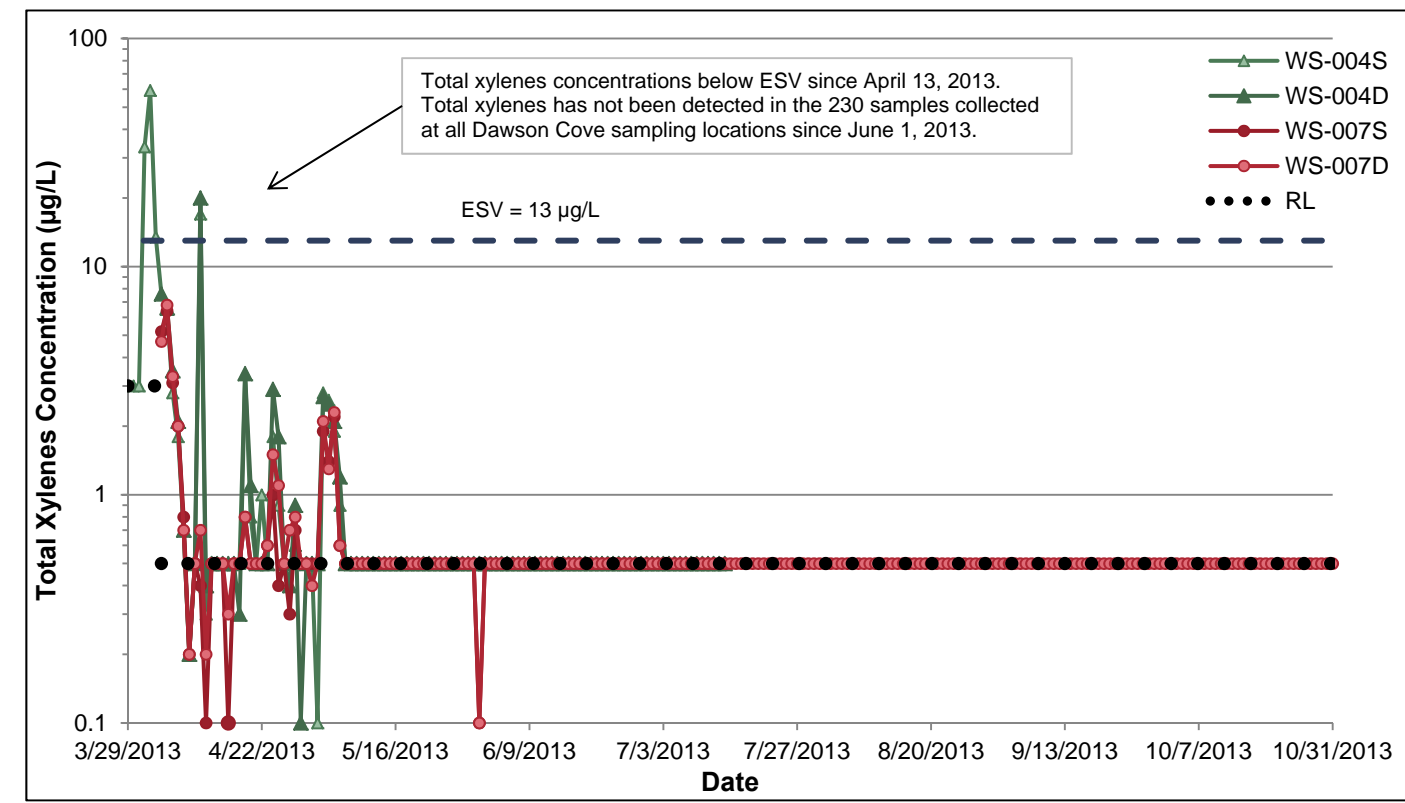
The graphs below show benzene and total xylenes concentrations with time for the locations that had at least one detection.

MAYFLOWER PIPELINE INCIDENT RESPONSE EXXONMOBIL ENVIRONMENTAL SERVICES COMPANY DOWNSTREAM AREAS DATA ASSESSMENT REPORT	
EVALUATION OF VOCs IN DAWSON COVE SURFACE WATER (MARCH 29 - OCTOBER 31, 2013)	
	FIGURE 8-3

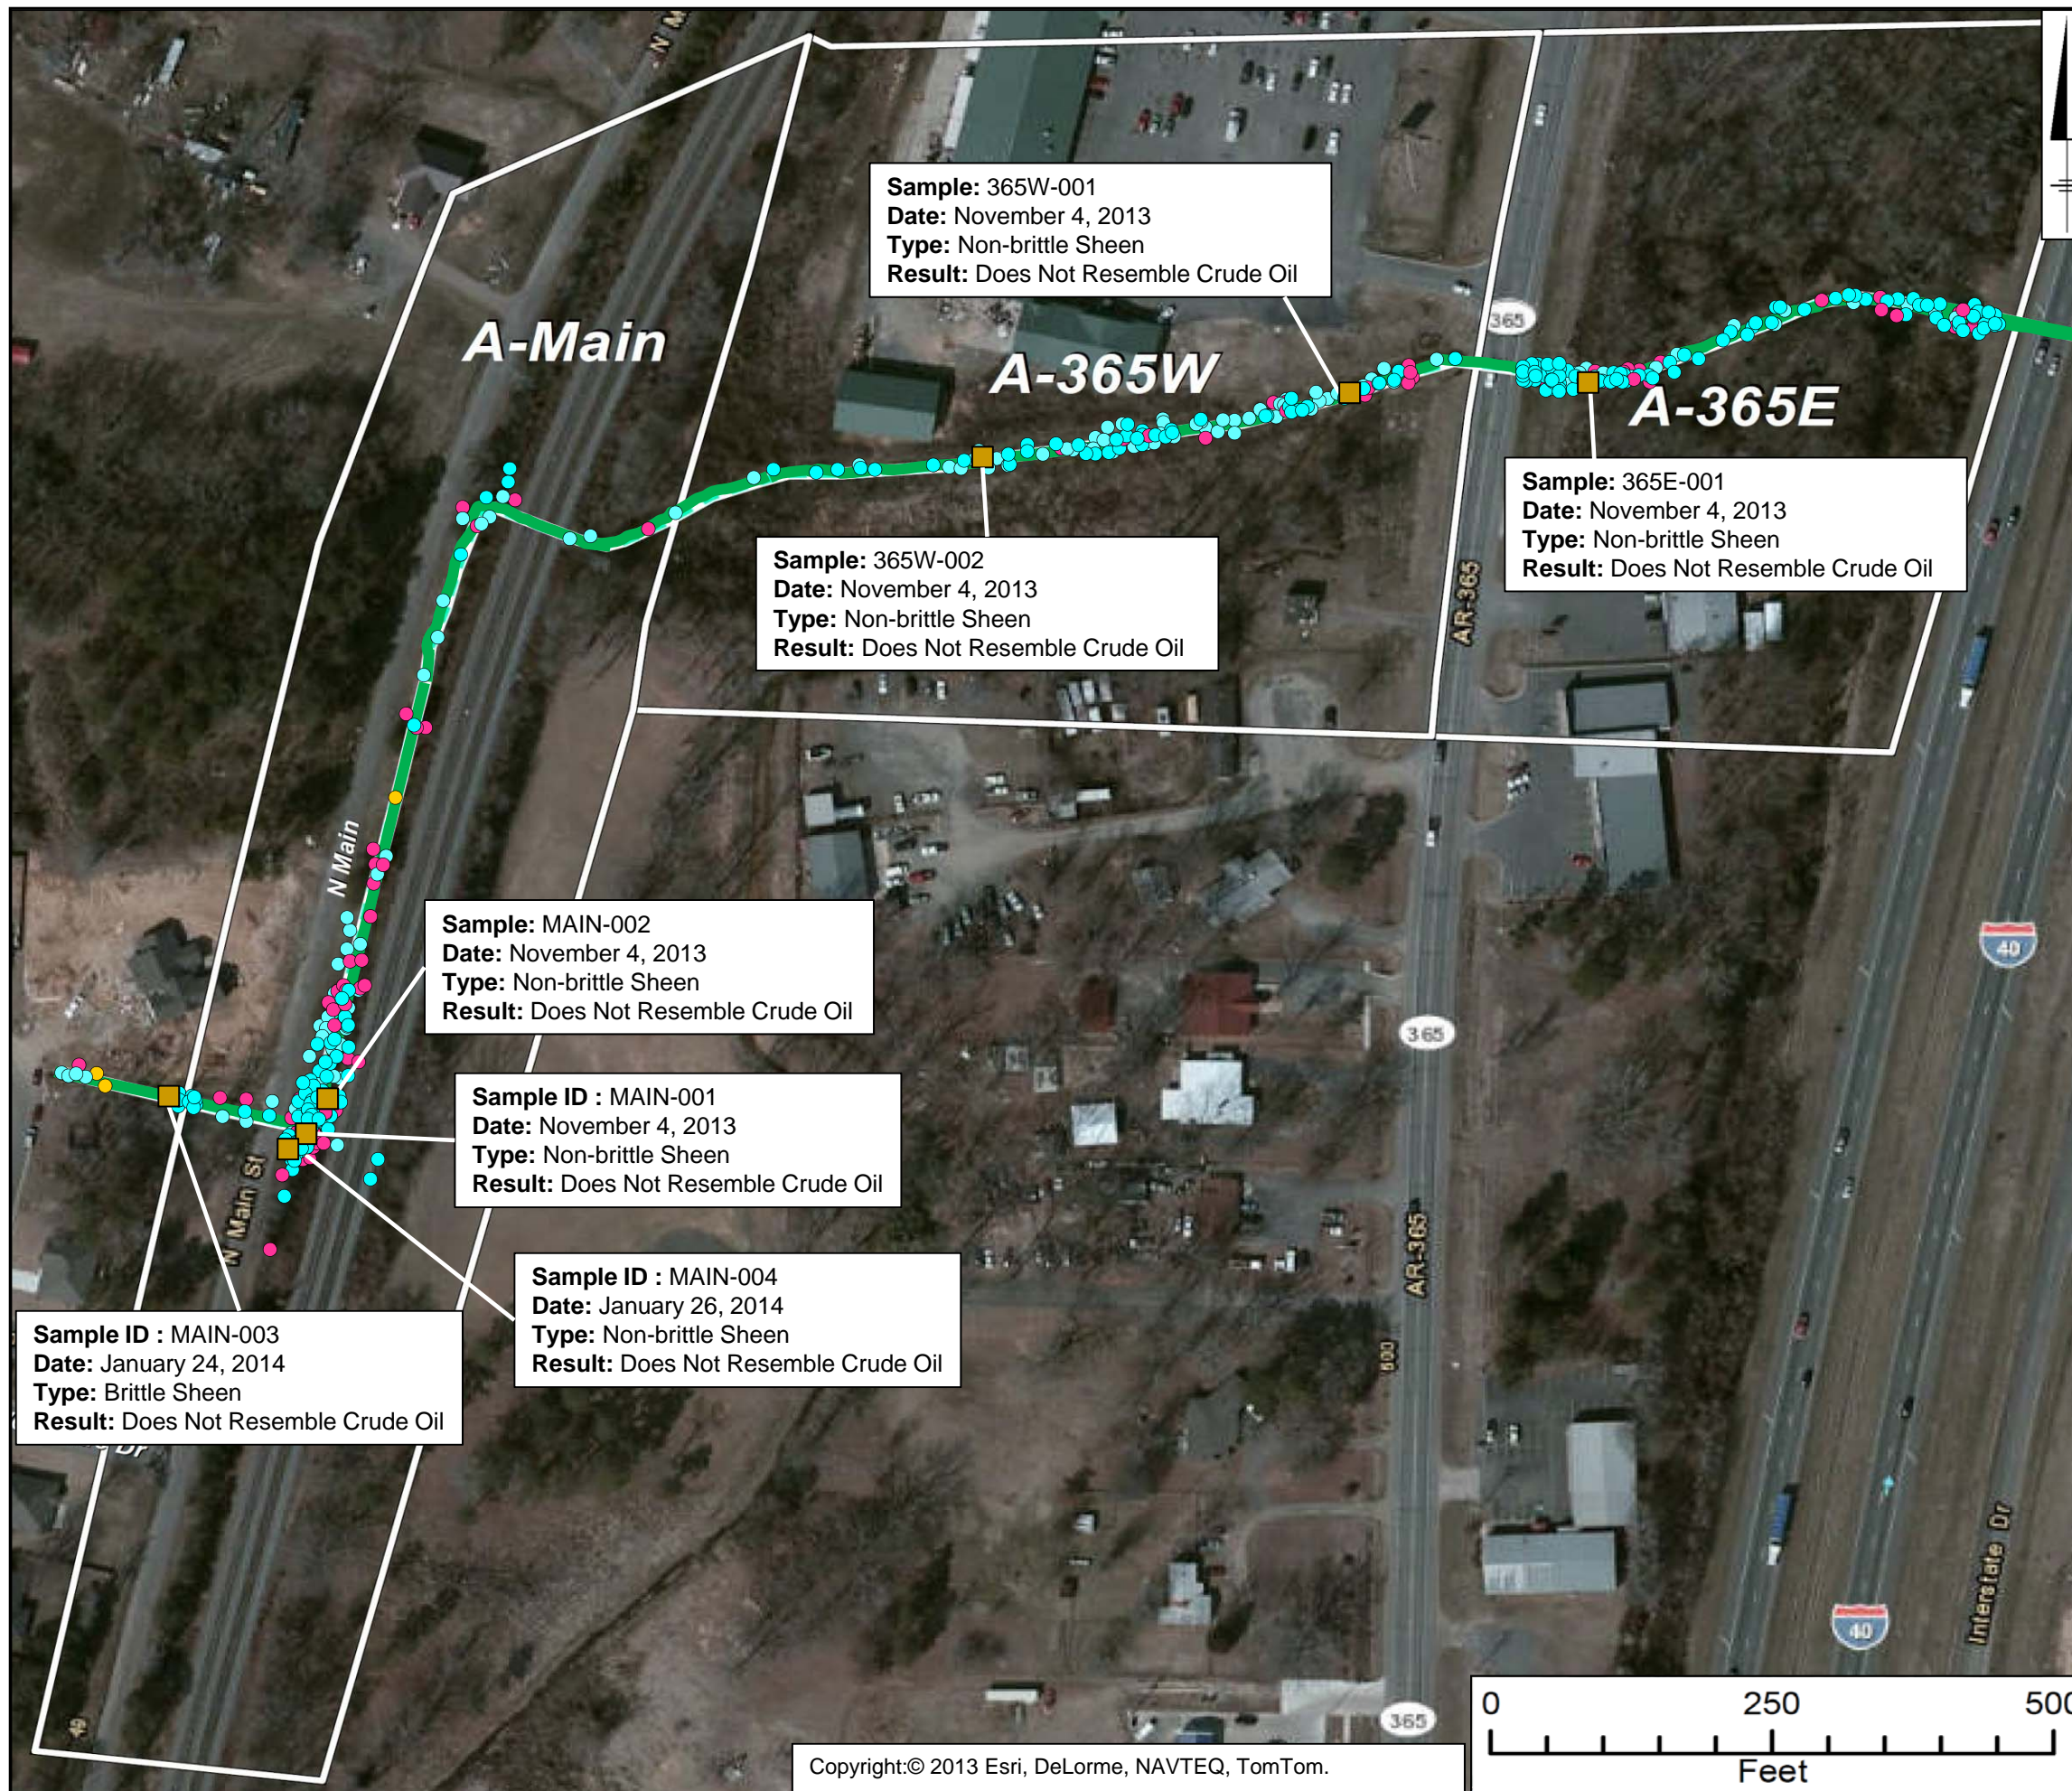
Sample: 365W-001
Date: November 4, 2013
Type: Non-brittle Sheen
Result: Does Not Resemble Crude Oil

1. Location of sheens observed during daily sheen monitoring activities conducted from October 21, 2013 through February 23, 2014. Approximate locations are shown on this figure.
2. Approximate locations of sheen sampling conducted on November 4, 2013 and January 24 and 26, 2014 are shown. Type of sheen based on field characterization. Sampling results based on data analysis presented in Appendix M.

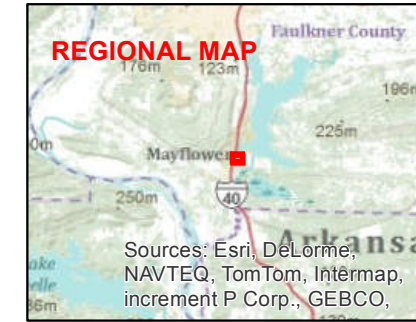
- Approximate Areas for Sheen Mitigation
- Areas with Heavy Vegetation
- Drainage Path
- Water's Edge
- Containment Boom
- Operations Areas

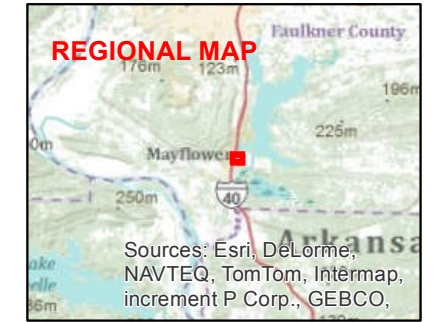
- Approximate Inlet Channel Targeted Removal Area
- Approximate Open Water Cap Placement Area
- Areas with Heavy Vegetation
- Approximate Heavily Vegetated Targeted In-Situ Amendment Area
- Drainage Path
- Water's Edge
- Containment Boom
- Operations Areas
