Cove Restoration Planting Plan

Mayflower Pipeline Incident Response
Mayflower, Arkansas

February 2015

Revision 1

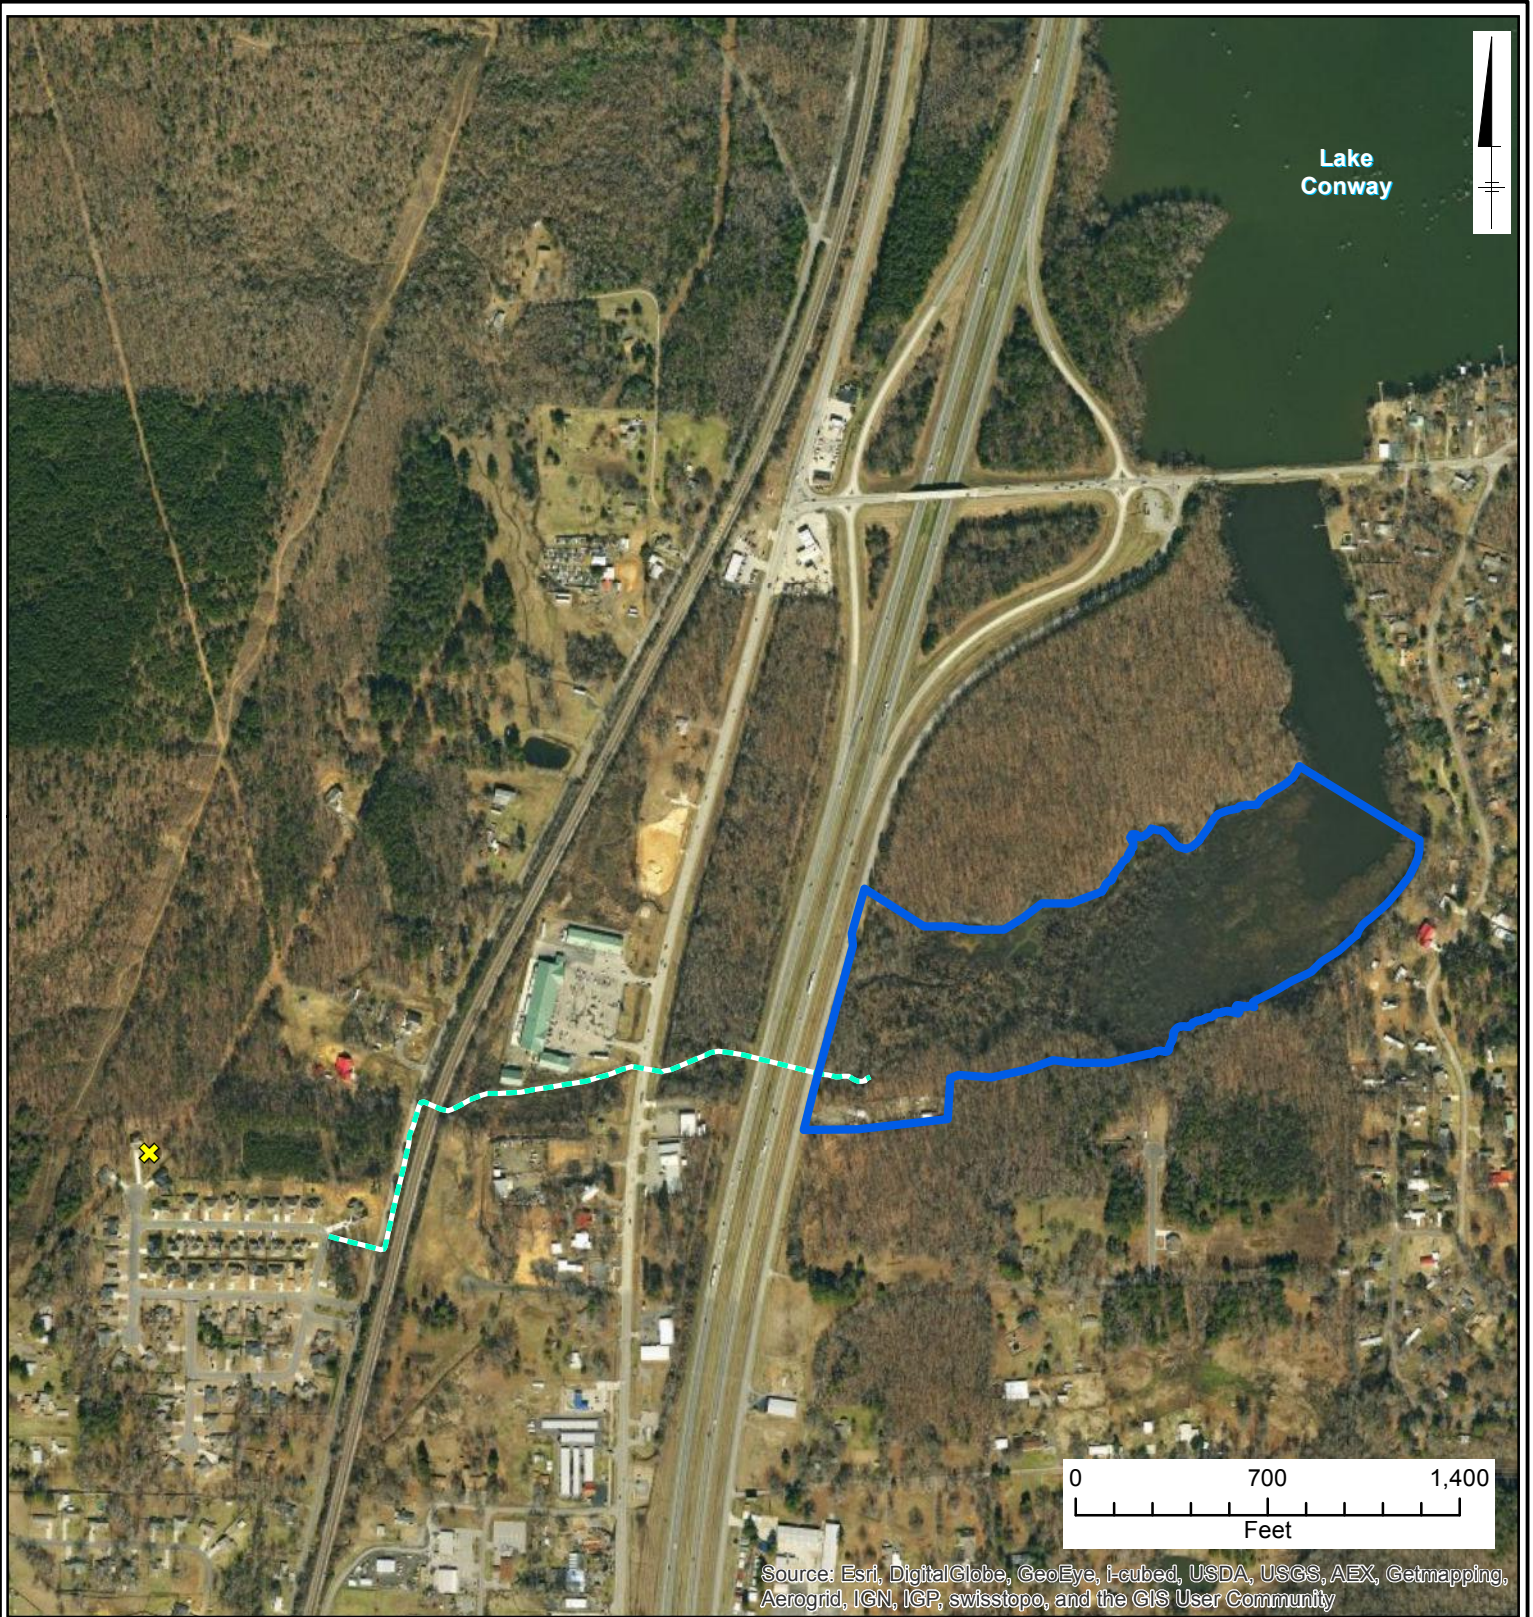
**FIGURE
1**

SITE LOCATION MAP

ARCADIS U.S., Inc. (ARCADIS) prepared this Cove Restoration Planting Plan (CRPP) for ExxonMobil Environmental Services Company (EMES) on behalf of ExxonMobil Pipeline Company (EMPCo) for the Mayflower Pipeline Incident Response located in Mayflower, Arkansas (site; Figure 1). In April 2013, the U.S. Army Corps of Engineers (USACE) issued a Nationwide Permit 38 Cleanup of Toxic and Hazardous Waste (NWP 38) to EMPCo (Permit No. 2013-00129) for the cleanup of a crude oil release on March 29, 2013.

On March 29, 2013, a breach in a pipeline operated by EMPCo (the 20-inch Pegasus Pipeline) released crude oil in Mayflower, Arkansas (Figure 1). The crude oil was identified as Wabasca heavy crude oil (herein referred to as “crude oil”). An emergency response action was implemented immediately to mitigate the release, and a substantial amount of the crude oil was removed. Wetland, riparian and upland habitats of the cove were disturbed during the 2013 initial response action and 2014 mitigation activities.

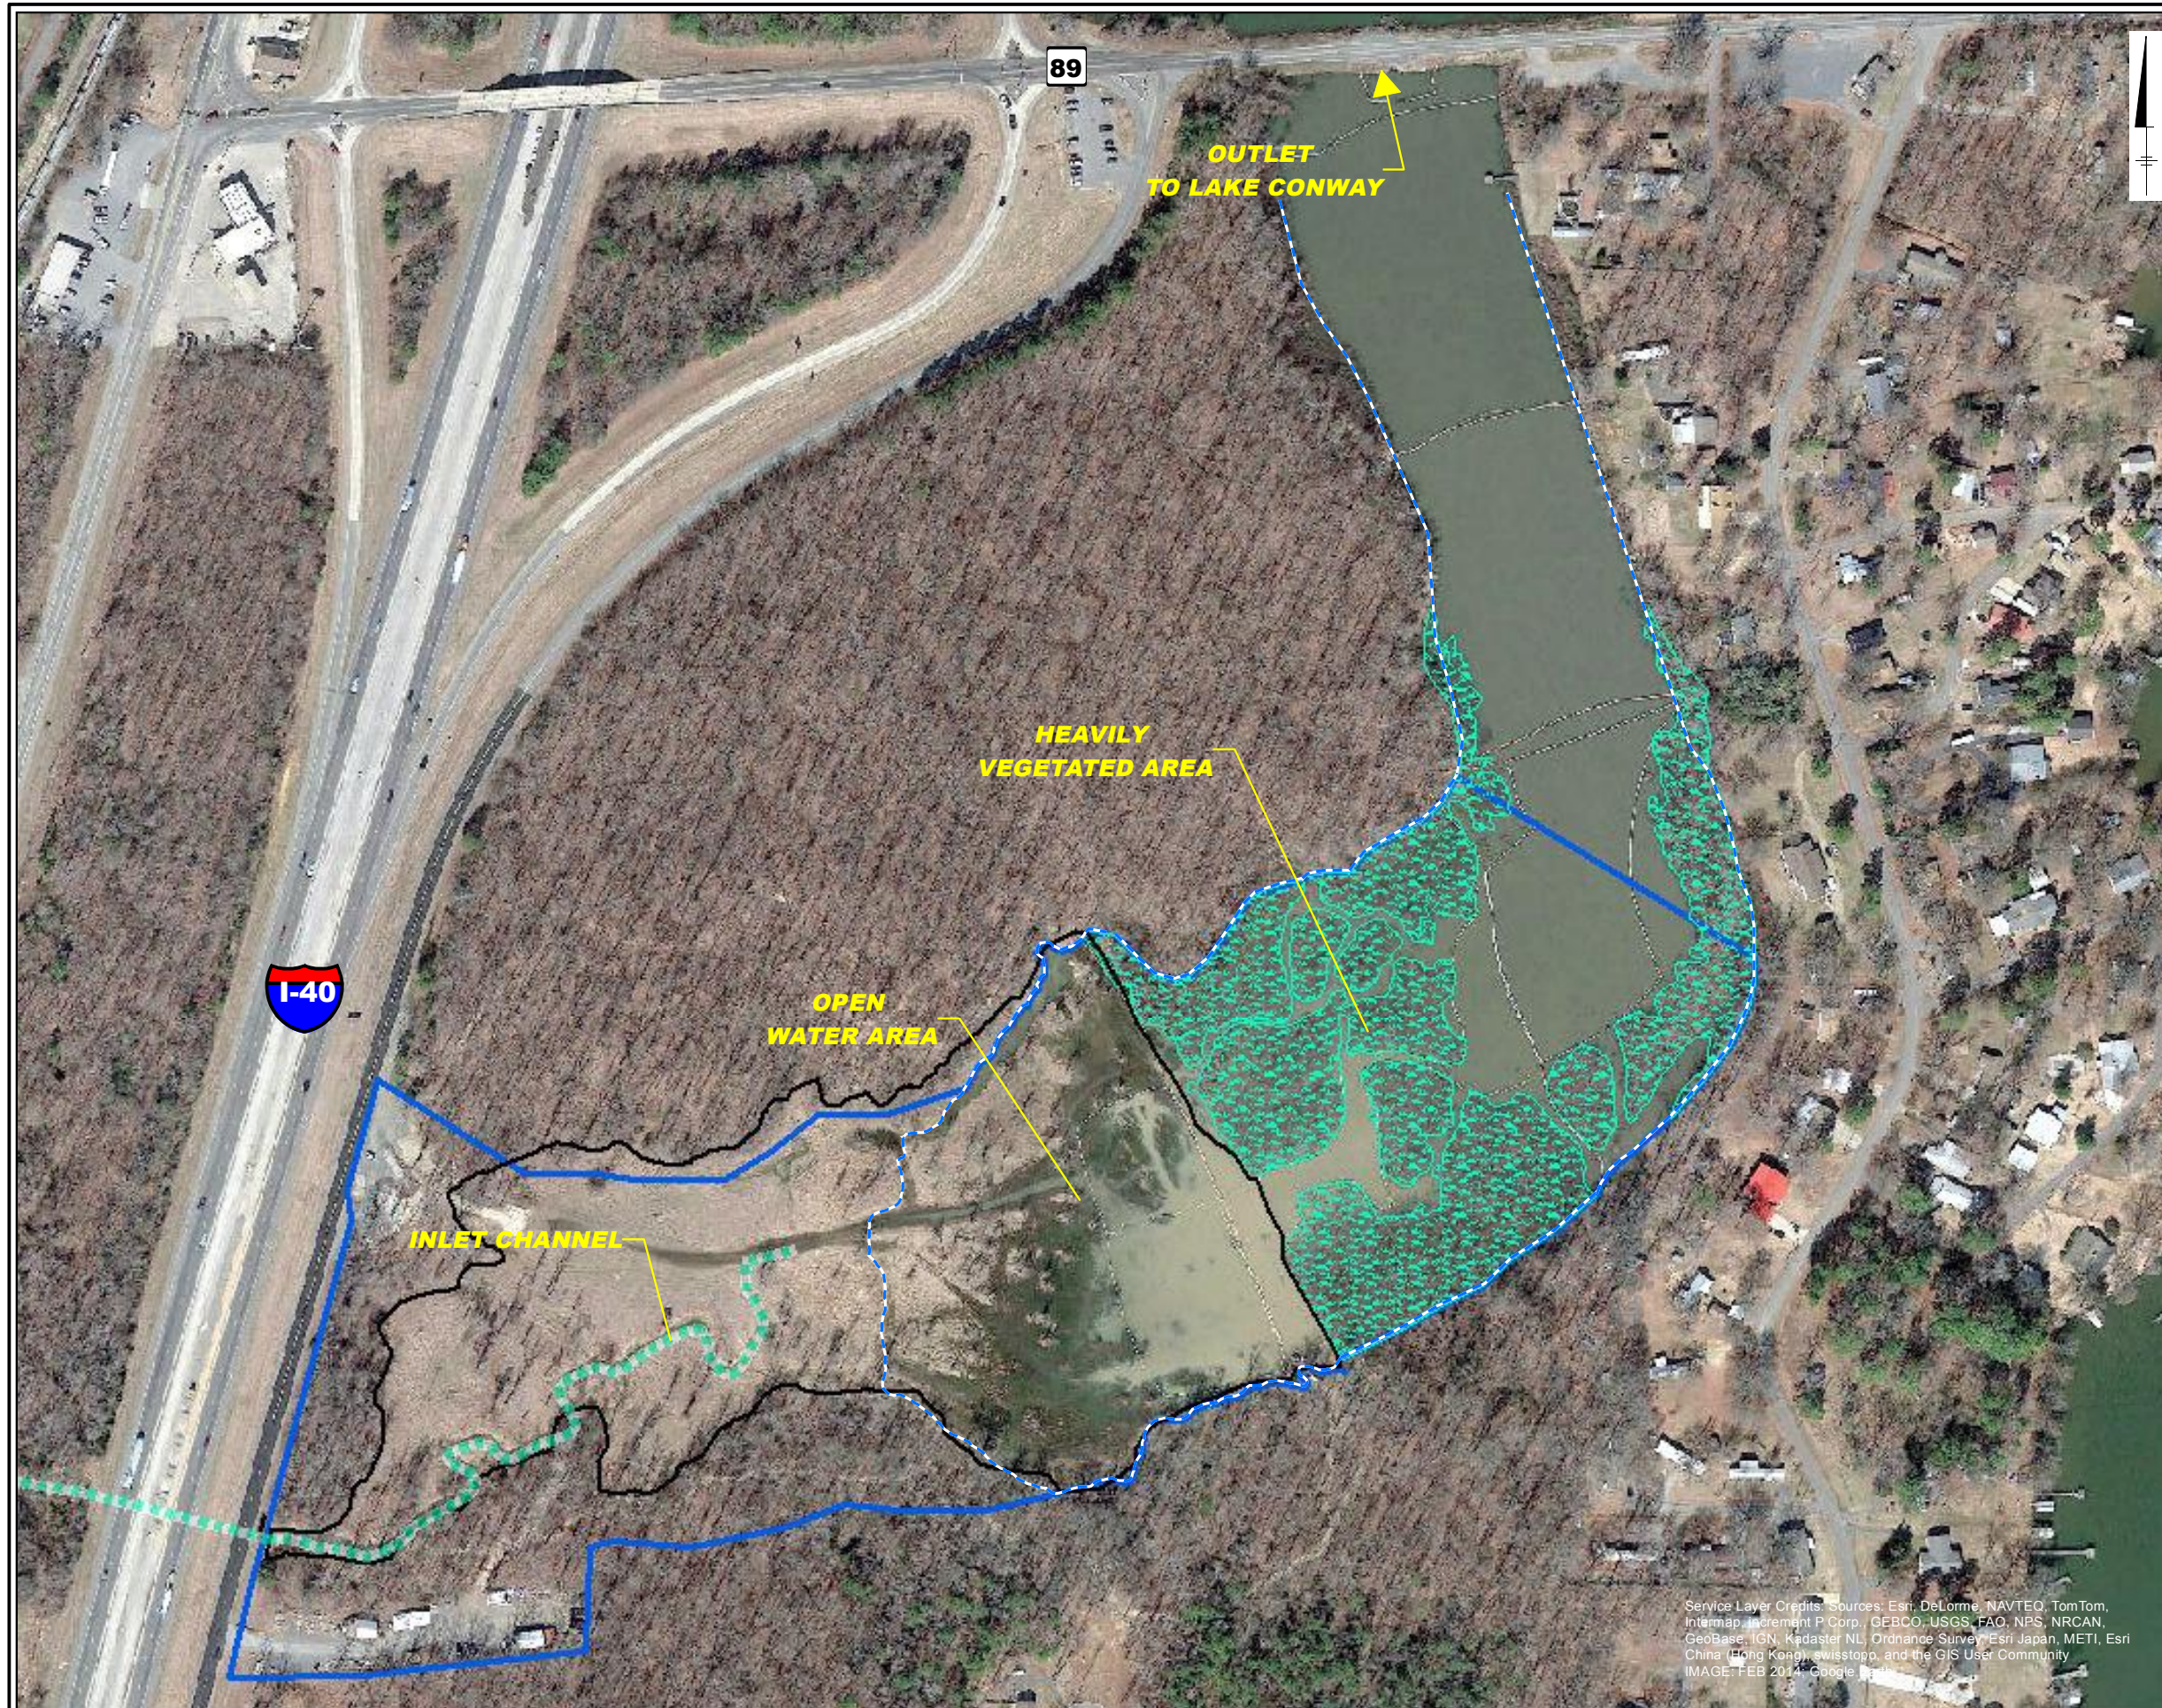
- - - Drainage Path
- - - Approximate Water's Edge
- Approximate Limit of Work
- ▨ Areas with Heavy Vegetation
- Disturbed Wetlands Outline

1. The Heavily Vegetated Area shown in this plan was digitized based on the February 2014 aerial photo that was acquired via Google Enterprise Geo Master License.
2. The water's edge changes based on season and recent rainfall. The approximate water's edge is based on conditions during the pre-design study in April 2014.

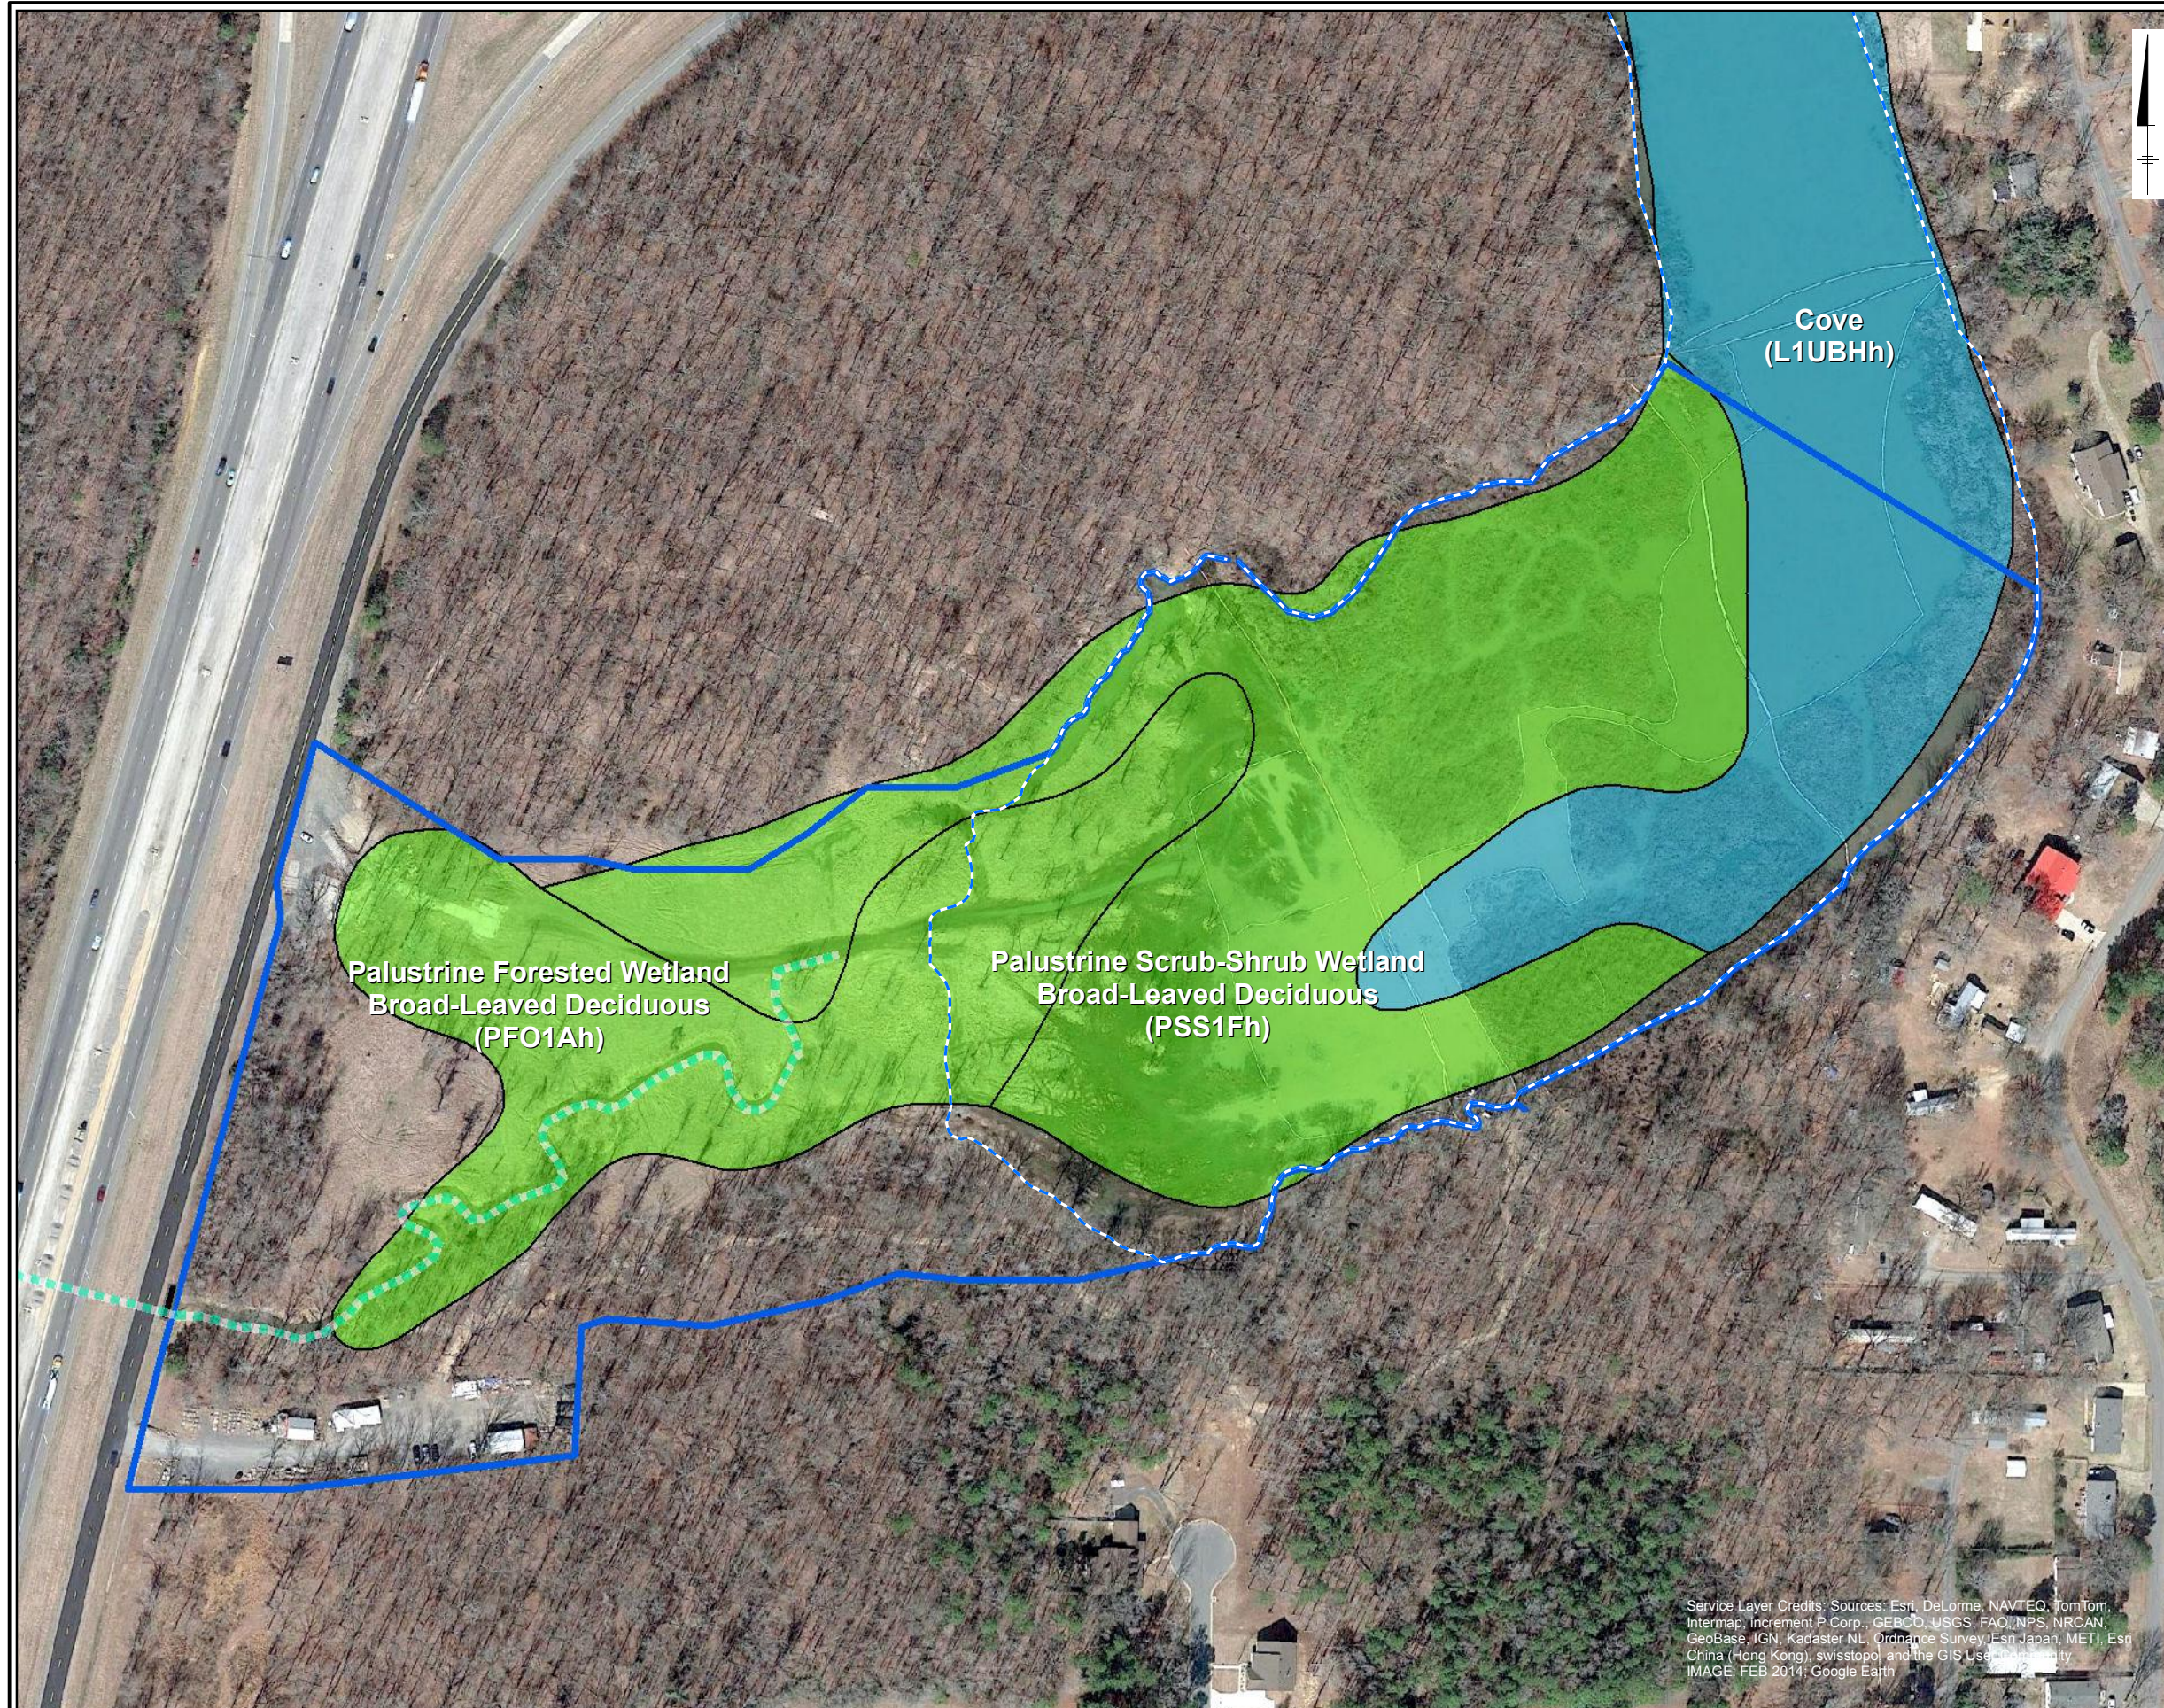
FIGURE
 3

- Drainage Path
 - Approximate Water's Edge
 - Approximate Limit of Work
- Wetlands**
- Freshwater Forested/Shrub Wetland
 - Cove

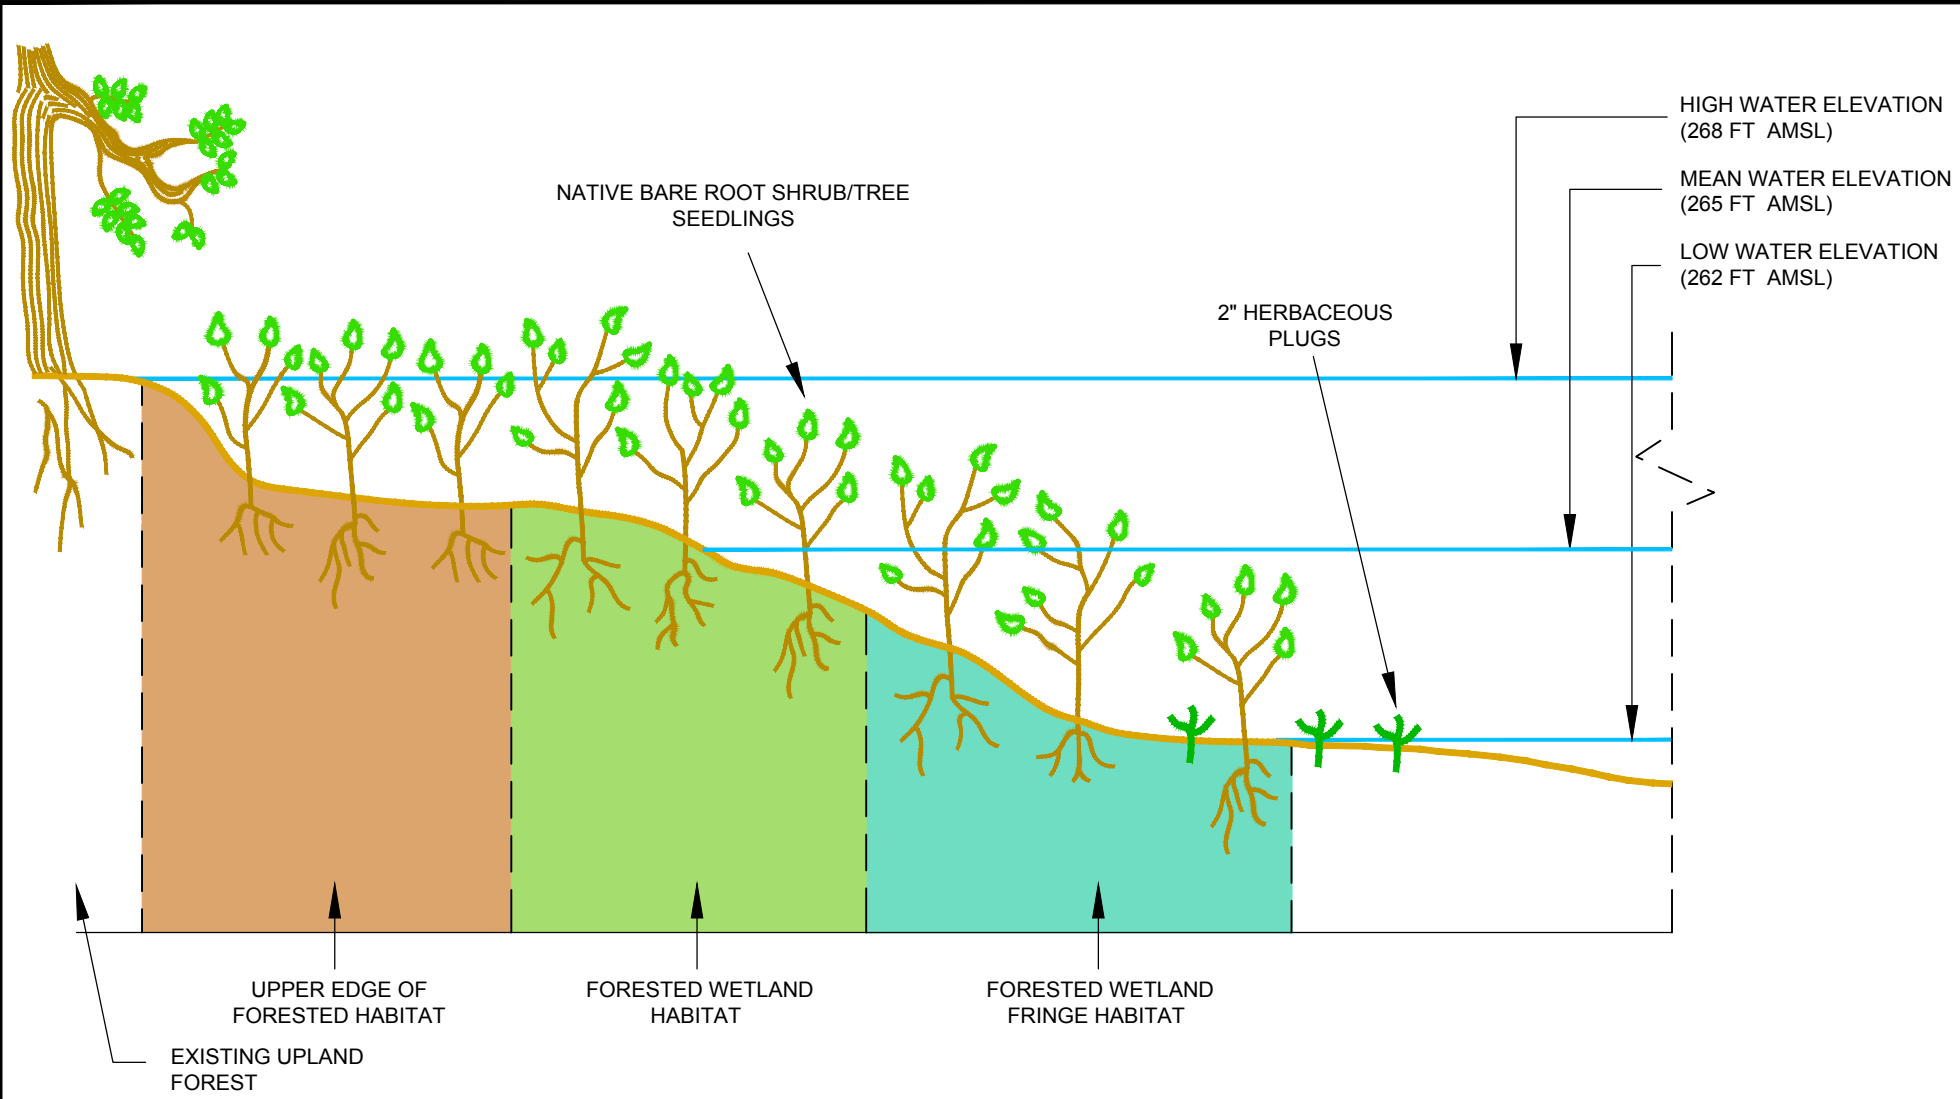
FIGURE
10

BARE ROOT SEEDLING NOTES:

1. SELECTED SHRUB AND TREE SEEDLING SPECIES BASED ON OBSERVATIONS OF HIGH-VALUE FORESTED WETLAND SYSTEMS ASSOCIATED WITH UNDISTURBED PORTIONS OF LAKE CONWAY CONDUCTED DURING THE SEPTEMBER 2014 WETLAND ASSESSMENT. SPECIES AND THE LOCATION THAT THEY WERE OBSERVED CAN BE FOUND IN TABLE 1.

2. 2" NATIVE HERBACEOUS PLUGS WILL BE PLANTED AS NEEDED IN THE "FORESTED WETLAND FRINGE HABITAT".
3. DURING THE SEPTEMBER 2014 WETLAND ASSESSMENT THE FOLLOWING SPECIES WERE OBSERVED TO BE NATURALLY RECOLONIZING THE PROJECT AREA: BLACK WILLOW, BUTTONBUSH, WATER WILLOW. NO BARE ROOT SEEDLINGS OF THESE SPECIES WILL BE PLANTED DURING THE INITIAL RESTORATION EFFORTS.

Figure 10 shows a conceptual drawing of a cross-section of the proposed planting plan across the range of habitats as well as the species recommended for each hydrological condition. The approximate locations of these habitats are shown on Figure 11. Based on current site conditions and the assessment of other hydrologically comparable forested wetlands associated with Lake Conway, the planned restoration of the cove is as follows:

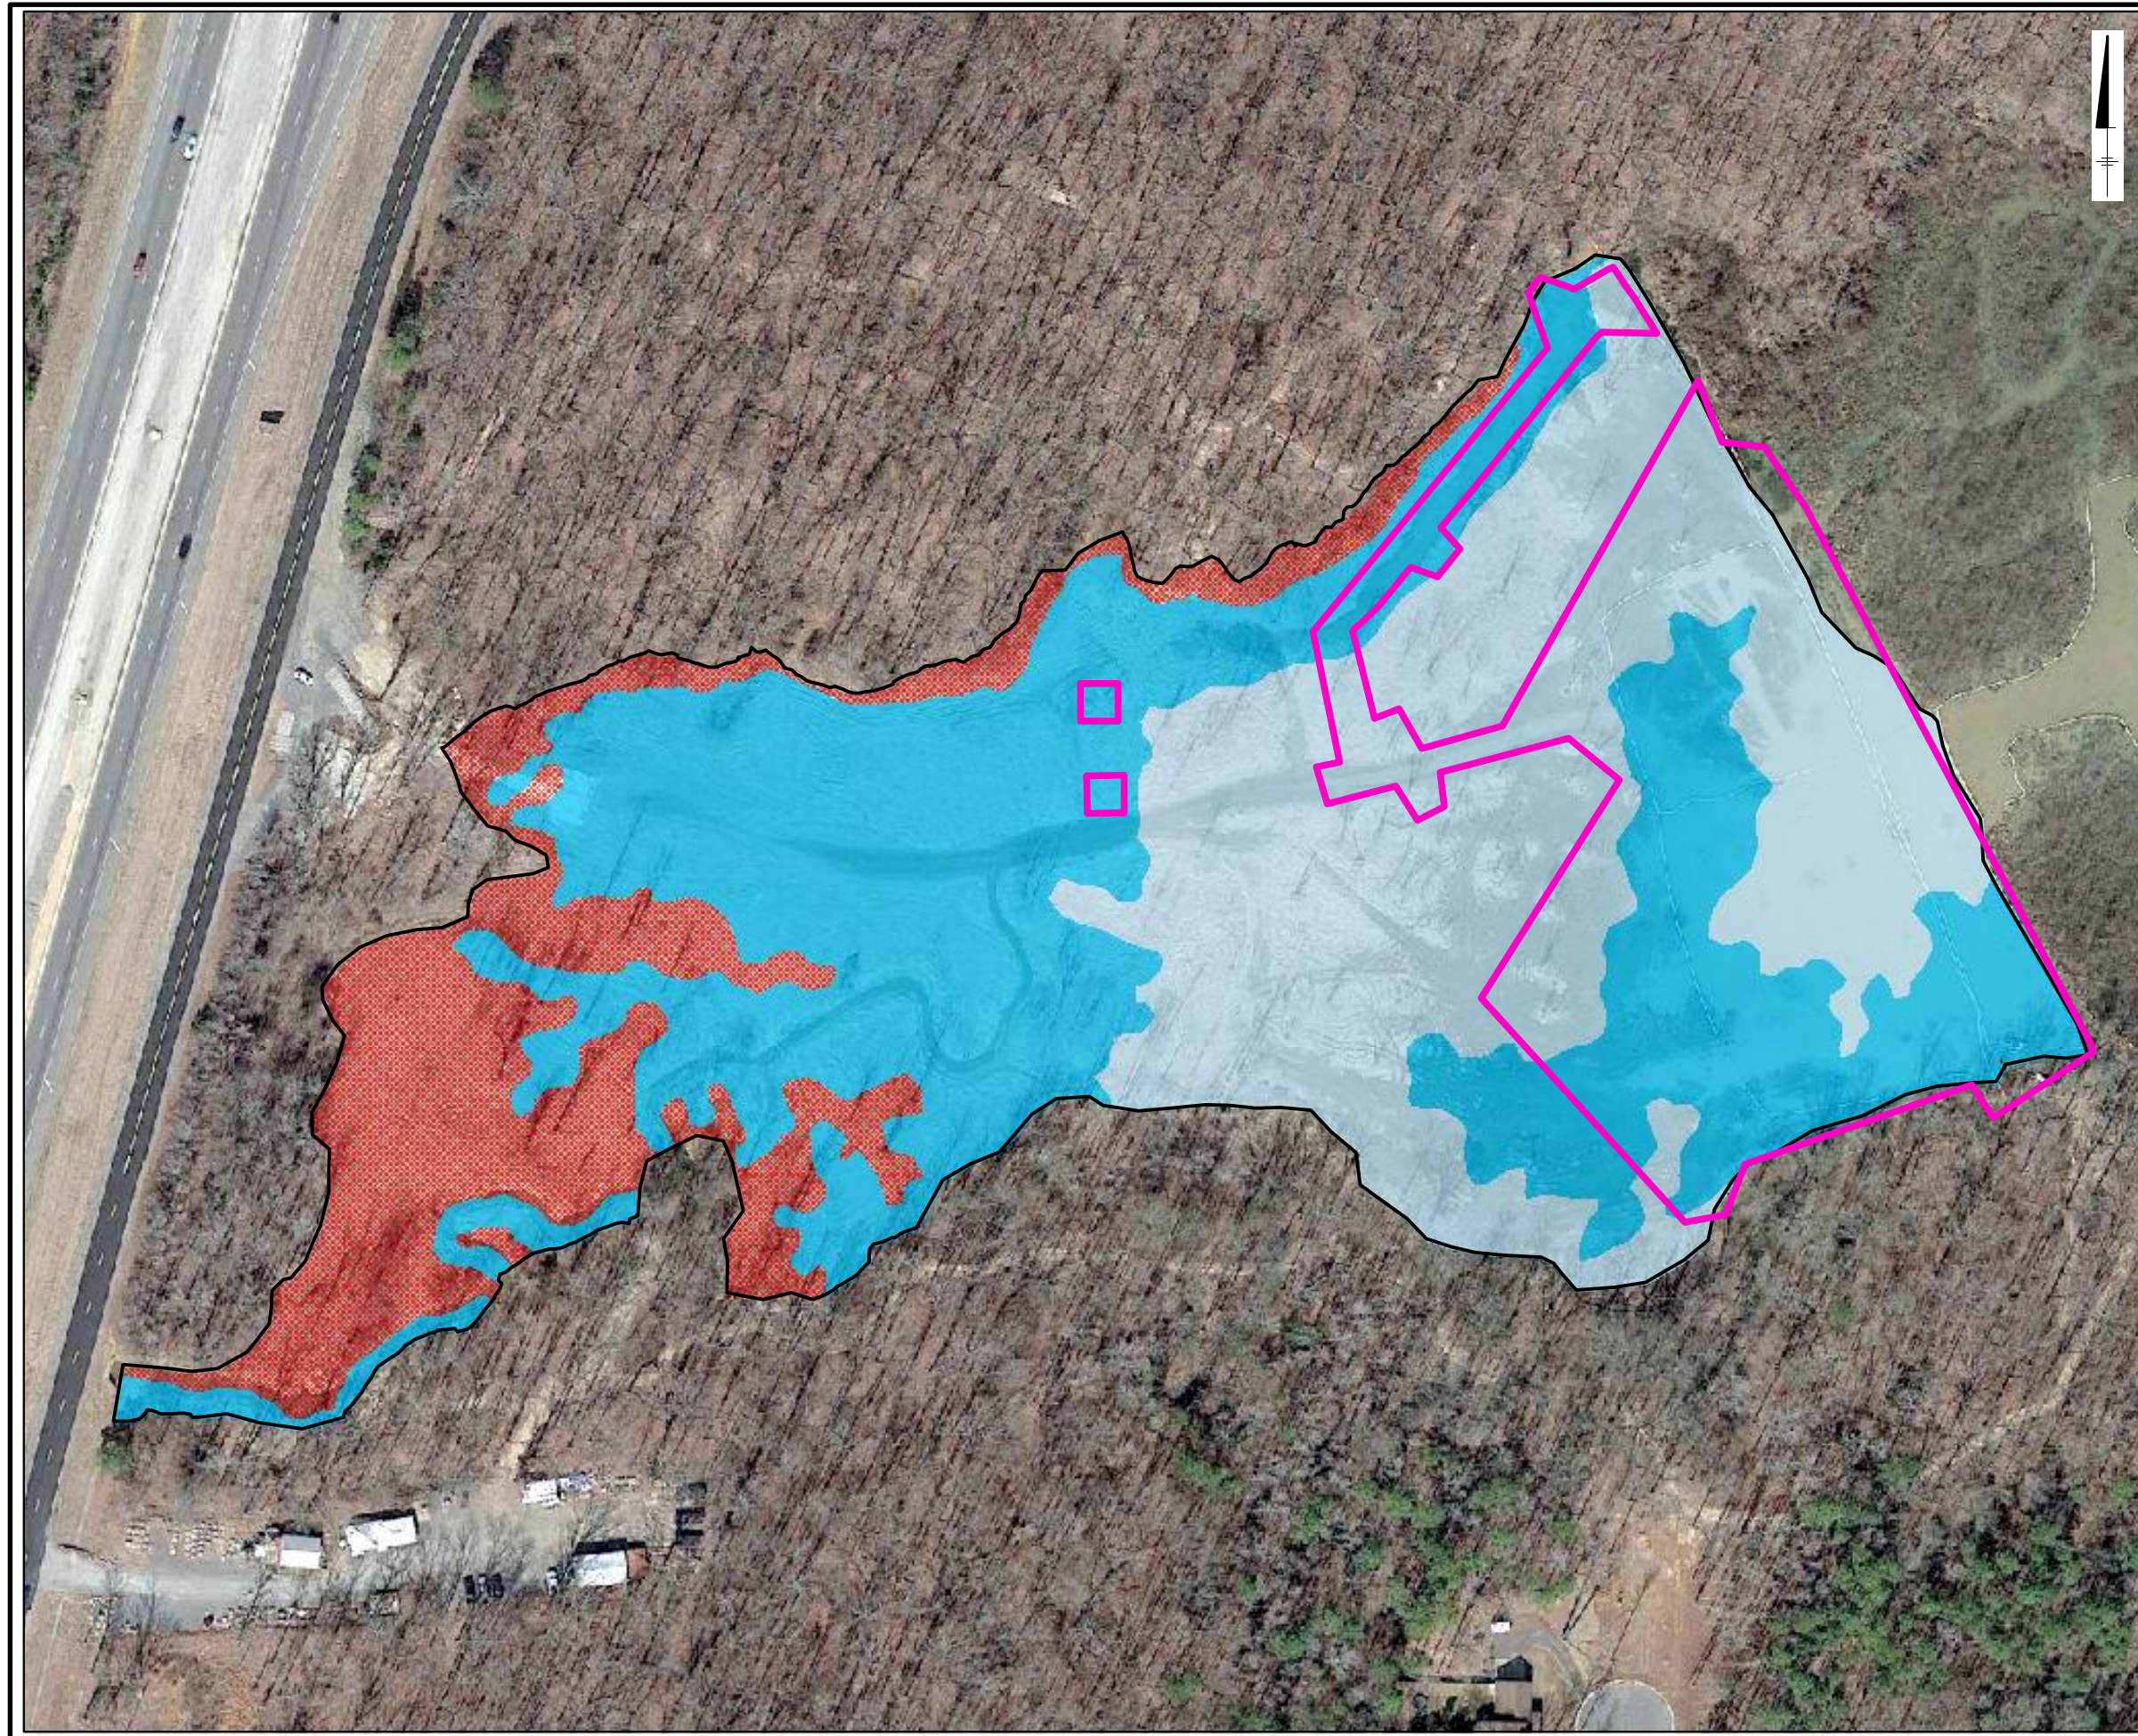
FIGURE
11

-   Reactive Cap Extent
-   Upper Edge Forested Habitat
-   Forested Wetland Habitat
-   Forested Wetland Fringe Habitat

- *Forested Wetland Fringe Habitat (5.5 acres)*. The lower elevations of the cove wetlands will be planted with bare root seedlings of bald cypress and water tupelo trees. Historical Lake Conway water elevations will be used to estimate average hydrologic conditions and select seedling placement within the cove. Wetland swales provide ideal hydrology for the development of cypress/water tupelo communities as observed in Reference Area C. A native wet meadow seed mix (NC Piedmont FACW Mix, ERNMX-308; Table 2) will be applied in the saturated soils of the Fringe Forested Wetland habitat to provide species diversity with modifications.

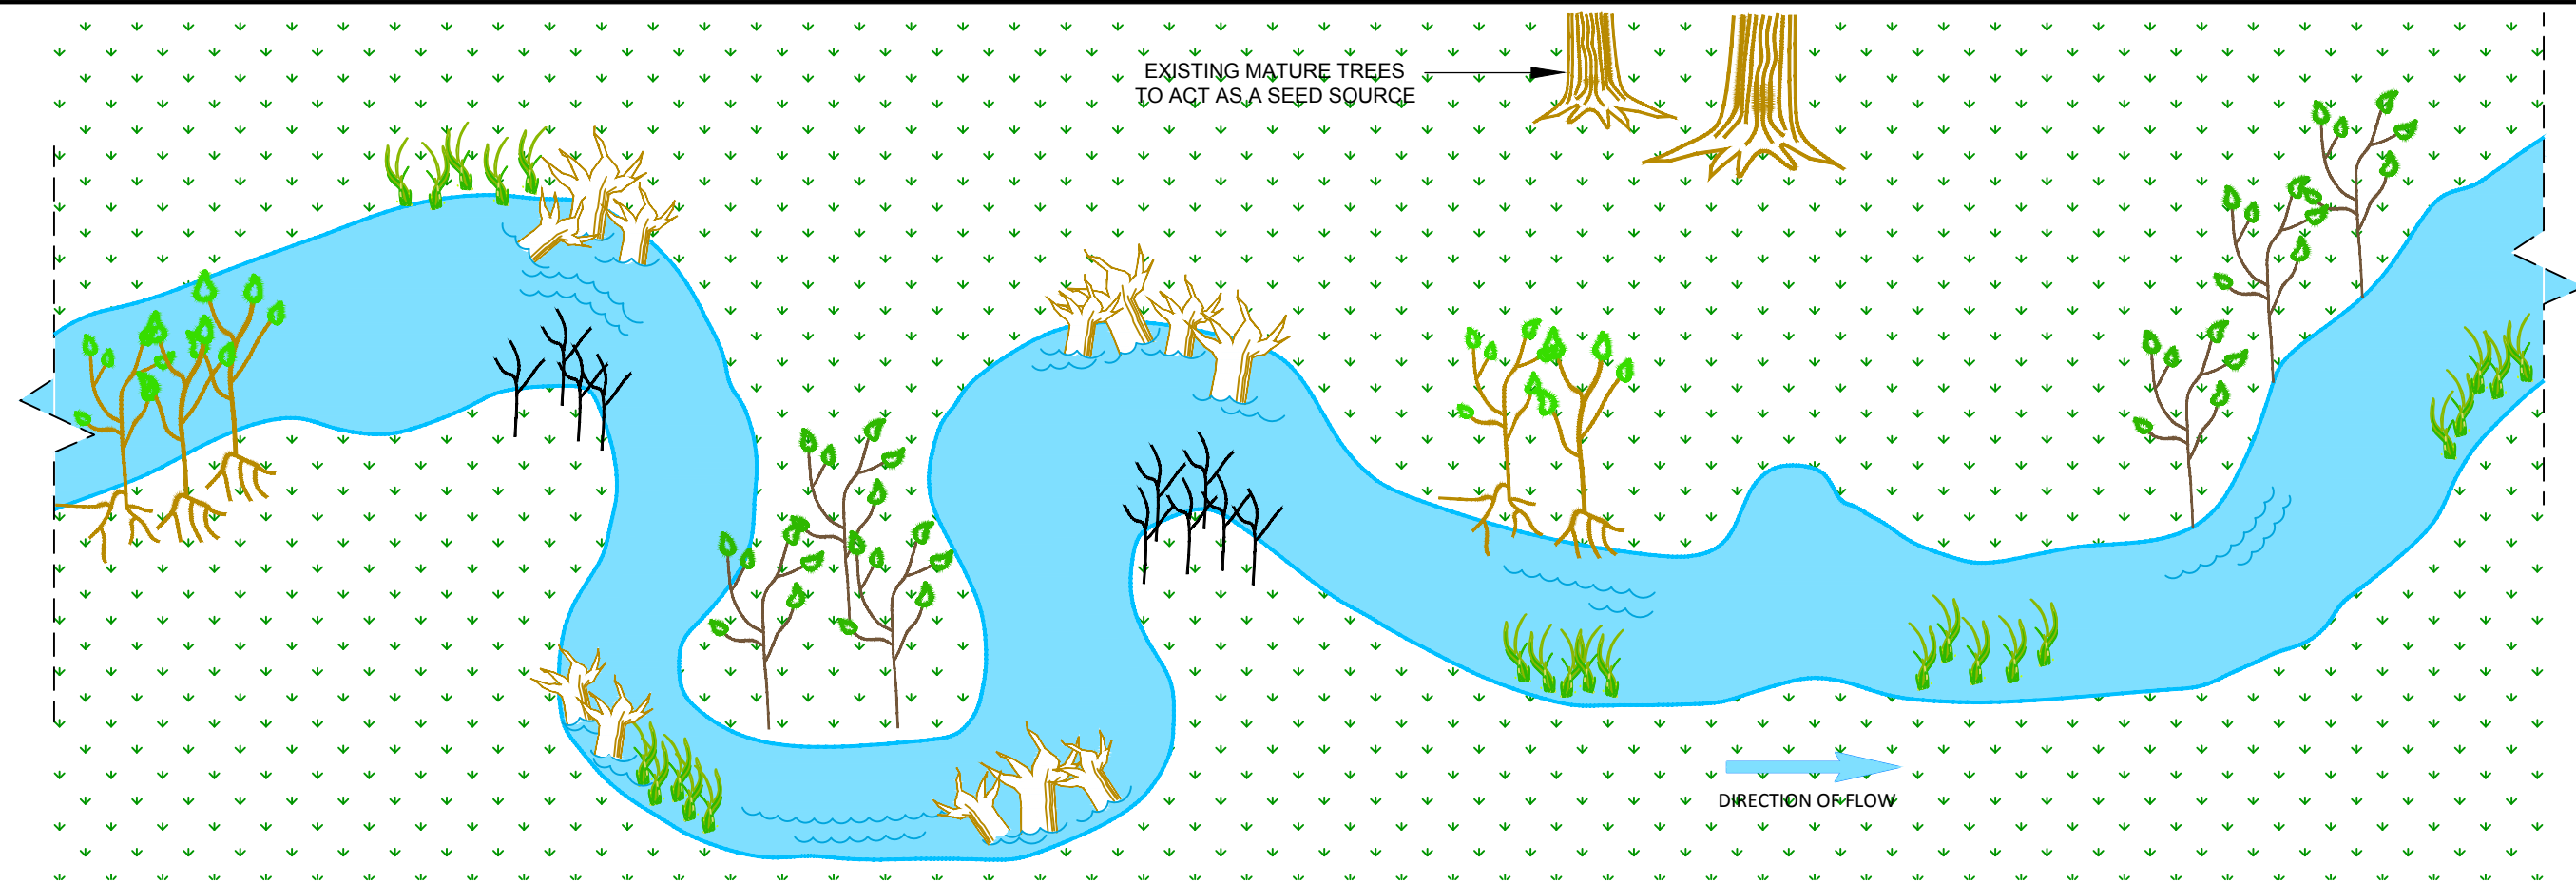
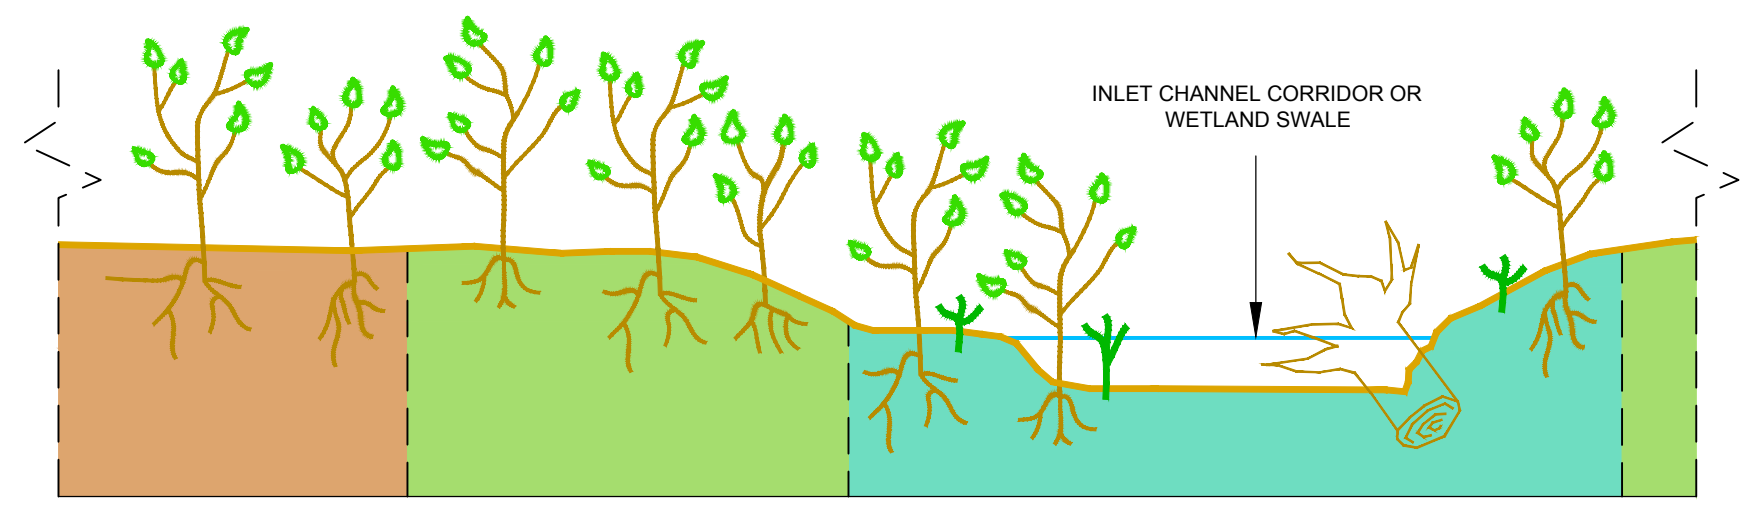
MAYFLOWER PIPELINE INCIDENT RESPONSE EXXONMOBIL ENVIRONMENTAL SERVICES COMPANY COVE PLANTING PLAN	
INLET CHANNEL RESTORATION PLAN	
	FIGURE 12

- NOTES:**
1. SELECTED SHRUB AND TREE SEEDLING SPECIES BASED ON OBSERVATIONS OF HIGH VALUE FORESTED WETLAND SYSTEMS ASSOCIATED WITH UNDISTURBED PORTIONS OF LAKE CONWAY CONDUCTED DURING THE SEPTEMBER 2014 WETLAND ASSESSMENT. SPECIES AND THE LOCATION THAT THEY WERE OBSERVED CAN BE FOUND IN TABLE 1.

2. NATIVE SEED MIXES WILL BE APPLIED THROUGHOUT THE RIPARIAN AREA IN ADDITION TO THE PLANTED TREES AND SHRUBS. THE SPECIES INCLUDED IN THE SEED MIXES ARE LISTED IN TABLE 2. RIPARIAN SEED MIX (NC PIEDMONT RIPARIAN MIX, ERNMX-307) WILL BE APPLIED TO THE INLET CHANNEL BANKS AND ADJACENT FLOODPLAIN. WET MEADOW AND WETLAND SEED MIX (NC PIEDMONT FACW MIX, ERNMX-308) WILL BE APPLIED TO PORTIONS OF THE INLET CHANNEL CORRIDOR EXHIBITING APPROPRIATE HYDROLOGIC CONDITIONS.

5. SHRUB AND TREE SEEDLING SPECIES WILL BE PLANTED AS AVAILABLE.
 6. LOCATIONS OF THE FEATURES SHOWN HAVE BEEN APPROXIMATED. ACTUAL PLANT PLACEMENT WILL BE SELECTED BY AN ECOLOGIST IN THE FIELD.

7. ROOT WADS WILL BE PLACED THROUGHOUT THE CORRIDOR TO PROVIDE WILDLIFE HABITAT AND ARMOR INLET CHANNEL BANKS.
