Cove Restoration Planting Plan

Mayflower Pipeline Incident Response
Mayflower, Arkansas

February 2015

Revision 1

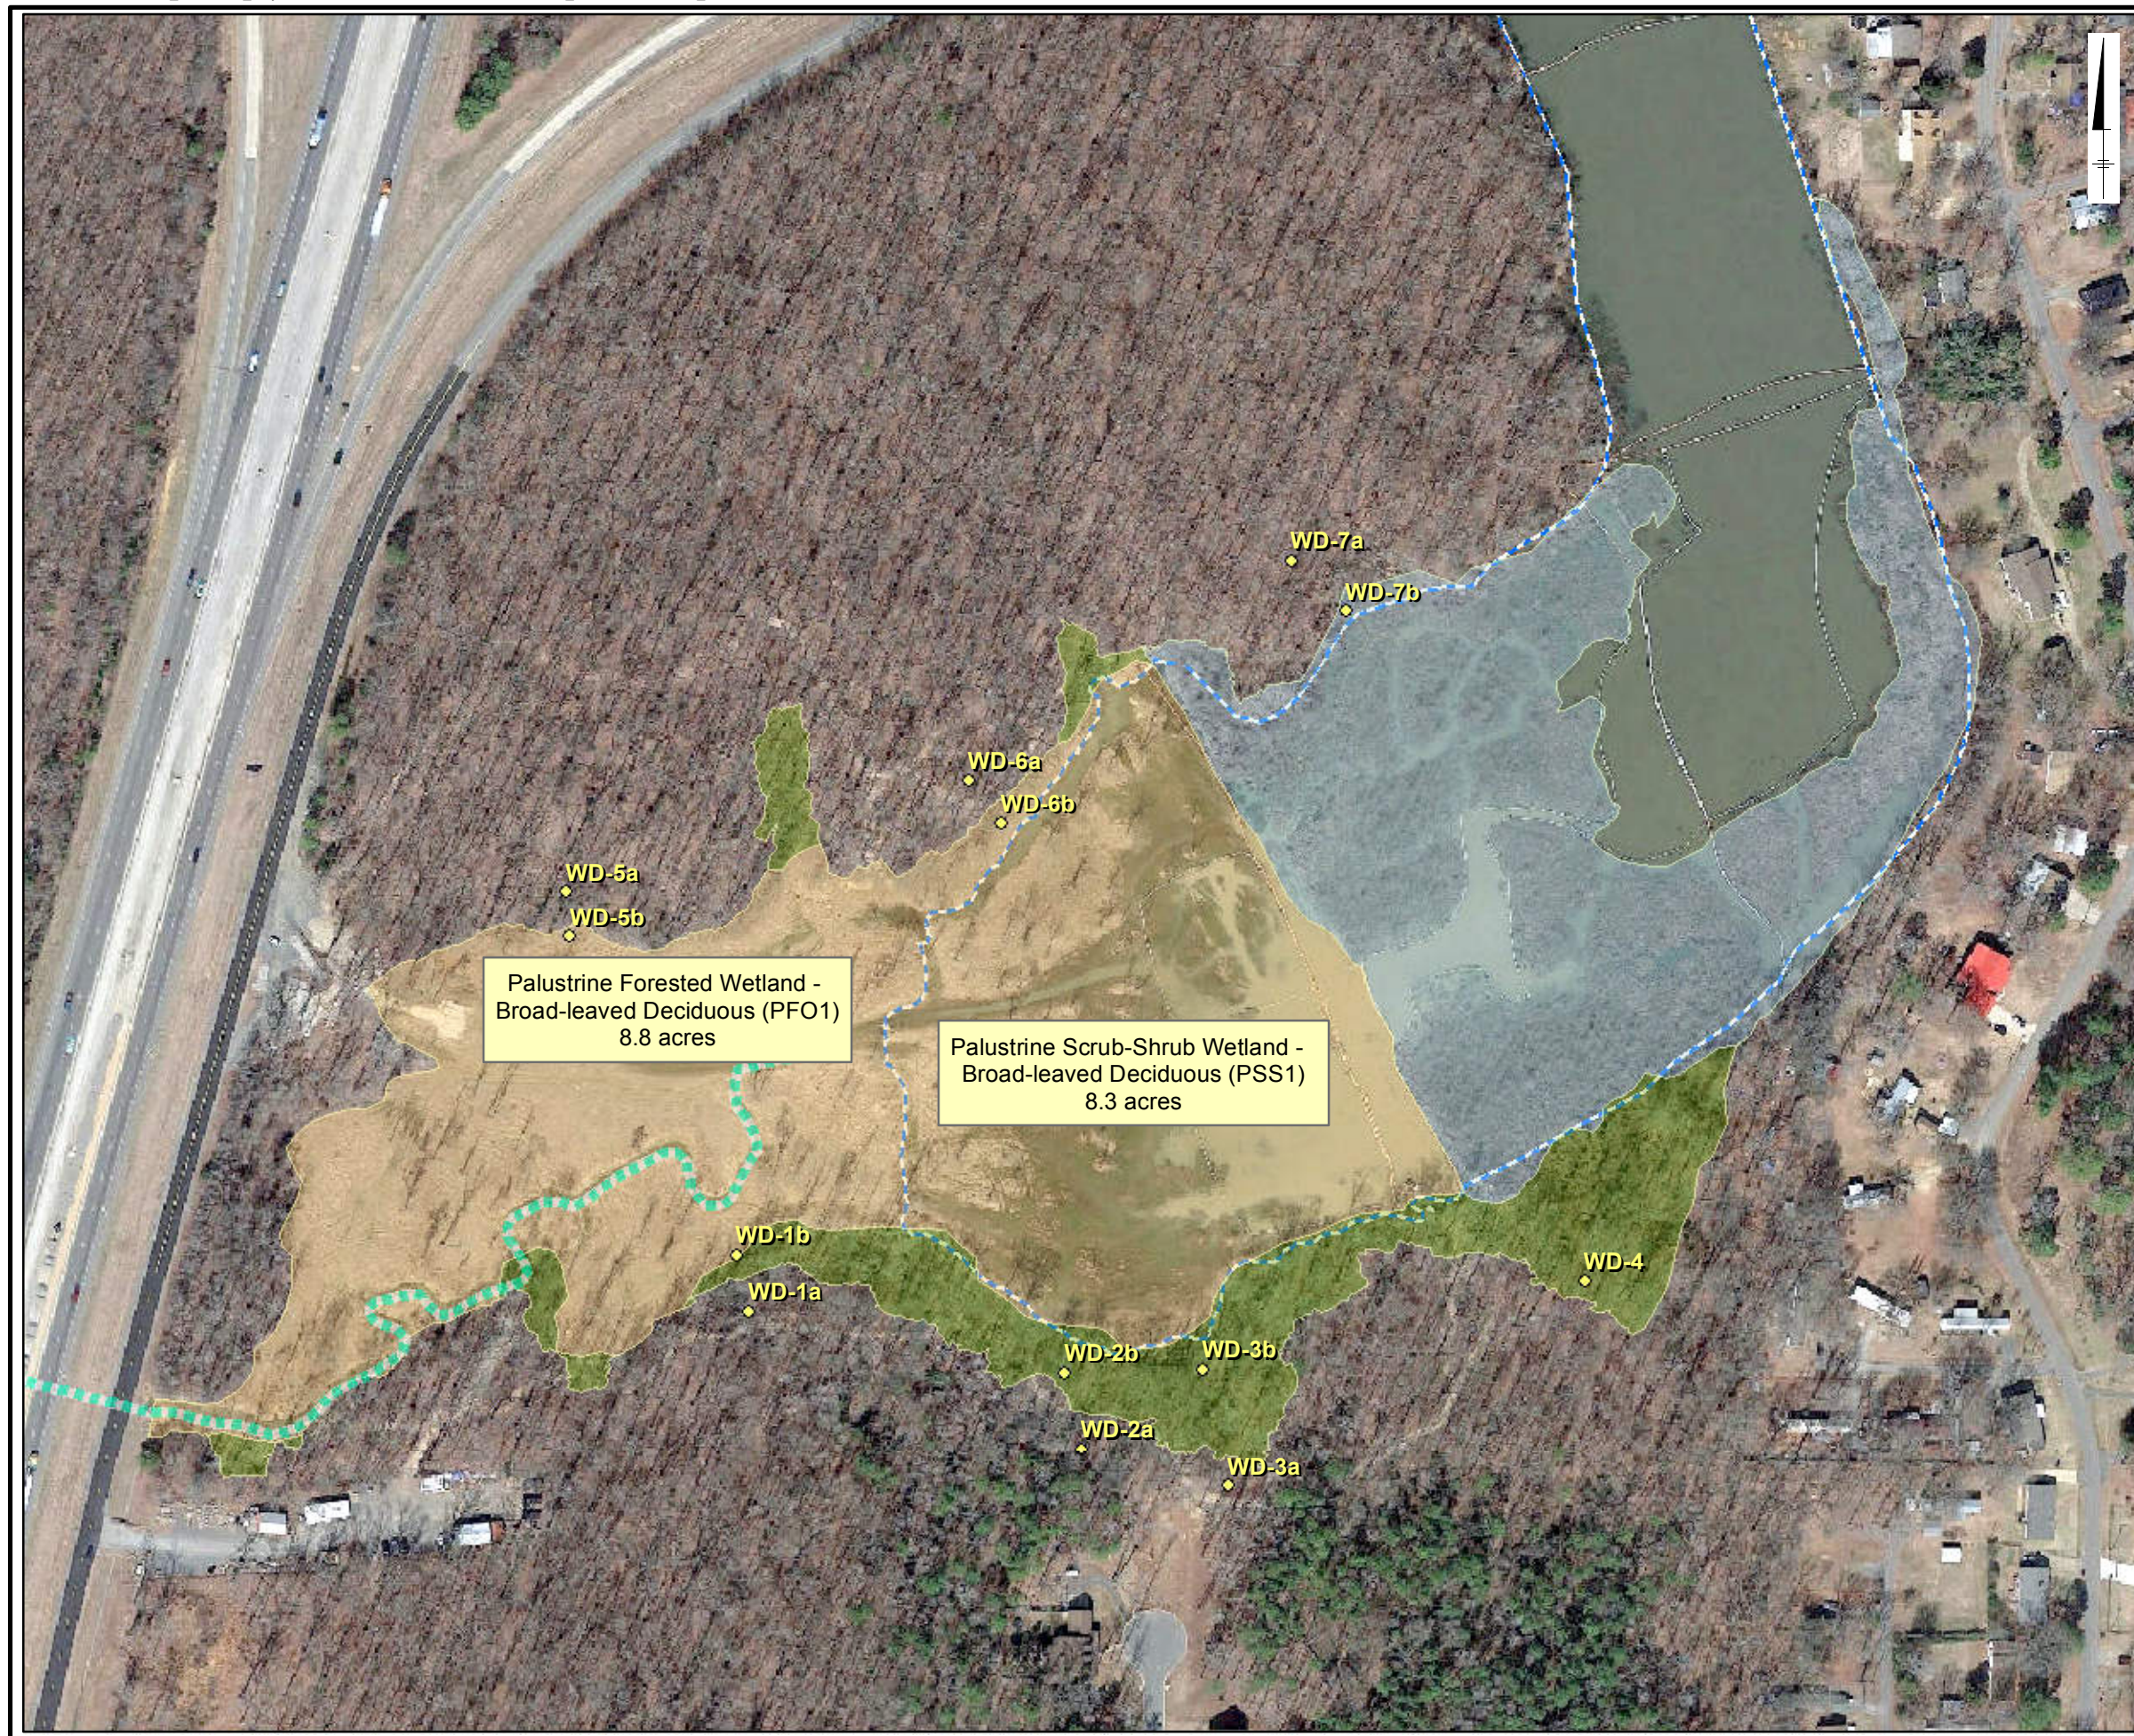
Wetland Delineation Summary

- Wetland Delineation Points
- Drainage Path
- Approximate Waters Edge
- Existing Forested Wetlands (4.4 acres)
- Existing Vegetated Wetlands (10.3 acres)
- Disturbed Wetlands (17.1 acres)

1. Conastoga-Rovers & Associates conducted a wetland delineation in April 2014 using the methodology outlined in the 1987 USACE Wetland Delineation Manual, including the Atlantic and Gulf Coast Regional Supplement, and Regulatory Guidance Letter 08-02.
2. The vegetated area shown in this plan was digitized based on the February 2014 aerial photo that was acquired via Google Enterprise Geo Master License
3. The water's edge changes based on season and recent rainfall. The approximate water's edge is based on conditions during the pre-design study in April 2014.
4. Vegetation was not cleared from the areas labeled "Existing Forested Wetland" and "Existing Vegetated".
