**Targeted Organoclay Placement in the Heavily Vegetated Area  
Post-Construction Maintenance Work Plan  
Mayflower Pipeline Incident Response, Mayflower, Arkansas**

## Post-Construction Sheen Monitoring Monthly Report #1: April 2015

### Post-Construction Sheen Monitoring Monthly Report #2: May 2015

## Post-Construction Sheen Monitoring Monthly Report #3: June 2015

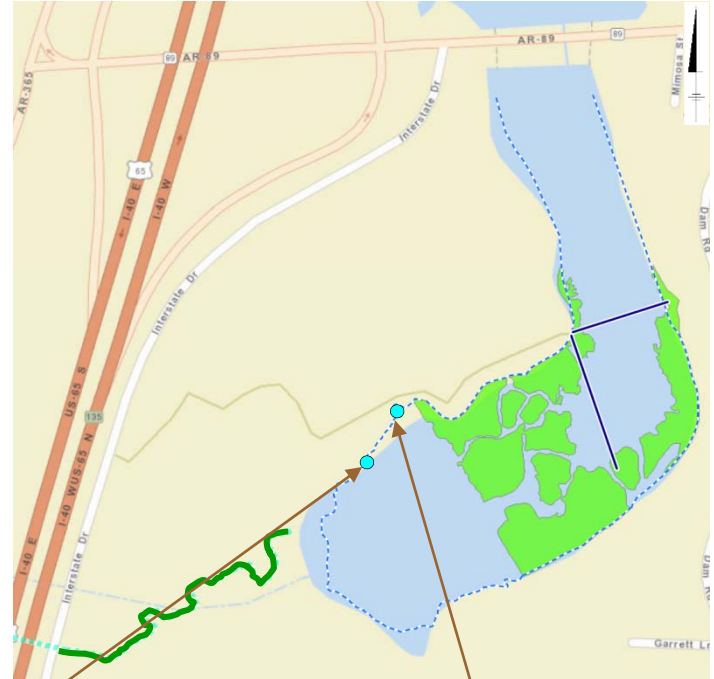
Cove (Summary of Observations from April 2015)

- No sheen observed.

- Two brittle sheens observed, one silver gray and one rainbow/silver gray, in Open Water Area.
- No sheen observed in Heavily Vegetated Area.
- No sheen observed downstream of Heavily Vegetated Area.

Mitigation: None needed

Path Forward for May 2015: Continue biweekly sheen monitoring in cove.

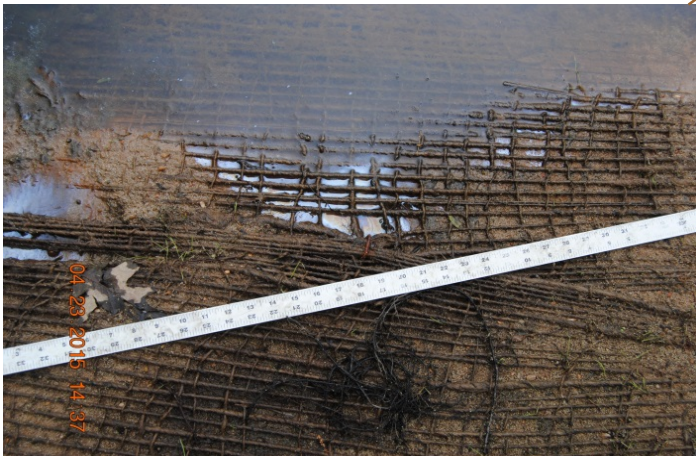
Rainbow/Silver Gray Sheen Observation on 04/23/2015

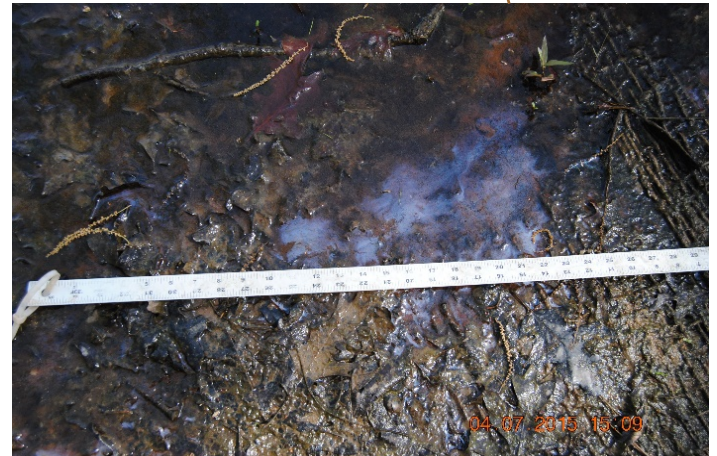
Silver Gray Sheen Observation on 04/07/2015

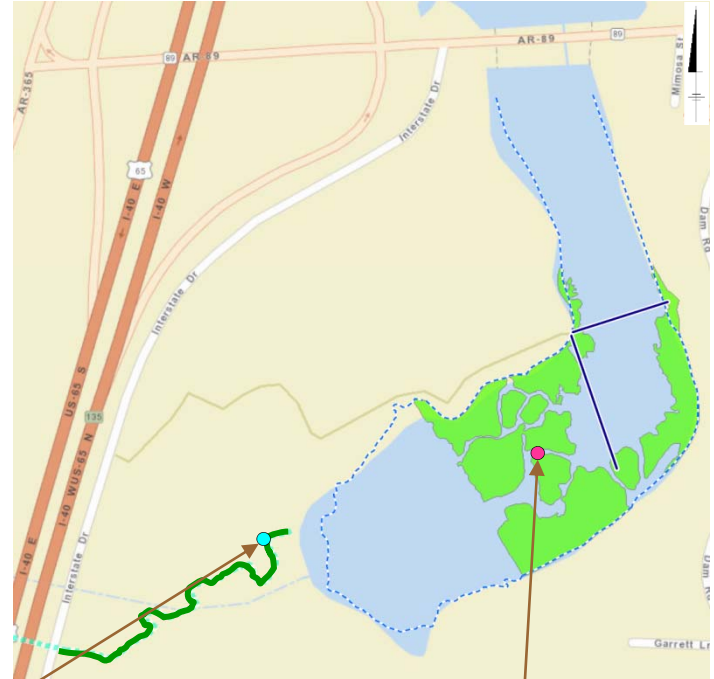
Cove (Summary of Observations from May 2015)

- One brittle silver gray sheen observed.

- No sheen observed in Open Water Area.
- One patch/streamer of silver gray sheen observed in Heavily Vegetated Area. Sheen did not break when disturbed ("non-brittle")<sup>2</sup>.
- No sheen observed downstream of Heavily Vegetated Area.

Mitigation: Non-brittle sheen was removed.

Path Forward for June 2015: Continue biweekly sheen monitoring in cove.

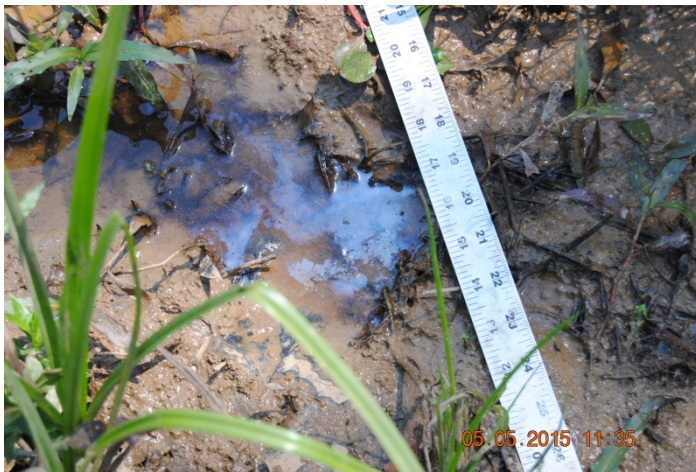
Silver Gray Sheen Cover Observation on 05/05/2015

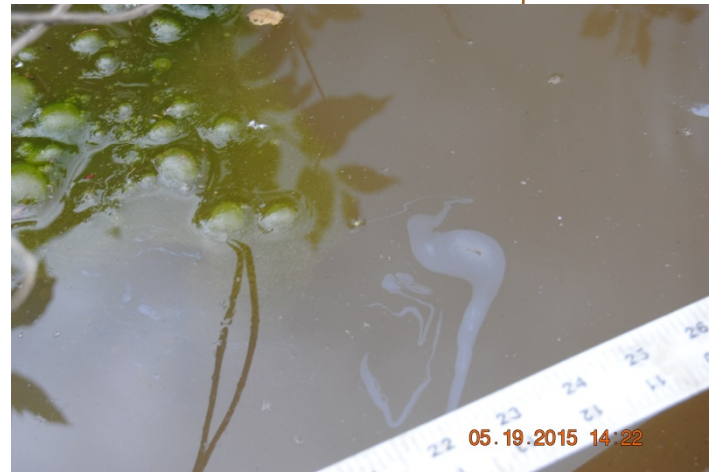
Silver Gray Sheen Patch/Streamer Observation on 05/19/2015

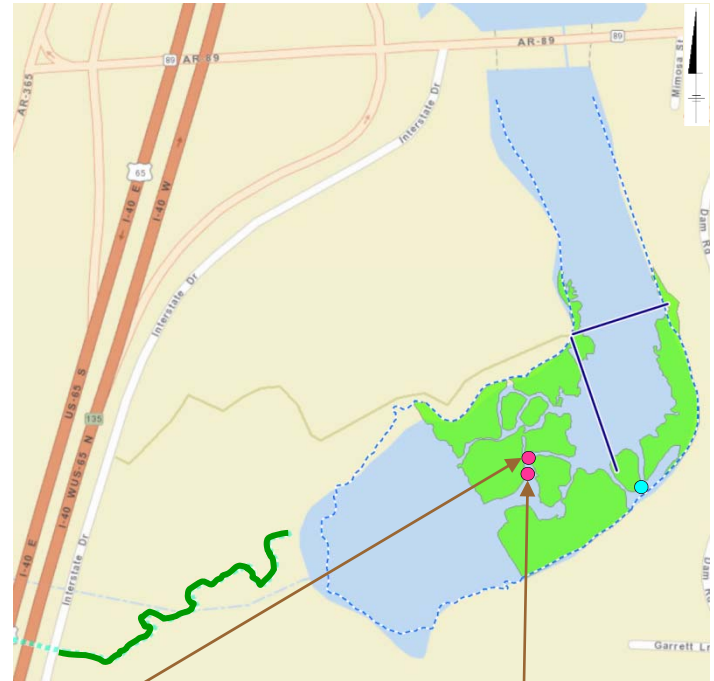
Cove (Summary of Observations from June 2015)

- No sheen observed in Open Water Area.
- June 12, 2015: One patch/streamer of silver gray sheen observed in Heavily Vegetated Area. Sheen did not break when disturbed (“non-brittle”)¹. A sheen sample was collected for laboratory analysis.
- June 12, 2015: One cover (no particular structure) of silver gray sheen observed downstream of Heavily Vegetated Area. Sheen broke apart when disturbed (“brittle”)².
- June 23, 2015: One patch/streamer of non-brittle¹ silver gray sheen observed in Heavily Vegetated Area. A sheen sample was collected for laboratory analysis.

- The laboratory analysis of sheen net samples collected from Heavily Vegetated Area on May 19, June 12, and June 23, 2015 indicated that sheens resemble to crude oil from the Pegasus Pipeline.

Mitigation: Sheens were removed.

Path Forward for July 2015: Continue biweekly sheen monitoring in cove.

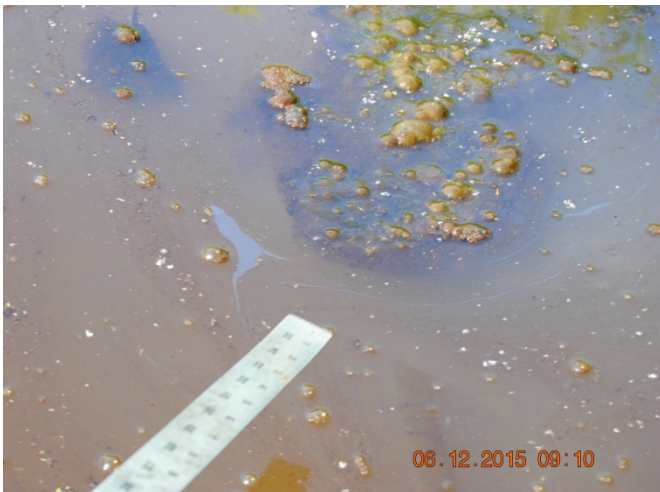
Silver Gray Sheen Cover Observation on 06/12/2015

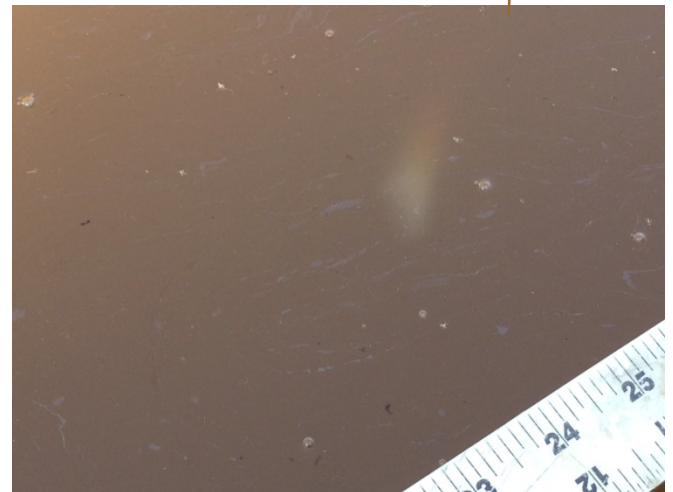
Silver Gray Sheen Patch/Streamer Observation on 06/23/2015

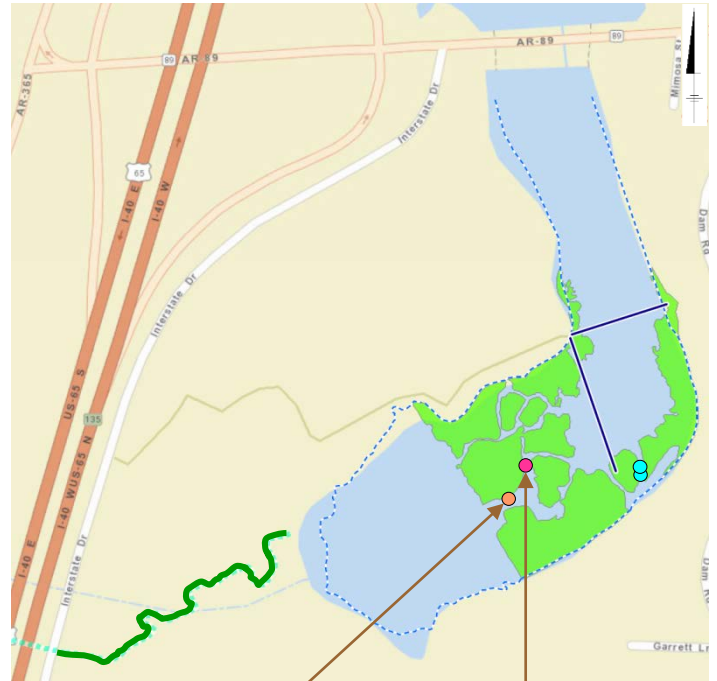
**Cove (Summary of Observations from July 2015)**

- No sheen observed in Open Water Area.
- July 2, 2015: One streamer of silver gray sheen observed in Heavily Vegetated Area. Sheen did not break when disturbed ("non-brittle"<sup>1</sup>). A sheen sample was collected for laboratory analysis.
- July 16, 2015: One patch/streamer of non-brittle<sup>1</sup> silver gray sheen with an oil spot (0.125-inch wide) observed in Heavily Vegetated Area. A sheen sample was collected for laboratory analysis.
- July 16, 2015: One cover (no particular structure) of silver gray sheen observed in Heavily Vegetated Area. Sheen broke apart when disturbed ("brittle"<sup>2</sup>).
- July 30, 2015: One patch of brittle<sup>2</sup> silver gray sheen observed in Heavily Vegetated Area.

- The laboratory analysis of sheen net samples collected from Heavily Vegetated Area on July 2 and 16, 2015 indicated that sheens resemble crude oil from the Pegasus Pipeline.

Mitigation: Non-brittle sheens were removed by sampling.

- Continue biweekly sheen monitoring in Cove.

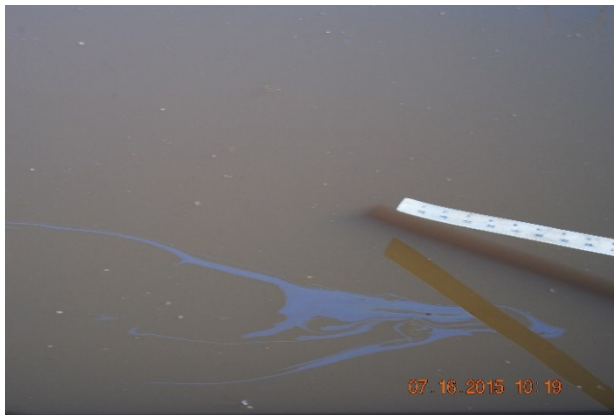
**Silver Gray Sheen Patch/Streamer Observation with an Oil Spot (0.125-inch Wide) on 07/16/2015**

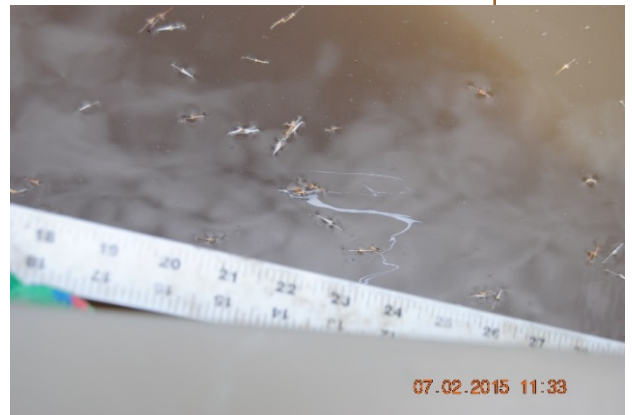
**Silver Gray Sheen Streamer Observation on 07/02/2015**
