**Completion of Targeted Organoclay Placement in the Heavily Vegetated Area
 Post-Construction Maintenance Summary
 Mayflower Pipeline Incident Response, Mayflower, Arkansas**

On August 20, 2015, ExxonMobil Environmental Services Company submitted a work plan (ARCADIS 2015) to the Arkansas Department of Environmental Quality (ADEQ) proposing the targeted placement of additional organoclay in a portion of the cove at the Mayflower Pipeline Incident Response site to mitigate crude oil-related sheens observed during recent monitoring events. As described in this work plan, the targeted organoclay placement was proposed in an area of up to 3,500 square feet in the natural channels (see Figure 1 below).

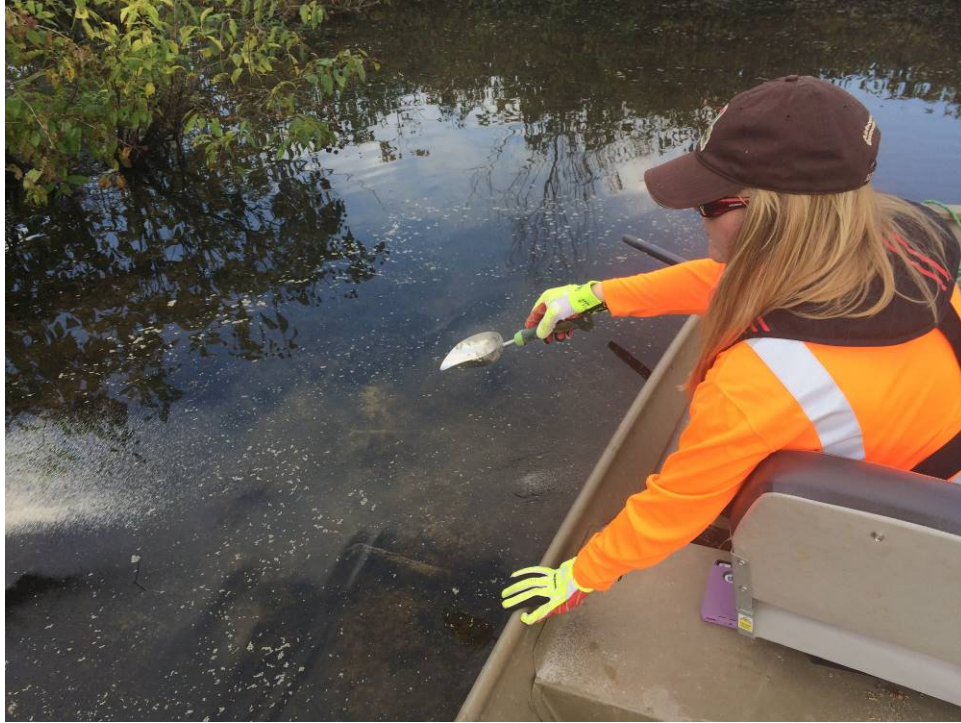
Photo 1 Manual Spreading of Organoclay in the Heavily Vegetated Area

The described targeted organoclay placement was completed on September 15 and 16, 2015 within the Heavily Vegetated Area by GHD of Little Rock, Arkansas. PMFI® organoclay material (developed by CETCO™) was placed directly over the sediment surface within the targeted area by manually spreading the organoclay from a boat. Prior to the organoclay placement, the targeted area was marked using flagging tape to assist with the organoclay placement. A total of 396 pounds of organoclay was placed over an area of 3,457 square feet, at an application of approximately 1.1 pound per 10 square feet. An Arcadis U.S., Inc. Construction Quality Assurance (CQA) Monitor recorded and verified the weight of organoclay material placed in the targeted area to confirm that the target placement was met. Personnel from the ADEQ were on site during the performance of the work.

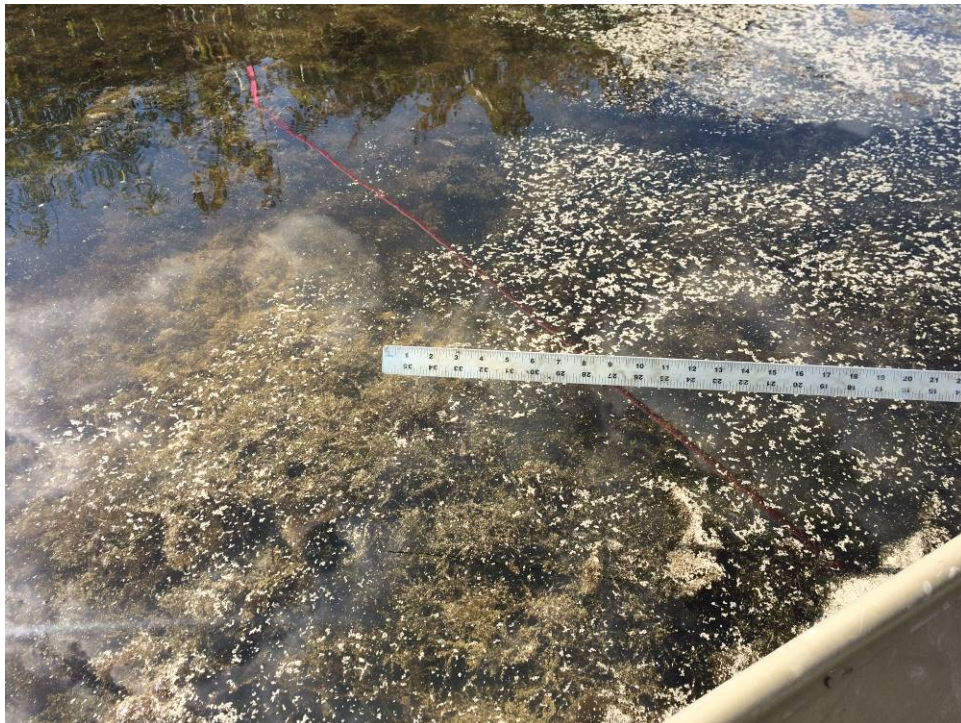
Photo 2 Organoclay Placement in the Heavily Vegetated Area

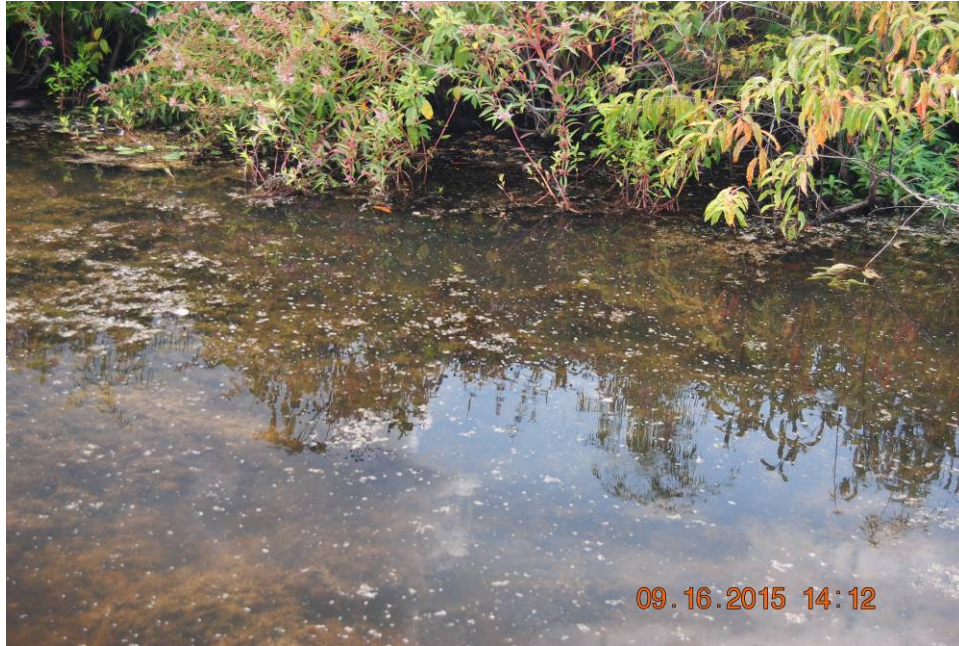
Photo 3 Organoclay Placement in the Heavily Vegetated Area
